## Appendix C3

### SEM/EDS Data for Unused and Test-2 Day-30 Galvanized Steel Coupons

This appendix shows SEM/EDS results for the metal galvanized steel coupons in three different categories: (1) unused; (2) suspended or unsubmerged; and (3) submerged. *Unused* refers to the coupon condition before being subjected to ICET test conditions. *Suspended* or *unsubmerged* refers to coupons located above the water level of the solution during ICET tests. Suspended coupons contacted the solution only during the 4-hour spraying period at the start of the test. In addition, the surface of the suspended coupons may also be affected by moisture in the test chamber gas space. *Submerged* refers to the coupons that were immersed in the solution for the entire test.

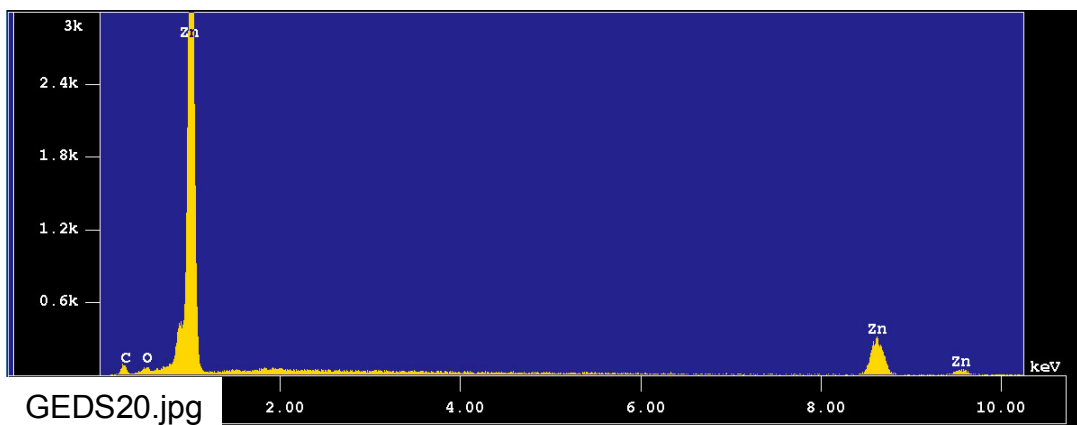
Figure C3-5. EDS counting spectrum for smooth zinc surface (GEDS20).

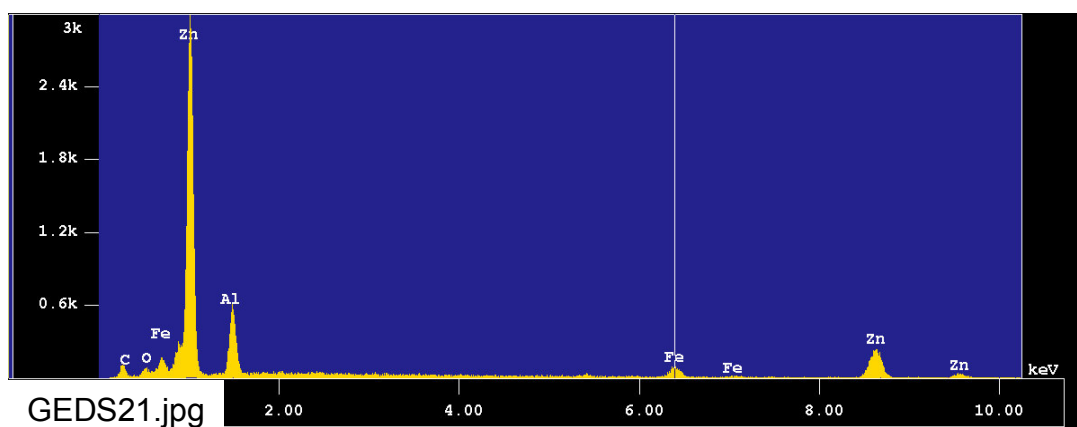
Figure C3-6. EDS counting spectrum for the small dark circular spots shown in Figure C3-4 (GEDS21).

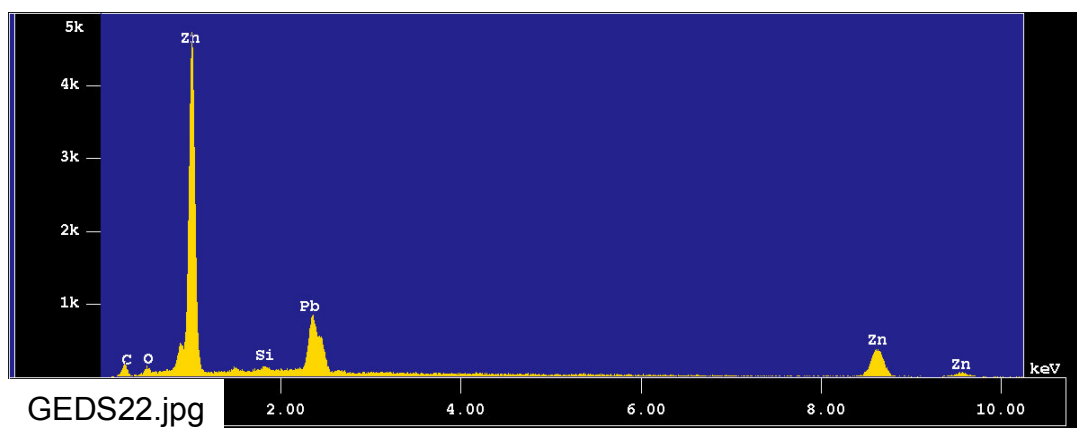
Figure C3-7. EDS counting spectrum for the bright spots shown in Figure C3-4 (GEDS22).

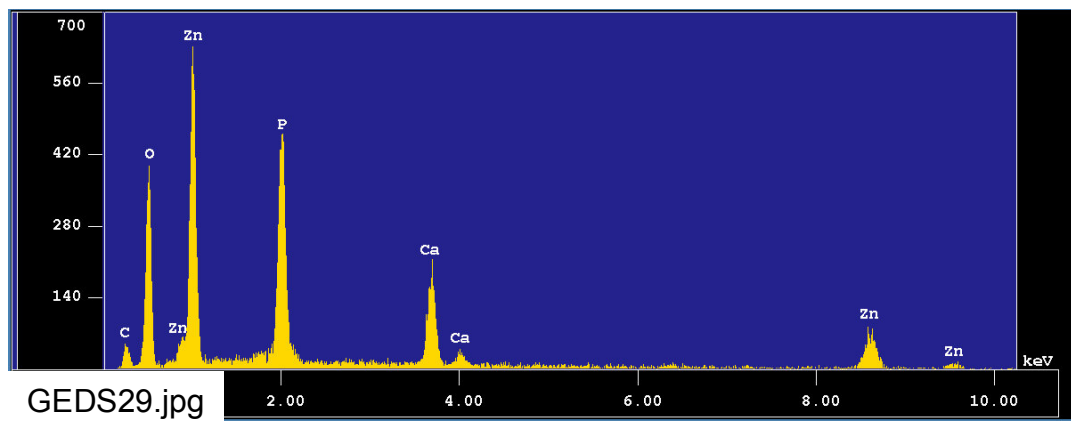
**Figure C3-11. EDS counting spectrum on fiberlike crystals shown in Figure C3-10 (GEDS29).**

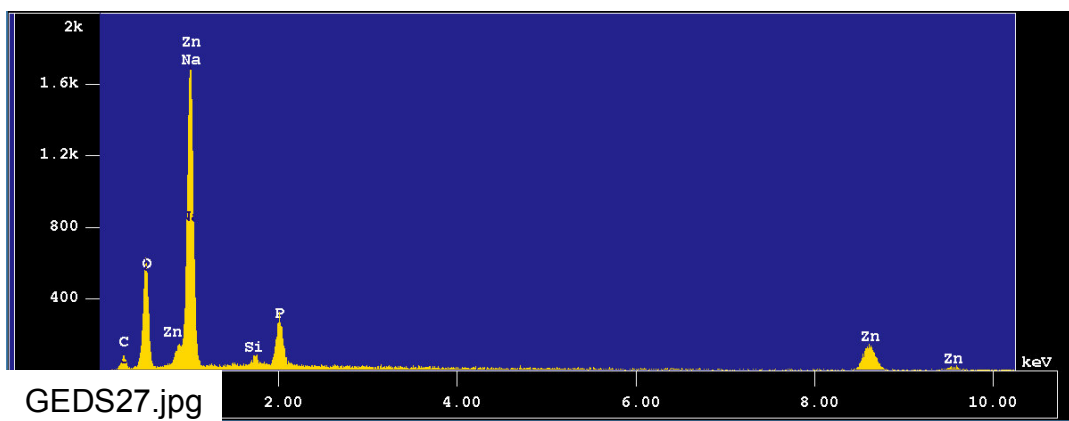
**Figure C3-16. EDS counting spectrum on the dark spots shown in Figure C3-15 (GEDS27).**

The results from the chemical composition analysis for GEDS27 are given in Table C3-1.

Element	Mass%	Atomic%	ZAF	Z	A	F
O	25.047	54.4632	0.9144	0.8736	1.0468	0.9999
Na	0.000	0.0000	2.3046	0.9205	2.5030	1.0002
Si	1.403	1.7380	1.5824	0.8740	1.8129	0.9987
P	7.881	8.8519	1.0292	1.0482	0.9818	1.0000
Zn	65.668	34.9468	1.1110	1.1123	0.9988	1.0000

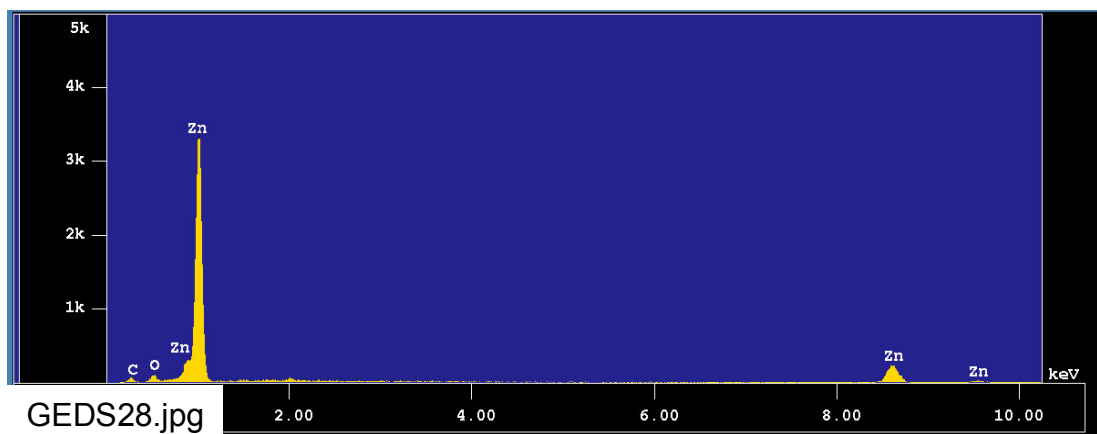
**Figure C3-17. EDS counting spectrum on the light surface shown in Figure C3-15 (GEDS28).**
