Appendix D1

ESEM and SEM/EDS Data for Test-2 Day-16 Fiberglass in High- and Low-Flow Zones

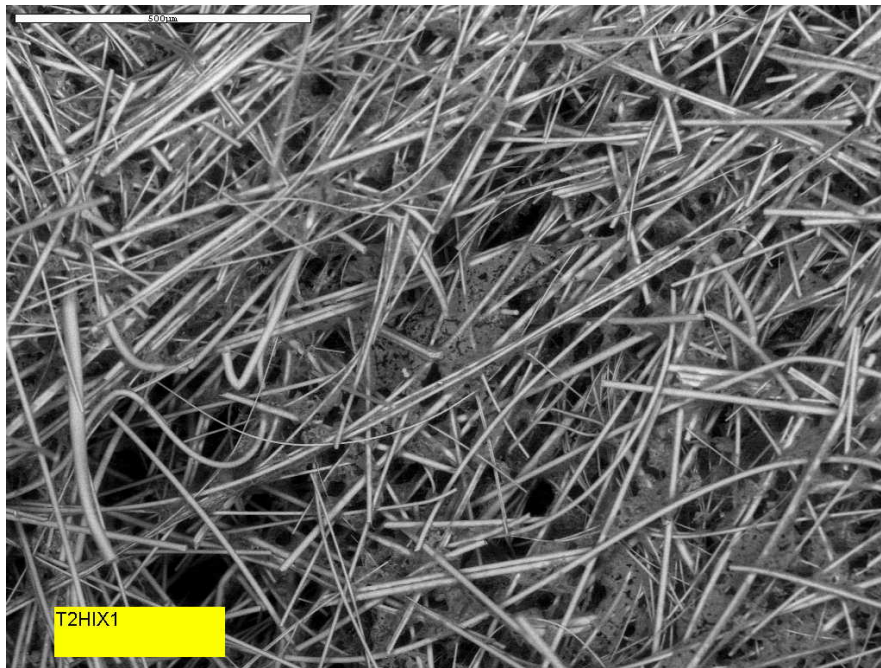
Figure D1-1. BSE image overview (T2HIX1).

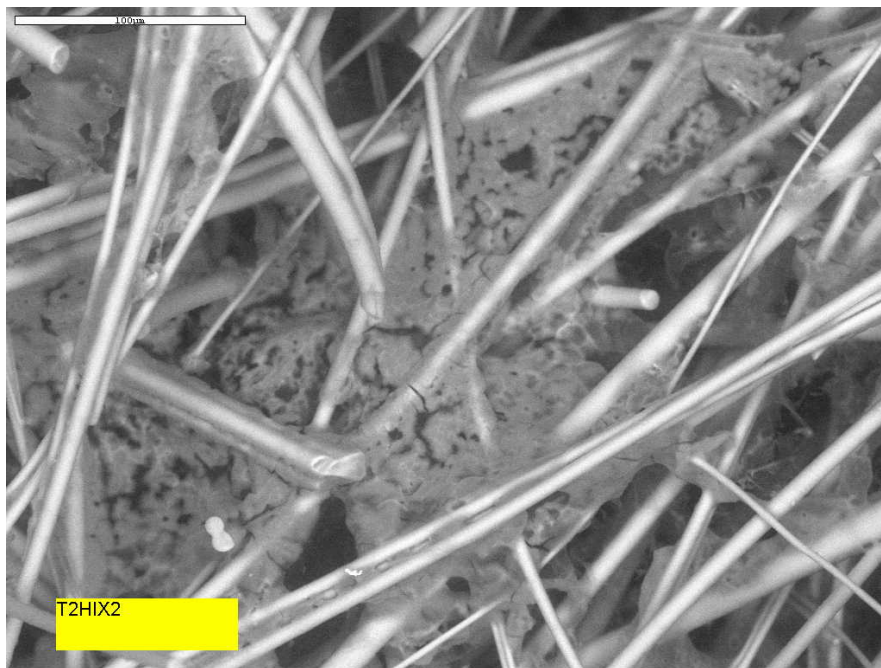
Figure D1-2. BSE image on center of image T2HIX1 above (T2HIX2).

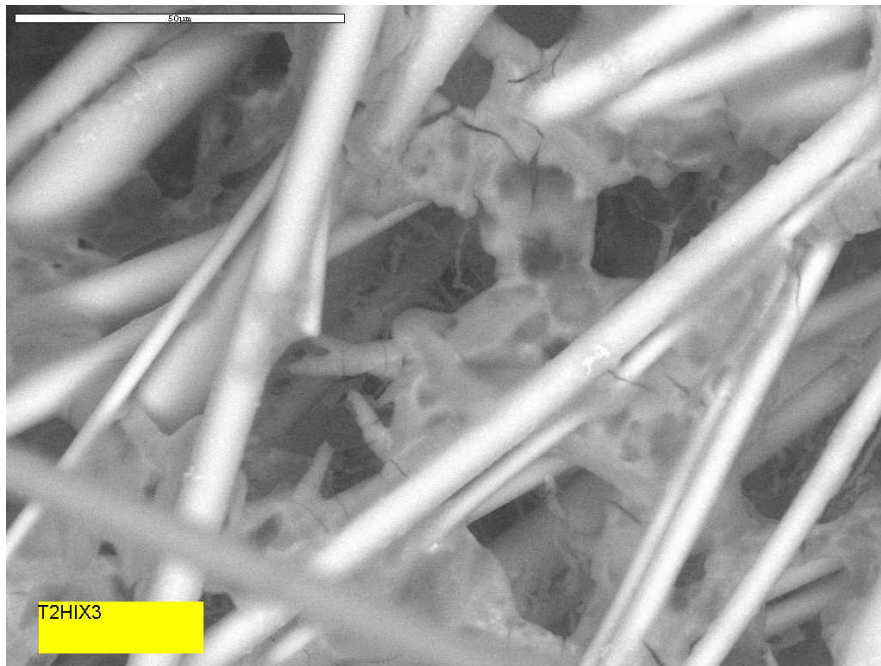
Figure D1-3. BSE image at 1000 times magnification (T2HIX3).

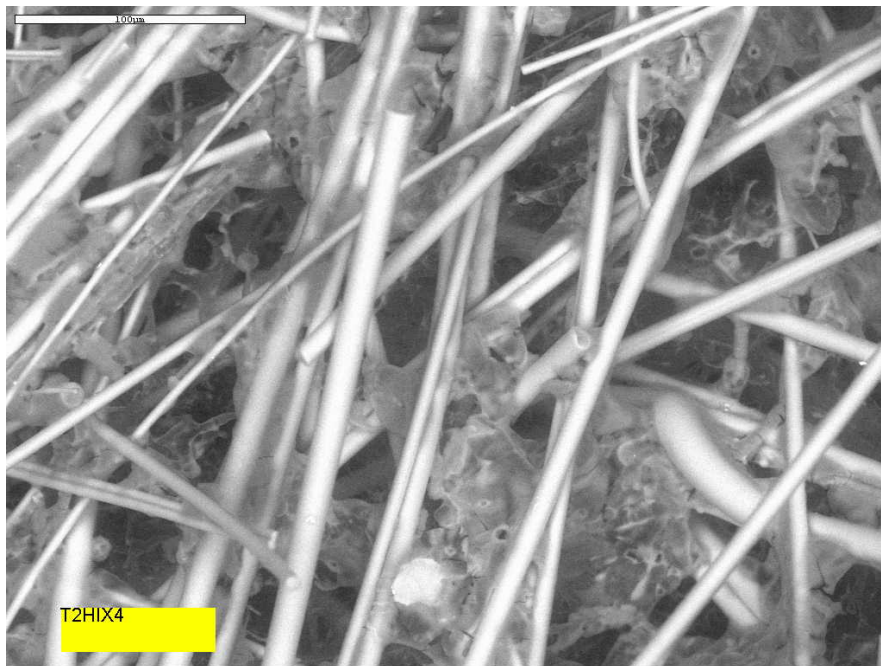
Figure D1-4. BSE image at another angle on the center of the image (T2HIX4).

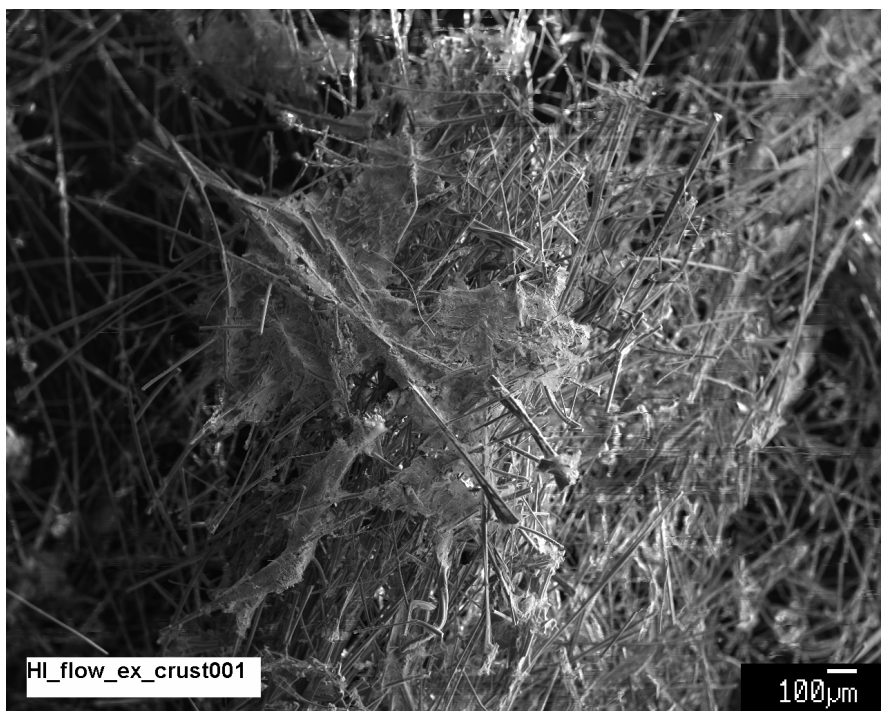
Figure D1-12. SEM image overview of exterior crust (HI_flow_ex_crust001).

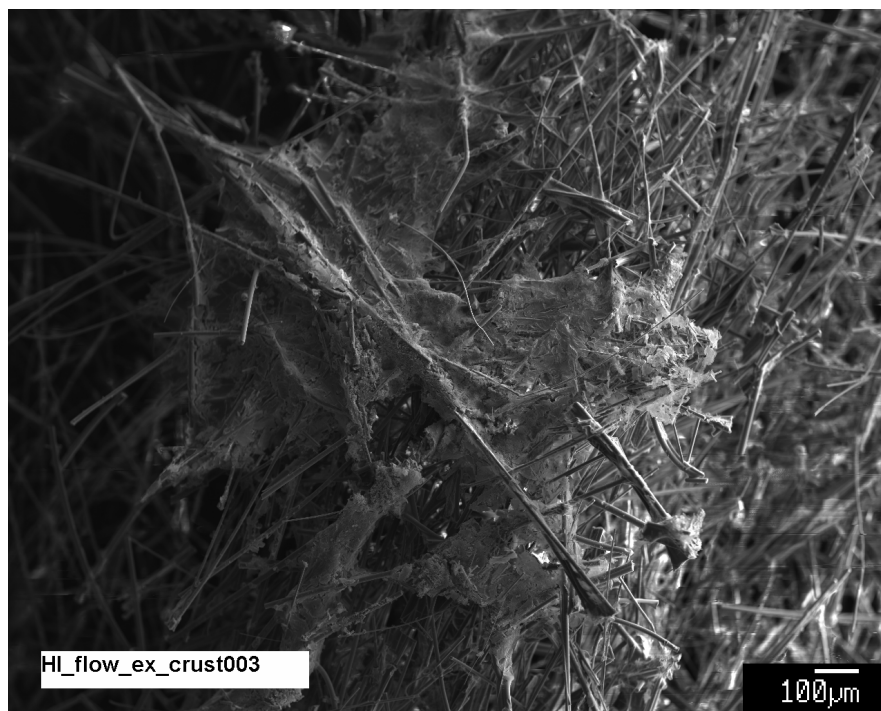
Figure D1-14. SEM image close-up view of crust (HI_flow_ex_crust003).

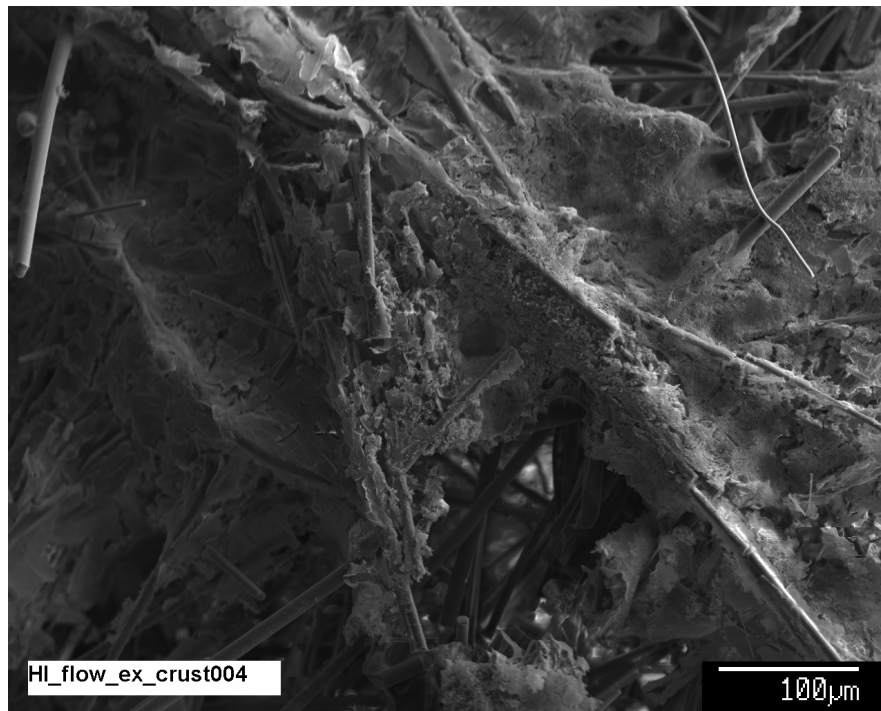
Figure D1-15. SEM image of crust at 150 times magnification (HI_flow_ex_crust004).

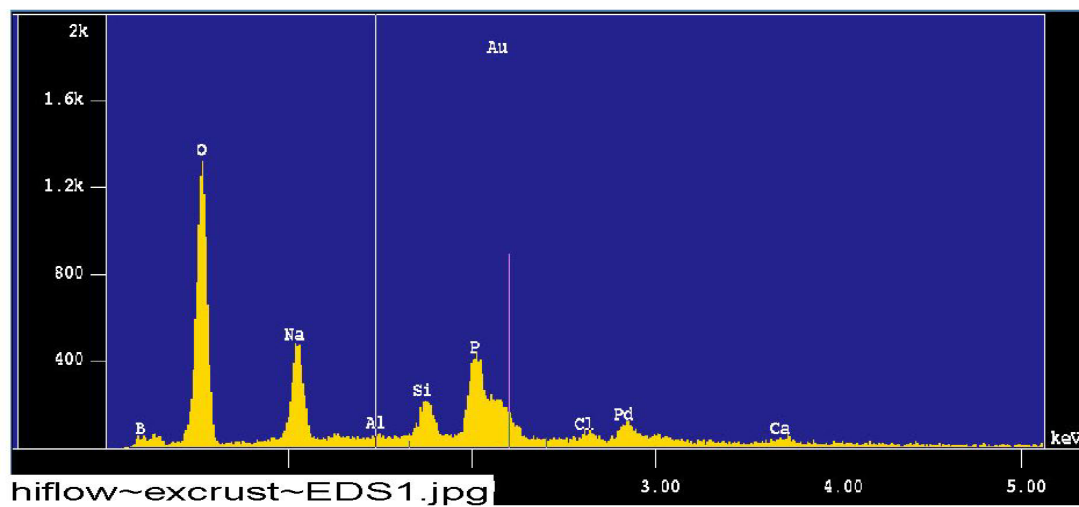
Figure D1-16. Counting spectrum image of the deposit area in Figure D1-15 (hiflow~excrust~EDS1).

The results from the chemical composition analysis for hiflow~excrust~EDS1 are given Table D1-1.

Element	Mass%	Atomic%	ZAF	Z	A	F
O	69.992	80.1268	0.7836	0.9917	0.7902	1.0000
Al	0.265	0.1798	1.1962	1.0046	1.1939	0.9974
Si	2.944	1.9201	1.0946	0.9924	1.1082	0.9953
Ca	1.156	0.5280	0.9997	1.0065	0.9932	1.0001
Na	11.074	8.8224	1.1534	0.9963	1.1562	1.0013
P	11.995	7.0932	0.8861	1.1964	0.7411	0.9993
Cl	2.574	1.3297	1.0964	1.0507	1.0440	0.9996

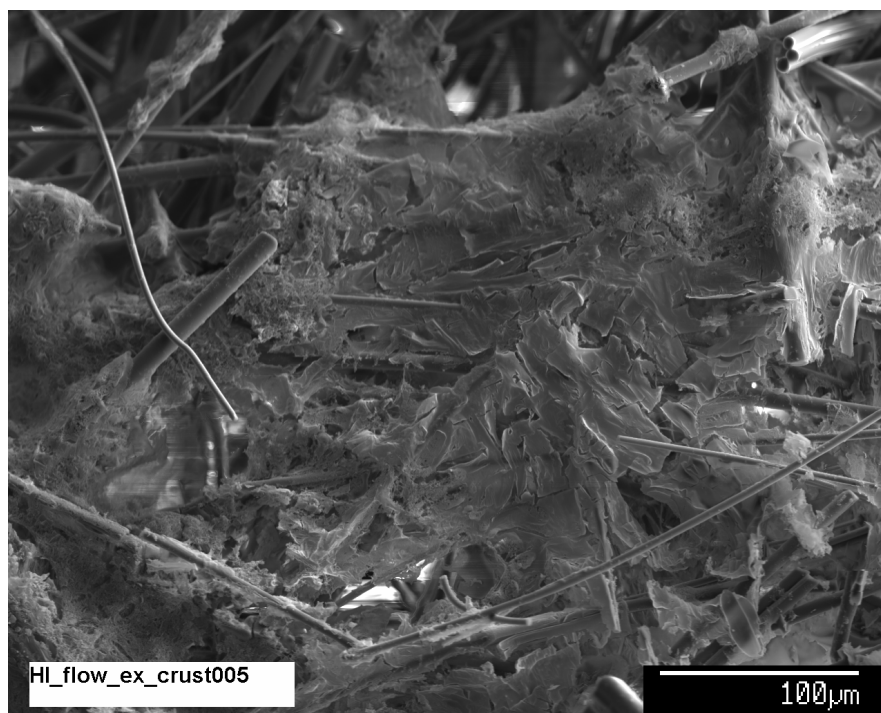
Figure D1-17. SEM image of a new exterior crust area at 270 times magnification (HI_flow_ex_crust005).

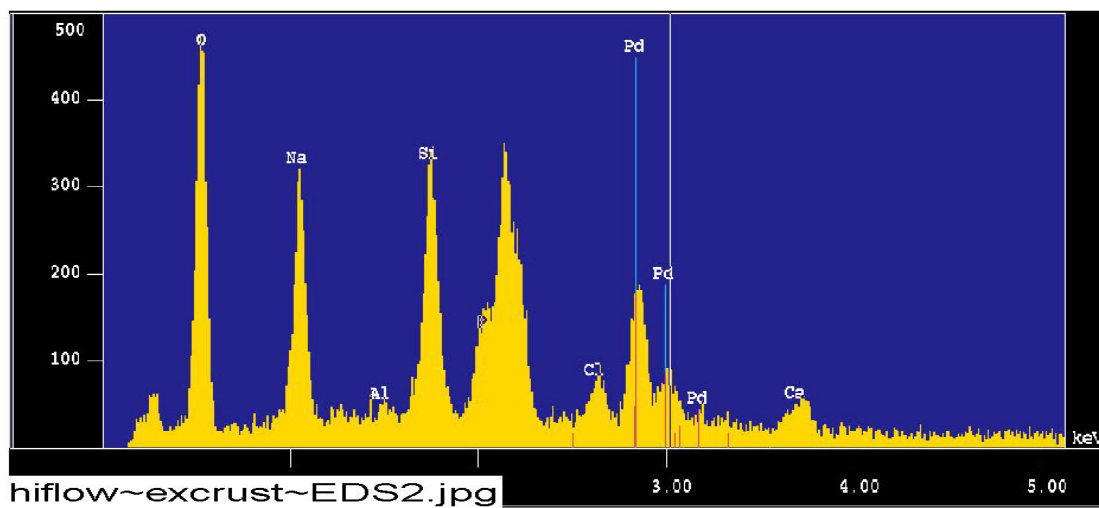
Figure D1-18. Counting spectrum image of the deposit area in Figure D1-17 (hiflow~excrust~EDS2).

The results from the chemical composition analysis for hiflow~excrust~EDS2 are given in Table D1-2.

Element	Mass%	Atomic%	ZAF	Z	A	F
O	63.140	74.8335	0.8873	0.9904	0.8959	1.0000
Al	0.704	0.4946	1.2005	1.0030	1.2008	0.9967
Si	9.996	6.7486	1.1053	0.9908	1.1175	0.9982
Ca	2.633	1.2457	1.0047	1.0045	1.0001	1.0001
Na	13.248	10.9272	1.1201	0.9948	1.1246	1.0012
P	3.262	1.9970	0.9380	1.1944	0.7868	0.9981
Cl	7.017	3.7533	1.0828	1.0488	1.0332	0.9992

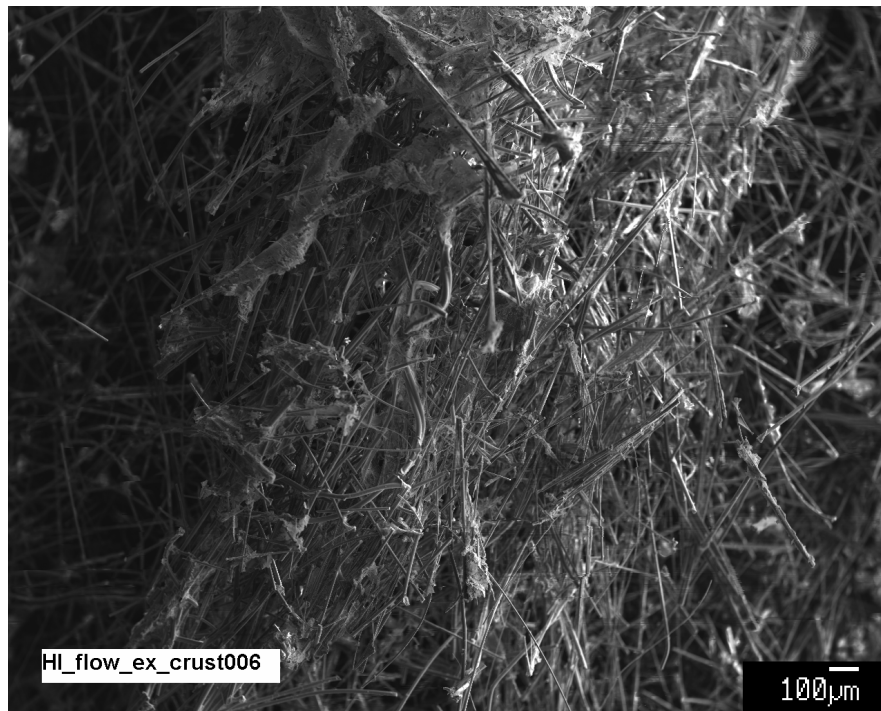
Figure D1-19. SEM image overview of another area for the exterior crust (HI_flow_ex_crust006).

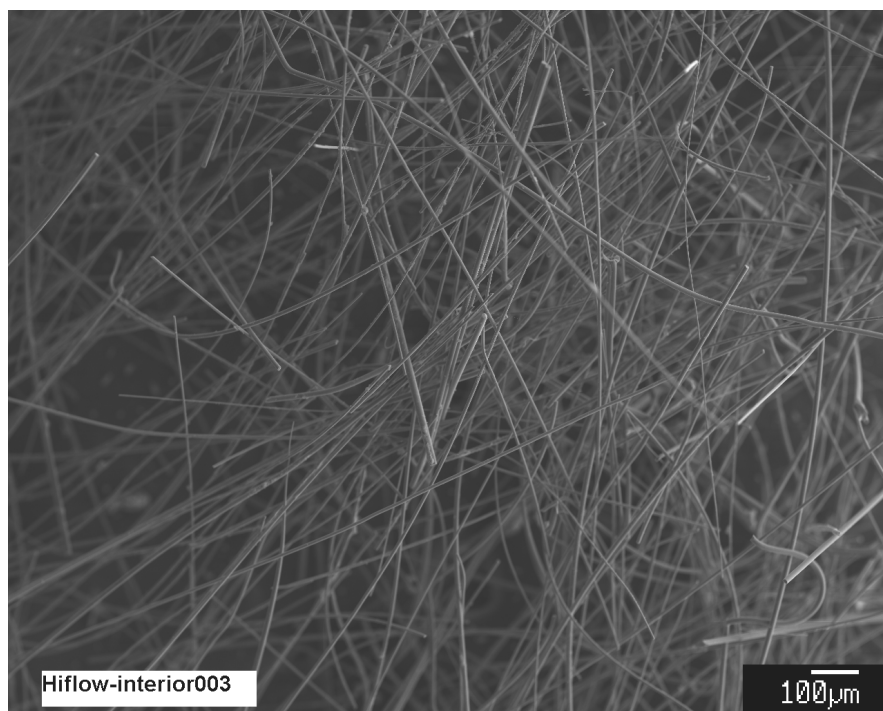
Figure D1-22. Test-2 Day-16 SEM image showing clean fibers (Hiflow-interior003).

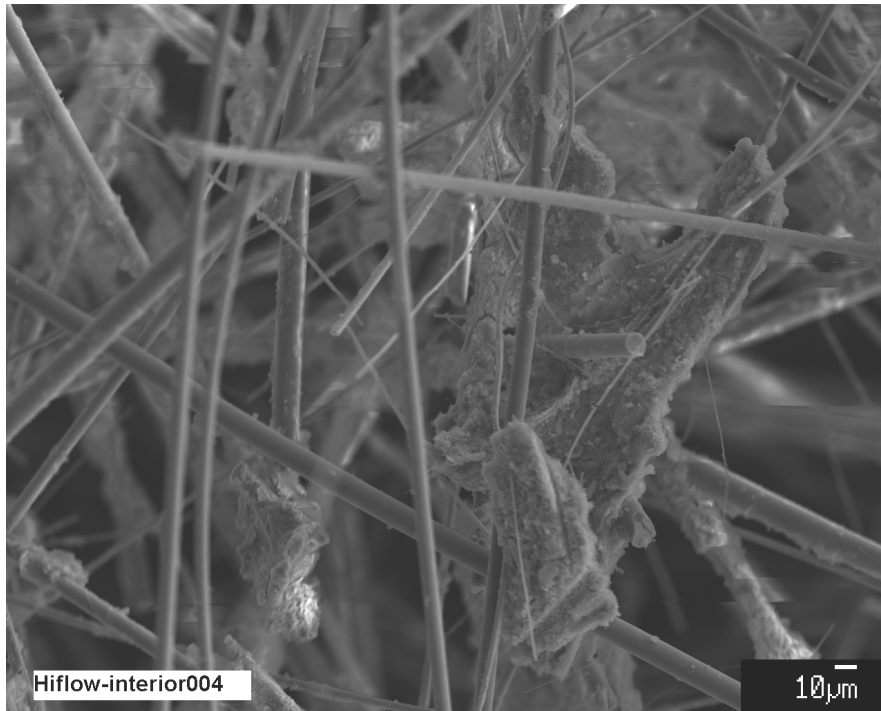
Figure D1-23. Test-2 Day-16 SEM image of deposits for high-flow interior (Hiflow-interior004).

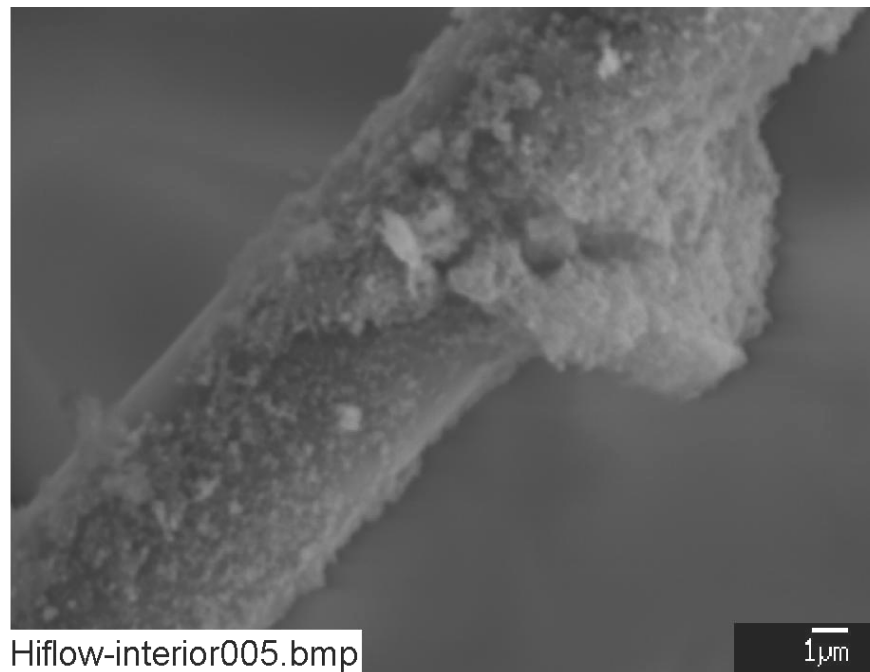
Figure D1-24. Test 2-Day-4 SEM image zoomed in on deposits on fiberglass, magnification 5000 times (Hiflow-interior005).

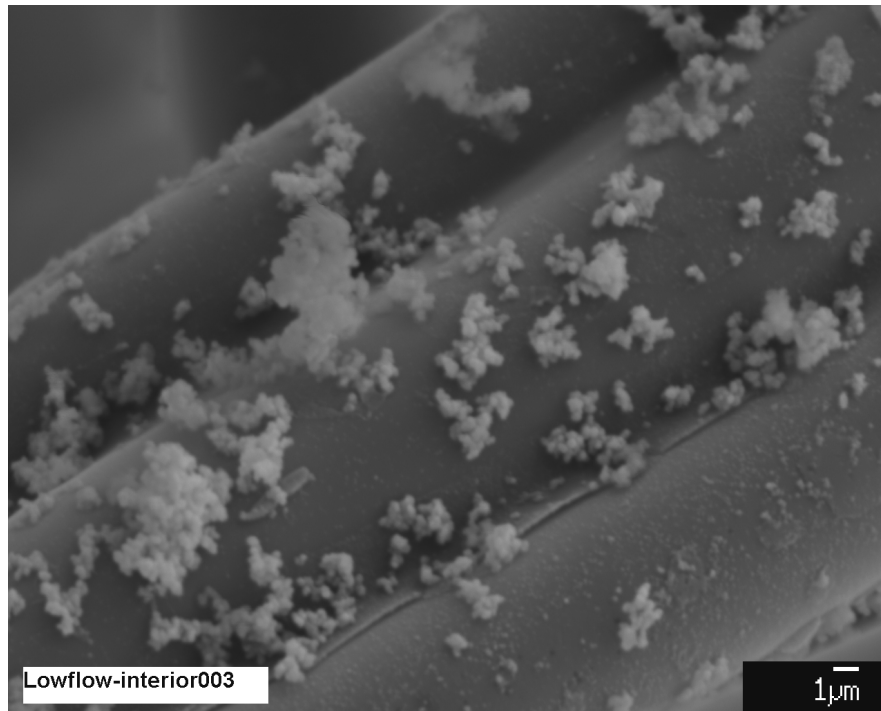
Figure D1-27. Test-2 Day-16 SEM image at 3500 times magnification of deposits shown in Lowflow-interior002 (Lowflow-interior003).

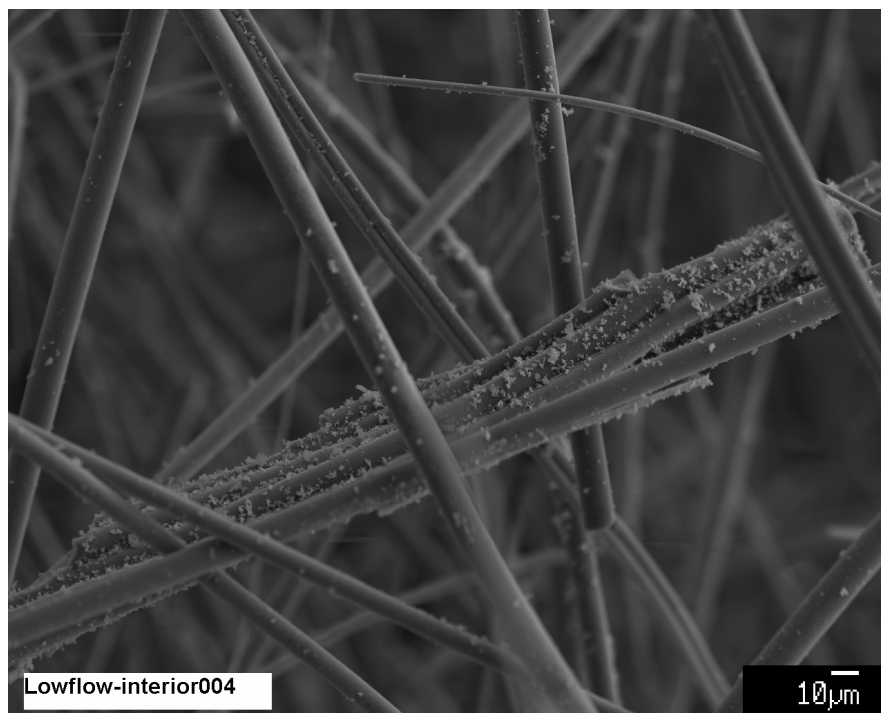
Figure D1-28. Test-2 Day-16 SEM image at 370 times magnification showing closeup of deposits in Lowflow-interior002 (Lowflow-interior004).

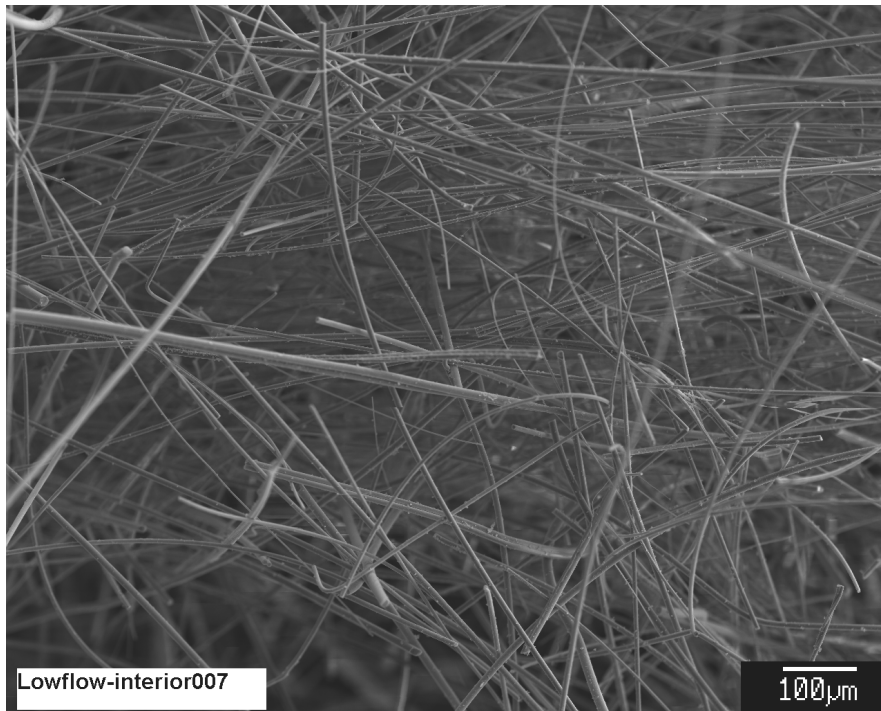
General Observations: Low-flow interior looks cleaner than high-flow interior.
No crusts, only small particles.
Images Lowflow-interior001 through 004 taken on the same region

Figure D1-31. Test-2 Day-16 SEM image showing a cleaner appearance than seen in some high-flow interior samples (Lowflow-interior007).

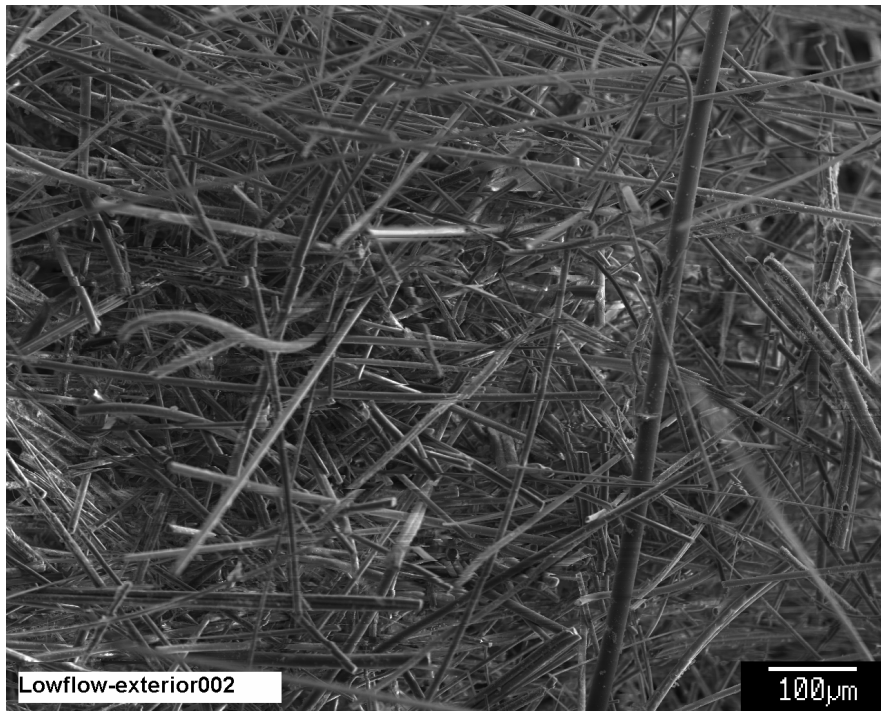
General Observations: Although sputtered again, some problems with charging remain.

Figure D1-33. Test-2 Day-16 SEM image closeup (charging) of the image Lowflow-exterior001 (Lowflow-exterior002).

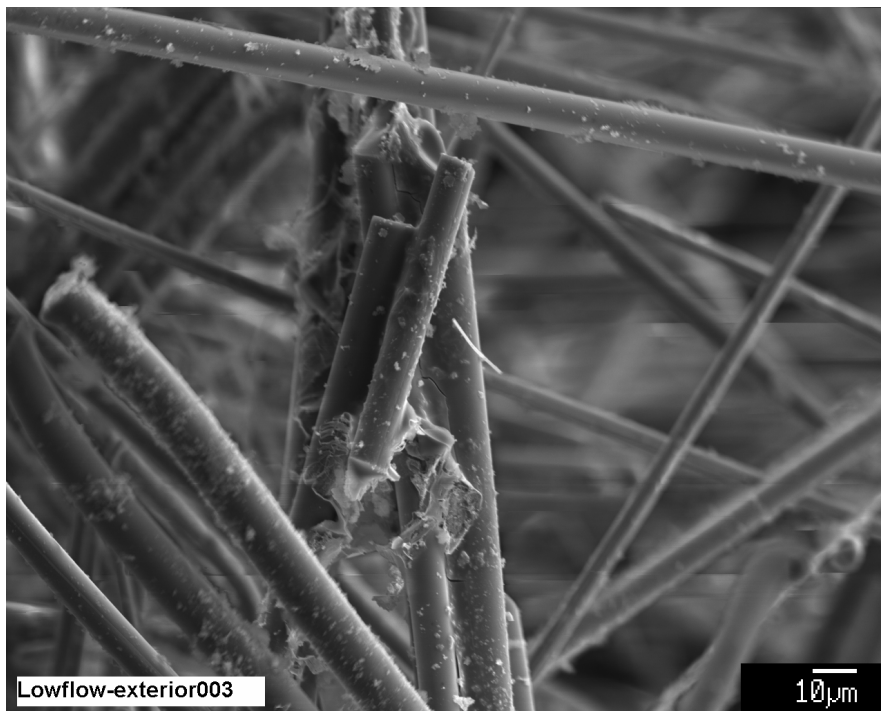
Figure D1-34. Test-2 Day-16 SEM image zooming in on deposits at 600 times magnification (Lowflow-exterior003).

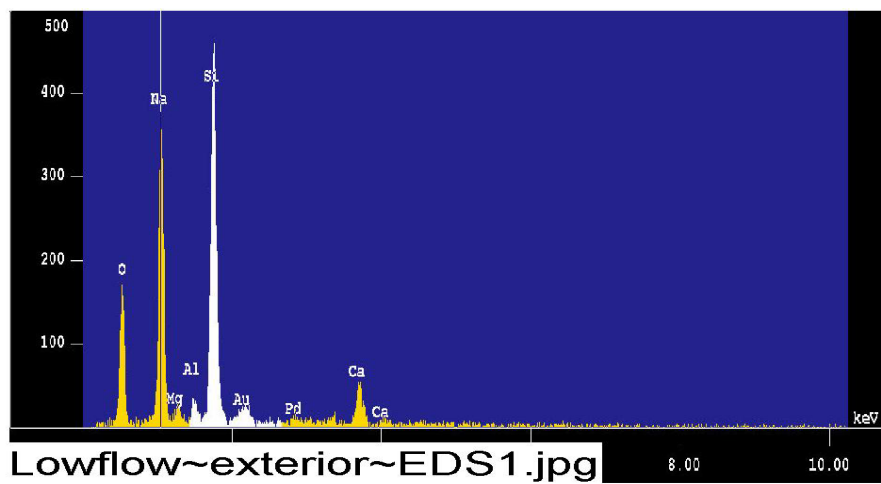
Figure D1-35. Test-2 Day-16 counting spectrum image for a particle on the fiberglass shown in Figure D1-34 (Lowflow~exterior~EDS1).

The results from the chemical composition analysis for Lowflow~exterior~EDS1 are given in Table D1-3.

Element	Mass%	Atomic%	ZAF	Z	A	F
O	41.276	53.6697	1.0489	0.9914	1.0580	0.9999
Na	24.595	22.2554	0.9716	0.9956	0.9752	1.0007
Mg	0.973	0.8323	1.2621	0.9981	1.2653	0.9993
Al	1.542	1.1892	1.2481	1.0035	1.2512	0.9940
Si	25.465	18.8616	1.1493	0.9912	1.1597	0.9999
Ca	6.149	3.1917	1.0088	1.0039	1.0048	1.0001

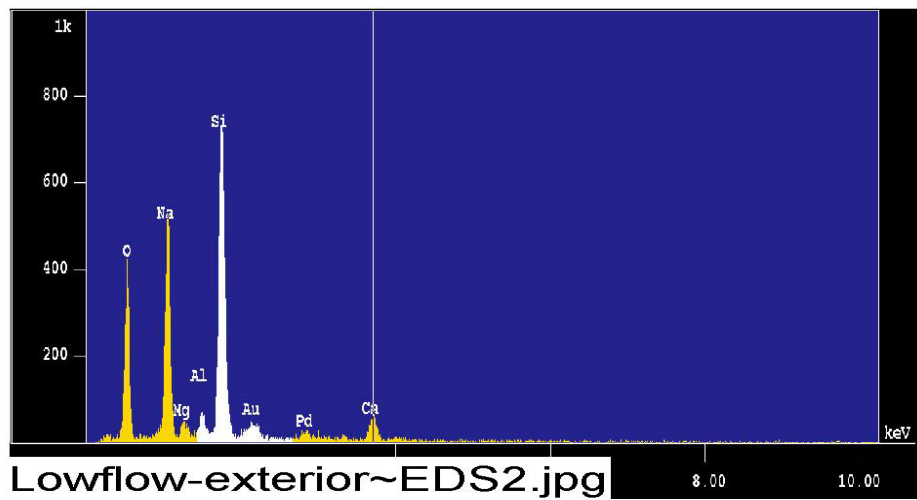
Figure D1-36. Test-2 Day-16 counting spectrum for a particle on the fiberglass shown in Figure D1-34 (Lowflow-exterior~EDS2).

The results from the chemical composition analysis for Lowflow~exterior~EDS2 are given in Table D1-4.

Element	Mass%	Atomic%	ZAF	Z	A	F
O	48.657	60.9403	0.9606	0.9936	0.9668	0.9999
Na	19.974	17.4088	1.0115	0.9979	1.0129	1.0007
Mg	1.370	1.1292	1.2286	1.0005	1.2288	0.9993
Al	1.568	1.1644	1.2300	1.0060	1.2299	0.9941
Si	24.091	17.1875	1.1384	0.9937	1.1458	0.9999
Ca	4.340	2.1699	1.0081	1.0068	1.0012	1.0001
