10 CFR §50.55a
L-2005-168

Subject: Turkey Point Nuclear Plant Unit 3
Docket No. 50-250
10 CFR 50.55a Request for Temporary Non-Code Repair
Spent Fuel Pool Cooling Line (Request No. 6)

Florida Power & Light Letter No. L-2005-168
10 CFR 50.55a Request for Temporary Non-Code Repair
Spent Fuel Pool Cooling Line (Request No. 6)
Enclosure 1

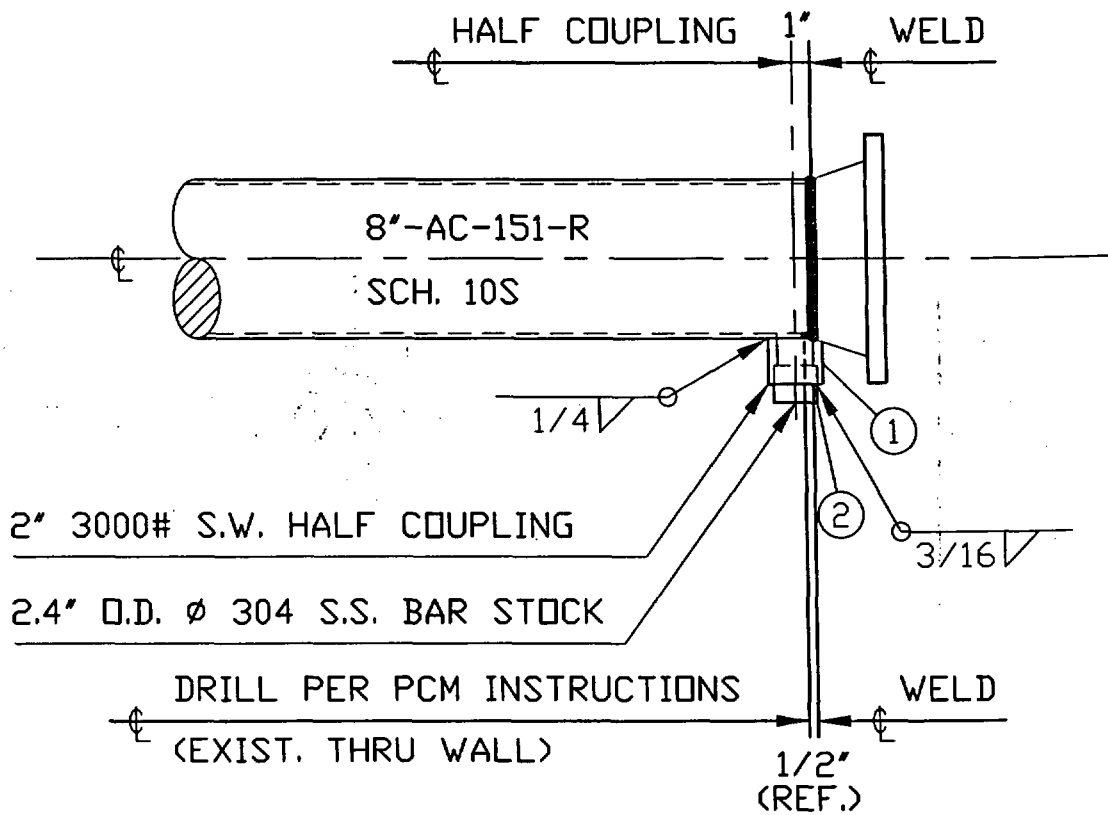
Figure 1

CODE REPAIR – WELDED BRANCH CONNECTION

- 1.1 Option 1 (Figure 1) is to add a 2-inch diameter welded branch connection at the through-wall pinhole leak. The branch connection with a welded plug will act as the new pressure boundary at the attachment profile. All selected materials are compatible with SFP cooling system class and service. The time estimate for completion of this repair option is 20 hours.

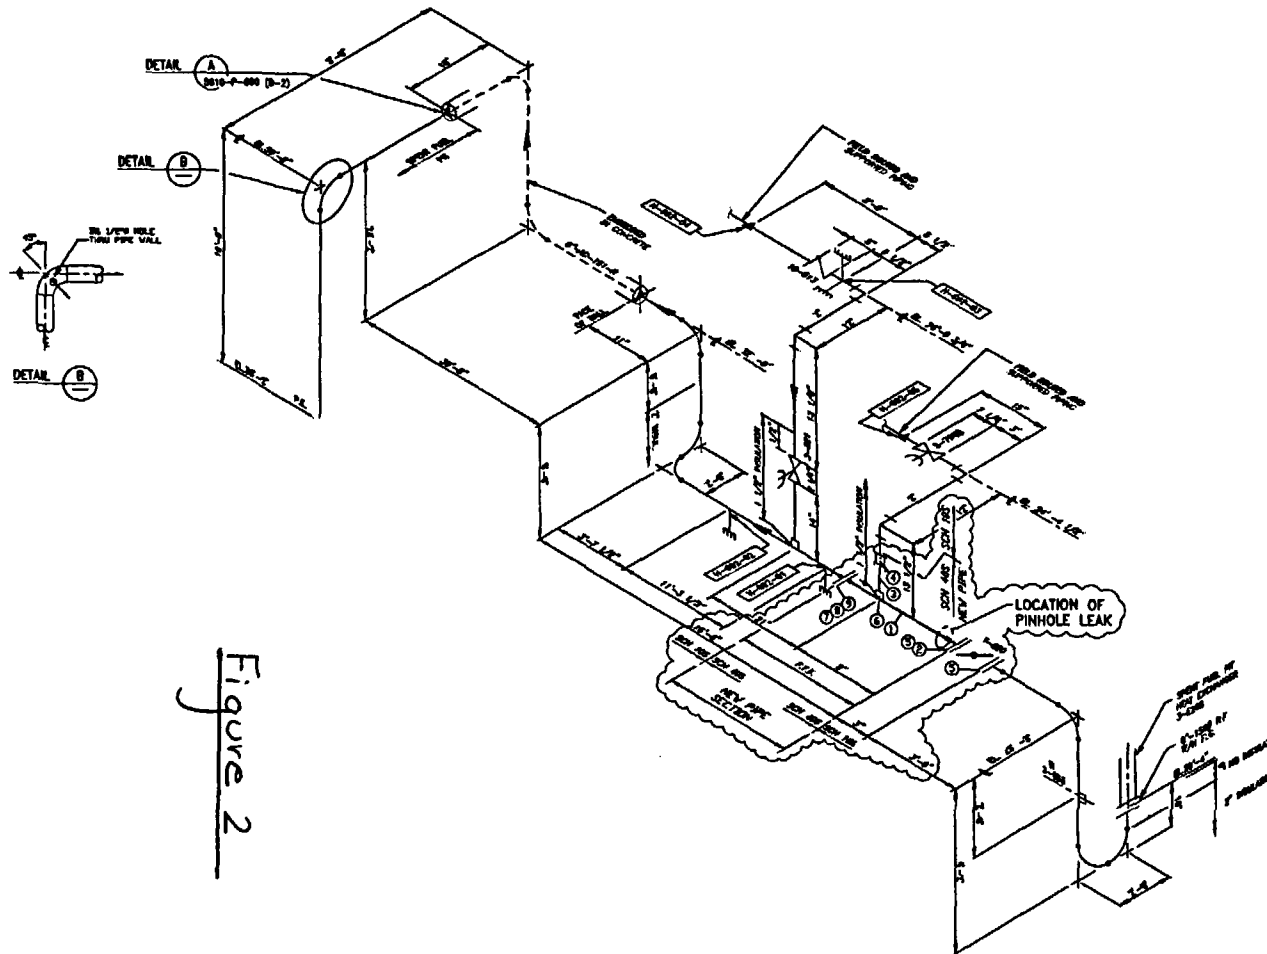
Figure 2

CODE REPAIR REPLACEMENT PIPE SPOOL

- 1.2 Option 2 (Figure 2) is the installation of a pipe spool piece to replace the affected portion of the 8-inch diameter piping. The spool piece will be shop prepared. This replacement section of pipe will be pre-sized and will be designed to minimize required field welding (one slip-on flange). All selected materials are designed to be compatible with SFP cooling system class and service. The time estimate for completion of this repair option is 40 hours.

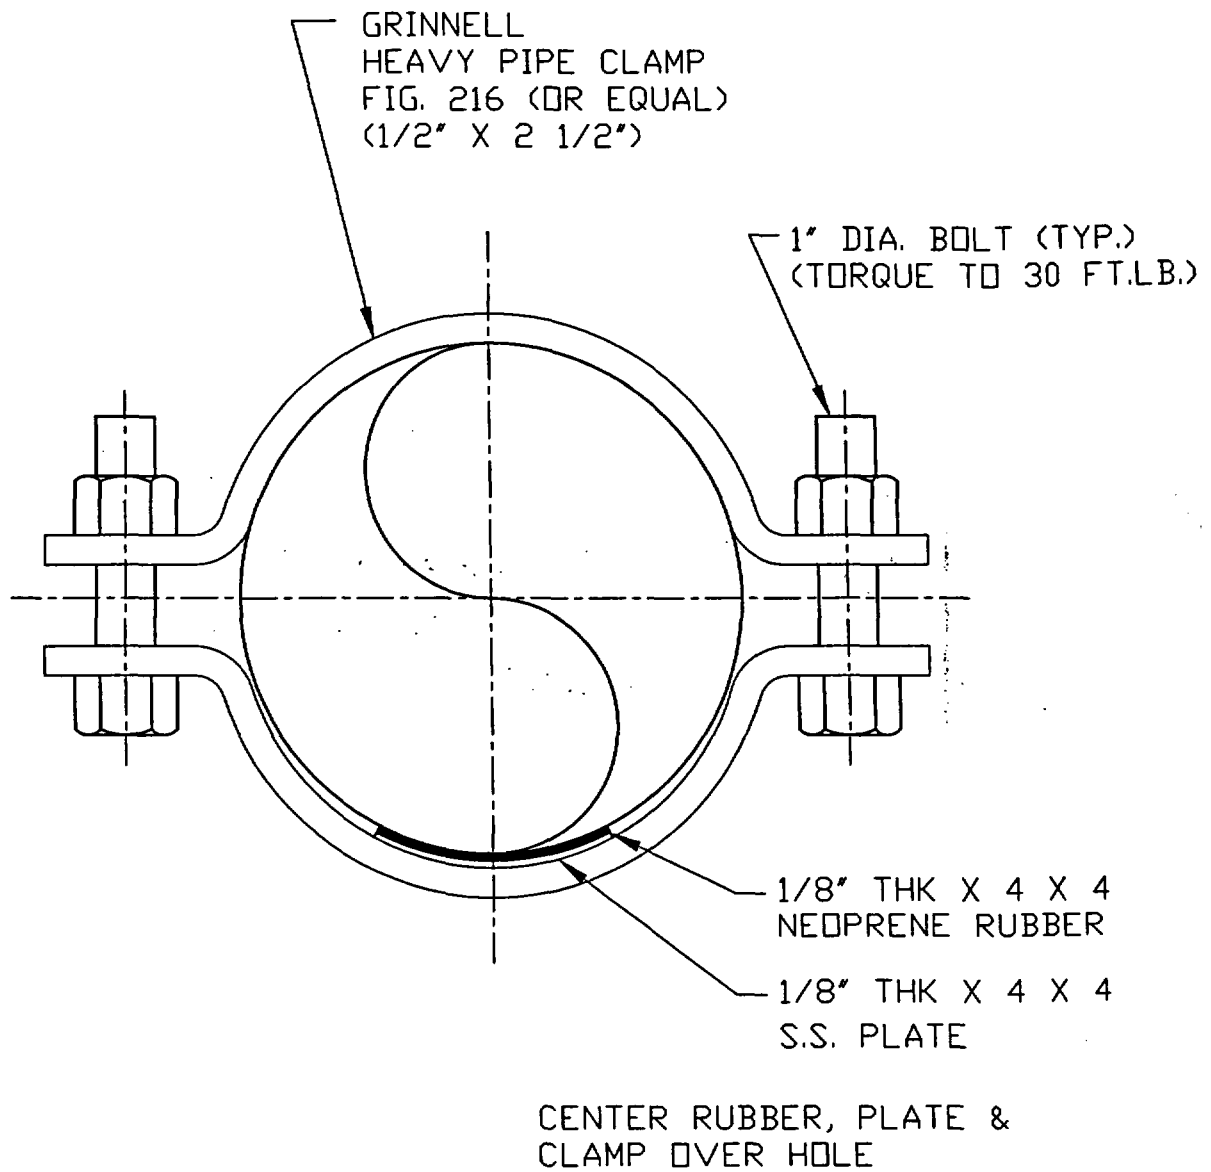
Figure 3

NON-CODE REPAIR PIPE CLAMP

The selected design for the temporary non-Code repair contingency employs commercial grade materials able to withstand expected operating pressure and temperature conditions should a burn-through be created on the Schedule 10S 8-inch diameter stainless steel pipe during welding for the Code repair activity. The non-Code component is a simplified pipe clamp (Figure 3) designed to fit over a through-wall hole. The clamp and bolting material is robust and able to withstand any anticipated operating condition.

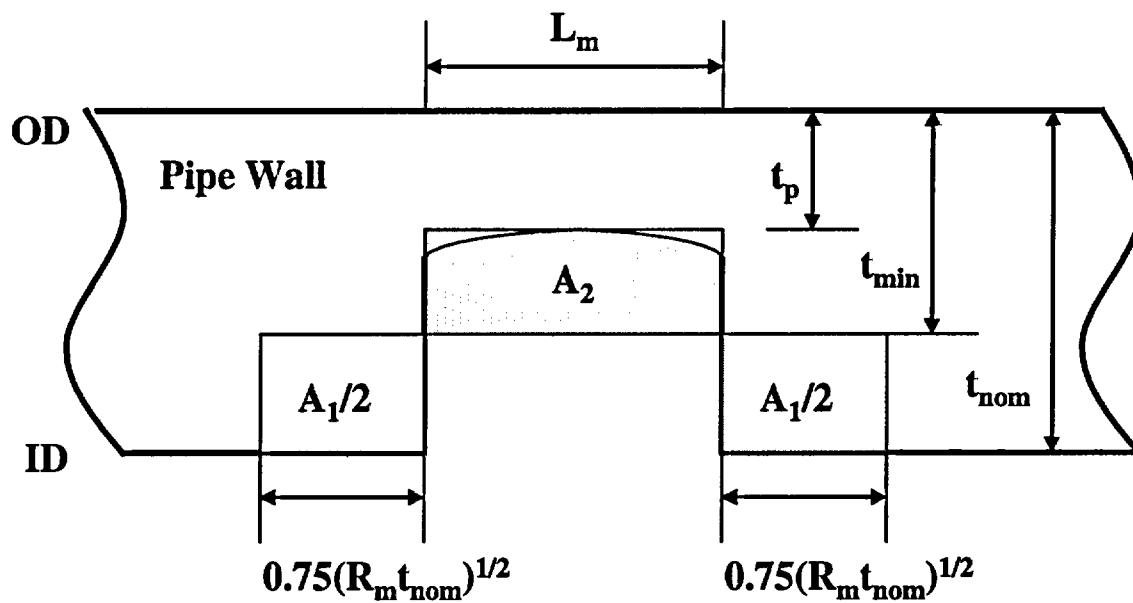
Figure 4: Model for Development of Allowable Non-Planar Flaws

Guidance for evaluation of non-planar through-wall flaws is not provided in Code Case N-513. An alternate wall thinning criteria was developed using the "Limits of Reinforcement" rules in Paragraph NB-3640 of the ASME Code. The model used is illustrated in Figure 4.

Referring to Figure 4, Area A₁ (which is between the thinned area and the limits of reinforcement) should be balanced by Area A₂ (which is within the thinned area) in which case the following equation can be written:

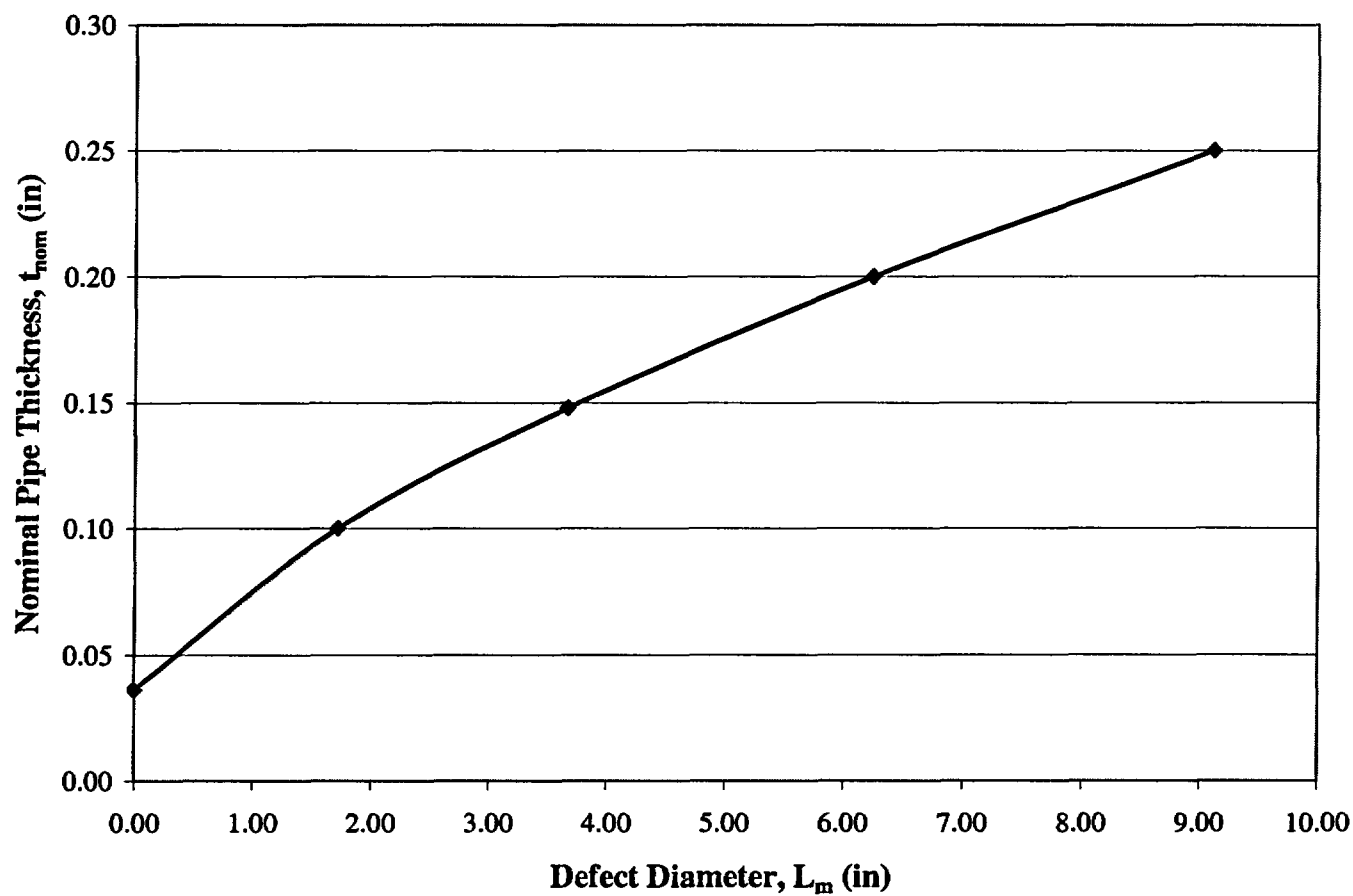
Figure 5: Allowable Non-Planar Flaws for Various Nominal Wall Thicknesses

By setting $t_p = 0$ in Equation 2 (through-wall pit), the allowable hole diameter may be determined for a range of nominal pipe wall thicknesses (see Figure 5). It can be seen that through-wall pit sizes up to approximately 3.65 inches in diameter can be tolerated for a nominal pipe thickness of 0.148 inch without exceeding ASME Code margins. This is much greater than the assumed flaw size.
