SUBJECT: INSPECTION 03030462/2005002, ECS MID-ATLANTIC, LLC, CHANTILLY,  
VIRGINIA SITE AND THE ASHBURN, VIRGINIA SITE

INSPECTION REPORT

ECS Mid-Atlantic, LLC  
NRC Inspection Report No. 03030462/2005002

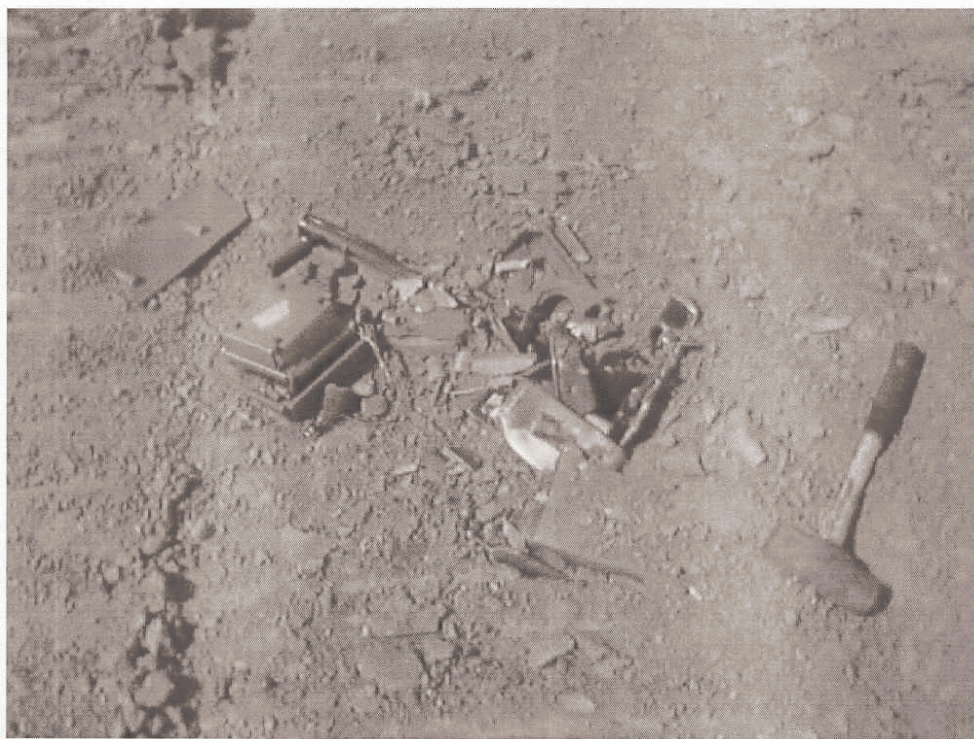
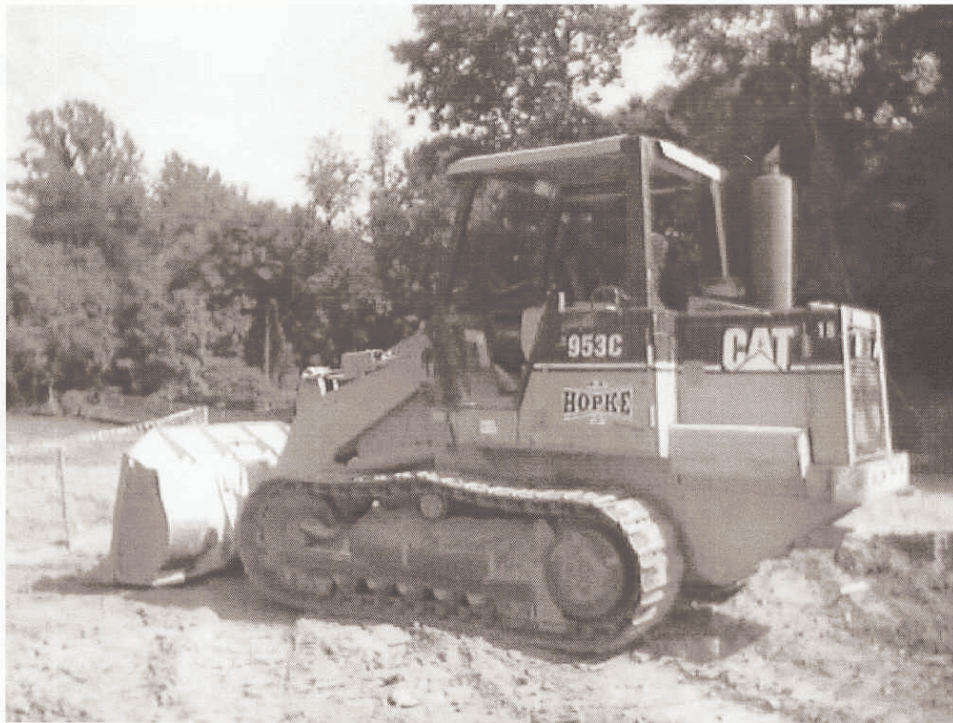
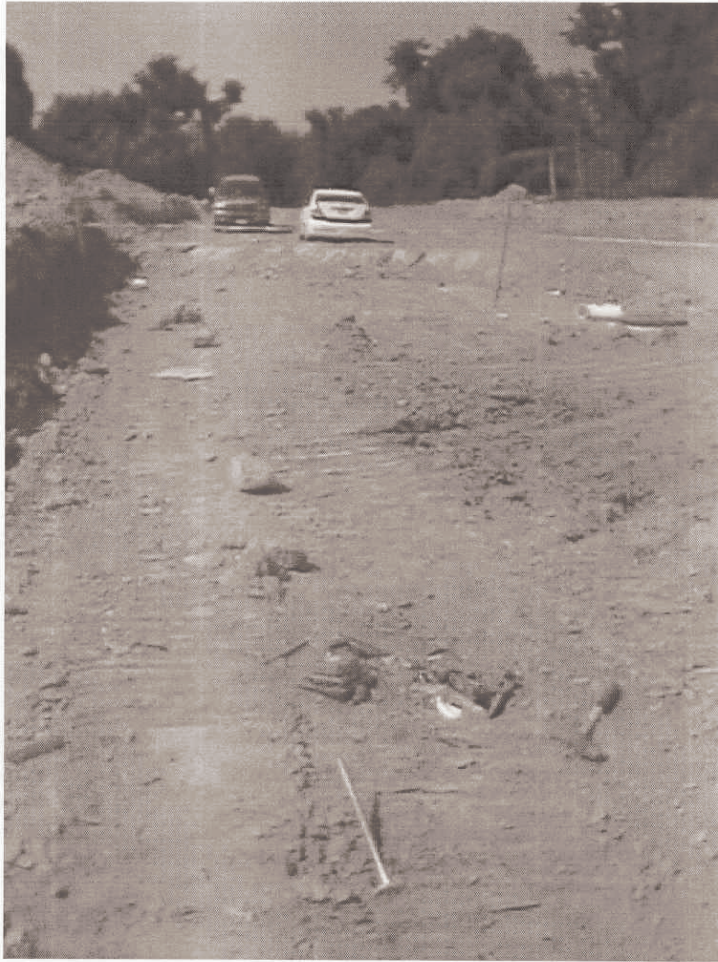
An accident has happened involving Nuclear Gauge #49 (CPN MC1DRP serial # MD00505618) on the Little River Glen II job site (#11012) at about 3:15 PM on 06/24/2005.

The nuke got run over by a loader operated by Juan Pablo Diatoro and destroyed while it was under the control of our technician, Sonu Shukla.

Contrary to the initial Nuke Safety Training, the gauge was sitting on the field in the path of a loader with the technician was approximately 40 yards away from the gauge sitting in her car with her back turned to the gauge. This is a direct violation to the NRC rules and ECS' written policy as she had to be within 10' of the gauge. The same technician had received a written warning for leaving her gauge unattended at her jobsite on 11/03/04, and as a result the technician was terminated the same day.

The gauge was totally destroyed due to the impact but the source was in the shielded position. Several surveys have been made by using a survey meter (Troxalert calibrated 1/15/05) at one meter distance, and the readings were found to be around 0.4 mR/hr range.

All the pieces of the gauge were put in the box #49 and it was hauled back to the designated nuke storage in the Chantilly office around 5:00 PM. The remaining of the gauge will be returned to the manufacturer (CPN) for them to recycle the radioactive sources properly.

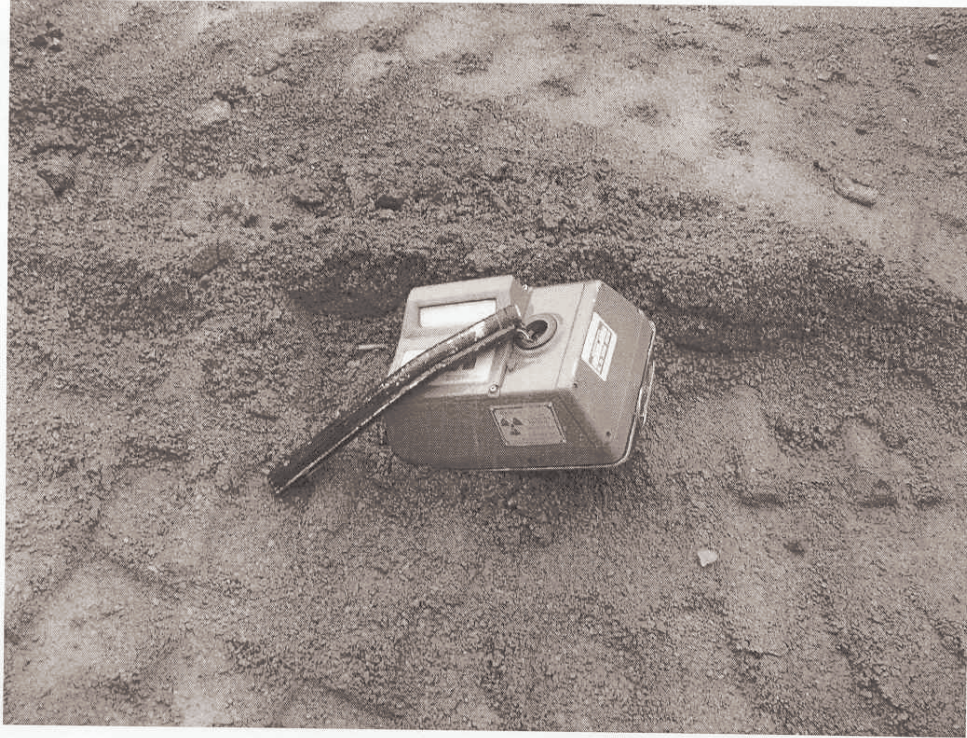
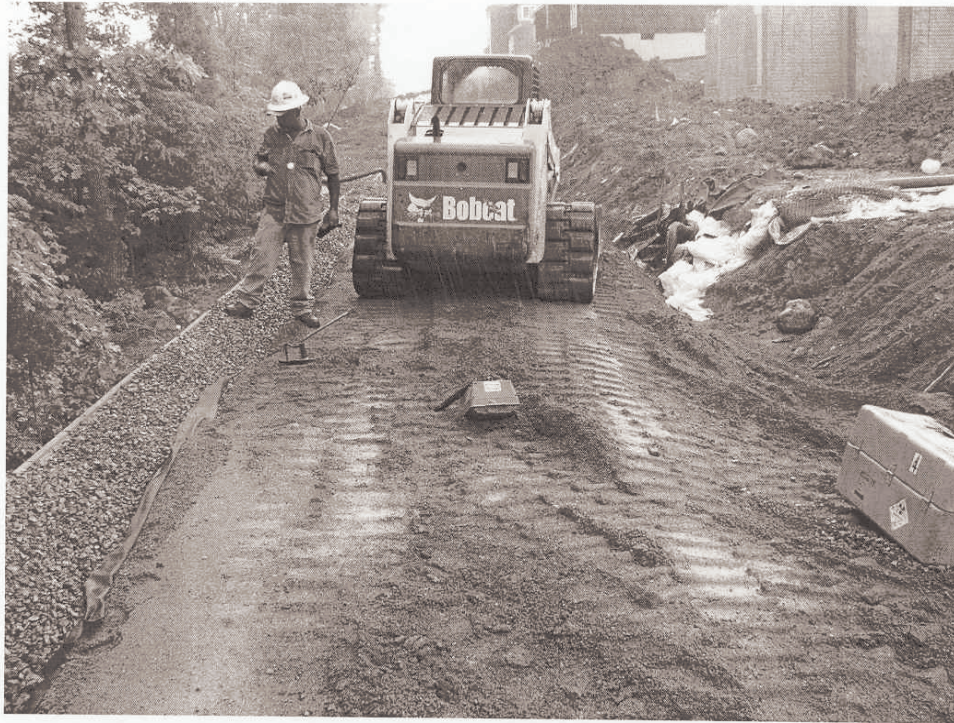
An accident has happened involving Nuclear Gauge #40 (CPN MC1DRP serial # MD90404949) on the Lanier Farms Section 2 - Retaining Wall Lots 40-41 job site (#8039-B3) at about 3:30 PM on 07/13/2005.

The nuke got run over by a bobcat operated by Oliver Antonio Hernandez of KT Enterprises (703)526 0293 and destroyed while it was under the control of our technician, Edmund Attoh.

The technician had all his PPE equipment on (hardhat, safety glasses, reflective vest & steel toed boots), and was in control of the nuke the whole time and within 10 feet of the gauge. He tried to stop the bobcat by yelling at the bobcat's operator while it was backing up on the gauge but he couldn't stop it on time.

The gauge's guide tube & rod were broken due to the impact but the source was in the shielded position. Several surveys have been made by using a survey meter (Troxalert calibrated 1/15/05) at one meter distance, and the readings were found to be around 0.4 mR/hr range.

All the pieces of the gauge were put in the box #40 and it was hauled back to the designated nuke storage in the Chantilly office around 5:15 PM. The remaining of the gauge will be returned to the manufacturer (CPN) for them to recycle the radioactive sources properly.
