U.S. Nuclear Regulatory Commission Operations Center Event Report

Event # 42062

PART 21 REPORT INVOLVING A RADIOGRAPHIC SEALED SOURCE WITH A POTENTIAL SAFETY CONCERN

"Material: Model 702 Radiographic Source

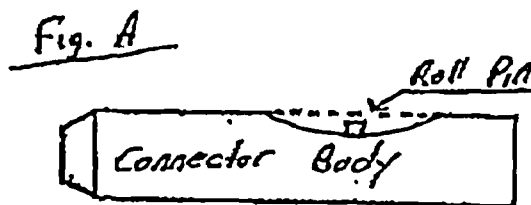
Connection Design

Roll Pin Flush or Below Flush With Connector Body
