Appendix C3

ESEM/EDS Data for Test #3 Day-30 Drain Collar Fiberglass

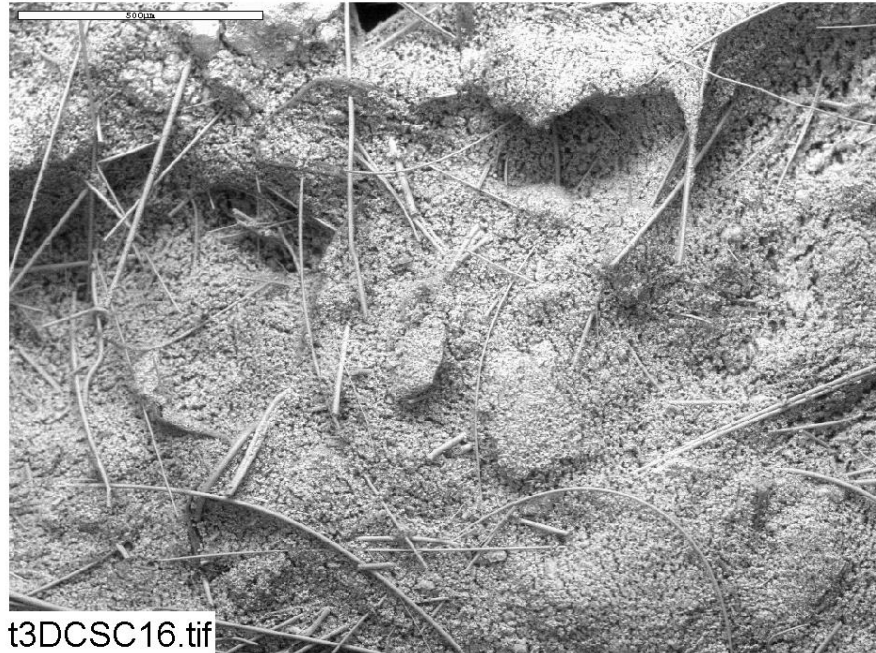
Figure C3-1: ESEM image magnified 100 times for a Test #3 Day-30 exterior fiberglass sample on the drain collar (adjacent to the drain screen). (t3DCSC16)

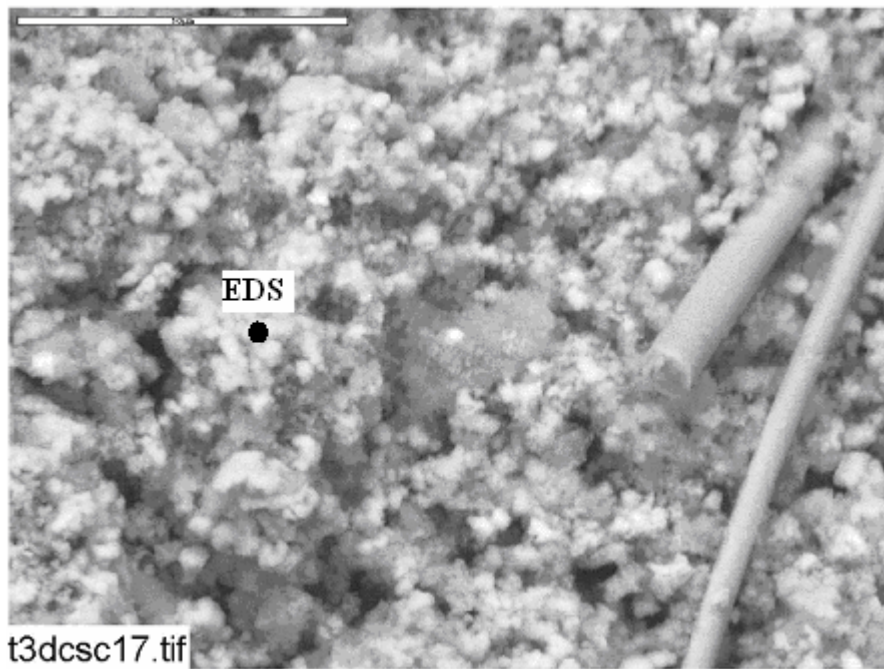
Figure C3-2: ESEM image magnified 1000 times for a Test #3 Day-30 exterior fiberglass sample on the drain collar (adjacent to the drain screen). (t3dcsc17)

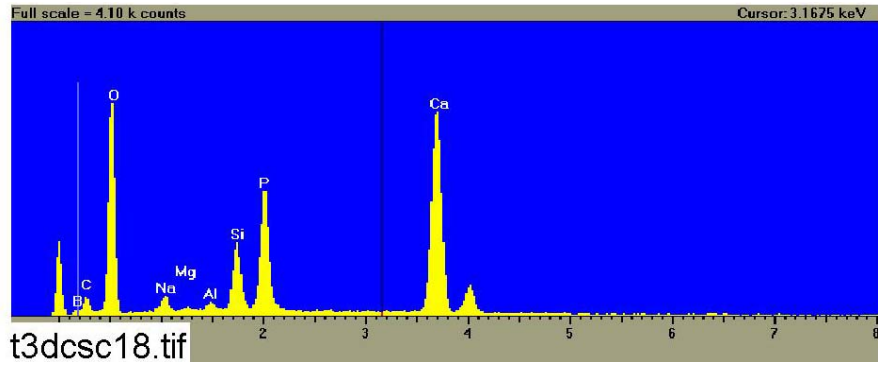
Figure C3-3: EDS counting spectrum for the particulate deposits shown in Figure C3-2. (t3dcsc18)

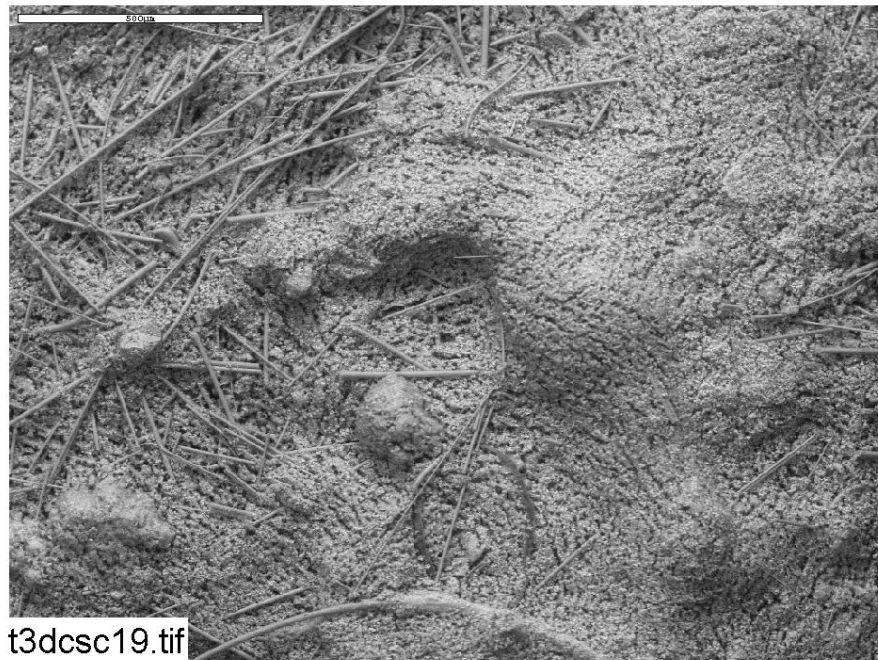
Figure C3-4: ESEM image magnified 70 times for a Test #3 Day-30 exterior fiberglass sample on the drain collar (adjacent to the drain screen). (t3dcsc19)

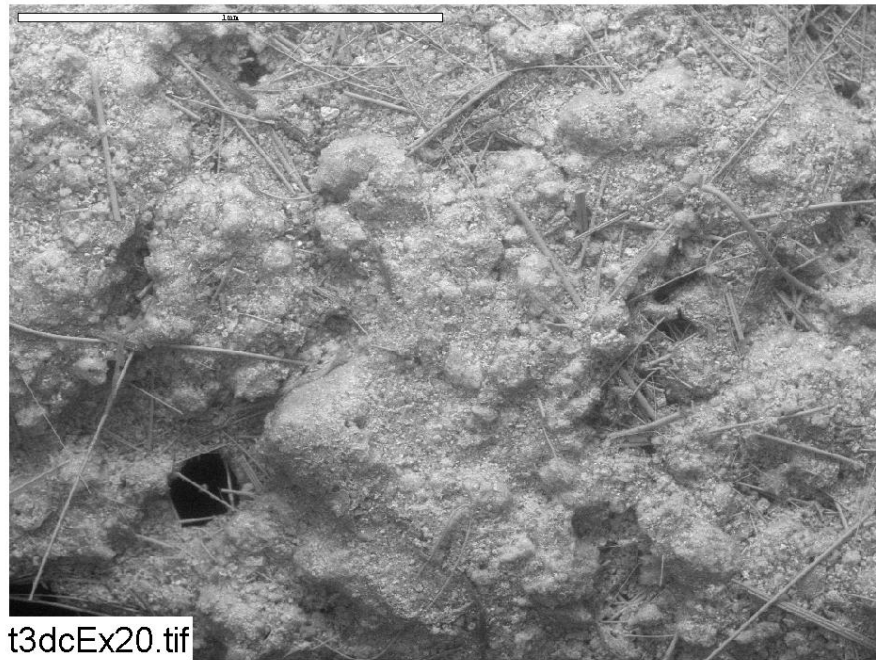
Figure C3-5: ESEM image magnified 70 times for a Test #3 Day-30 exterior fiberglass sample on the drain collar (away from the drain screen). (t3dcEx20)

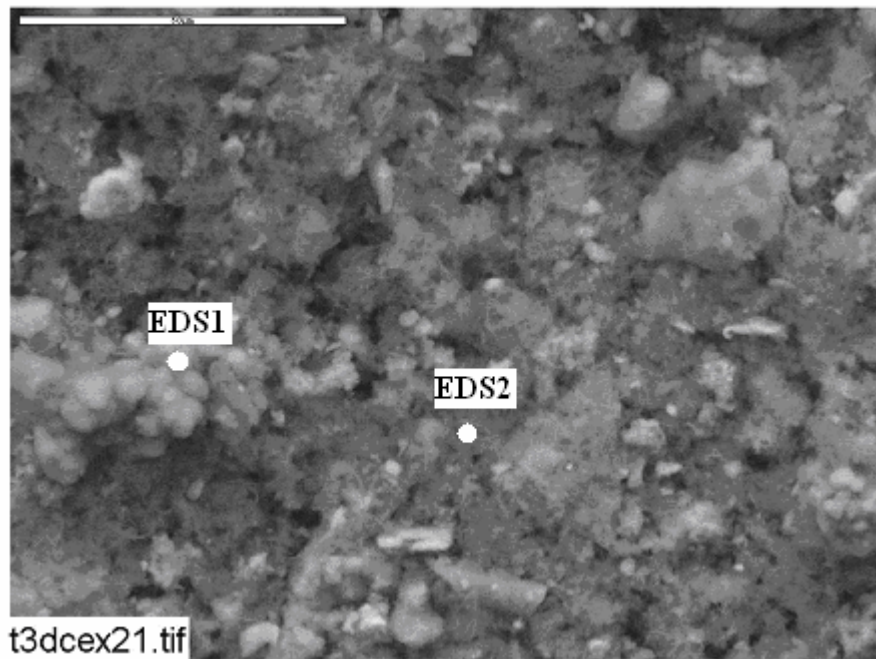
Figure C3-6: ESEM image magnified 1000 times for a Test #3 Day-30 exterior fiberglass sample on the drain collar (away from the drain screen). (t3dcex21)

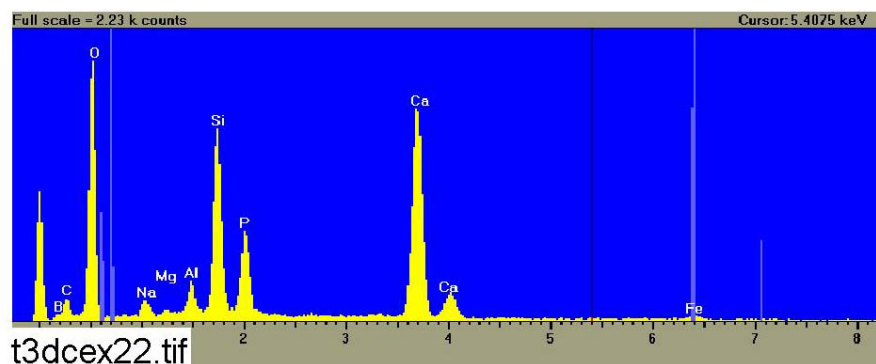
Figure C3-7: EDS counting spectrum for the light particulate deposits (EDS1) shown in Figure C3-6. (t3dcex22)

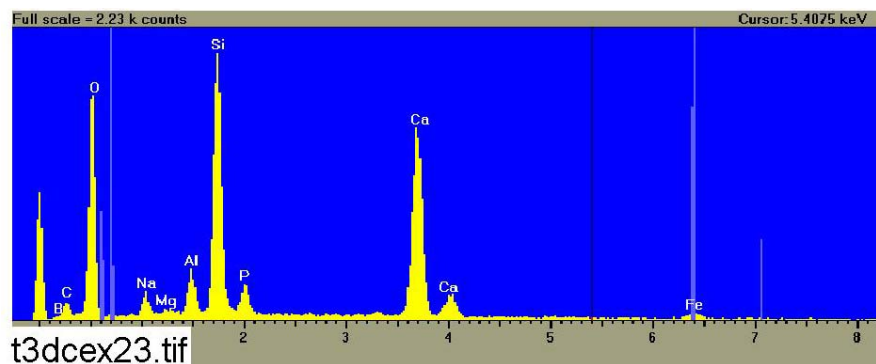
Figure C3-8: EDS counting spectrum for the dark deposits (EDS2) shown in Figure C3-6. (t3dcex23)

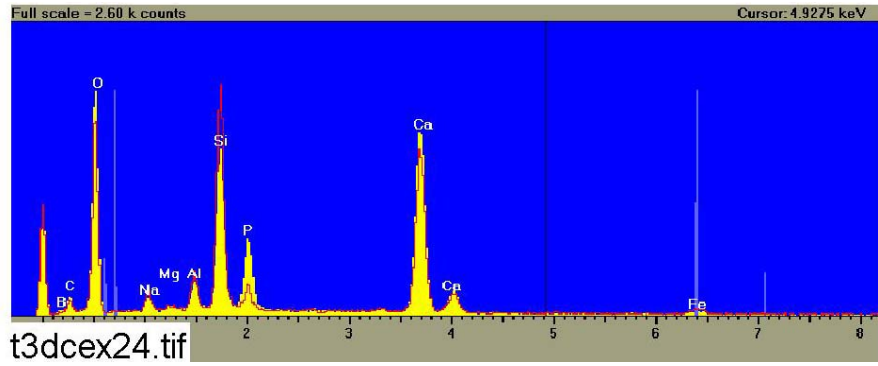
Figure C3-9: Comparison of EDS counting spectra between Figure C3-7 (yellow) and Figure C3-8 (red). (t3dcex24)

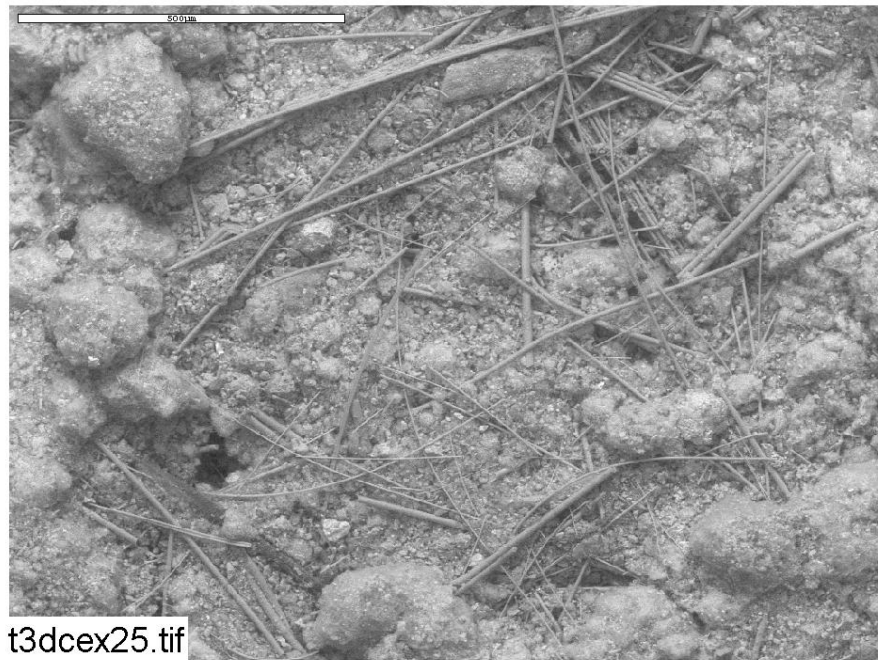
Figure C3-10: ESEM image magnified 100 times for a Test #3 Day-30 exterior fiberglass sample on the drain collar (away from the drain screen). (t3dcex25)

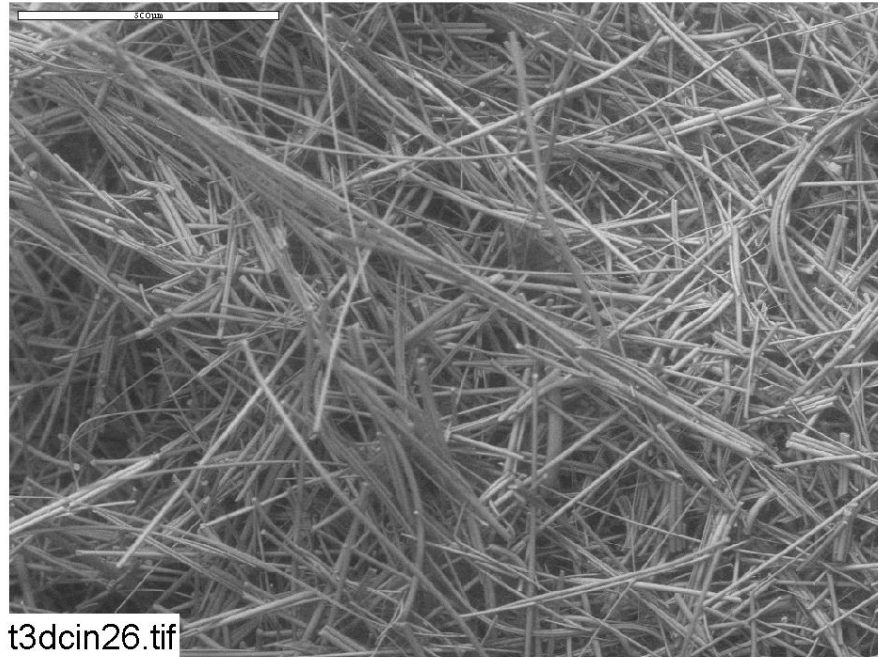
Figure C3-11: ESEM image magnified 80 times for a Test #3 Day-30 interior fiberglass sample on the drain collar. (t3dcin26)

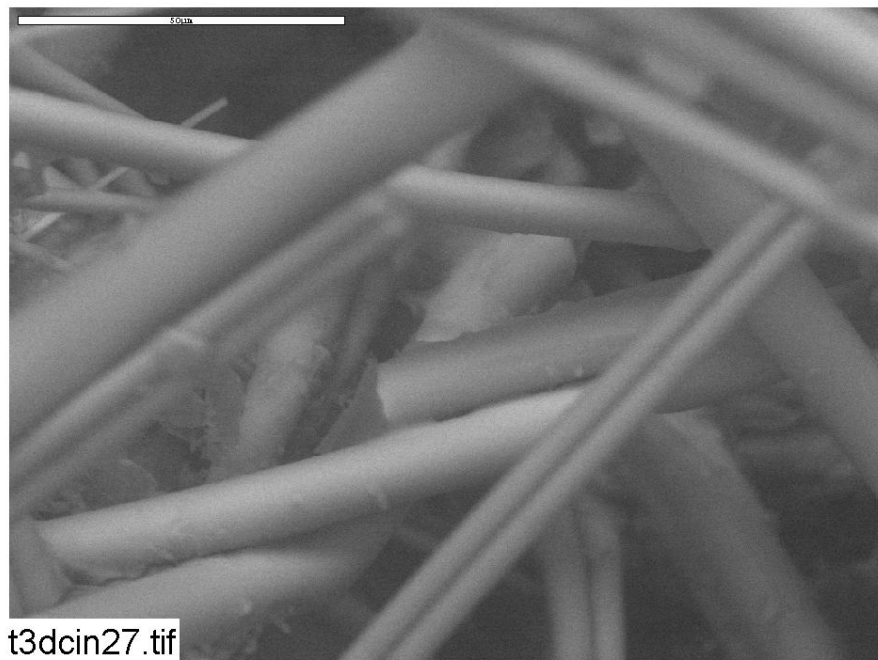
Figure C3-12: ESEM image magnified 1000 times for a Test #3 Day-30 interior fiberglass sample on the drain collar. (t3dcin27)

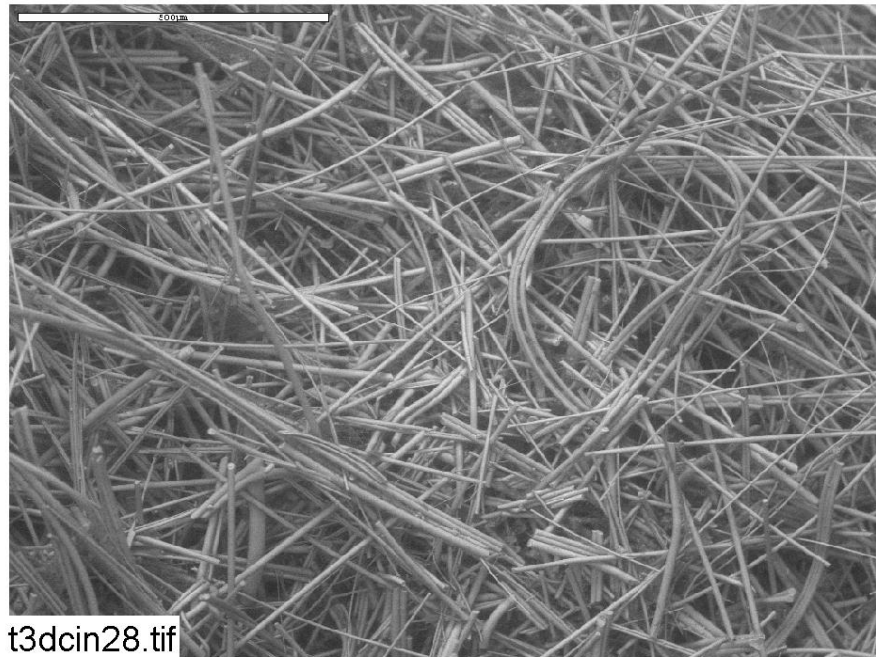
Figure C3-13: ESEM image magnified 100 times for a Test #3 Day-30 interior fiberglass sample on the drain collar. (t3dcin28)
