## Appendix D

### ESEM and SEM/EDS Data for Test #3 Day-30 Corrosion Products

For ICET tests, one process of interest is the corrosion effect of metal and concrete coupons. One means of understanding the corrosion process is through direct examination of the corrosion products after the test is completed. For this purpose, corrosion products were collected when Test #3 was shut down (May 5, 2005). These corrosion products included (1) fine powders on a vertical piece of the submerged CPVC rack; (2) corrosion products on a submerged galvanized steel coupon; (3) corrosion products on a submerged copper coupon; (4) corrosion products on a submerged aluminum coupon; and (5) corrosion products on a submerged concrete coupon.

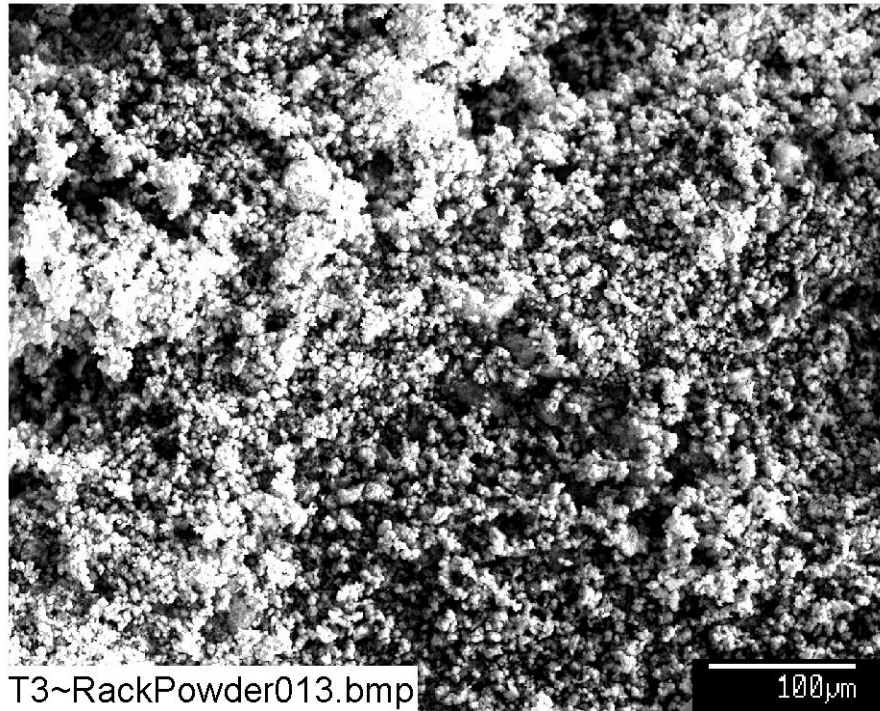
**Figure D-1: SEM image magnified 200 times for a Test #3 Day-30 powder on the submerged rack. (T3~RackPowder013)**

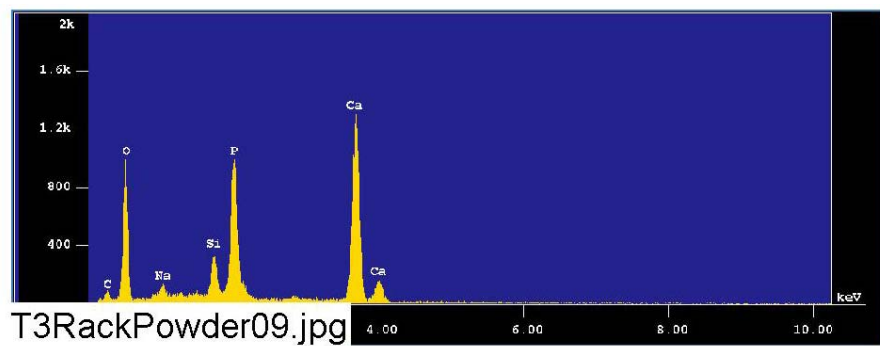
**Figure D-2: EDS counting spectrum for the powder on the submerged rack shown in Figure D-1. (T3RackPowder09)**

The results from the chemical composition analysis for T3RackPowder09 are given in Table D-1.

Element	Mass%	Atomic%	ZAF	Z	A	F
O	48.147	67.3988	1.8951	0.9734	1.9469	1.0000
Na	0.977	0.9516	1.5243	1.0269	1.4843	1.0000
Si	3.302	2.6332	1.1493	0.9767	1.1837	0.9941
P	13.197	9.5423	0.8517	1.1722	0.7283	0.9977
Ca	34.174	19.0962	0.9909	0.9956	0.9953	1.0000
C	0.203	0.3778	3.7963	1.0208	3.7192	0.9999

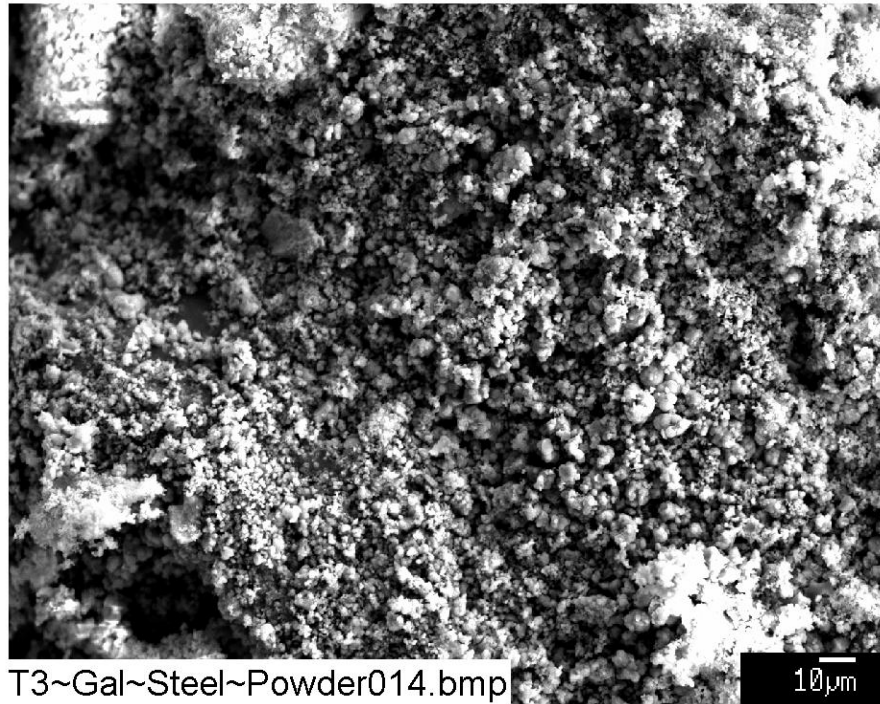
**Figure D-3: SEM image magnified 500 times for a Test #3 Day-30 powder on a submerged galvanized steel coupon. (T3~Gal~Steel~Powder014)**

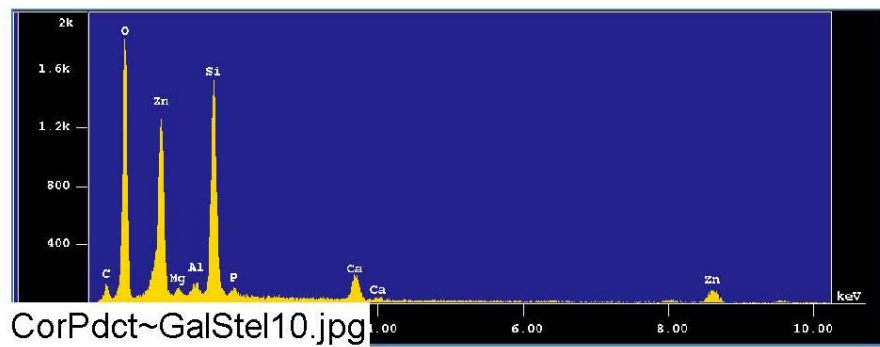
**Figure D-4: EDS counting spectrum for the white powder on galvanized steel shown in Figure D-3. (CorPdct~GalStel10)**

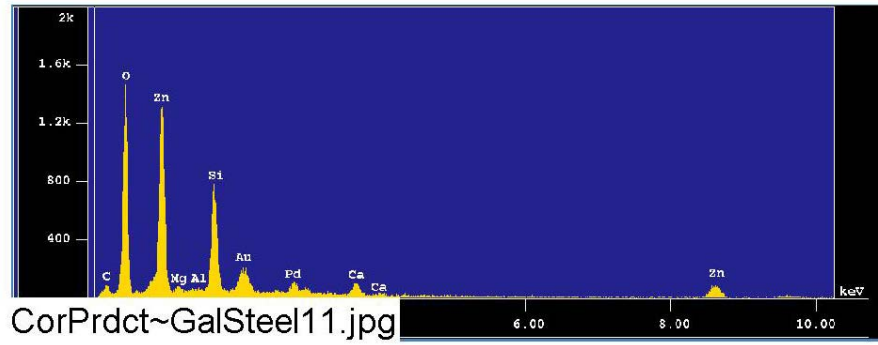
**Figure D-5: EDS counting spectrum for the dark powder on galvanized steel shown in Figure D-3. (CorPrdct~GalSteel11)**

The results from the chemical composition analysis for CorPrdct~GalSteel11 are given in Table D-2.

Element	Mass%	Atomic%	ZAF	Z	A	F
O	47.383	72.4077	0.9119	0.9354	0.9750	1.0000
Mg	0.655	0.6591	2.3126	0.9284	2.4928	0.9993
Si	13.143	11.4404	1.4344	0.9377	1.5298	0.9999
Ca	3.059	1.8657	0.9770	0.9542	1.0247	0.9991
Zn	35.285	13.1966	1.2102	1.2129	0.9978	1.0000
Al	0.475	0.4304	1.7897	0.9594	1.8692	0.9979
C	0.000	0.0000	5.2279	0.9811	5.3287	1.0000

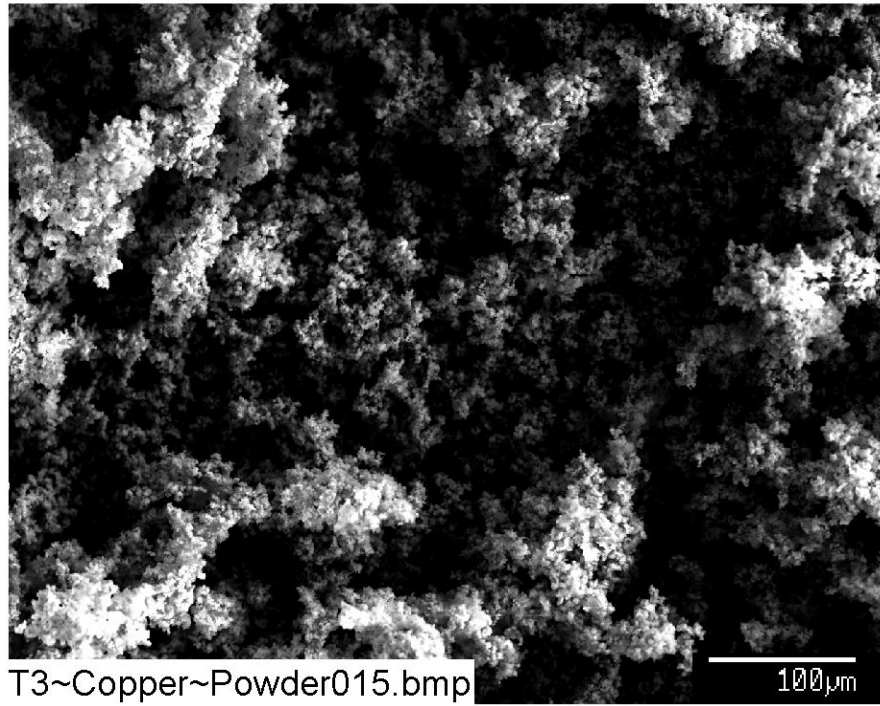
**Figure D-6: SEM image magnified 500 times for a Test #3 Day-30 powder on a submerged copper coupon. (T3~Copper~Powder015)**

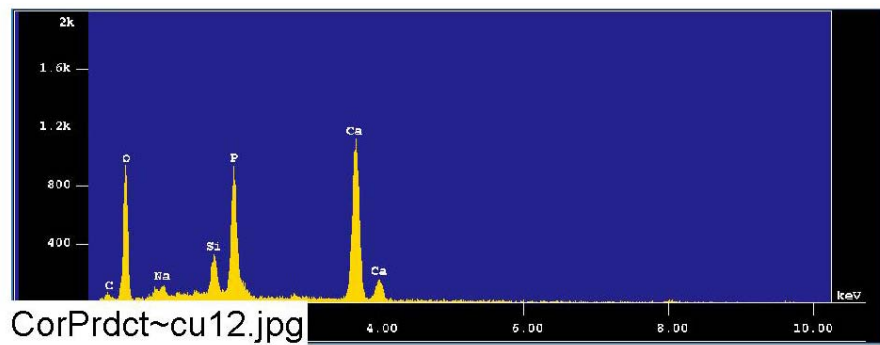
**Figure D-7: EDS counting spectrum for the powder on copper shown in Figure D-6. (CorPrdct~cu12)**

The results from the chemical composition analysis for CorPrdct~cu12 are given in Table D-3.

Element	Mass%	Atomic%	ZAF	Z	A	F
O	51.054	70.0693	1.8119	0.9751	1.8582	1.0000
Na	0.947	0.9045	1.5353	1.0287	1.4923	1.0000
Si	3.260	2.5484	1.1533	0.9785	1.1852	0.9945
P	12.216	8.6603	0.8538	1.1744	0.7286	0.9978
Ca	32.523	17.8176	0.9913	0.9976	0.9936	1.0000
C	0.000	0.0000	3.6900	1.0225	3.6090	0.9999

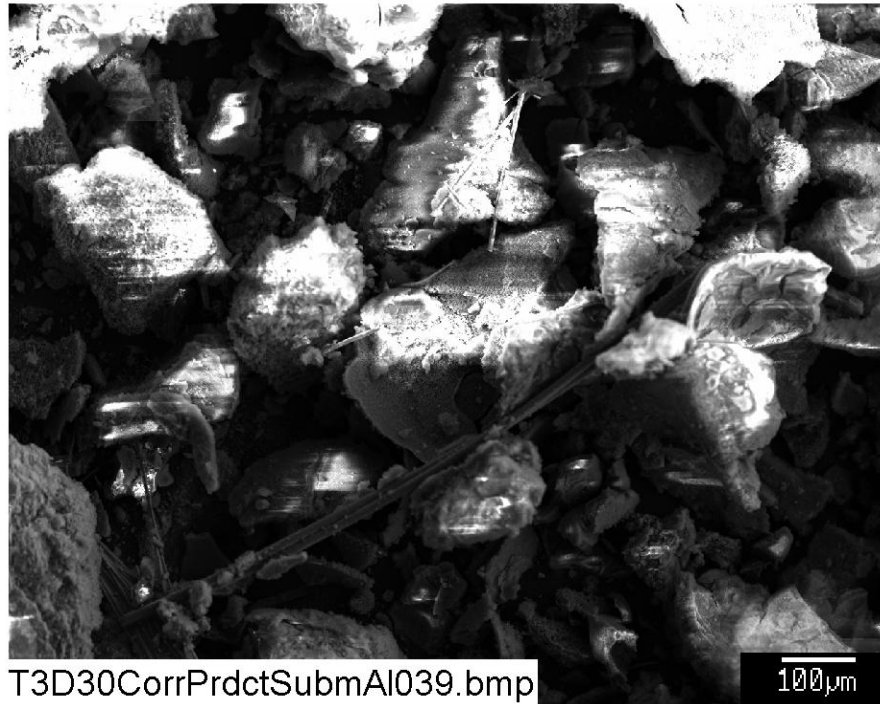
**Figure D-8: SEM image magnified 100 times for Test #3 Day-30 corrosion products on a submerged aluminum coupon. (T3D30CorrPrdctSubmAl039)**

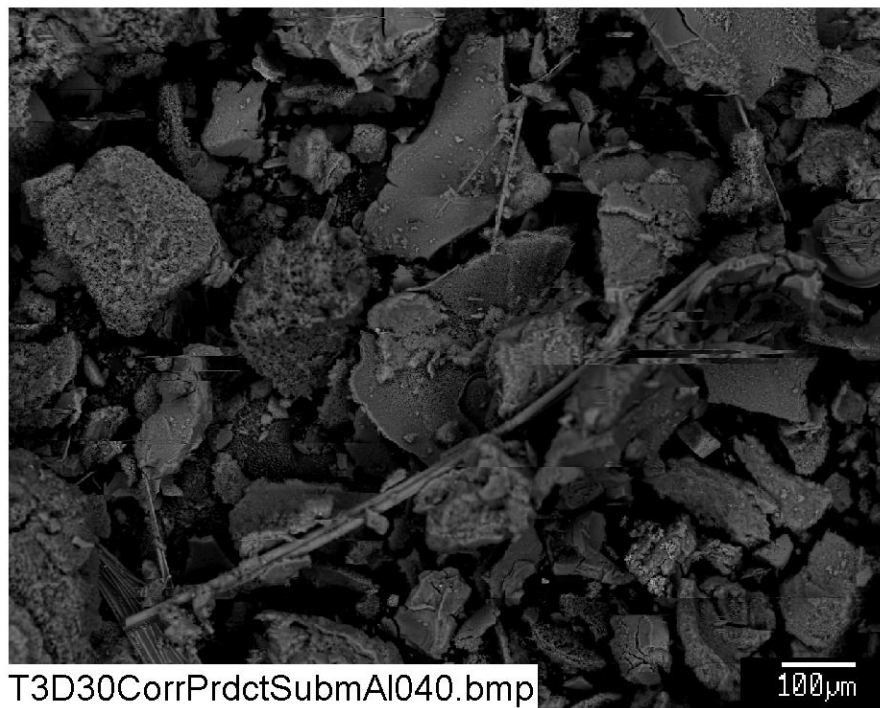
**Figure D-9: Backscattered SEM image magnified 100 times for Test #3 Day-30 corrosion products on a submerged aluminum coupon. (T3D30CorrPrdctSubmAl040)**

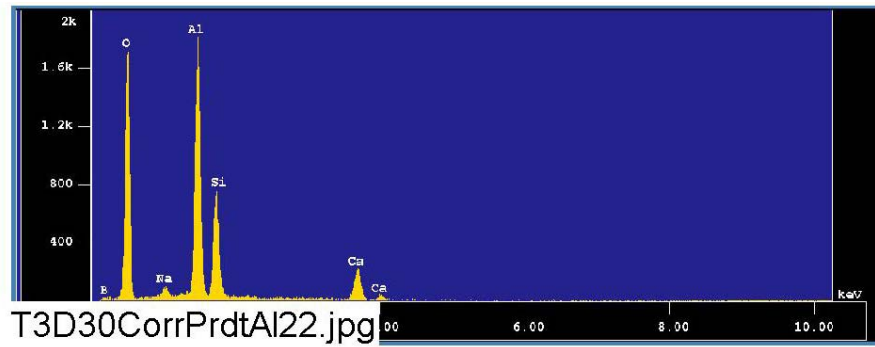
**Figure D-10: EDS counting spectrum for the corrosion products (particles) shown in Figure D-9. (T3D30CorrPrdtAl22)**

The results from the chemical composition analysis for T3D30CorrPrdtAl22 are given in Table D-4.

Element	Mass%	Atomic%	ZAF	Z	A	F
O	52.728	58.8383	1.0170	0.9767	1.0413	1.0000
Na	1.120	0.8699	1.2989	1.0311	1.2612	0.9988
Al	19.542	12.9304	1.0831	0.9932	1.0934	0.9974
Si	10.480	6.6618	1.3149	0.9816	1.3397	0.9999
Ca	4.923	2.1928	0.9814	0.9916	0.9896	1.0001
B	11.207	18.5068	13.5610	1.1342	11.9568	1.0000

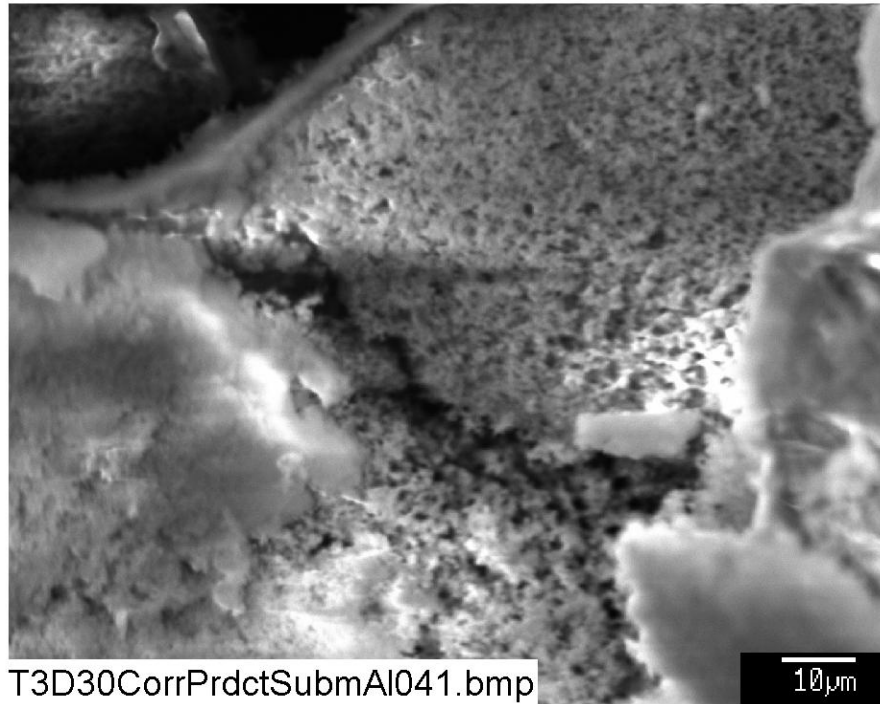
**Figure D-11: SEM image magnified 1000 times for Test #3 Day-30 corrosion products on a submerged aluminum coupon. (T3D30CorrPrdctSubmAl041)**

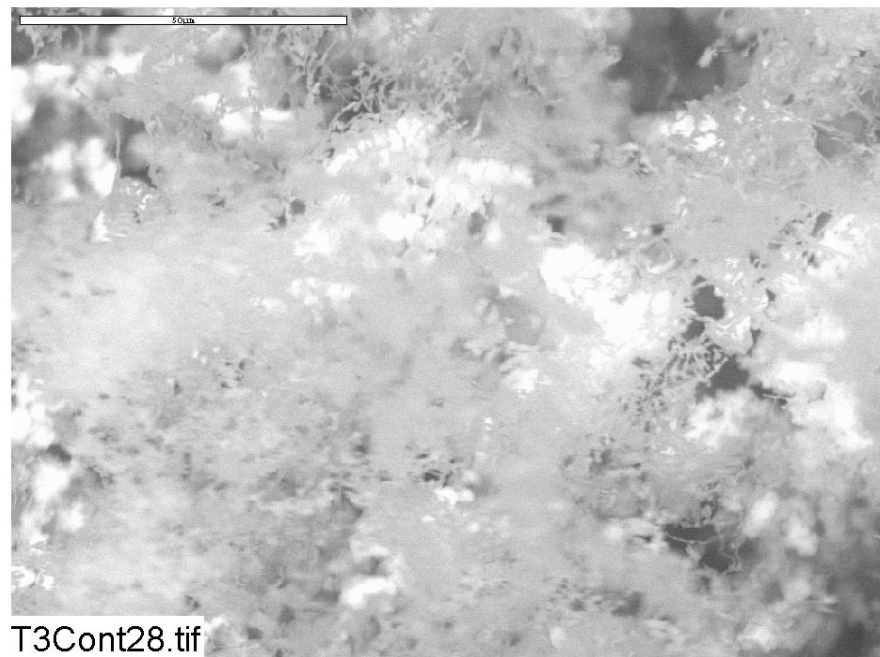
**Figure D-12: ESEM image magnified 1000 times for Test #3 Day-30 corrosion products on a submerged concrete coupon. (T3cont28)**

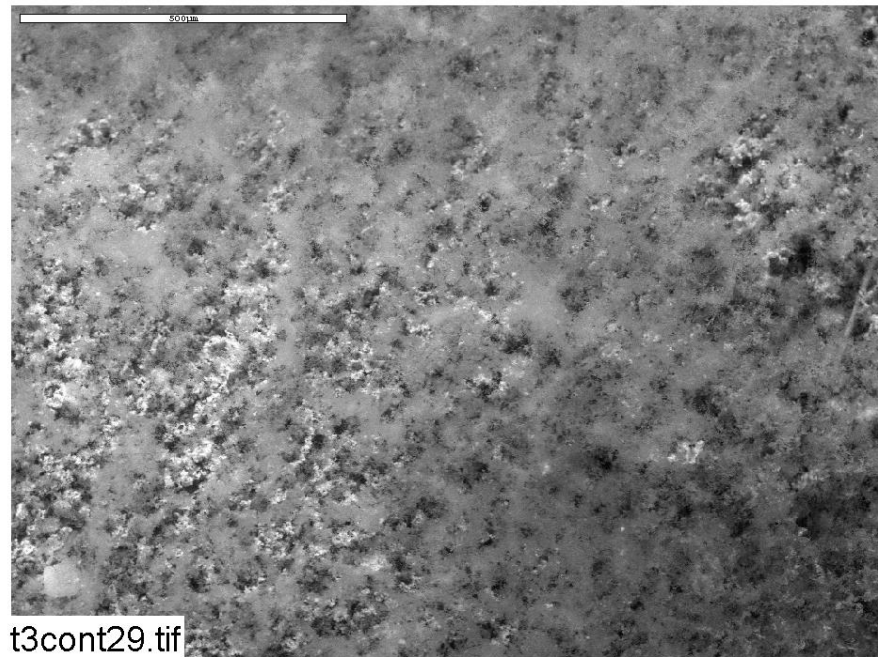
**Figure D-13: ESEM image magnified 100 times for Test #3 Day-30 corrosion products on a submerged concrete coupon. (t3cont29)**

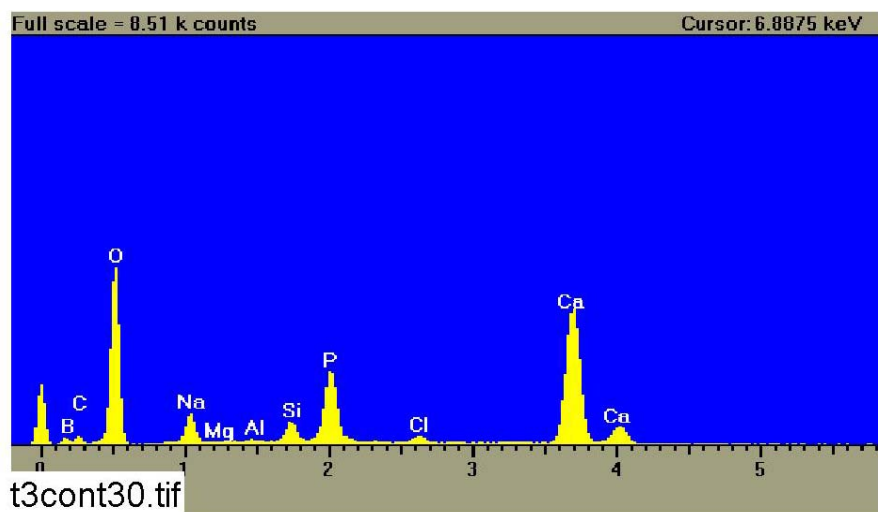
**Figure D-14: EDS counting spectrum for the corrosion products (particles) shown in Figure D-13. (t3cont30)**
