Peach Bottom Atomic Power Station (PBAPS) Unit 3
Facility Operating License No. DPR-56
NRC Docket No. 50-278

Subject: Licensee Event Report (LER) 3-05-03

LICENSEE EVENT REPORT (LER)

4. TITLE Residual Heat Removal System Small Bore Piping Leak due to Weld Deficiency
--

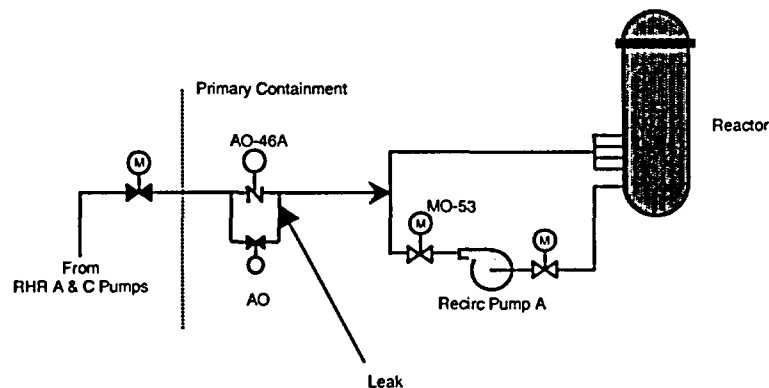
Simplified Diagram of 'A' RHR Loop

The RCS pressure boundary leakage (see below diagram) was determined to exist on a one-inch equalizing line for the 'A' Residual Heat Removal (RHR)(EIIS:BO) Loop testable air-operated check valve (AO-46A) (EIIS: V). The AO-46A valve is located on the 'A' RHR loop injection line. This line is located within the normally inaccessible Primary Containment and injects into the 'A' Recirculation (Recirc) line on the downstream side of the A Recirc line discharge motor-operated valve (MO-53A). The leak was located on a pipe coupling (EIIS: PSF) socket weld. This portion of the equalizing line is connected to the AO-46A check valve body on the downstream (Reactor) side of the check valve. The leaking pipe coupling is ASME Class 1 piping and therefore, is part of the RCS pressure boundary.

The RCS leakage was due to a socket weld crack in the one-inch pipe coupling associated with the 'A' RHR loop testable check valve equalizing line. The crack extended approximately 160 degrees around the circumference of the weld. The cause of the weld failure was due to lack of fusion (i.e. a weld flaw) associated with the root weld. The lack of fusion was the crack initiator. The lack of fusion extended approximately 120 degrees around the weld. Laboratory analysis indicated that the crack originated from the weld interior at the weld root. The lack of fusion at the root of this weld reduced the strength of the weld. This weld was completed as part of a Recirc / RHR pipe replacement project performed on Unit 3 in the 1987-1989 time period.

The welded joint was replaced and appropriately inspected and tested successfully during the Unit 3 Refueling Outage. The inspections included Non-Destructive Examinations (NDE).
