Re: St. Lucie Unit 1
Docket No. 50-335
Revised Steam Generator Tube Inservice Inspection
Special Report for Refueling Outage SL1-19 & RAI Response

Replacement St. Lucie Unit 1
Spring 2004 Refueling Outage SL1-19
Steam Generator Tube Inservice Inspection
Special Report

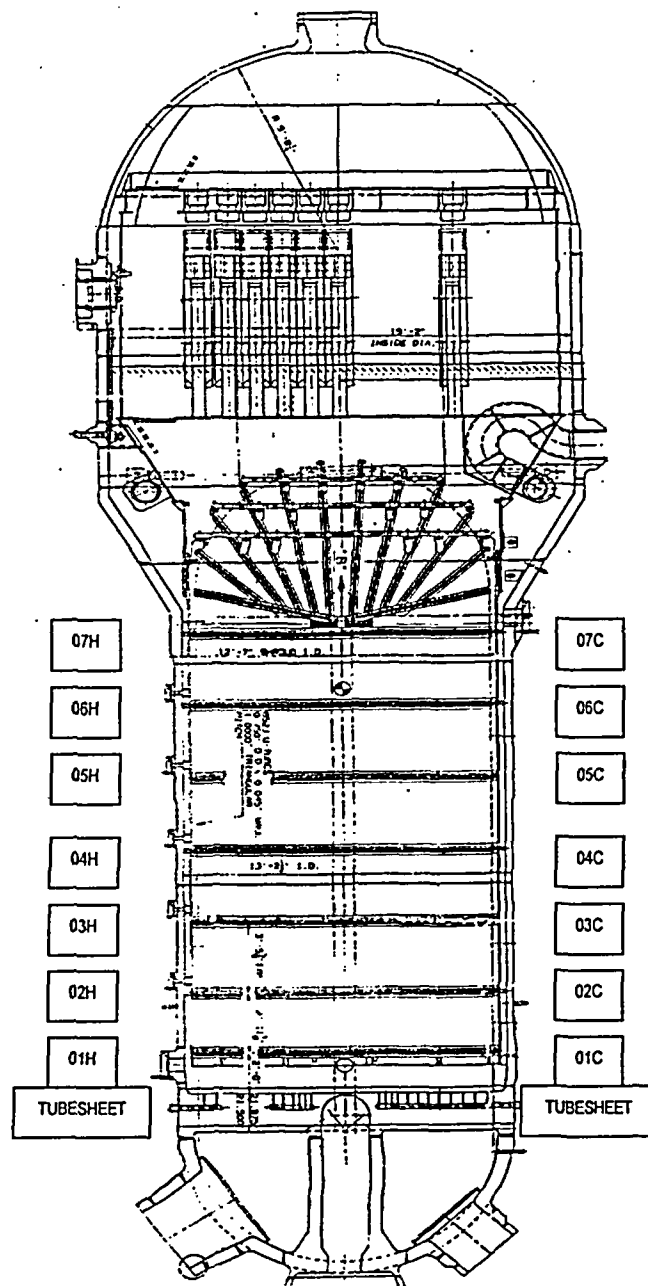
FIGURE 1
PSL-1 Replacement Steam Generator Support Identification

(e) tube pitch and pattern (e.g., 0.95 inches triangular)	1.0 inch triangular
(f) tubesheet thickness (with/without clad)	21.875 inches / 21.50 inches
(g) a sketch depicting the tube support structure naming	See Figure 1

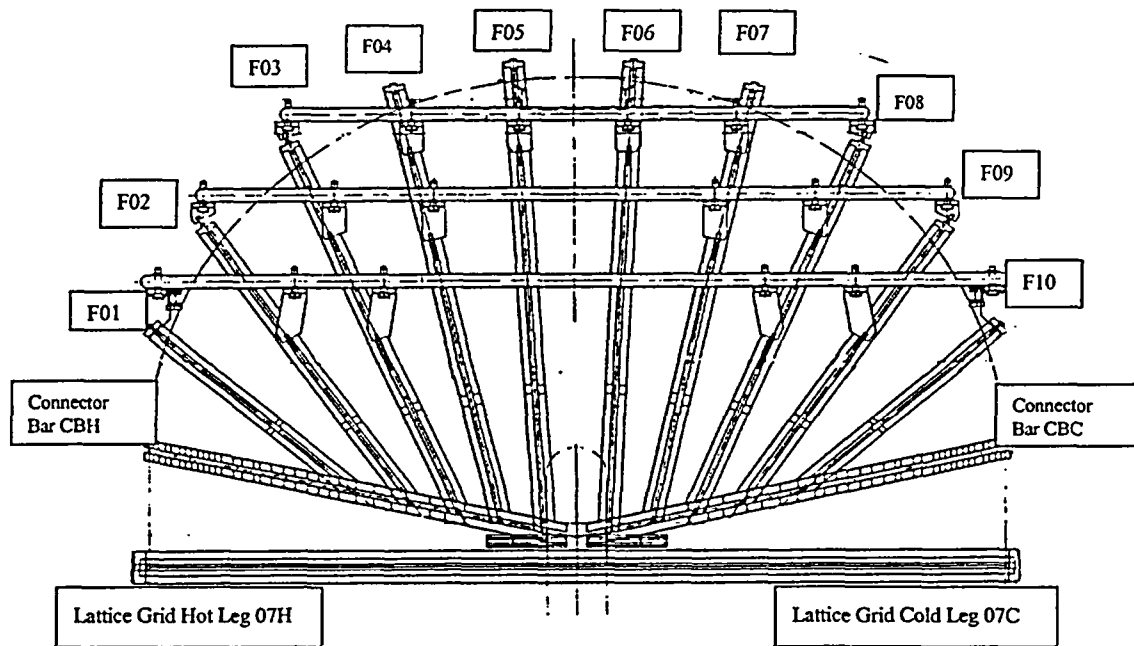
FIGURE 2
PSL-1 Replacement Steam Generator U-Bend Structure Identification

(h) anti-vibration bar (fan bar) design,	See Figure 2
(i) tube support material (e.g., 410 Stainless Steel)	410 Stainless Steel
(j) a sketch of a tubesheet map which depicts the rows and columns of the tubes in the steam generators	See Figure 3
