Hairline Crack in IPEC Unit 2 Spent Fuel Pool South Wall

9/8/05

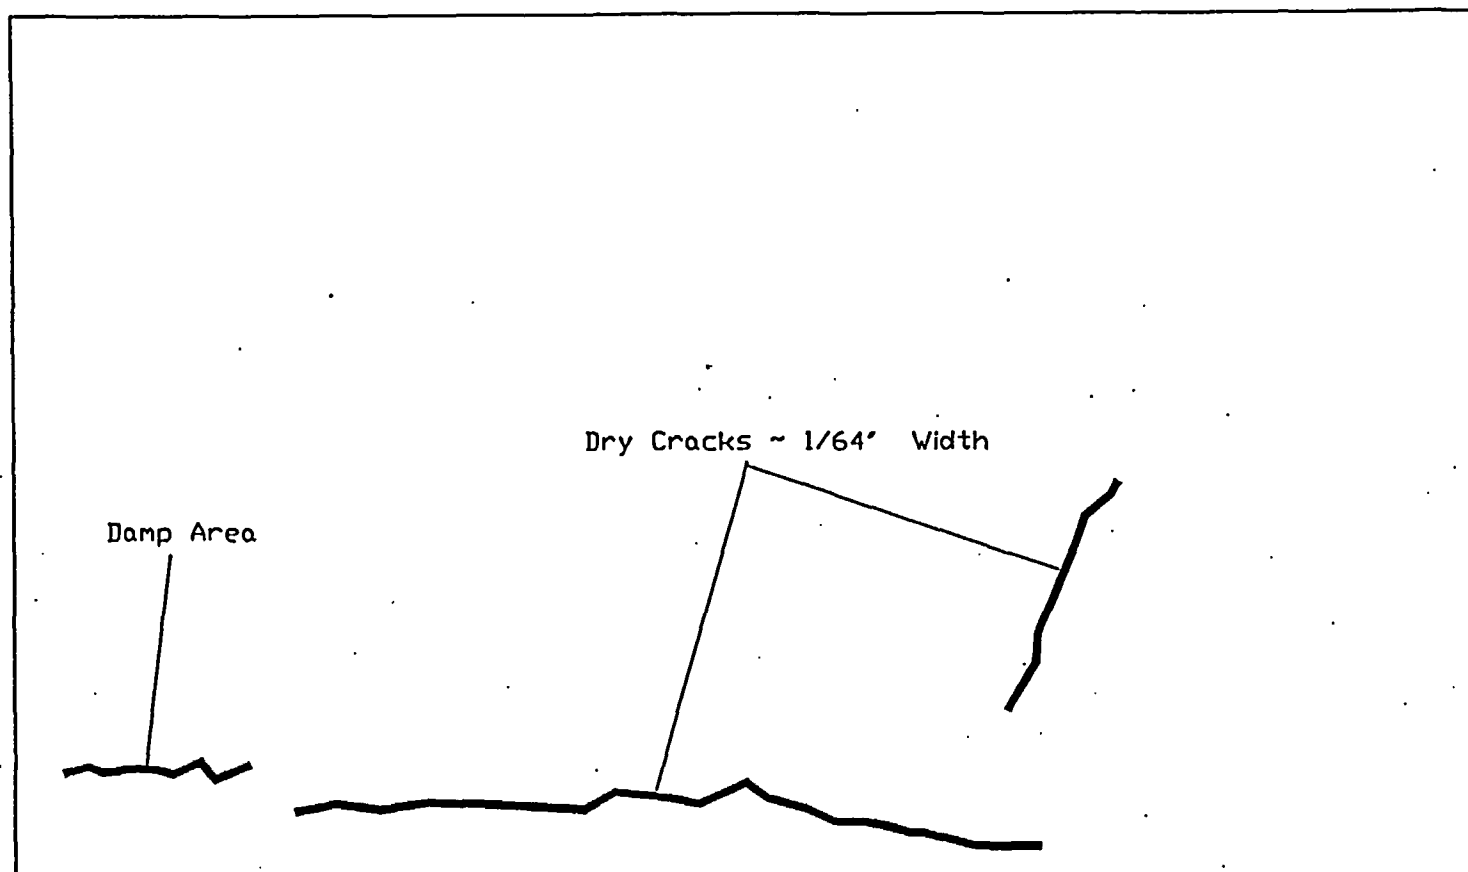
Crack Map of South Wall Spent Fuel Pit
Looking North

and replaced with a significantly more substantial structure. The original floor has been removed, and excavation of soil and rock in the loading bay is in progress. During removal of loose soil and rocks in the north area of the loading bay (along the SFP south wall), approximately horizontal cracks were exposed at an elevation of approximately 65 feet, and an approximately vertical crack above. The cracks are very narrow (less than 1/64-inch wide). One of the cracks, on the west side of the south SFP wall, has moisture in and near it.

*) The cracks have been visually inspected by an IPEC civil/structural engineer, and the IPEC Supervisor of Civil/Mechanical Engineering. The condition is typical of cracking due to shrinkage during post-construction concrete curing. The moisture in and around one of the cracks is very slight, essentially a film which is not dripping or beading. The moisture has been analyzed and found to contain trace amounts of Cesium 134 and 137, Cobalt-60, and Boron. The Boron concentration is about six times less than the concentration in the SFP, and the ratios of Cesium-134 and 137 indicate the activity is about six years old. The crack has calcium stains emanating from it, as is expected when moisture leaches through concrete, and no visual evidence of steel corrosion products (rust). Due to the thickness of the SFP wall, amount of steel reinforcement, and lack of evidence that the small amounts of moisture and boron have caused corrosion of the reinforcing rods, there is reasonable assurance that the SFP wall is structurally sound and capable of performing it's intended function.

West Side

Damp Area

Dry Cracks ~ 1/64" Width

East Side
