**Westinghouse  
Electric Corporation**

September 23, 1991

License No. SMB-1527  
Docket No. 040-08976

**ATTACHMENT 2: Survey Results: Areas found  
by ORAU and remediated by WEC**

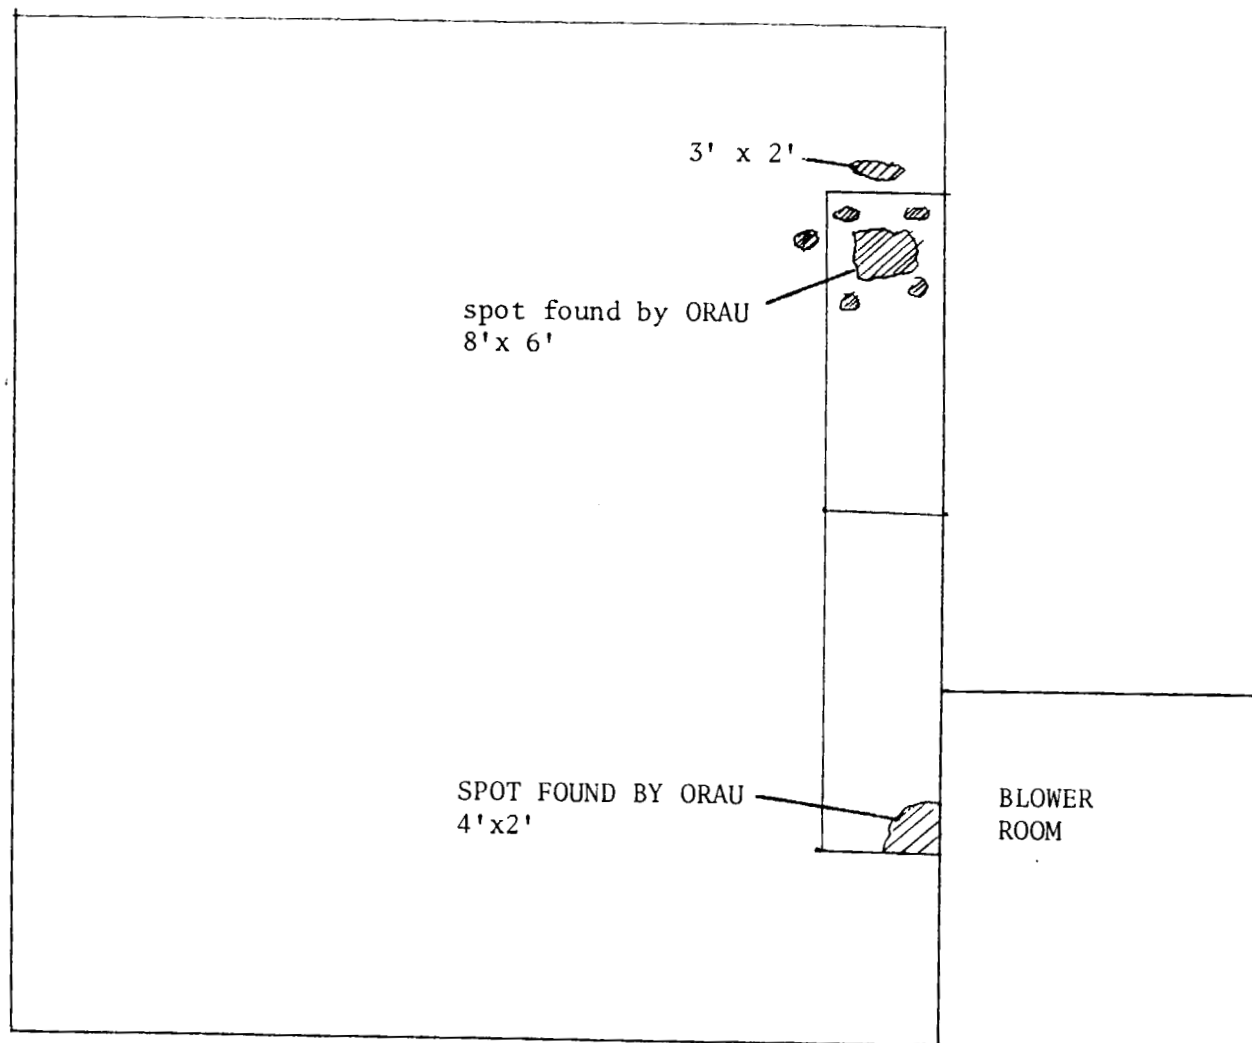
Location BUILDING 2 1st FLOOR

Six small, isolated spots were found to contain Ra-226 exceeding release criteria (no removable contamination found). The total contaminated area was less than 20 square feet. Follow-up surveys identified an additional area of

Comments ISOLATED SPOTS ON FLOOR Ra-226 1000 pCi SPOTS CLEANED AND RELEASED

200 square feet requiring remediation. All areas have been cleaned and cleared for release.

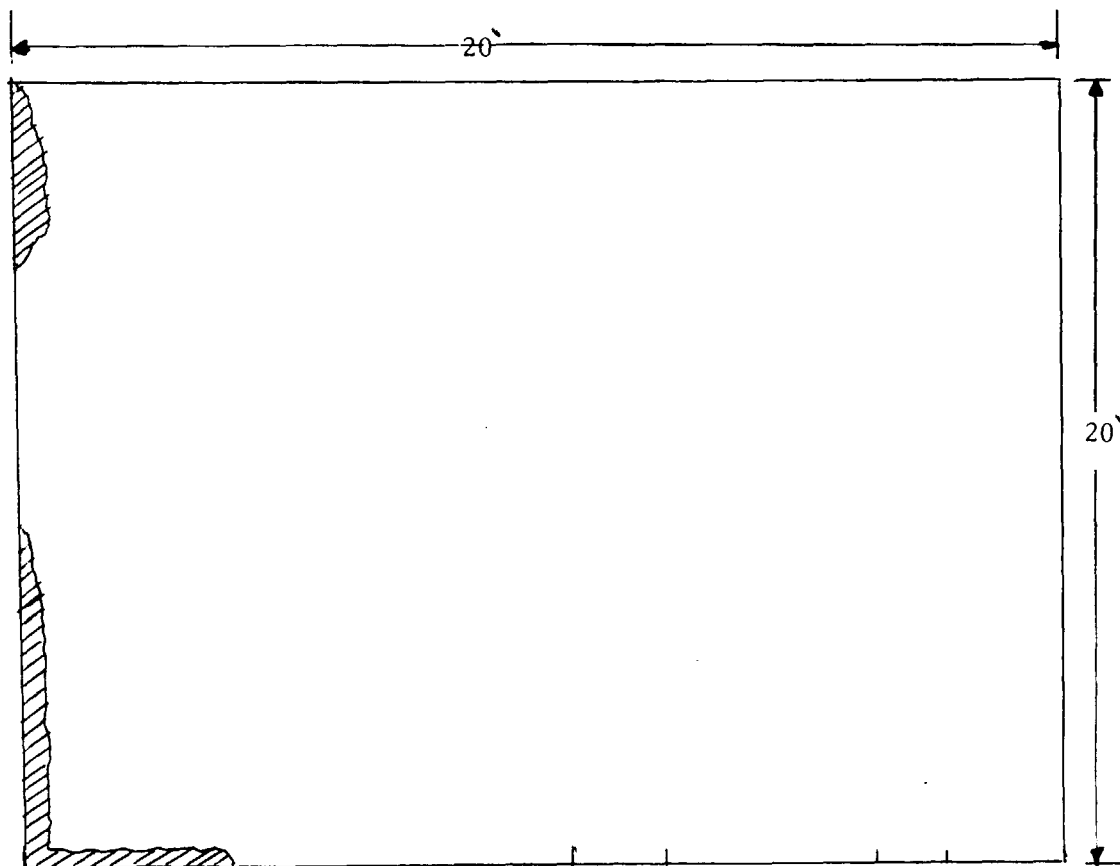
Location BUILDING 2 2nd FLOOR MOLY RIBBON ROOM

The Moly Ribbon Room, a remediated area, was found to have residual contamination. Several spots at the base of the door, the base of a pillar, and a spot on the wall were verified as exceeding criteria and cleaned by removal and vacuuming. An estimated 20 square feet was remediated.

AREA WAS PREVIOUSLY REMEDIATED BY S.E.G.

Comments ACTIVITY WAS FOUND ALONG BASEBOARDS BY ORAU. AREA WAS SAND BLASTED AND VACUUMED: RESURVEYED BY CANBERRA.

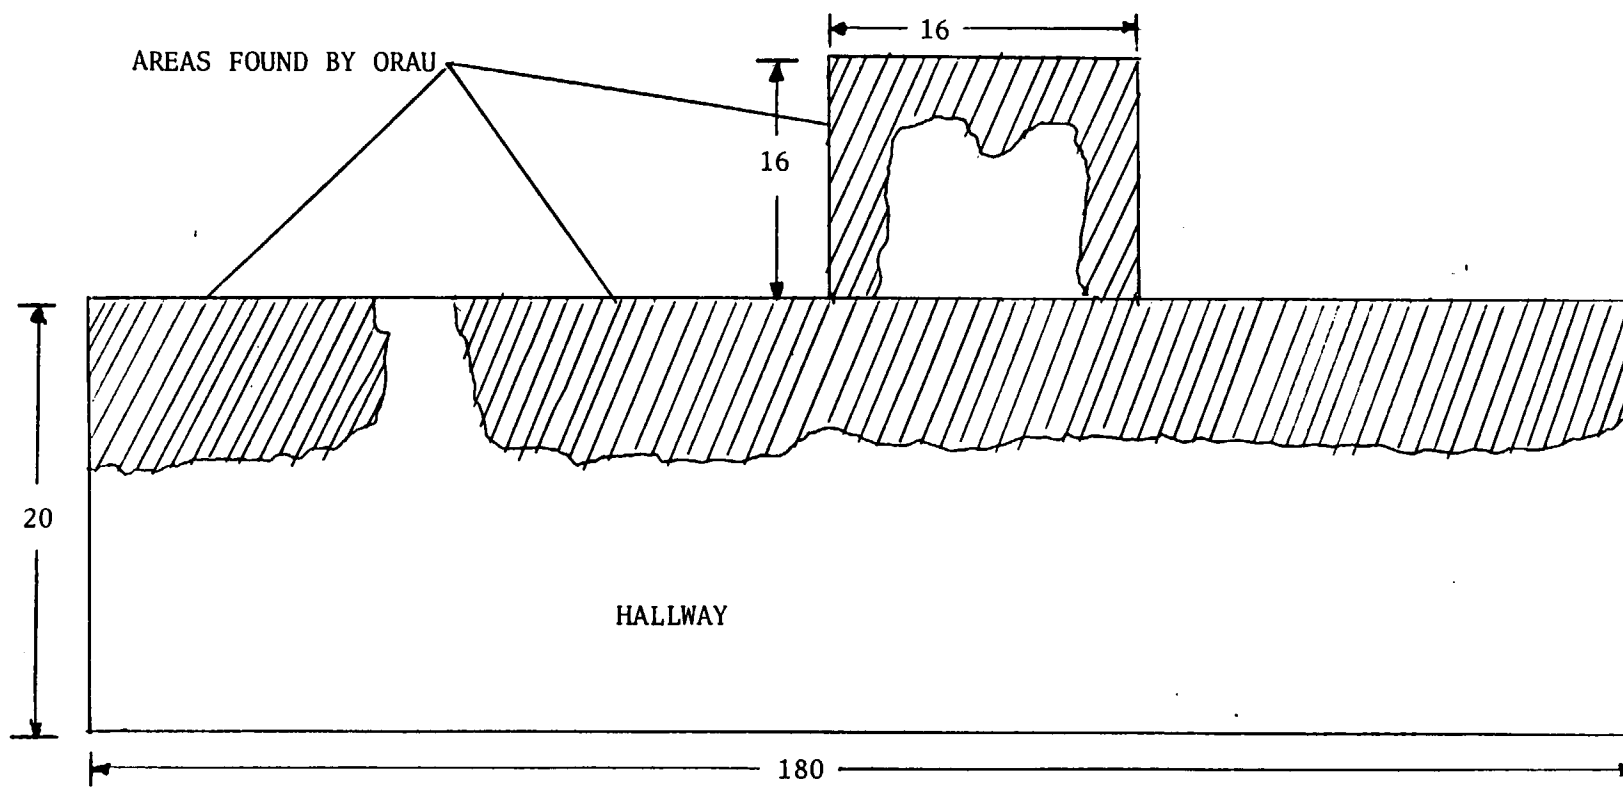
Location BUILDING 83 1st FLOOR HALLWAY AND ROOM

A corridor approximately 150 feet long was determined to contain uranium contamination. Verification measurements showed that while levels were generally elevated, actual readings exceeding criteria were very spotty and randomly distributed. Since it was more expeditious to perform large area surface removal than to locate and clean specific spots, the surface of the entire corridor was removed. A survey to confirm decontamination identified an additional 20 to 30 feet to be cleaned. The entire area was remediated and a confirmatory survey performed.

U-238 SMALL SPOTS ON FLOOR SOME ABOVE 5000 dpm/100cm<sup>2</sup>. NO REMOVEABLE ACTIVITY.

Comments HALL CONTAMINATED ALONG WITH SMALL ROOM ADJACENT TO HALL. HALLWAY WAS SCABBLED AND WOOD FLOOR REMOVED FROM ROOM.

A 10 foot storage area adjacent to the corridor was confirmed to be contaminated. The wooden flooring and the surface of the underlying concrete were removed and the area vacuumed. A confirmatory survey indicated decontamination was complete.

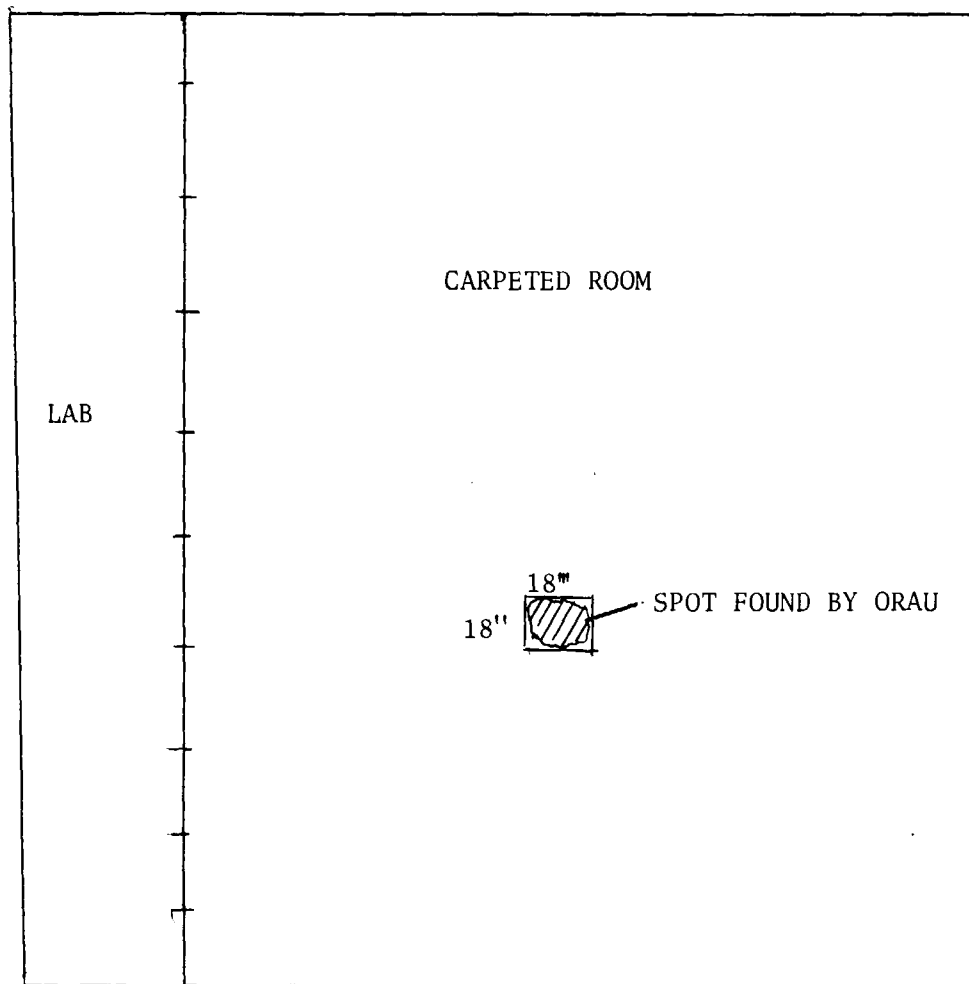
Location BUILDING 3 3rd FLOOR

A lab room was reported to have elevated readings throughout. Our confirmatory survey found only a single area approximately two feet by two feet, which was removed. All other readings are due to elevated background levels from wall materials containing natural radioactive materials, e.g. potassium, and do not exceed release criteria.

Comments SPOT FOUND UNDER CARPET U-238 ACTIVITY 120 pCi/gm SPOT REMOVED AND RELEASED

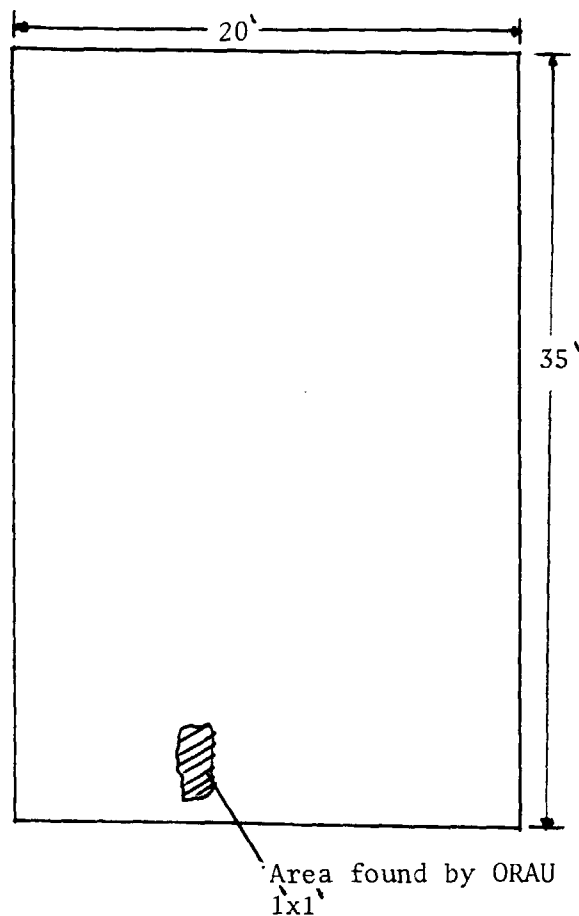
Location BUILDING 4 2nd FLOOR PLATING ROOM

A four square foot area in the plating room was confirmed to have spots exceeding criteria. The concrete surface was chipped and vacuumed to meet release limits.

Comments CONCRETE CHIPS FROM SMALL AREA SHOWED TRACE URANIUM AND THORIUM AREA FOUND TO MEET CRITERIA

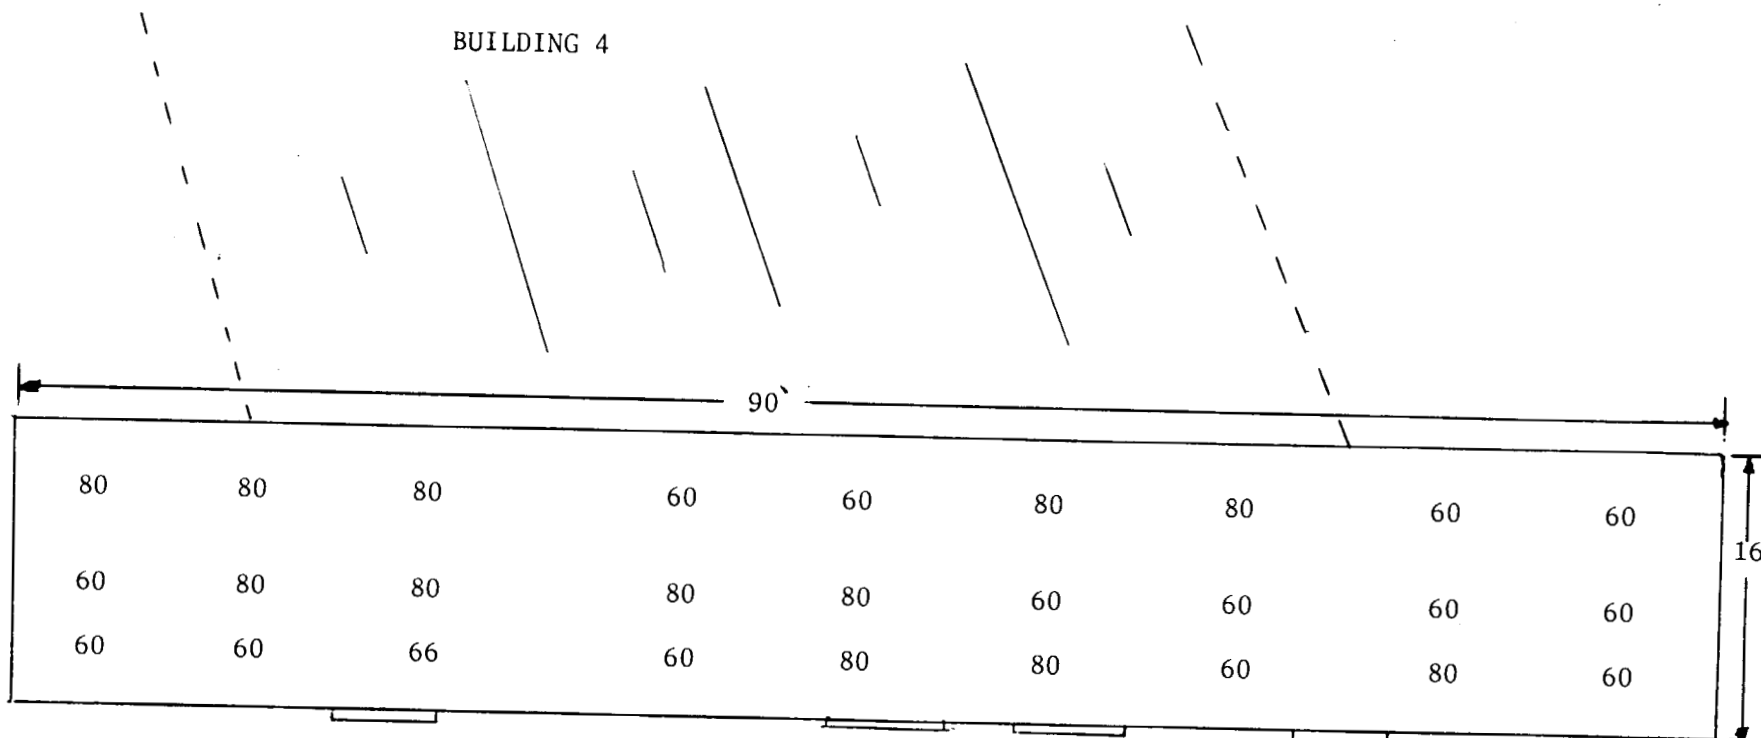
Location BUILDING 4 LOADING DOCK

Elevated readings were reported in this area, which had been previously remediated. A confirmatory survey failed to detect any readings exceeding uranium release criteria, although readings above ambient background were confirmed. No follow-up remediation has been performed in this area.

Comments AREA FOUND BY ORAU. CONFIRMED TO BE BELOW CRITERIA FOR URANIUM.

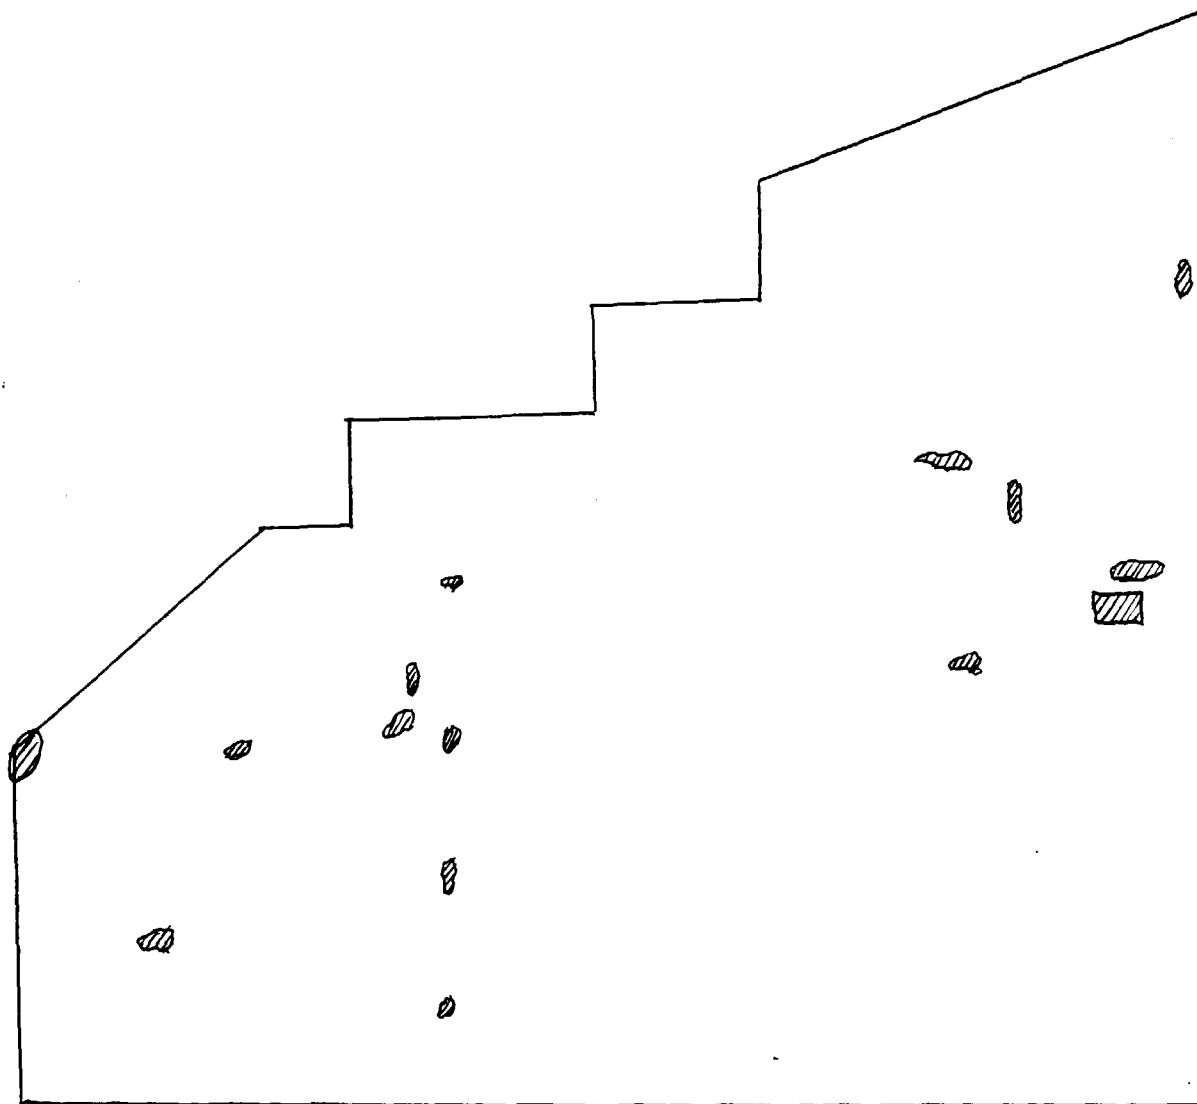
Location BUILDING 6

Several isolated spots were reported in this building. Based on this report, the WEC contractors completed a 100% resurvey of the floor, identifying an additional five spots. All areas were cleaned by removing the concrete top surface. A total of about 200 square feet of surface plus soils were removed to meet release criteria.

Comments Th-232 activity at 8pCi/gm various small spots with surface contamination Spots removed and cleared

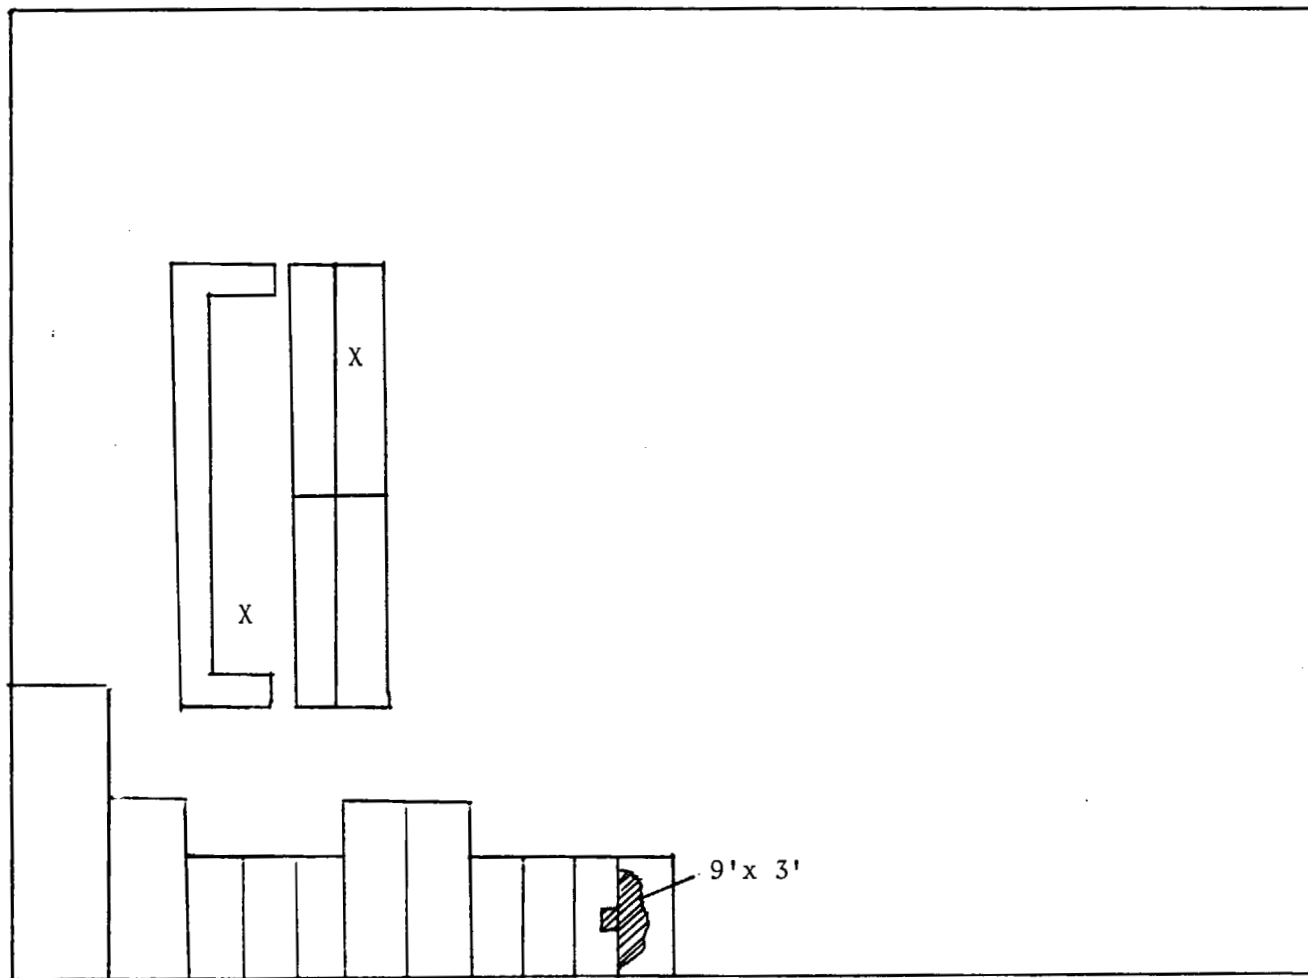
Location BUILDING 1 2nd FLOOR OFFICE

Xs REPRESENT ELEVATED READINGS BUT NOT OVER CRITERIA.

Comments COUNTS RANGE FROM 150 cpm to 2800 cpm. SHADED AREA IS OVER CRITERIA FOR THORIUM.  
AREAS CLEANED TO REL' Y CRITERIA 8/15/91

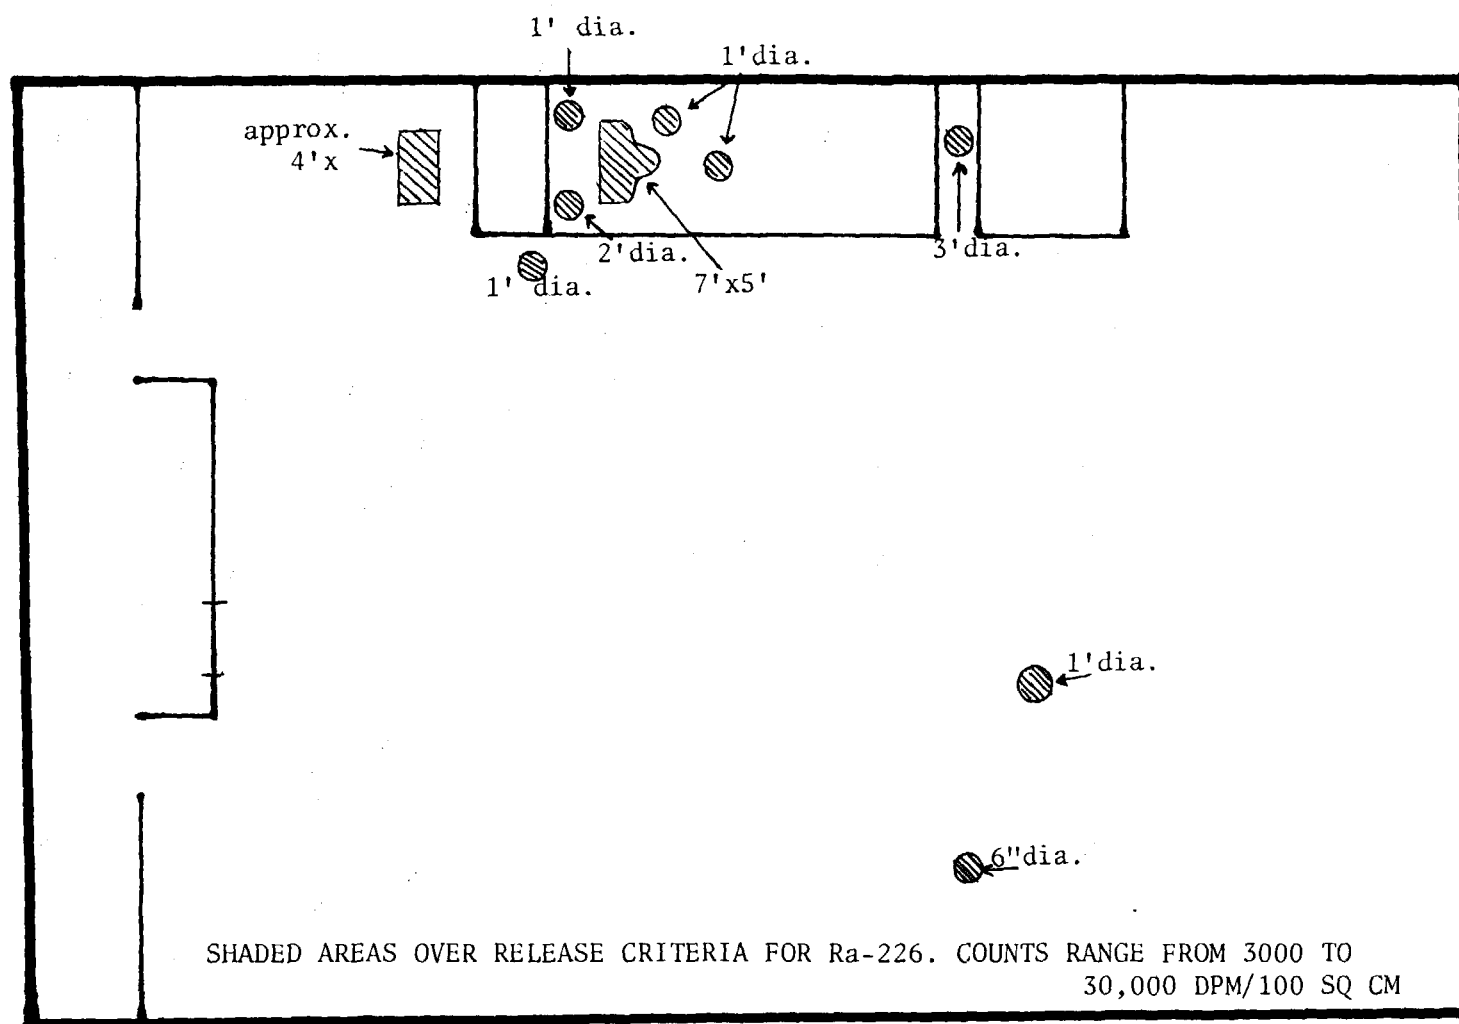
Location BUILDING #2 1st FLOOR

CHECKED & RELEASED BY ROB MADDOX (CI)

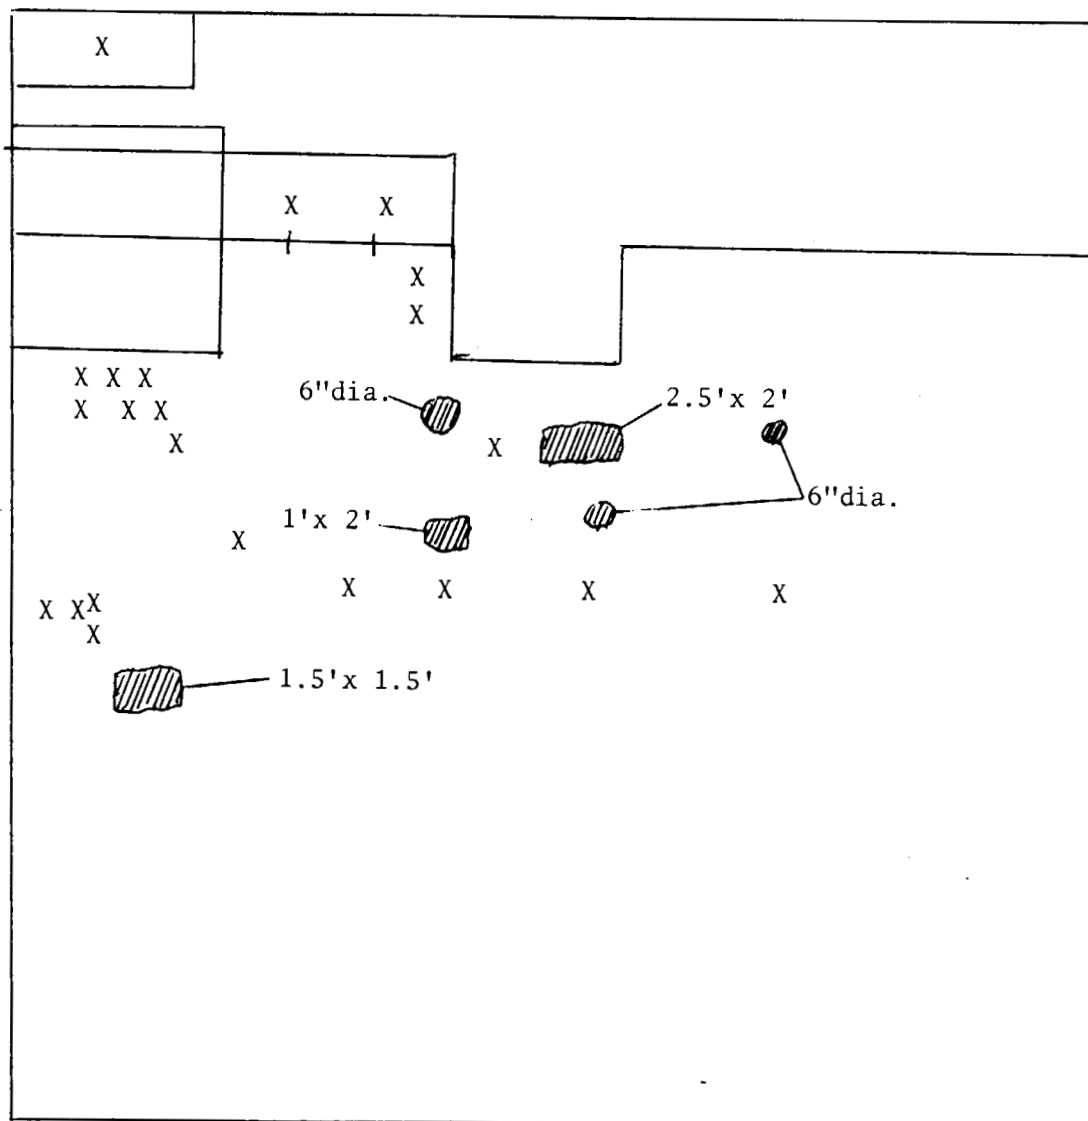
Location BUILDING 2 2nd FLOOR

Xs REPRESENT ELEVATED READINGS BUT NOT OVER CRITERIA.

Comments SHADED AREAS ARE OVER CRITERIA FOR THORIUM. COUNTS RANGE FROM 200 cpm to 1100 cpm

CHECKED AND RELEASED BY MADDOX AUG, 91

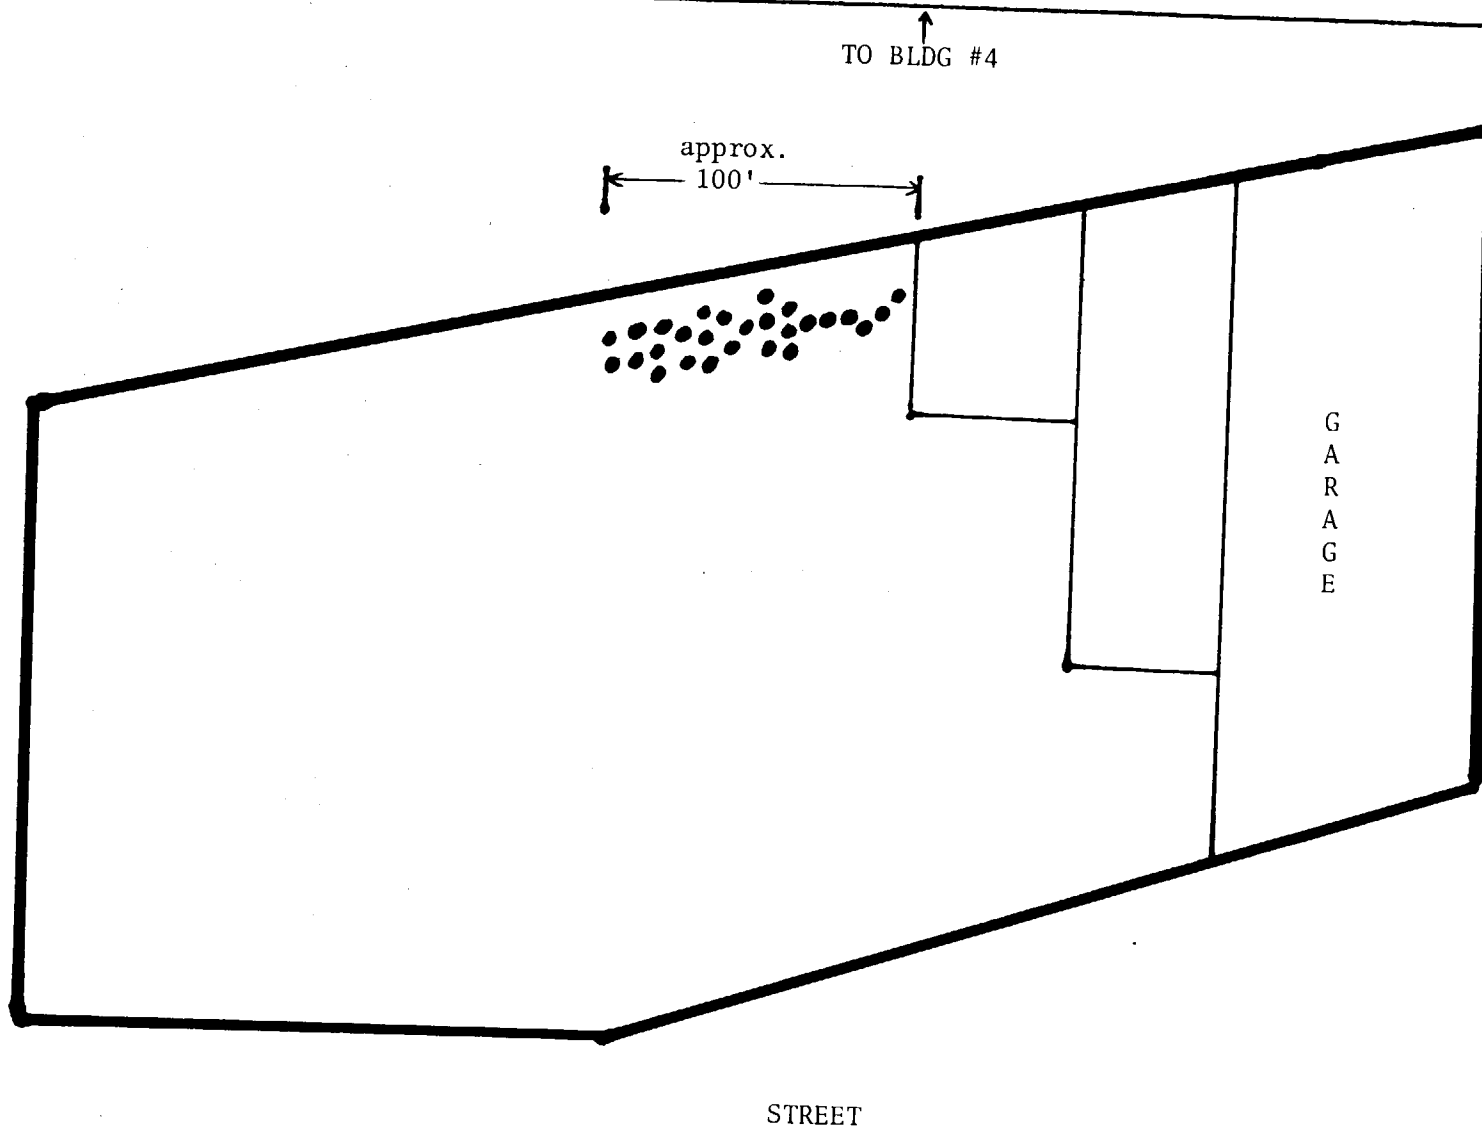
Location BUILDING #3 1st FLOOR

Comments AREA REMEDIATED TO NO ACTIVITY >120 GROSS CPM SURVEYED BY WALT TOMLINSON 8/8/91

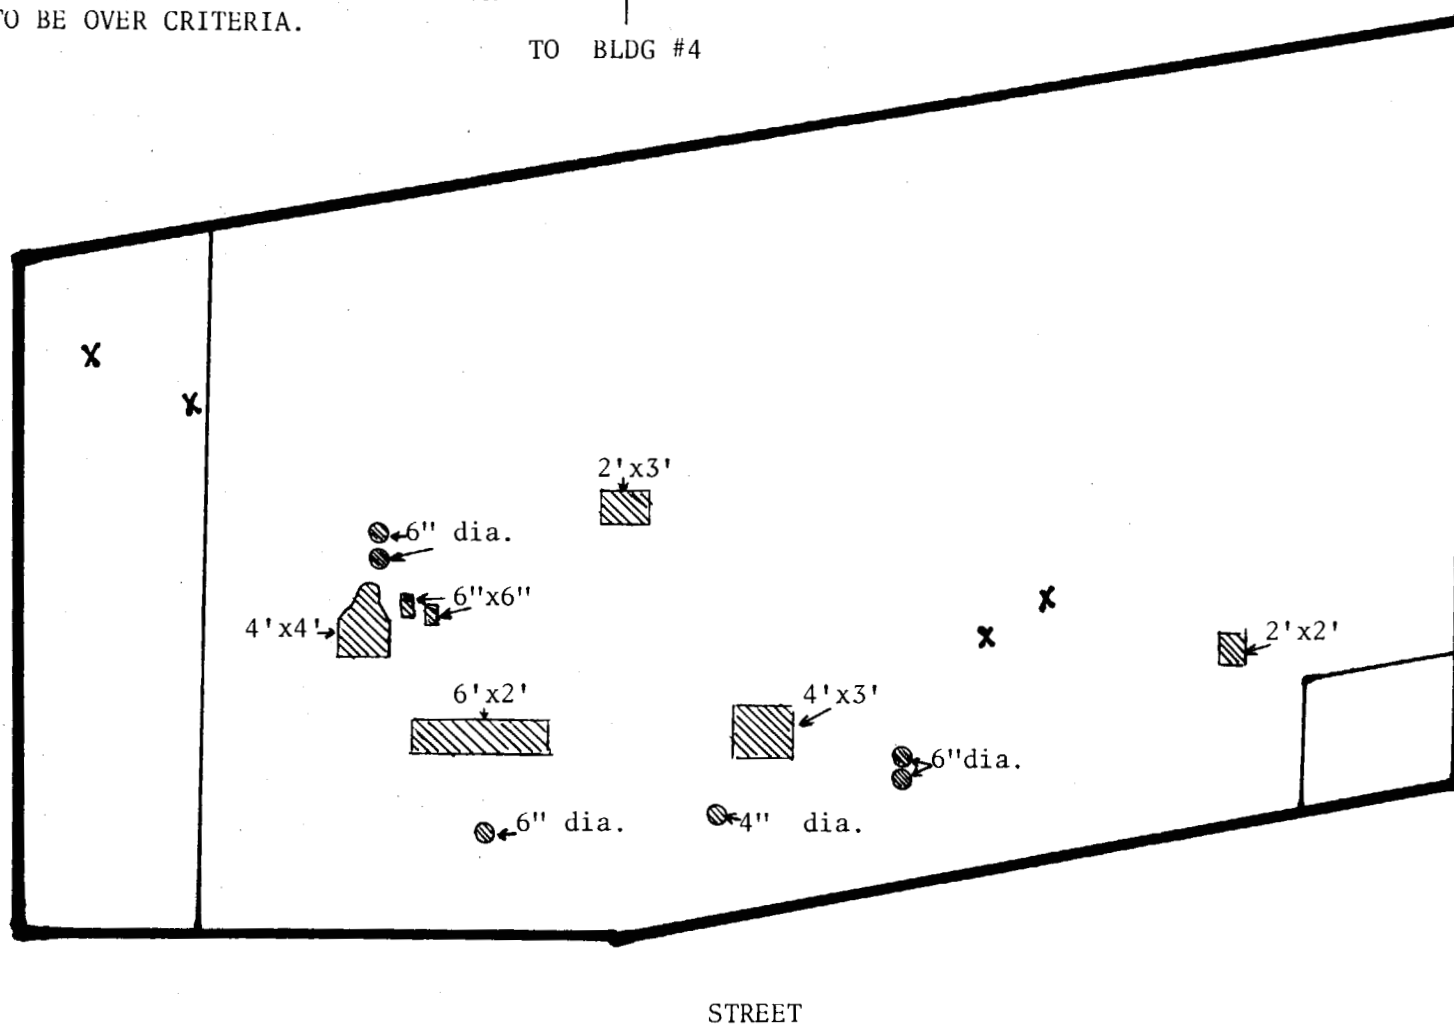
Location BUILDING #3 4th FLOOR

SHADED AREAS REPRESENT AREAS OVER CRITERIA  
FOR THORIUM COUNTS RANGE FROM 200 CPM TO 400 CPM  
X's REPRESENT AREAS FOUND BY THE FLOOR MONITOR  
BUT FOUND NOT TO BE OVER CRITERIA.

Comments SEE SEPARATE RELEASE SURVEY

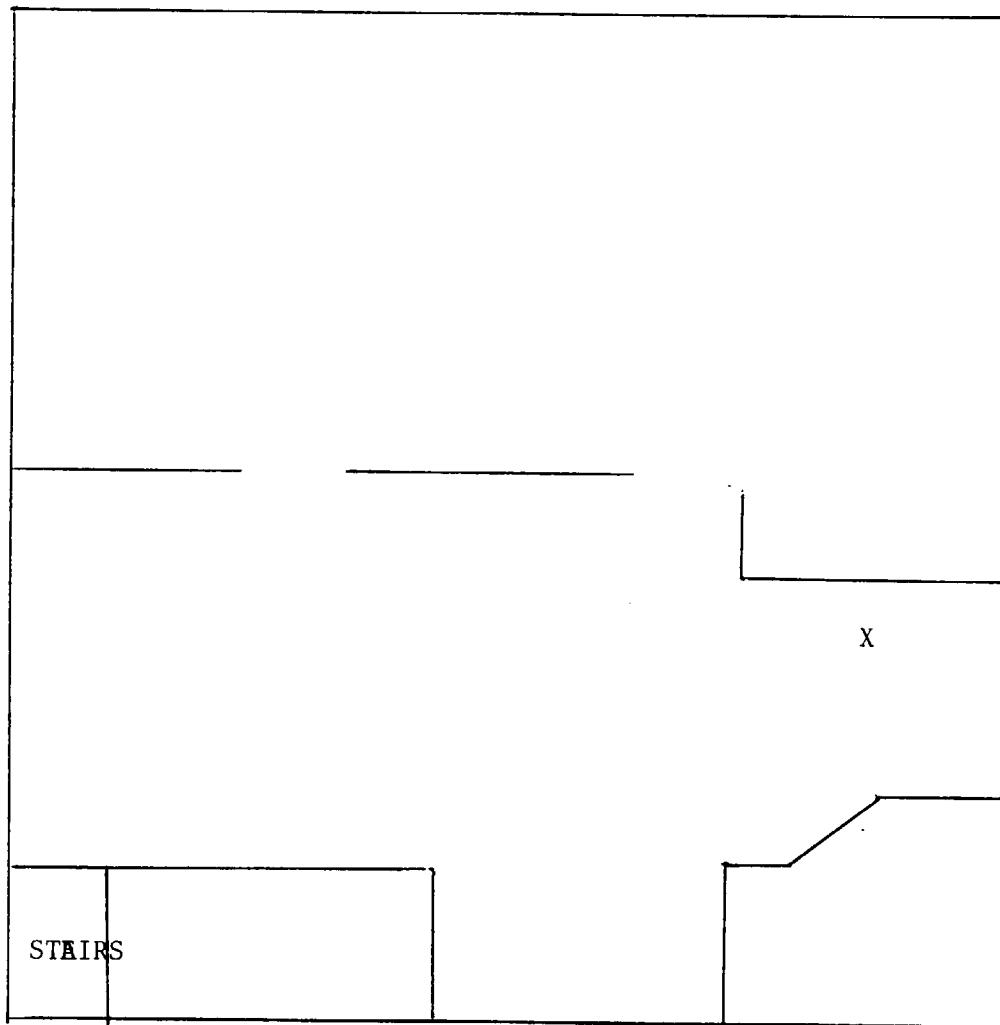
Location BUILDING 5 1st FLOOR

Comments X REPRESENTS ELEVATED READINGS BUT NOT OVER CRITERIA

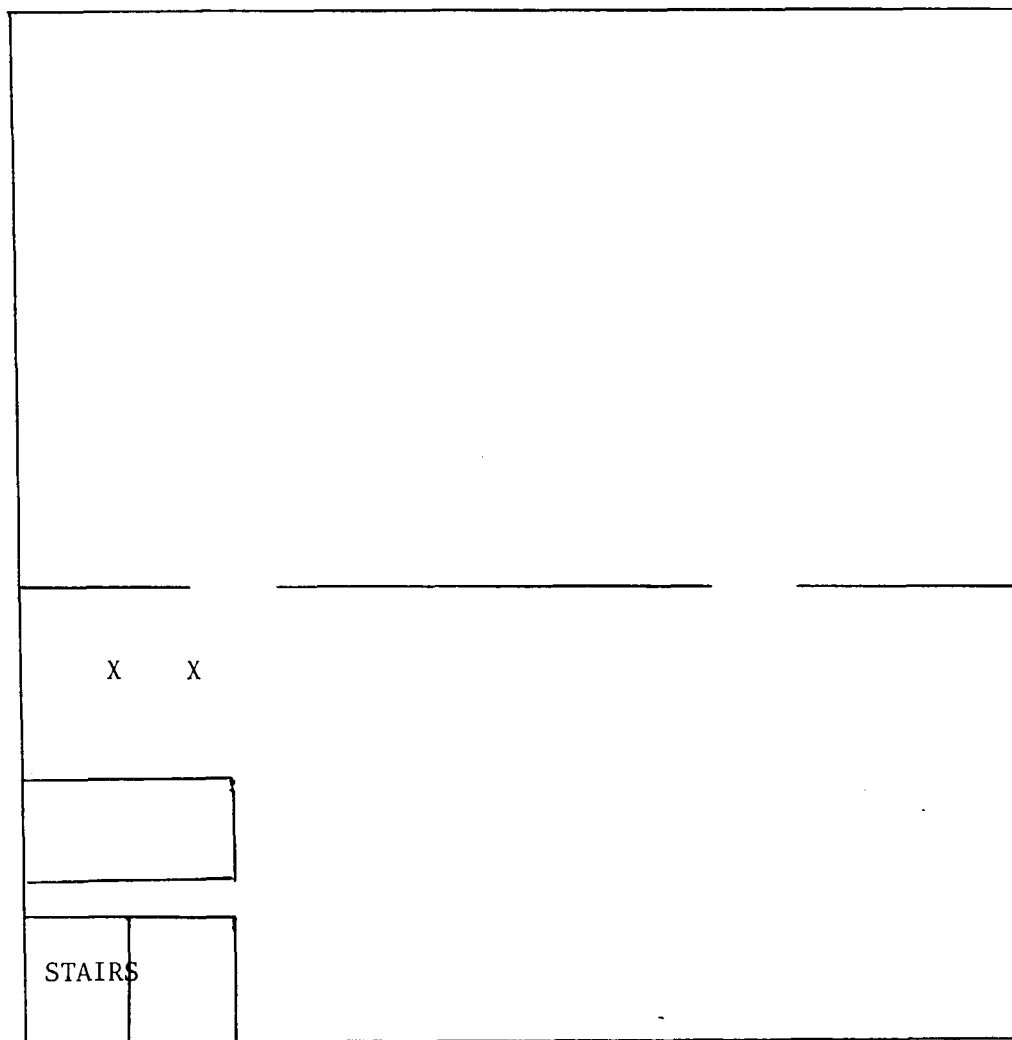
Location BUILDING 5 2nd FLOOR

Comments Xs REPRESENT ELEVATED READINGS BUT NOT OVER CRITERIA.

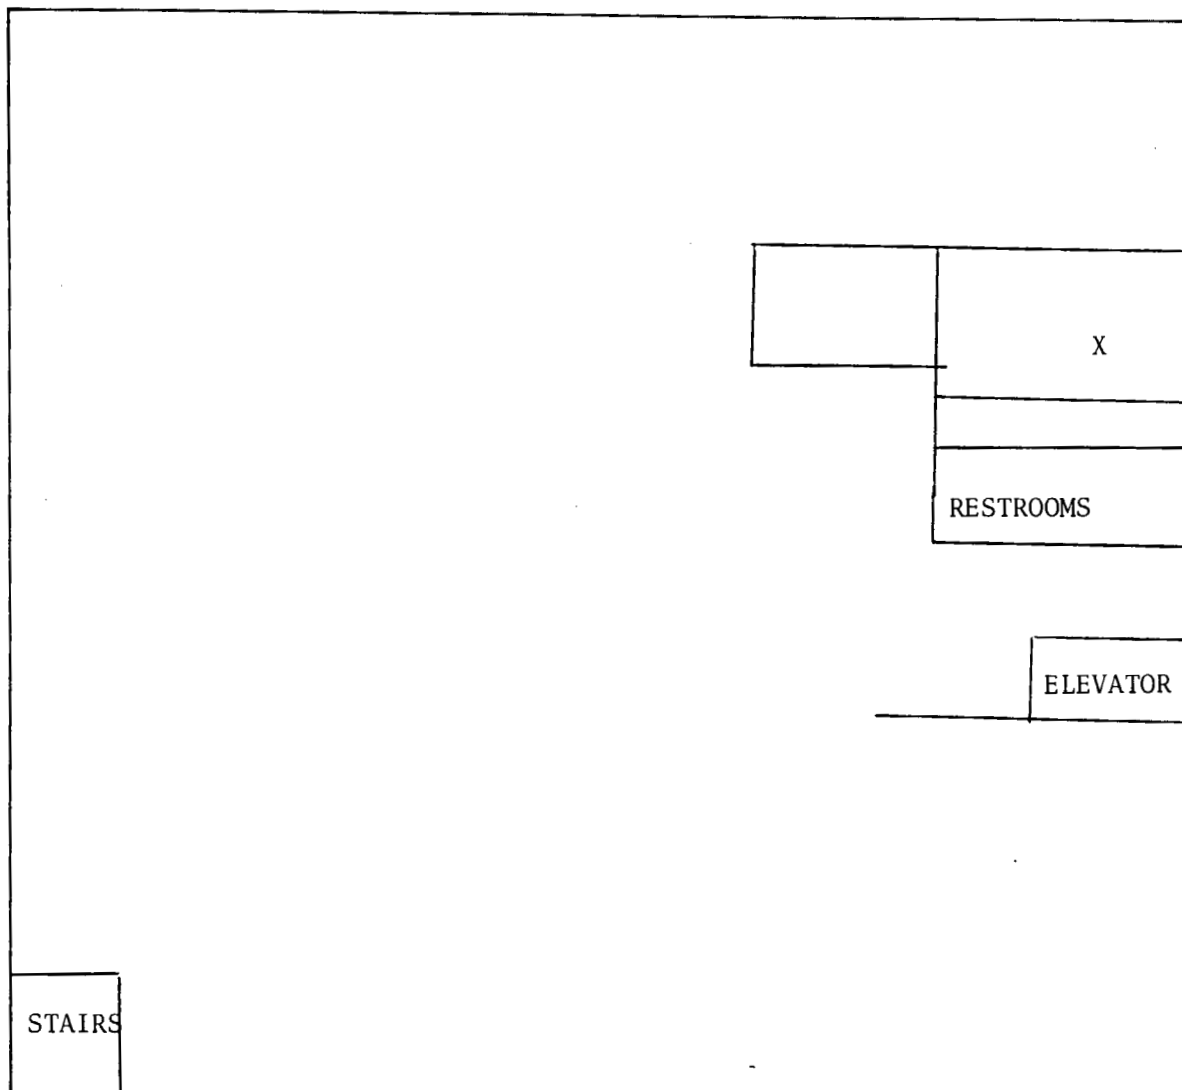
Location BUILDING 5 4th FLOOR

Comments X REPRESENTS ELEVATED READINGS BUT NOT OVER CTITERIA.
