VIRGINIA ELECTRIC AND POWER COMPANY
NORTH ANNA POWER STATION UNITS 1 AND 2
10 CFR 50.9 CORRECTION OF INFORMATION PROVIDED TO SUPPORT
TECHNICAL SPECIFICATION CHANGE FOR
QUENCH SPRAY AND RECIRCULATION SPRAY NOZZLES
SURVEILLANCE FREQUENCY

**10 CFR 50.9 Correction of Information Provided to Support
Technical Specification Change for
Quench Spray and Recirculation Spray Nozzles
Surveillance Frequency**

**North Anna Power Station
Units 1 and 2
Virginia Electric and Power Company
(Dominion)**

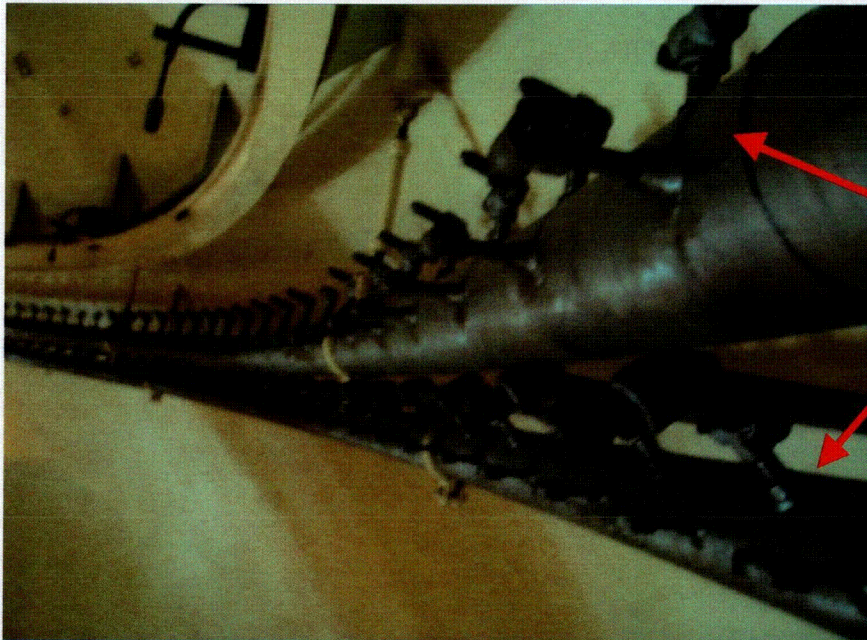
**North Anna Unit 2
Recirc. Spray system
nozzles in the
containment dome**

**Boroscope camera
view of the inside of
the RS piping.**

**The majority of the
piping looked like this.**

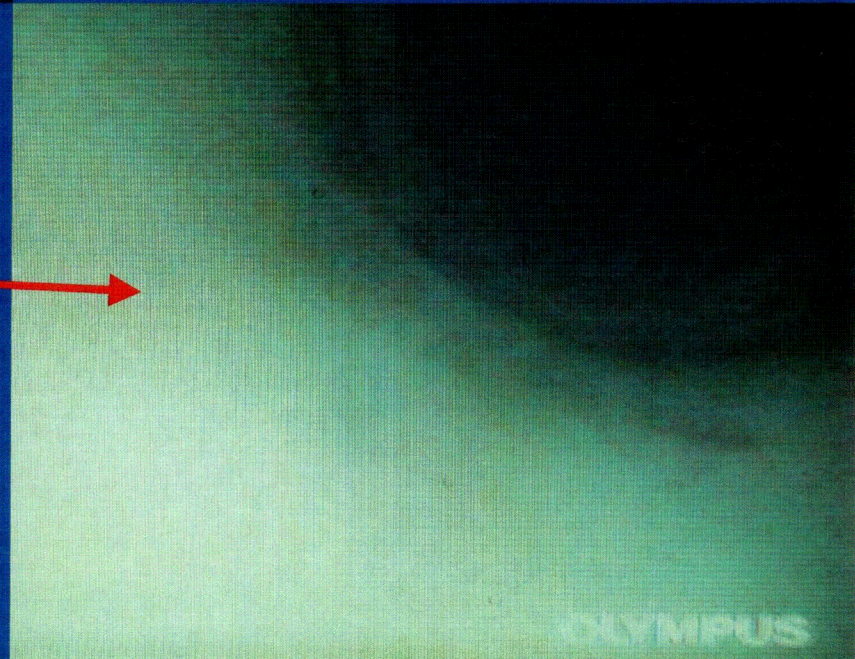
- ◆ A portion of the pipe that was inspected was also vacuumed to obtain a sample of the dust observed in the spray headers. The dust would not have affected the operation of the spray arrays.

**Dust like material found in
bottom of piping.**

**RED tubing in picture is 1/4
outside diameter test tubing.**

**Also note that movement of the
tubing and boroscope caused
dust to float in the air**

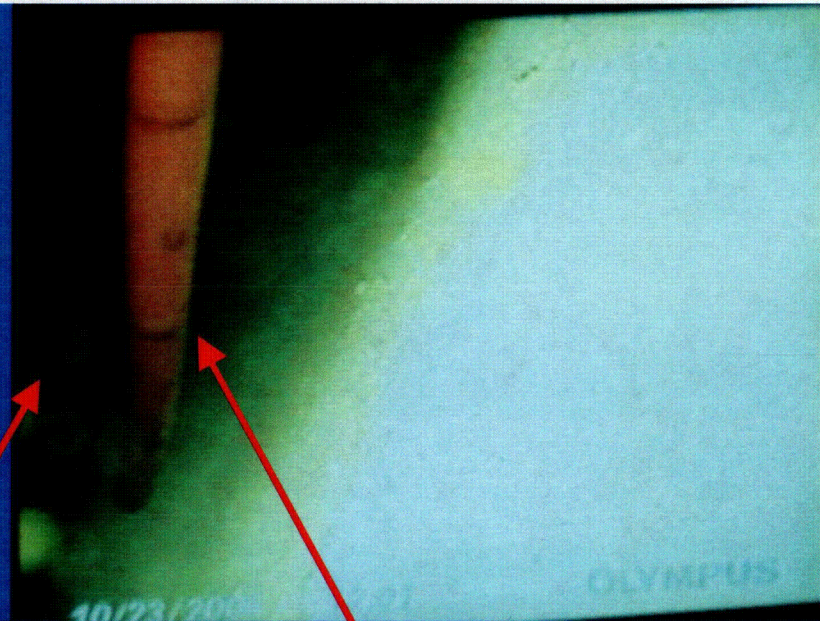
**Note that an inch scale
was drawn on the
outside of the tubing to
provide a reference**

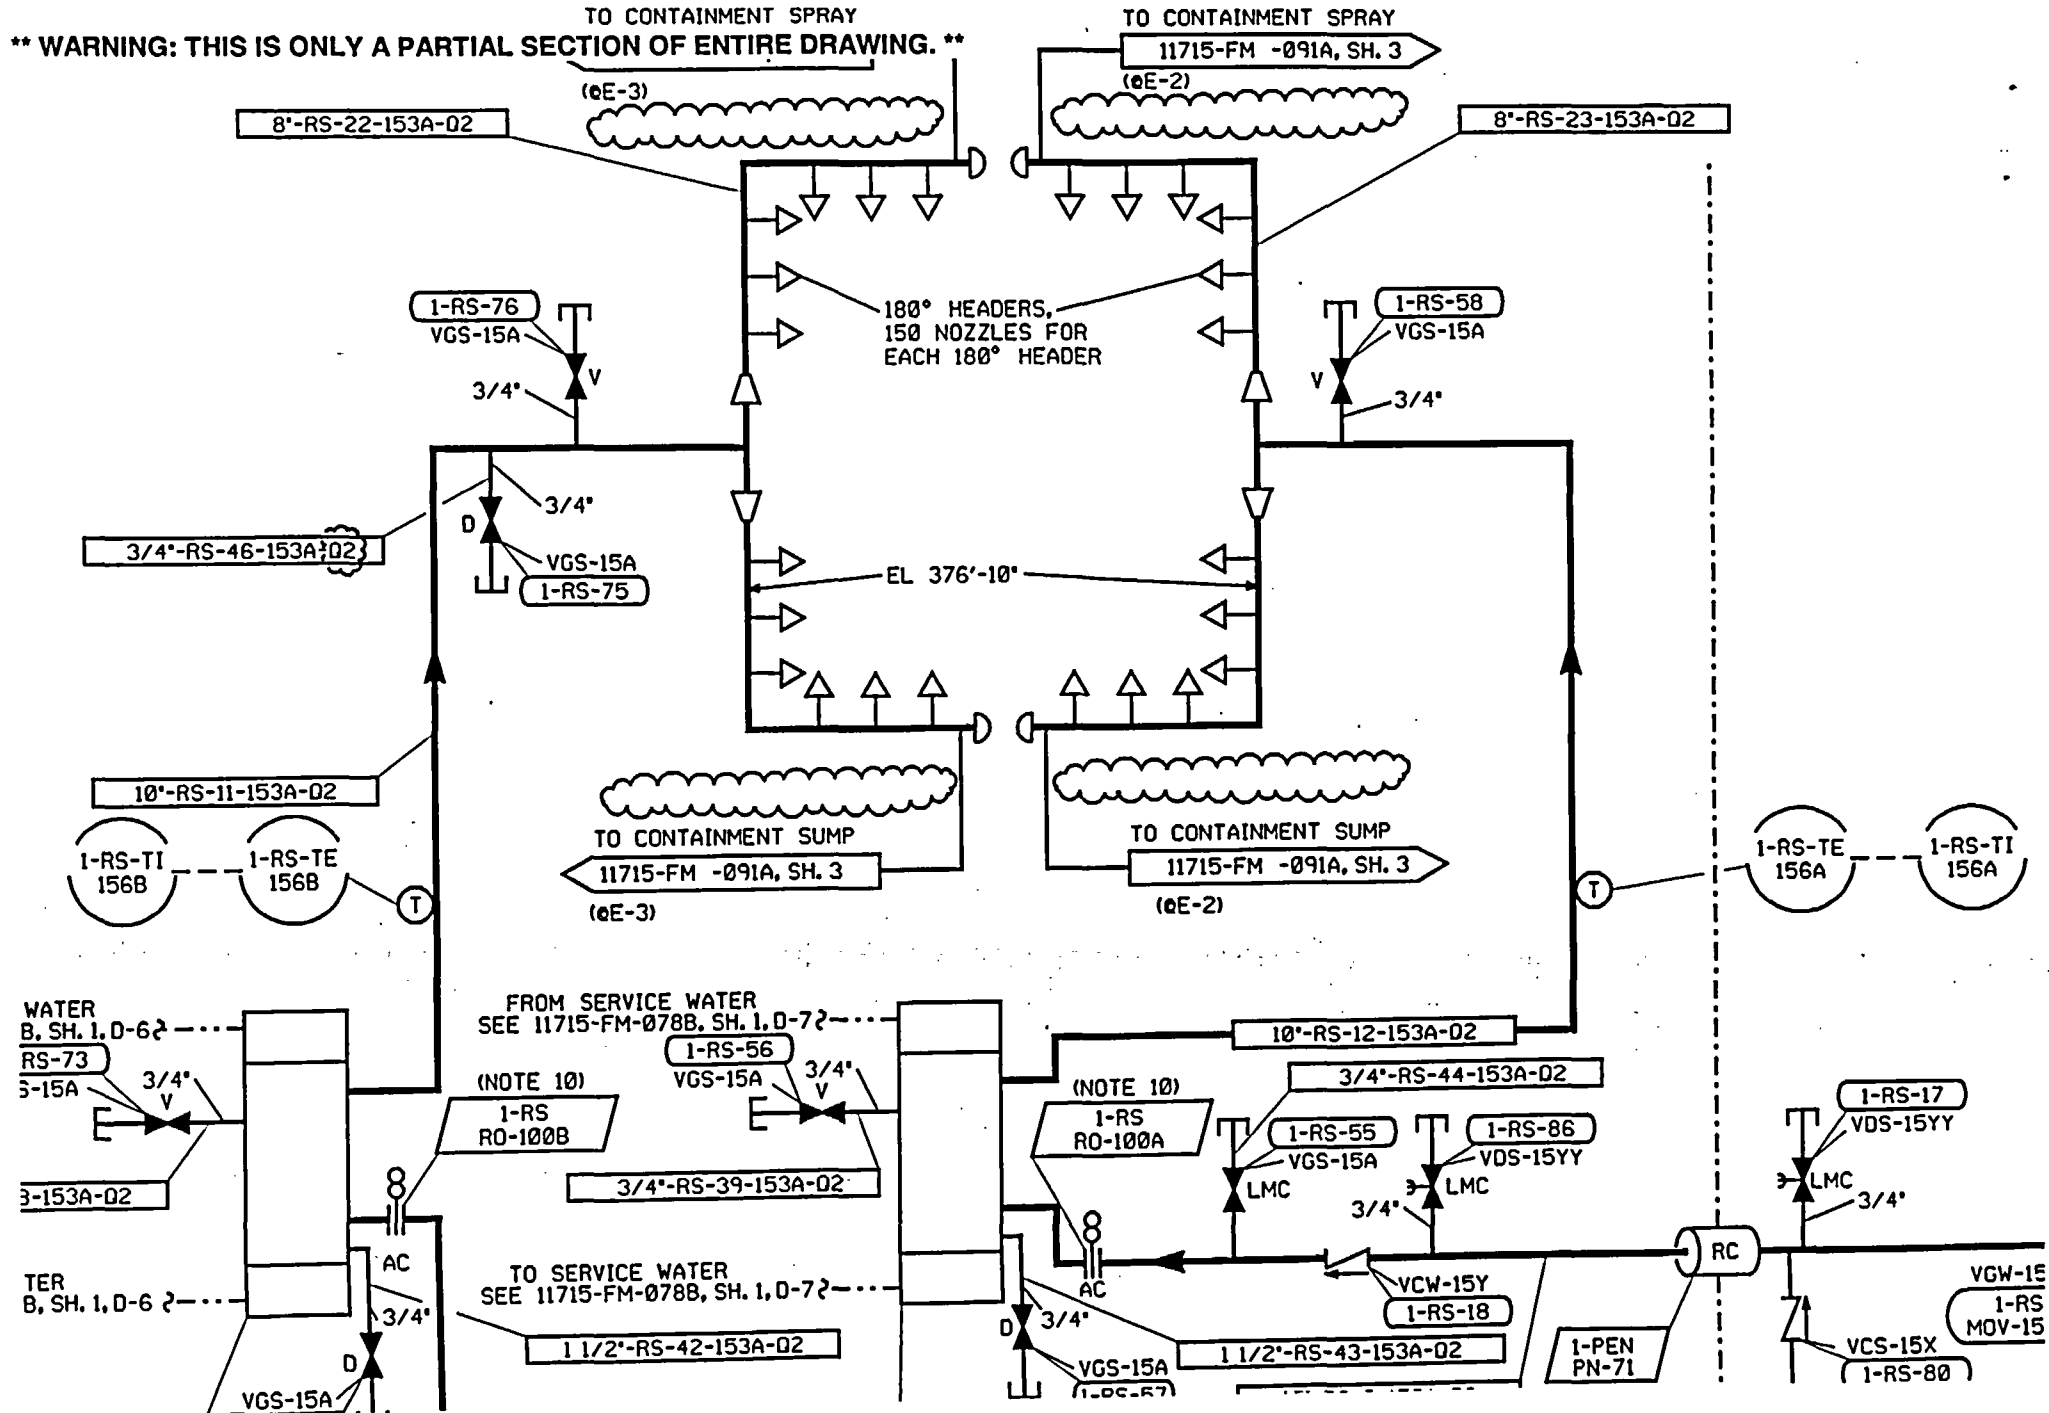
- ◆ A boroscope inspection of the portions of the Unit 2 RS spray headers that were not full flow tested. This included the spray headers - pipe segment 8"-RS-420-153A-Q2, 8"-RS-421-153A-Q2, 8"-RS-422-153A-Q2, and 8"-RS-423-153A-Q2 (see attached drawings). Experienced engineering, operations, and project management personnel performed the inspections. There was not significant debris identified in the spray array piping. See attached pictures.
