Department of Energy  
Office of Legacy Management

Subject: 2005 Annual Site Inspection and Monitoring Report for UMTRCA Title I Disposal Sites

# **2005 Annual Site Inspection and Monitoring Report for Uranium Mill Tailings Radiation Control Act Title I Disposal Sites**

**December 2005**

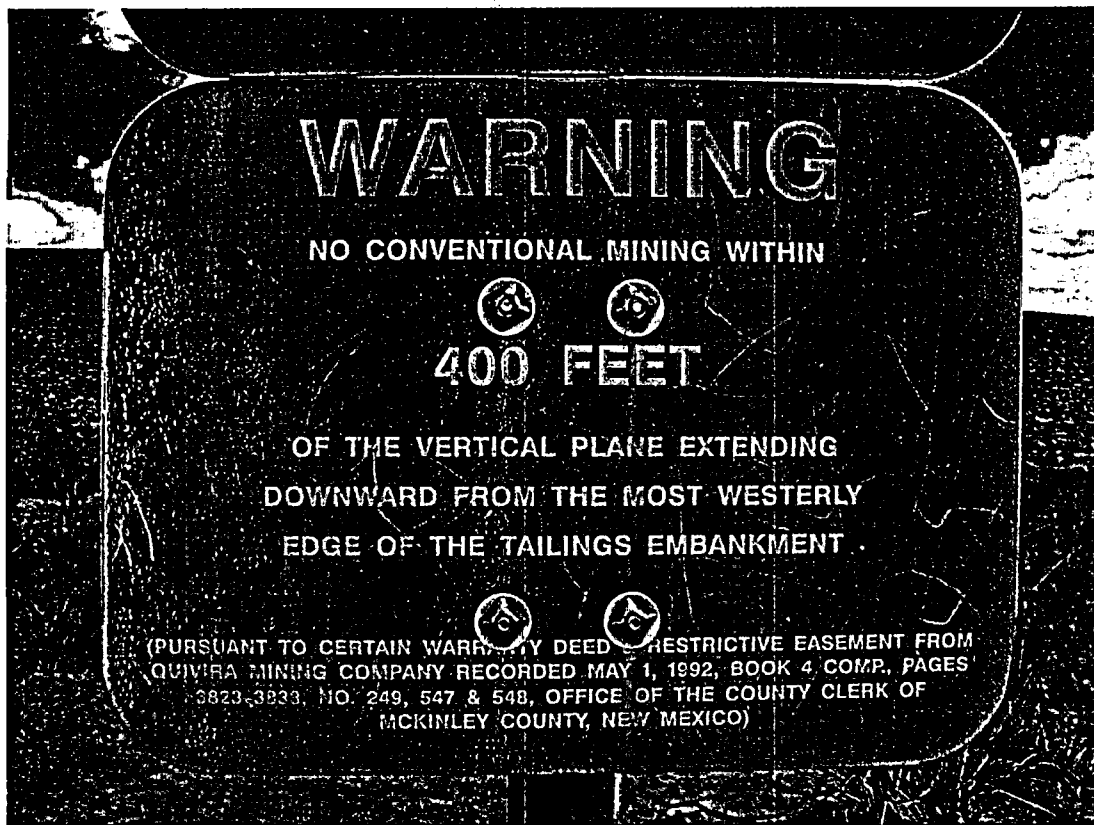
AMB 8/2005. PL-1. Mining restriction area warning sign.

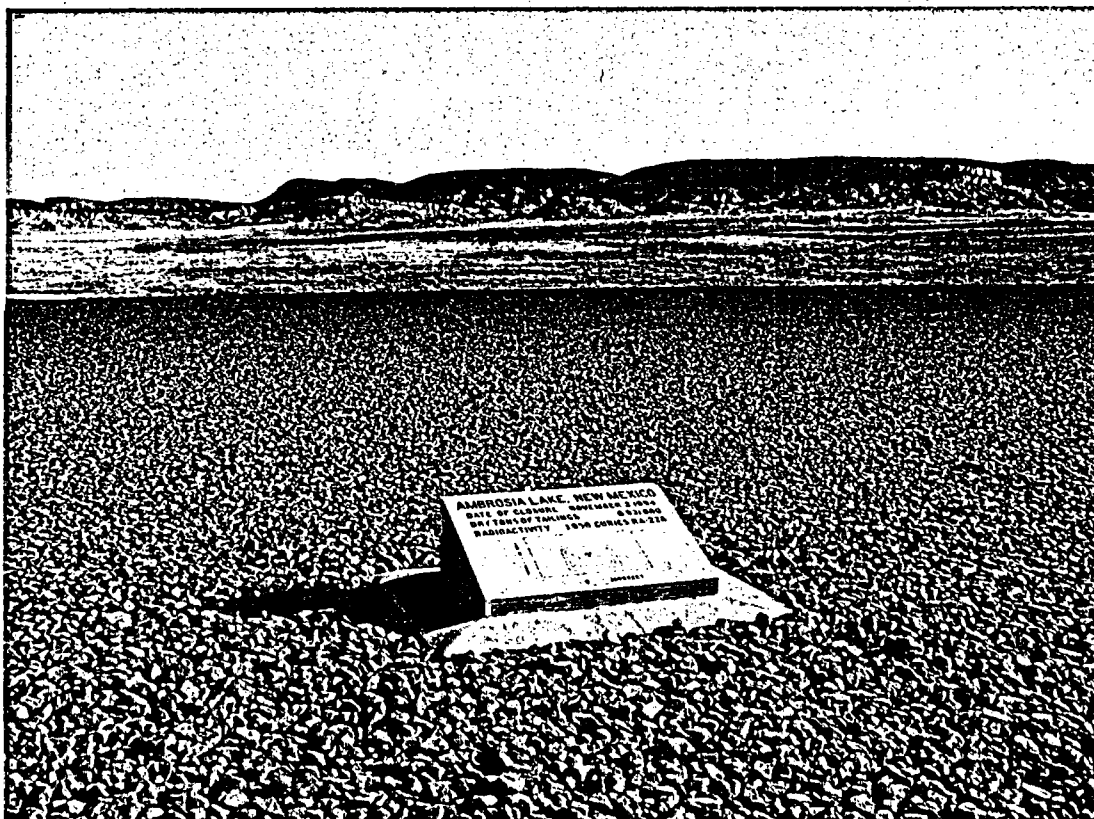
**Site Markers, Survey and Boundary Monuments**—The two granite site markers (PL-2), three combined survey and boundary monuments, and five additional boundary monuments were all undisturbed and in excellent condition.

AMB 8/2005. PL-2. Site marker SMK-2 on the disposal cell top.

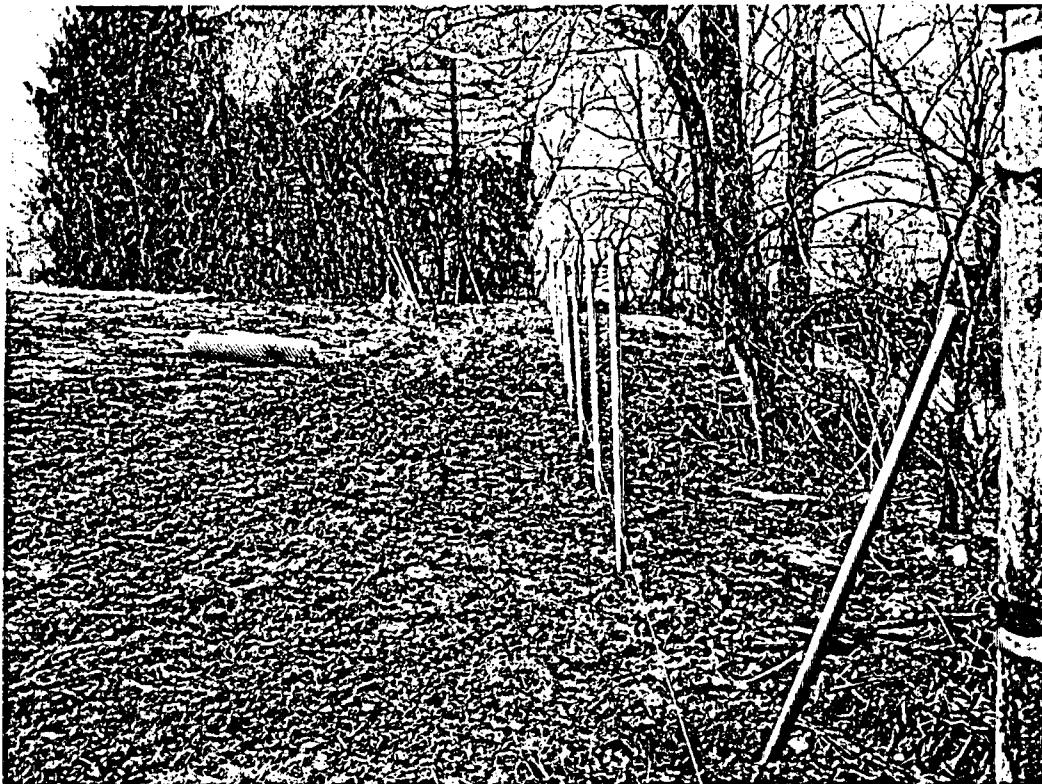
*CAN 3/2005. PL-1. Replacing the damaged portion of the security fence.*

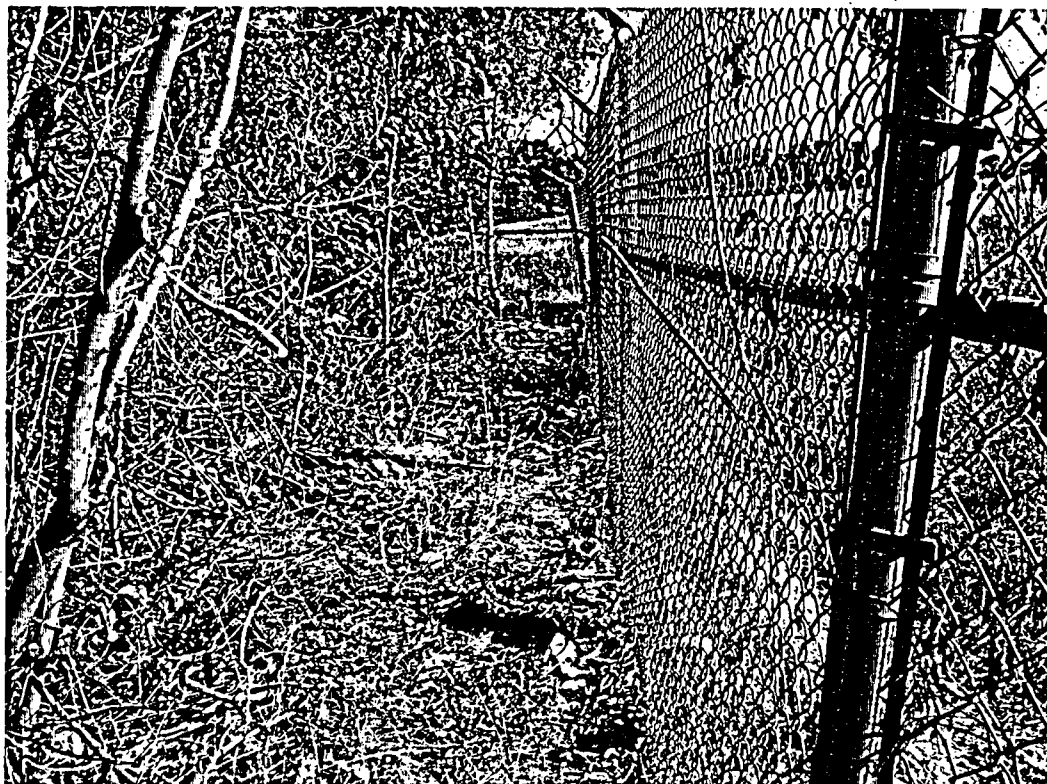
*CAN 9/2005. PL-3. Cleared path along outside of site perimeter security fence*

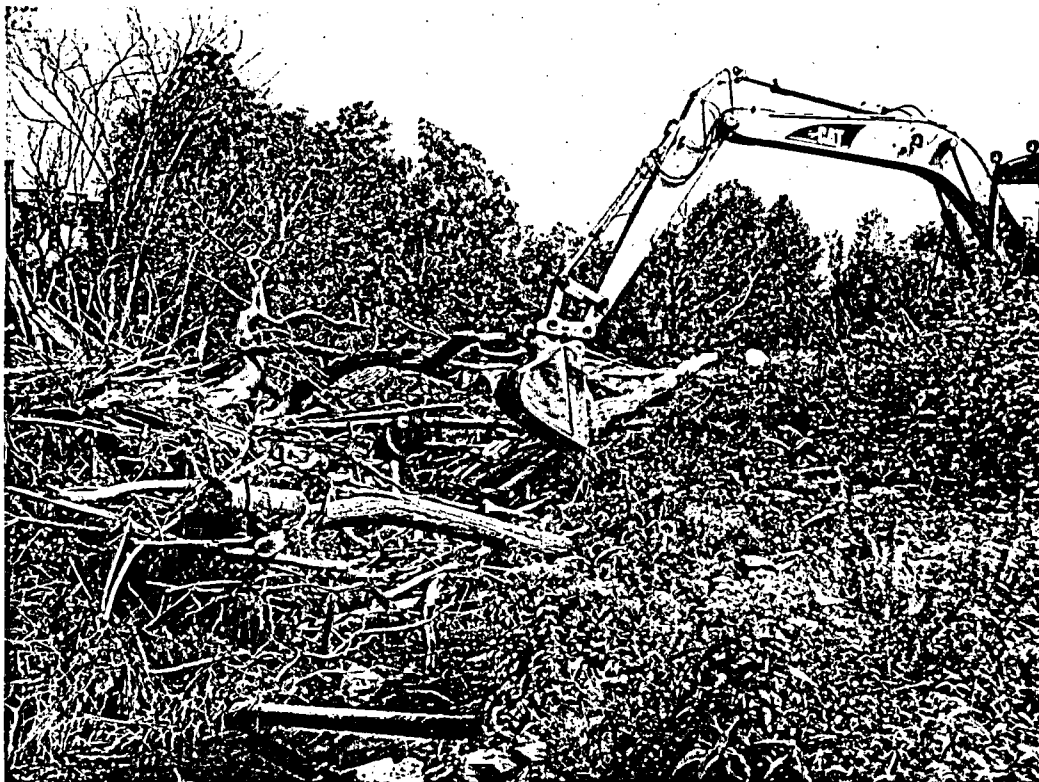
*CAN 9/2005. PL-5. Debris removal along Chartiers Creek.*

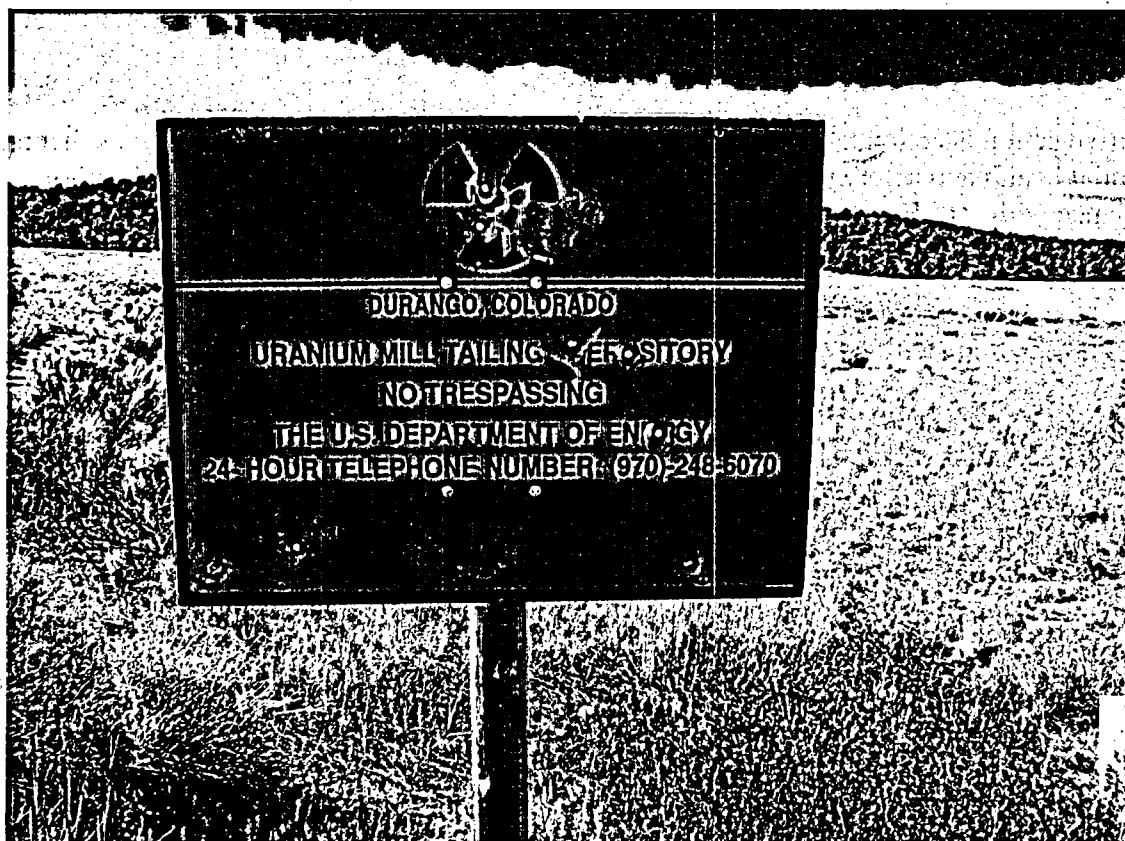
*DUR 6/2005. PL-1. Entrance sign damaged by gunshots but still legible*

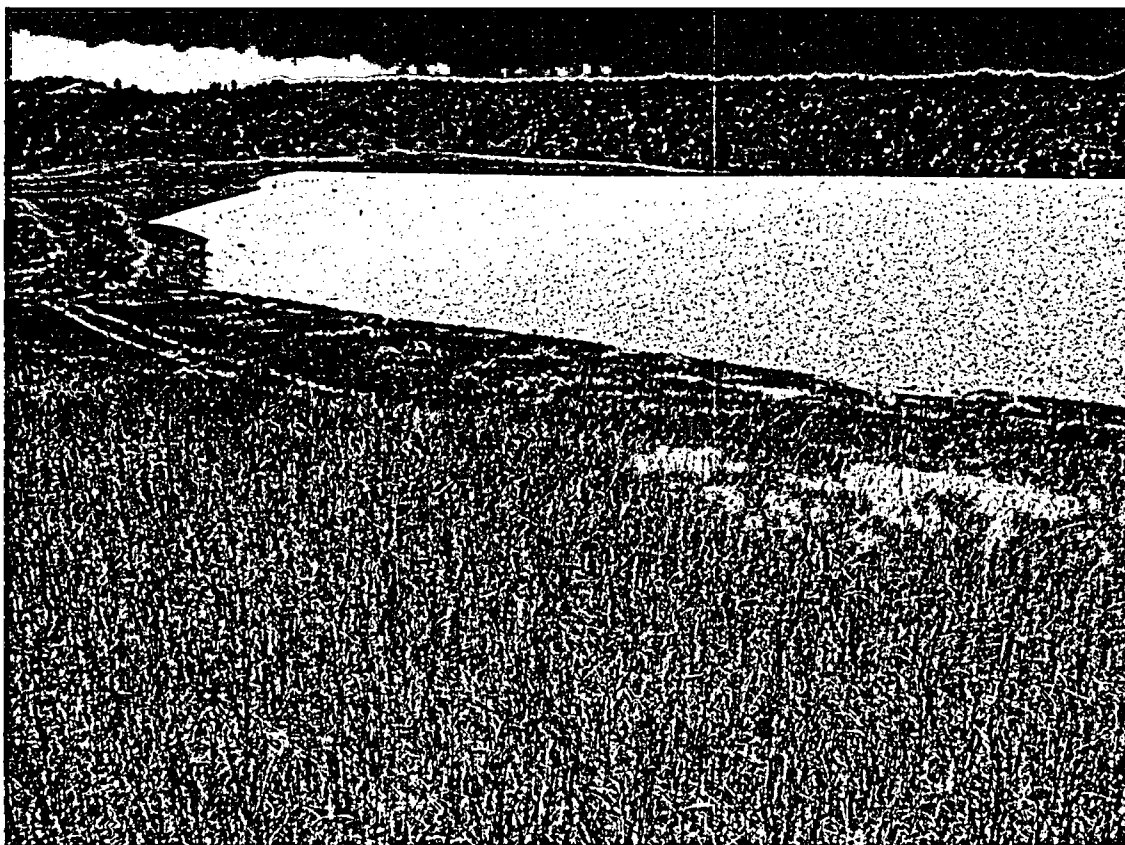
*DUR 6/2005. PL-2. Riprap-covered side slope.*

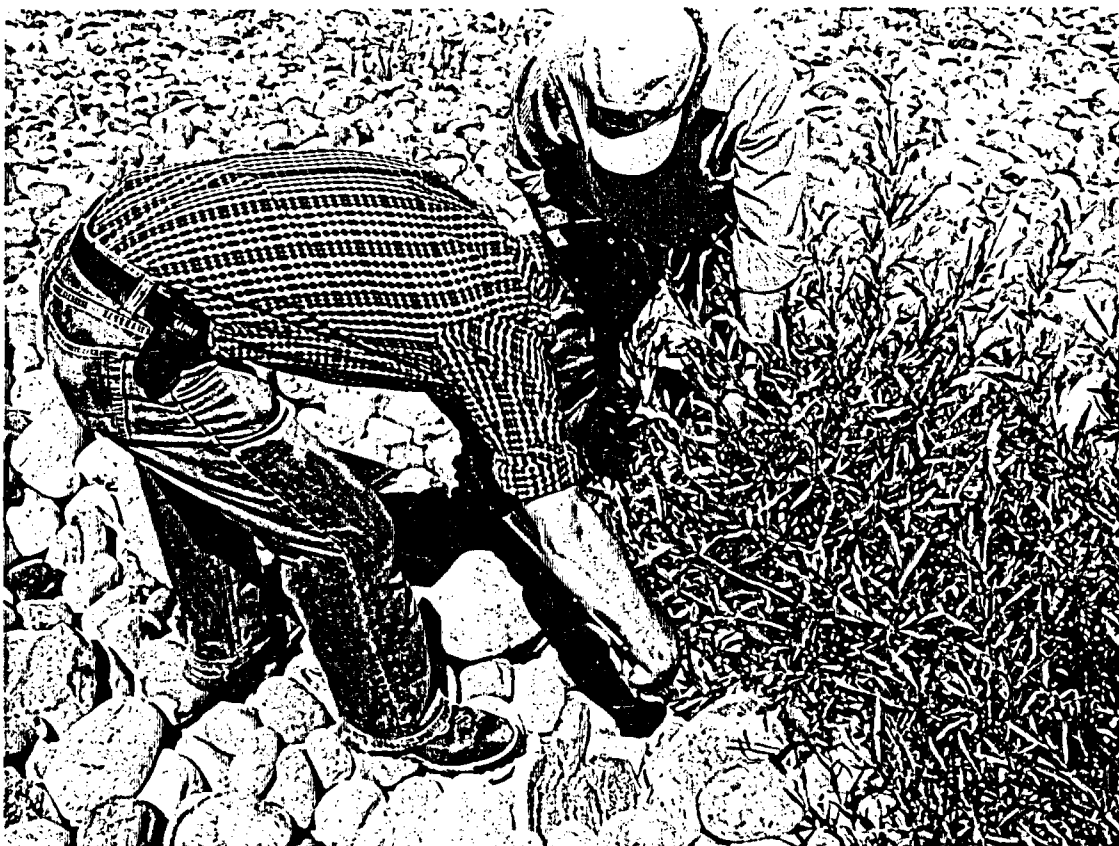
*DUR 6/2005. PL-3. Inspectors cutting deep-rooted species on western rip rap covered side slope.*

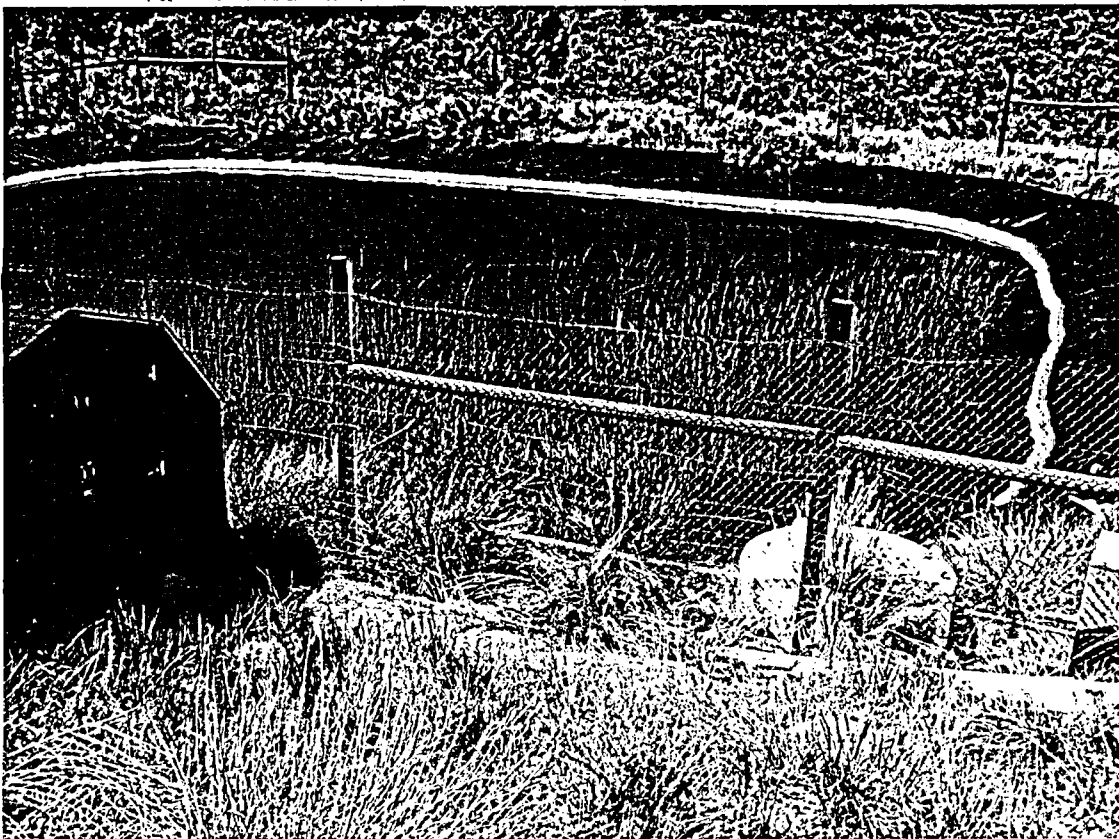
*DUR 6/2005. PL-4. Rushes growing in the disposal cell's transient drainage retention pond.*

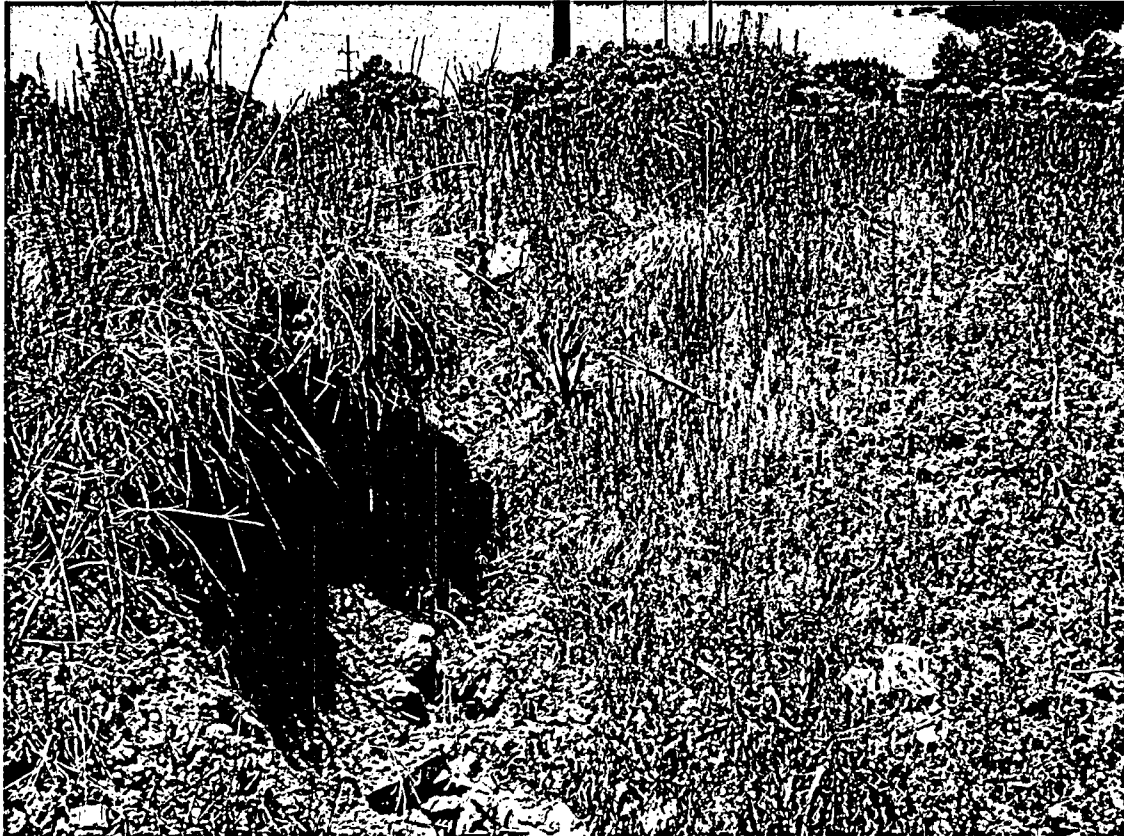
*DUR 6/2005. PL-5. Head cutting stabilized along southwest side of site.*

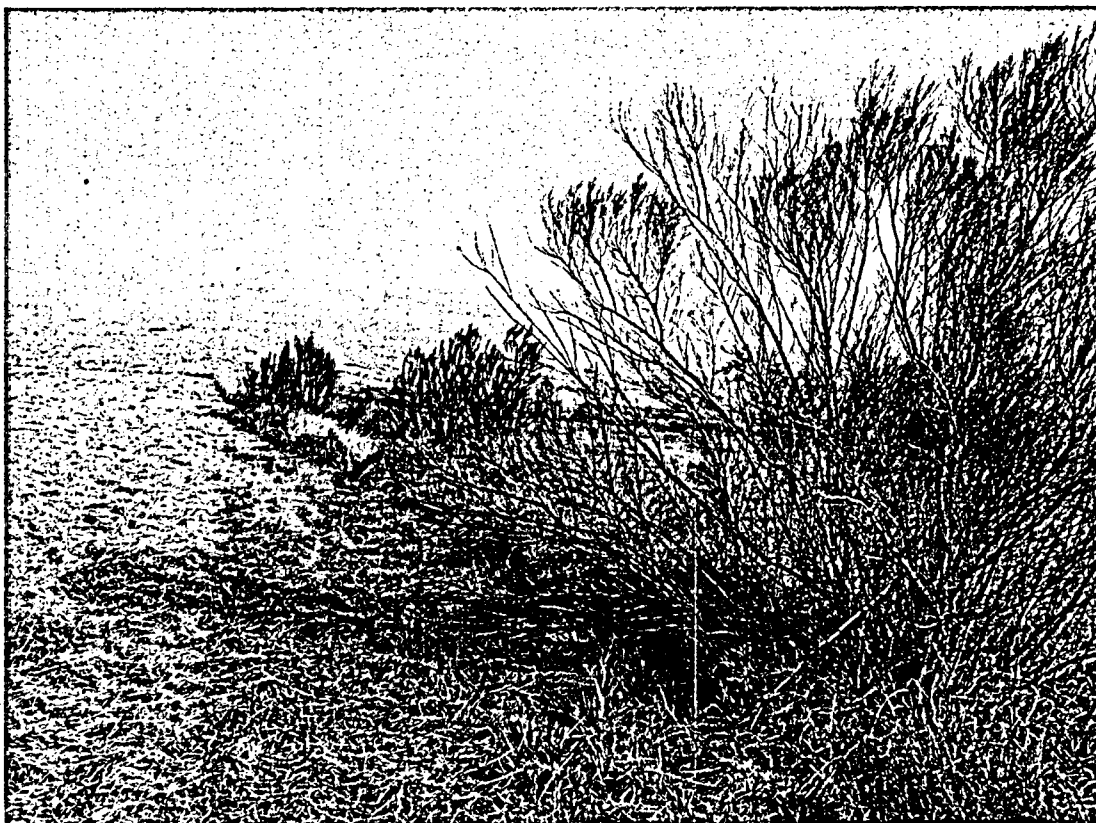
*FCT 1/2005. PL-4. Willows along south toe drain.*

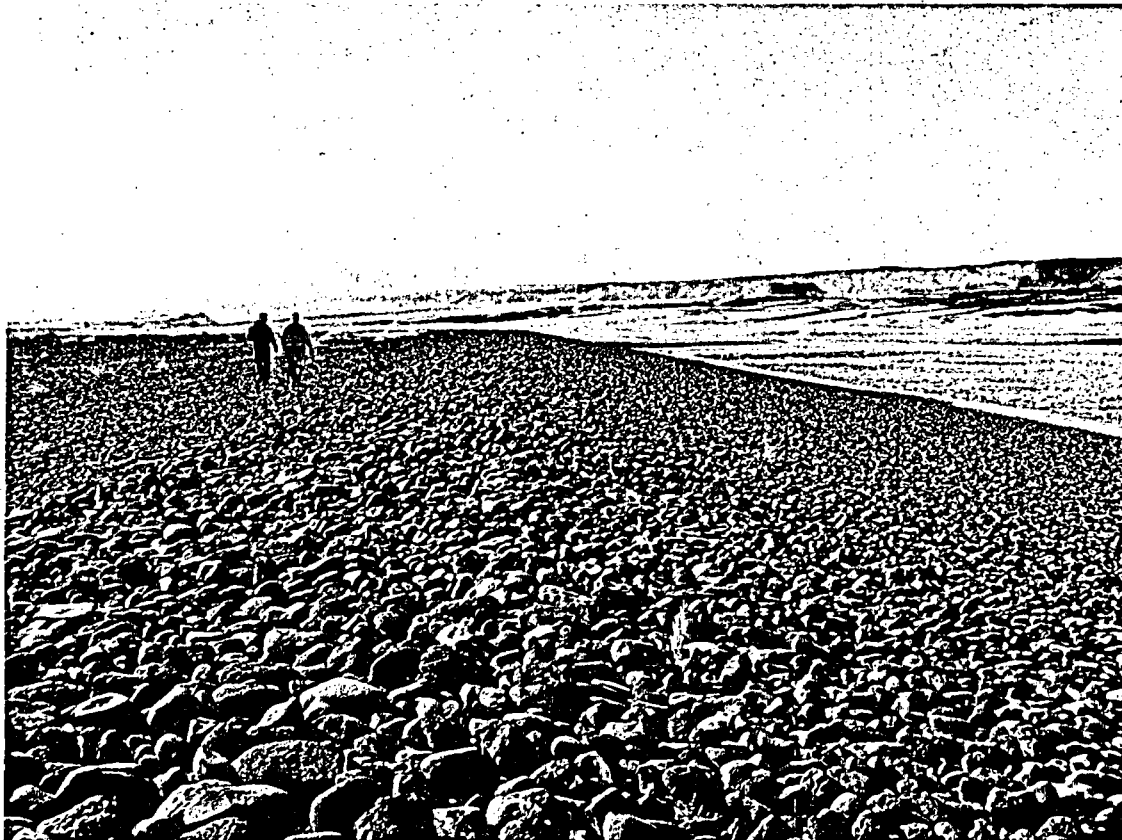
*GRJ 3/2005. PL-1. Rock-covered surfaces near the southwest corner of the disposal cell.*

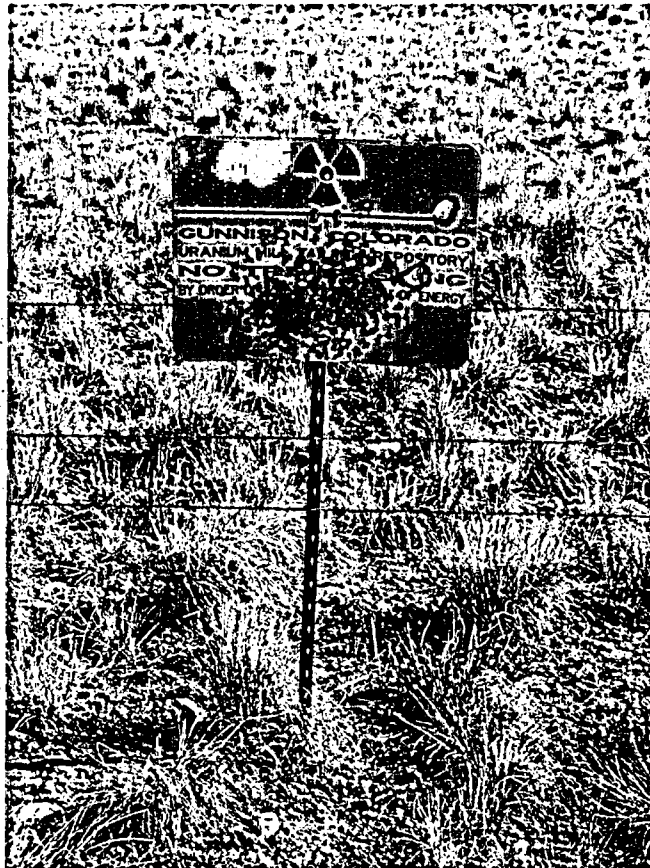
*GUN 6/2005. PL-1. Perimeter sign P44 showing gunshot damage.*

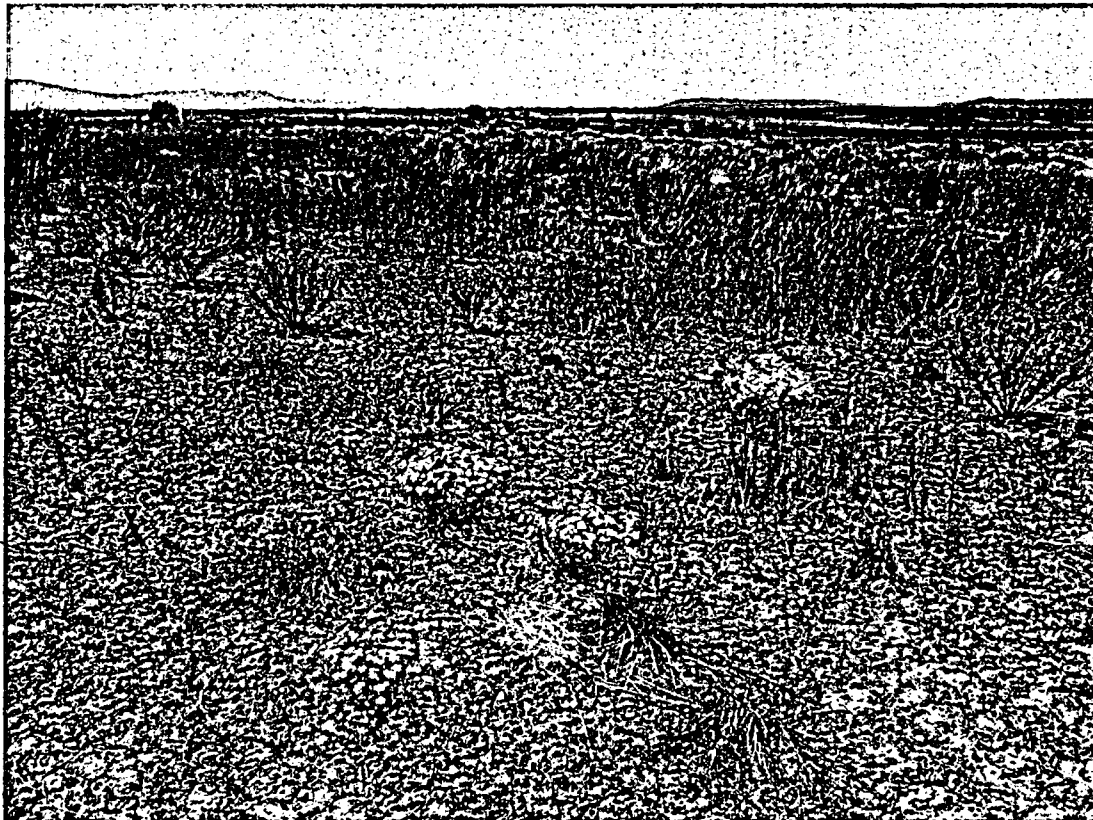
*LKV 7/2005. PL-1. Top of cell showing increased vegetation cover; sparse areas remain.*

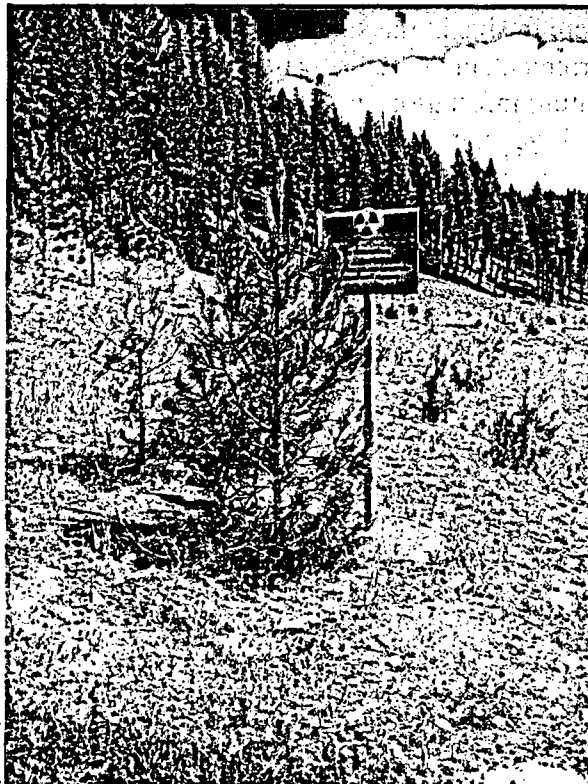
LOW 6/2005. PL-1. Ponderosa pine growing in front of perimeter sign P6.

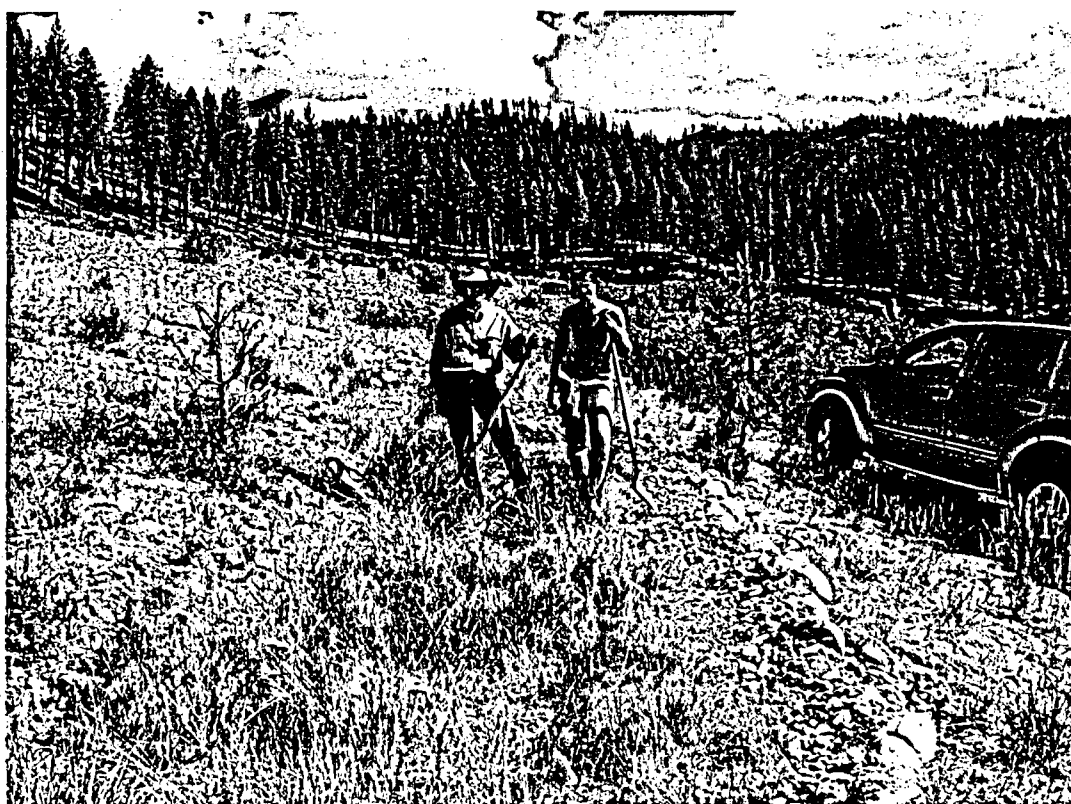
*LOW 6/2005. PL-4. Completed erosion repair of Interceptor Bench 1.*

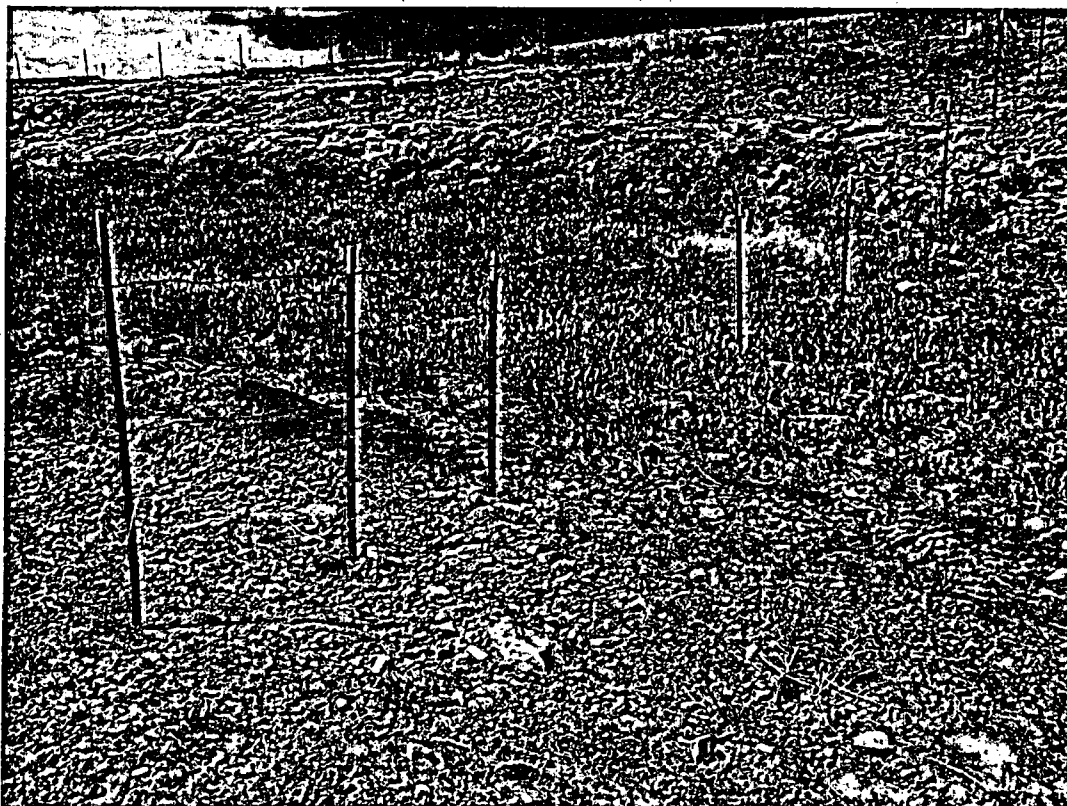
*HAT 4/2005. PL-1. Repaired fence at north end of the west diversion channel.*

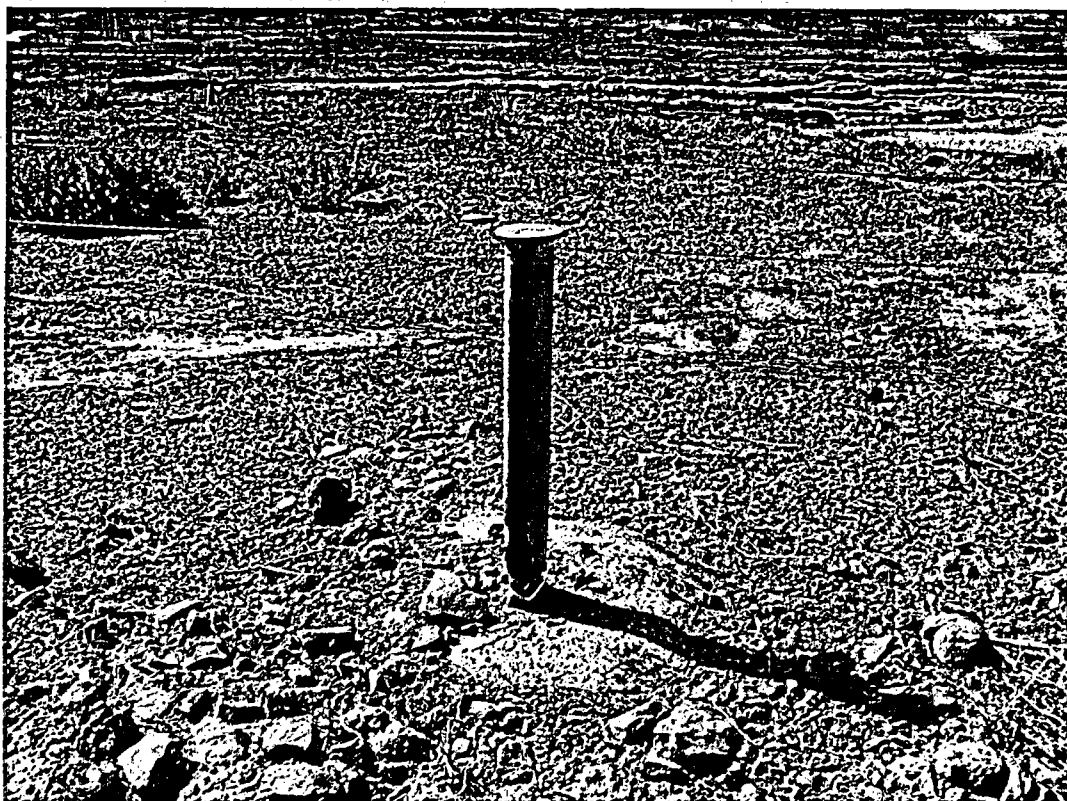
*HAT4/2005. PL-2. Damaged boundary monument BM-7; was found bent over to the ground.*

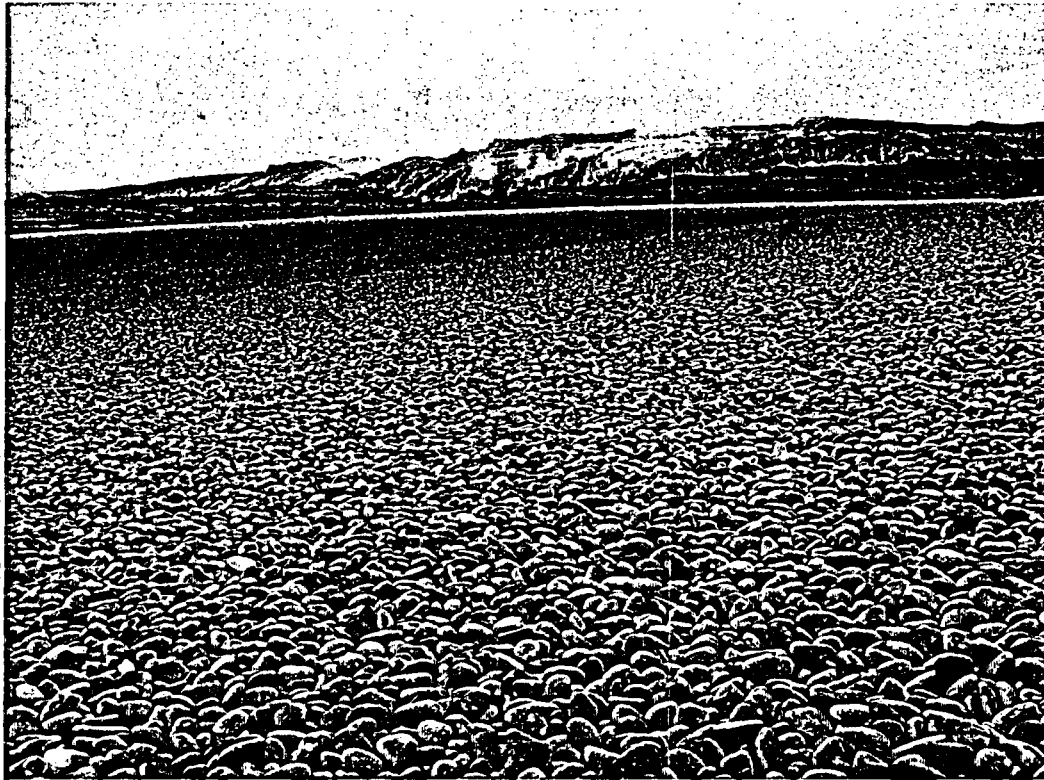
*HAT 4/2005. PL-3. View across the top of the disposal cell.*

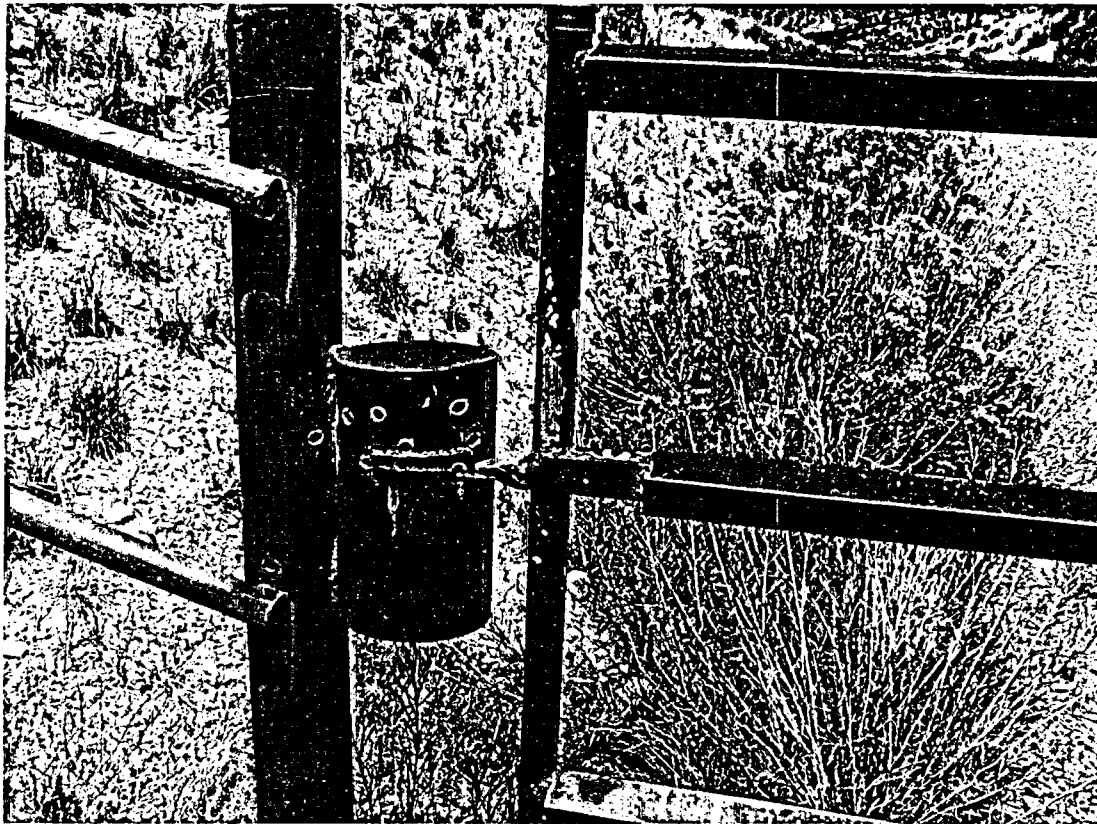
*RFL 8/2005. PL-1. Bullet damage to lock housing at lower access gate.*

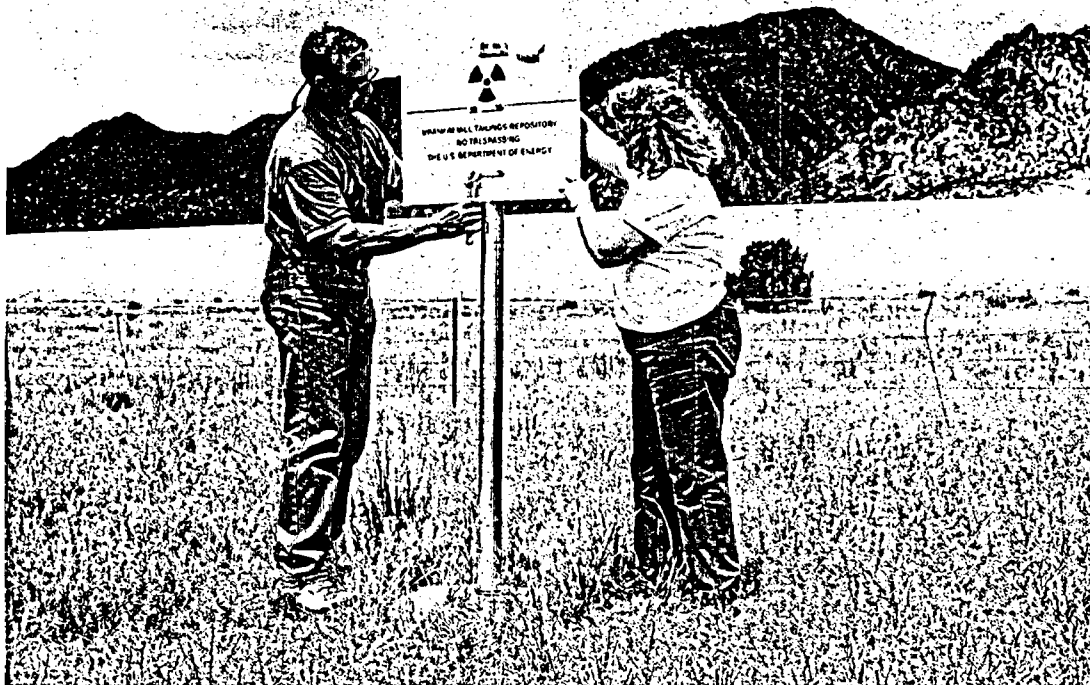
*RFL 8/2005. PL-2. Entrance sign replacement.*

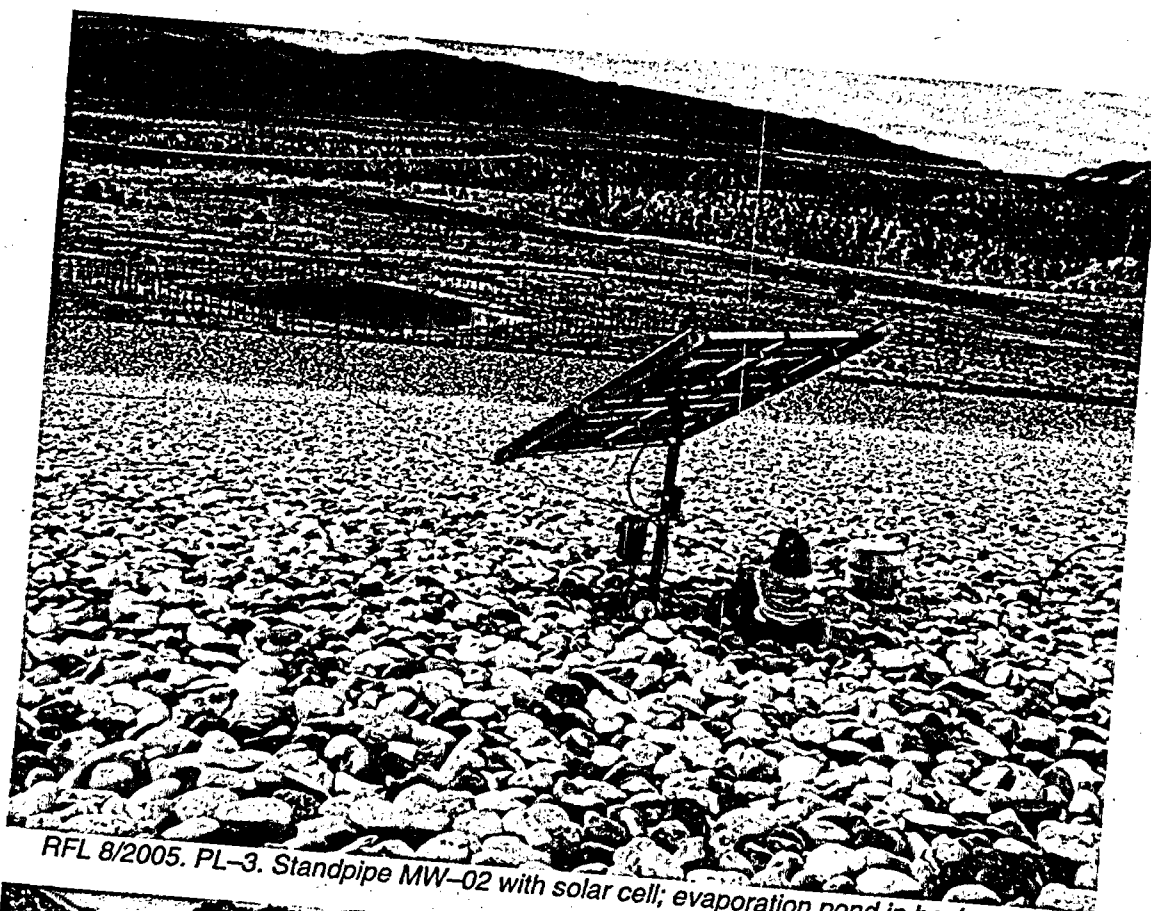
RFL 8/2005. PL-3. Standpipe MW-02 with solar cell; evaporation pond in background.

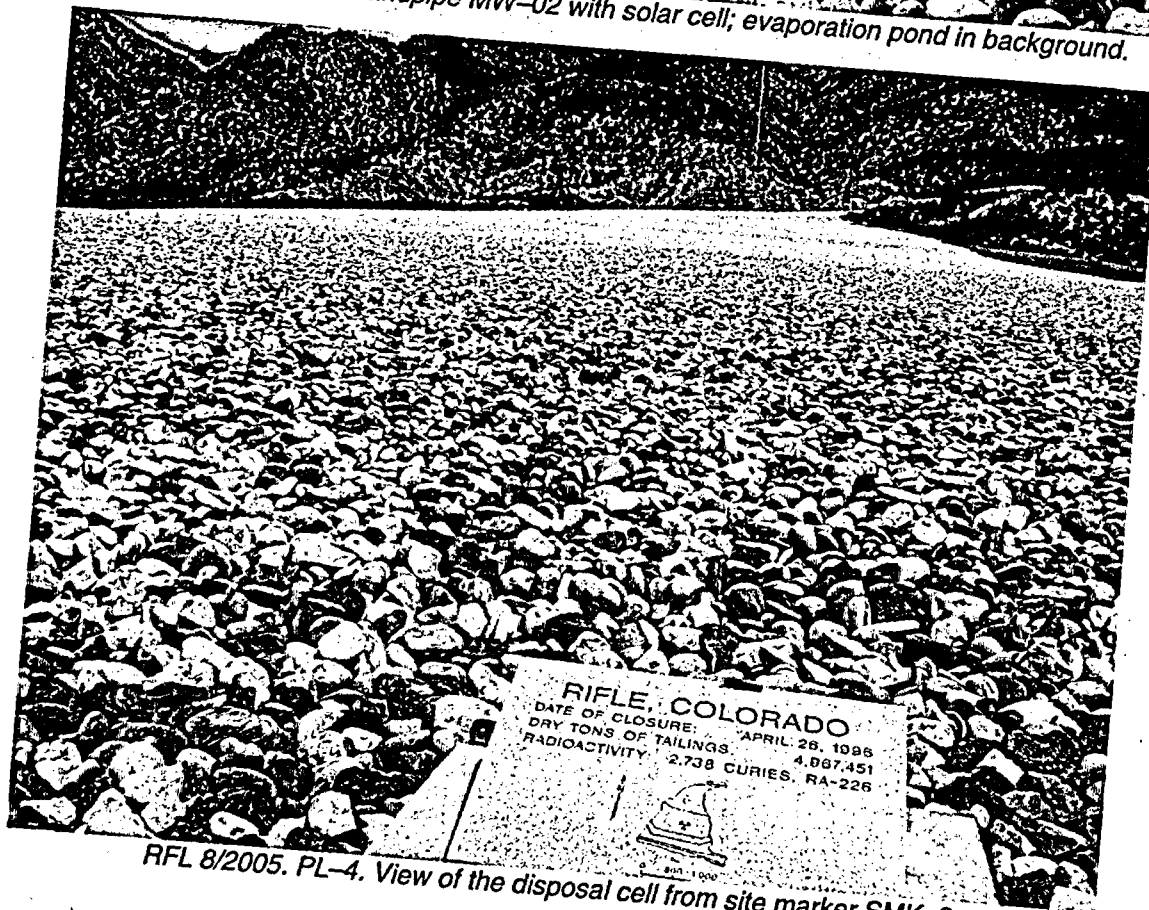
RFL 8/2005. PL-4. View of the disposal cell from site marker SMK-2.

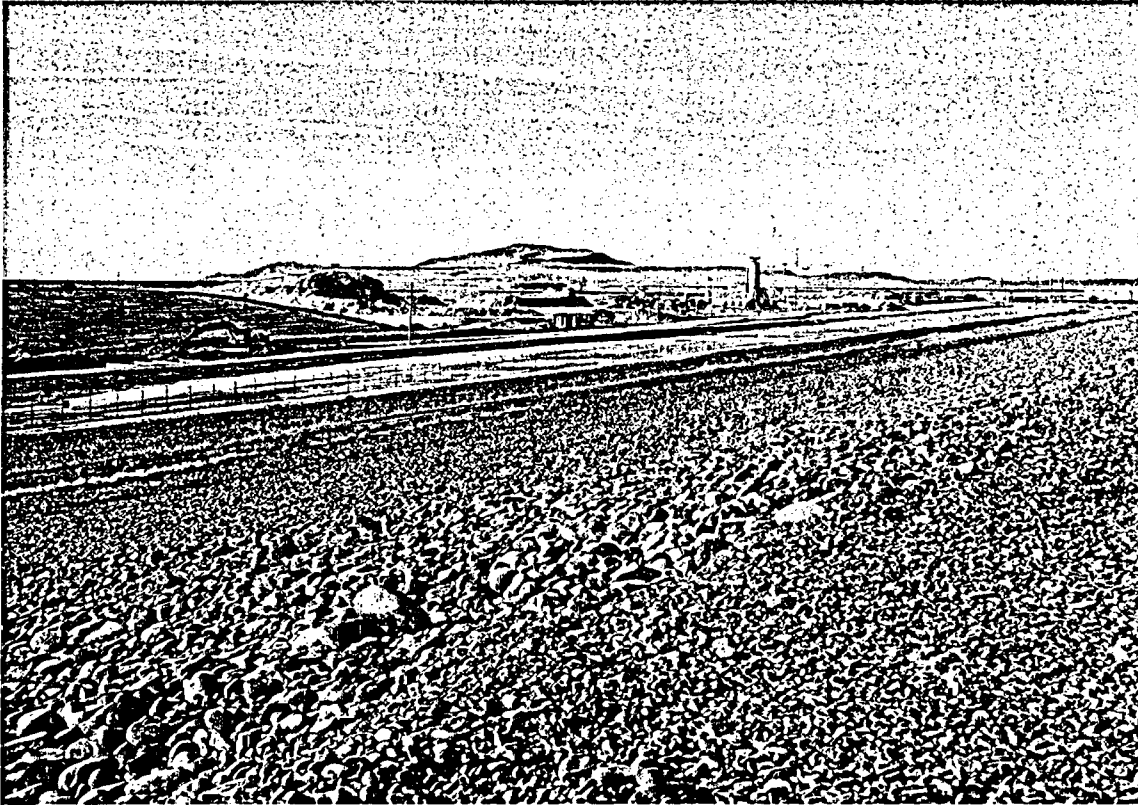
*SLC 3/2005. PL-1. Envirocare waste disposal activity directly west of the DOE cell.*

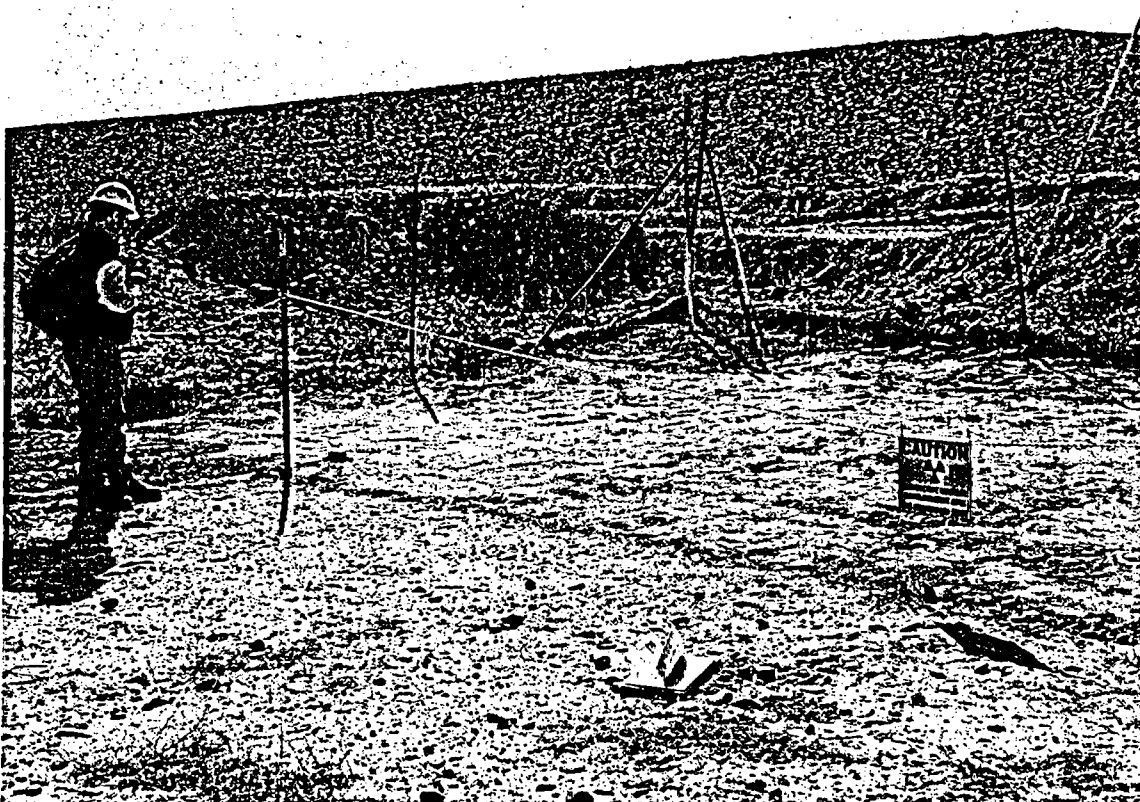
*SLC 3/2005. PL-2. Boundary monument BM-4 covered within a posted radiological surface contamination area.*

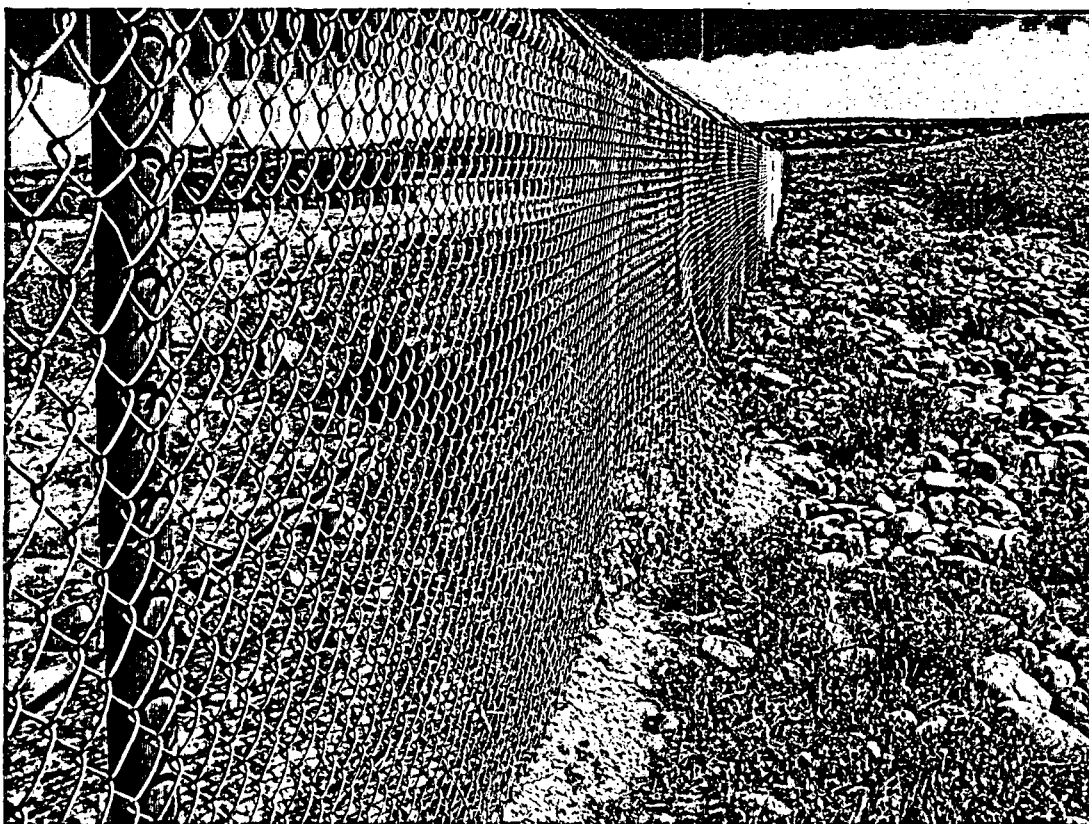
*SHP 6/2005. PL-1. Dirt bulldozed into perimeter fence near perimeter sign 13.*
