Department of Energy  
Office of Legacy Management

Subject: 2005 Annual Site Inspection and Monitoring Report for UMTRCA Title I Disposal Sites

# **2005 Annual Site Inspection and Monitoring Report for Uranium Mill Tailings Radiation Control Act Title I Disposal Sites**

**December 2005**

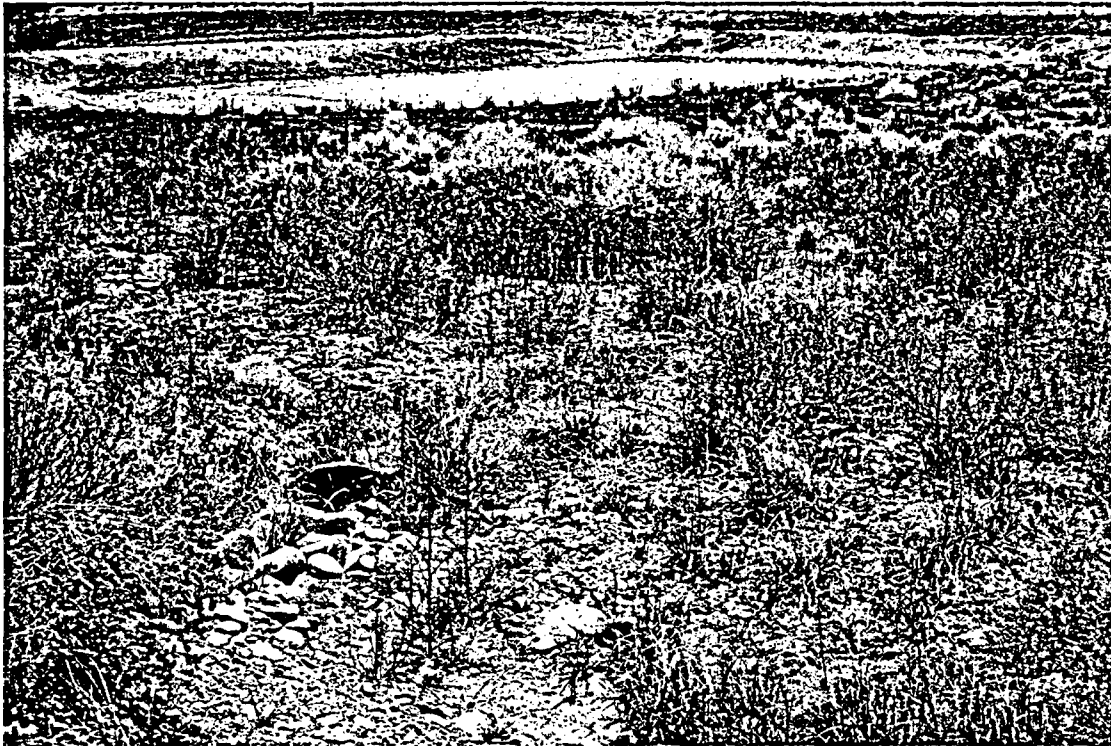
*SRK 4/2005. PL-1. Rock and soil placed in rills downgradient of the disposal cell in 2004 to prevent erosion; retention pond in background.*

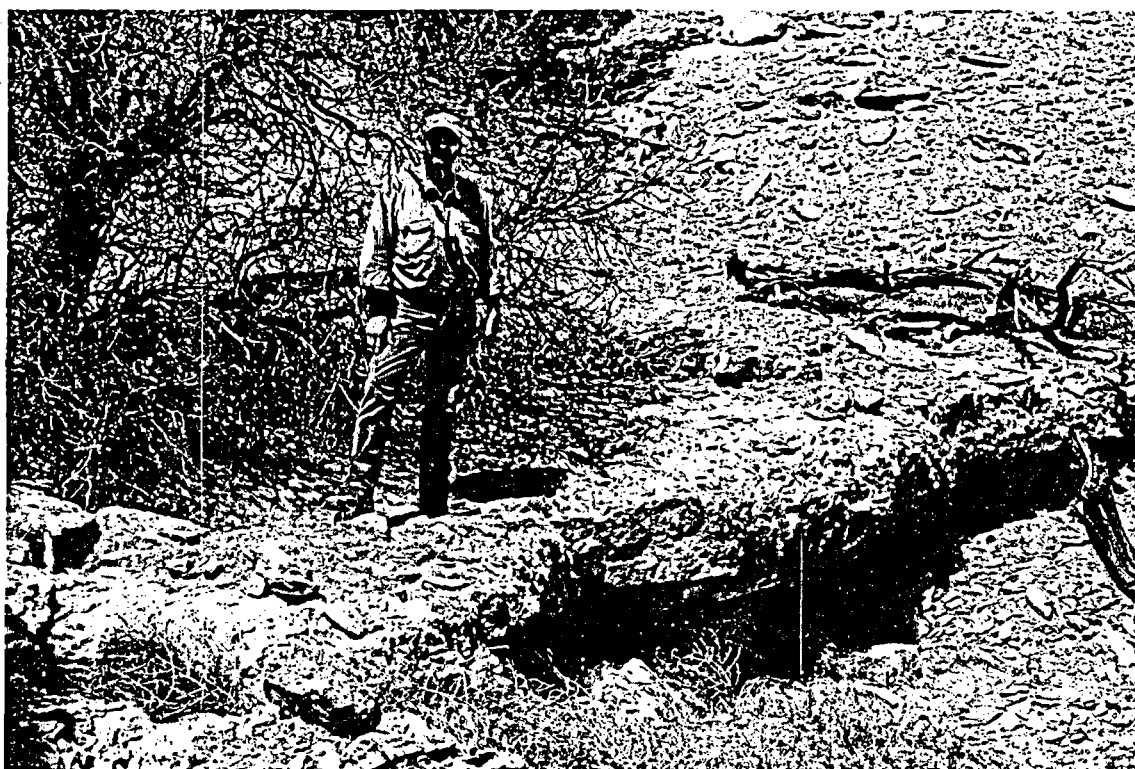
*SRK 4/2005. PL-4. View of Kd-1 sandstone outcrop near northeast corner of disposal cell showing lack of erosion or moisture.*

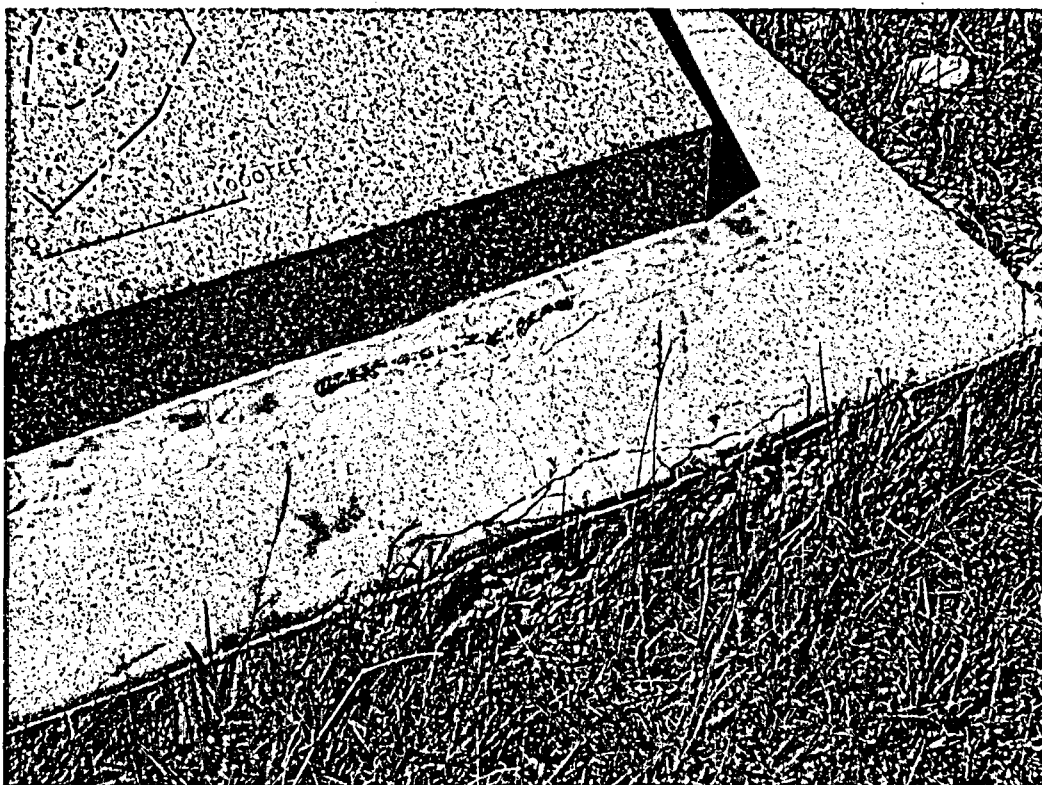
SPK 6/2005. PL-1. Close-up of spalling area on the concrete base of site marker SMK-1.

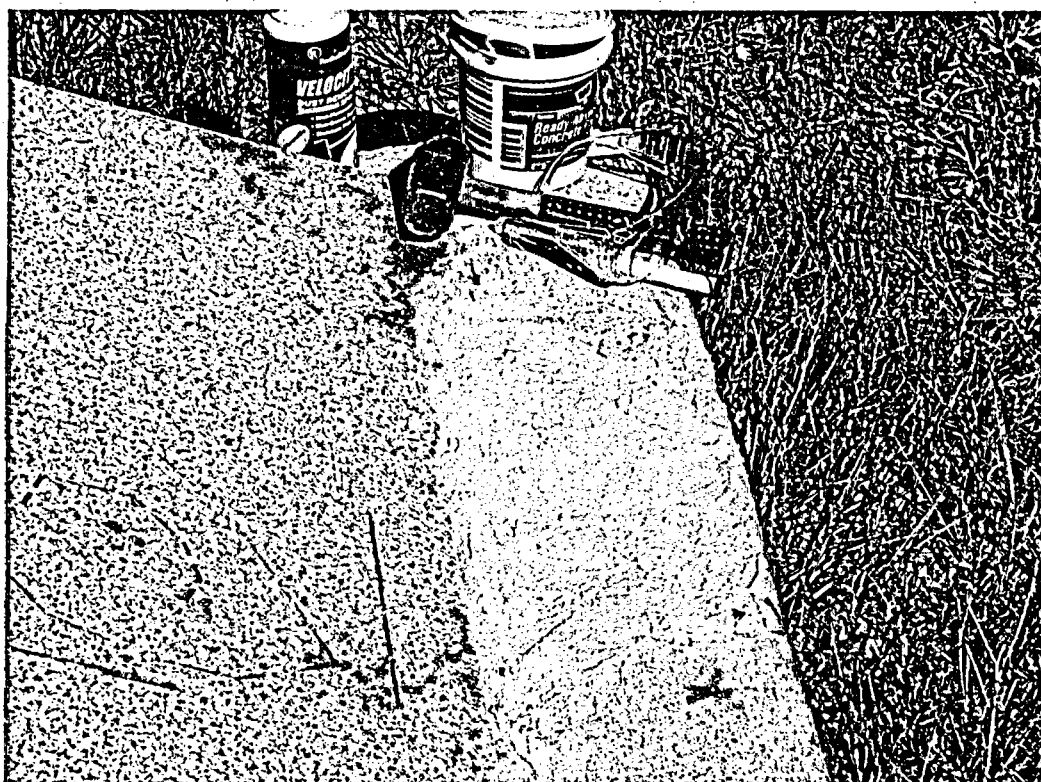
SPK 6/2005. PL-2. Repaired surface of the concrete base of site marker SMK-1.

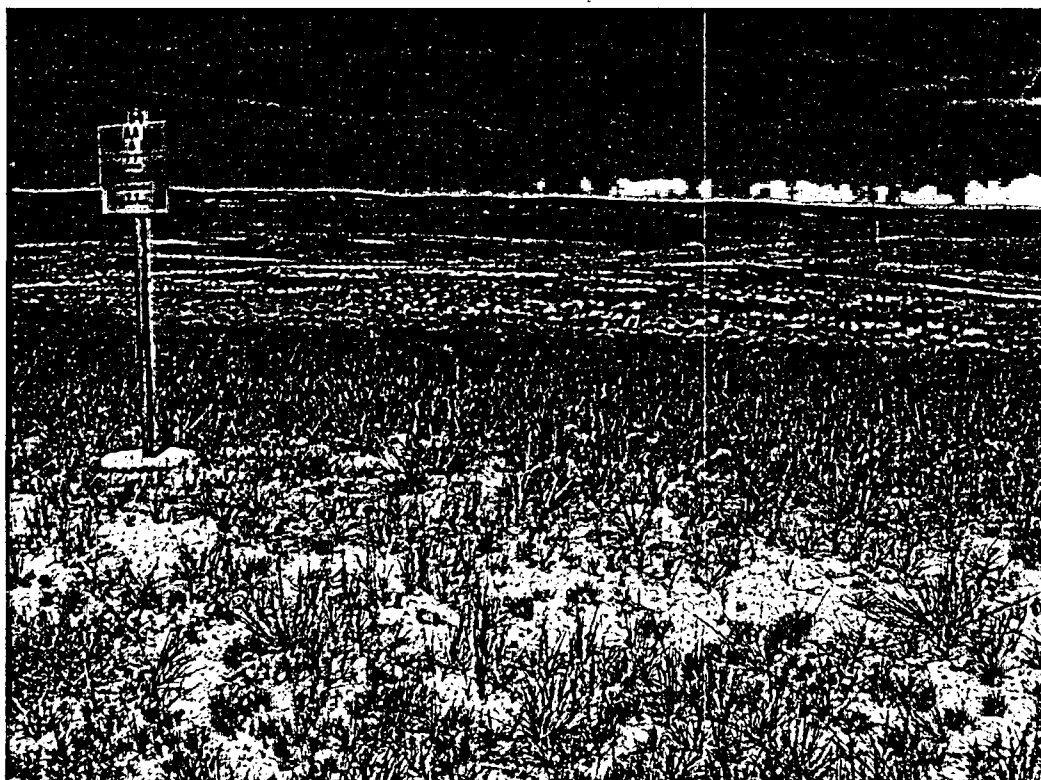
*SPK 6/2005. PL-3. View across the disposal cell from perimeter sign P10.*

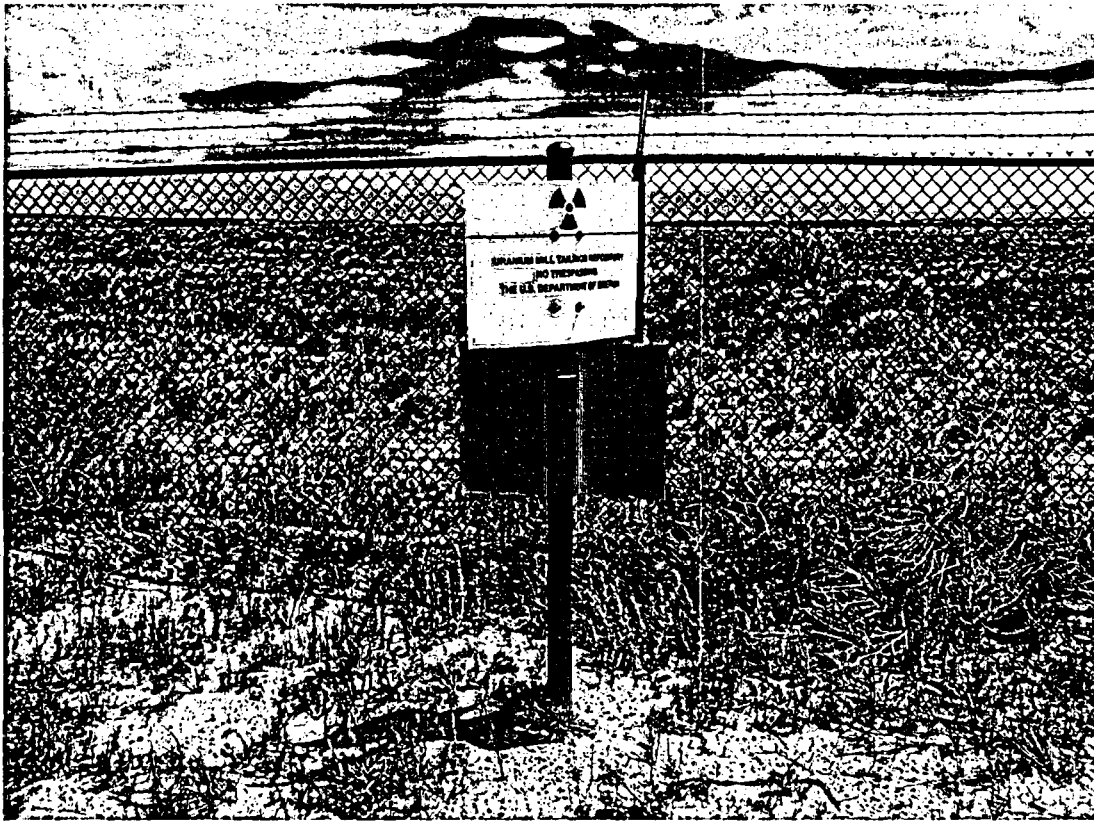
*TUB 9/2004. PL-1. New perimeter sign P24 turned around by wind.*
