Point Beach Nuclear Plant Unit 1
Docket No. 50-266
License No. DPR-24

Fall 2005 Unit 1 (U1R29) Steam Generator Tube Inspection Report

FALL 2005 UNIT 1 (U1R29) STEAM GENERATOR TUBE INSPECTION REPORT

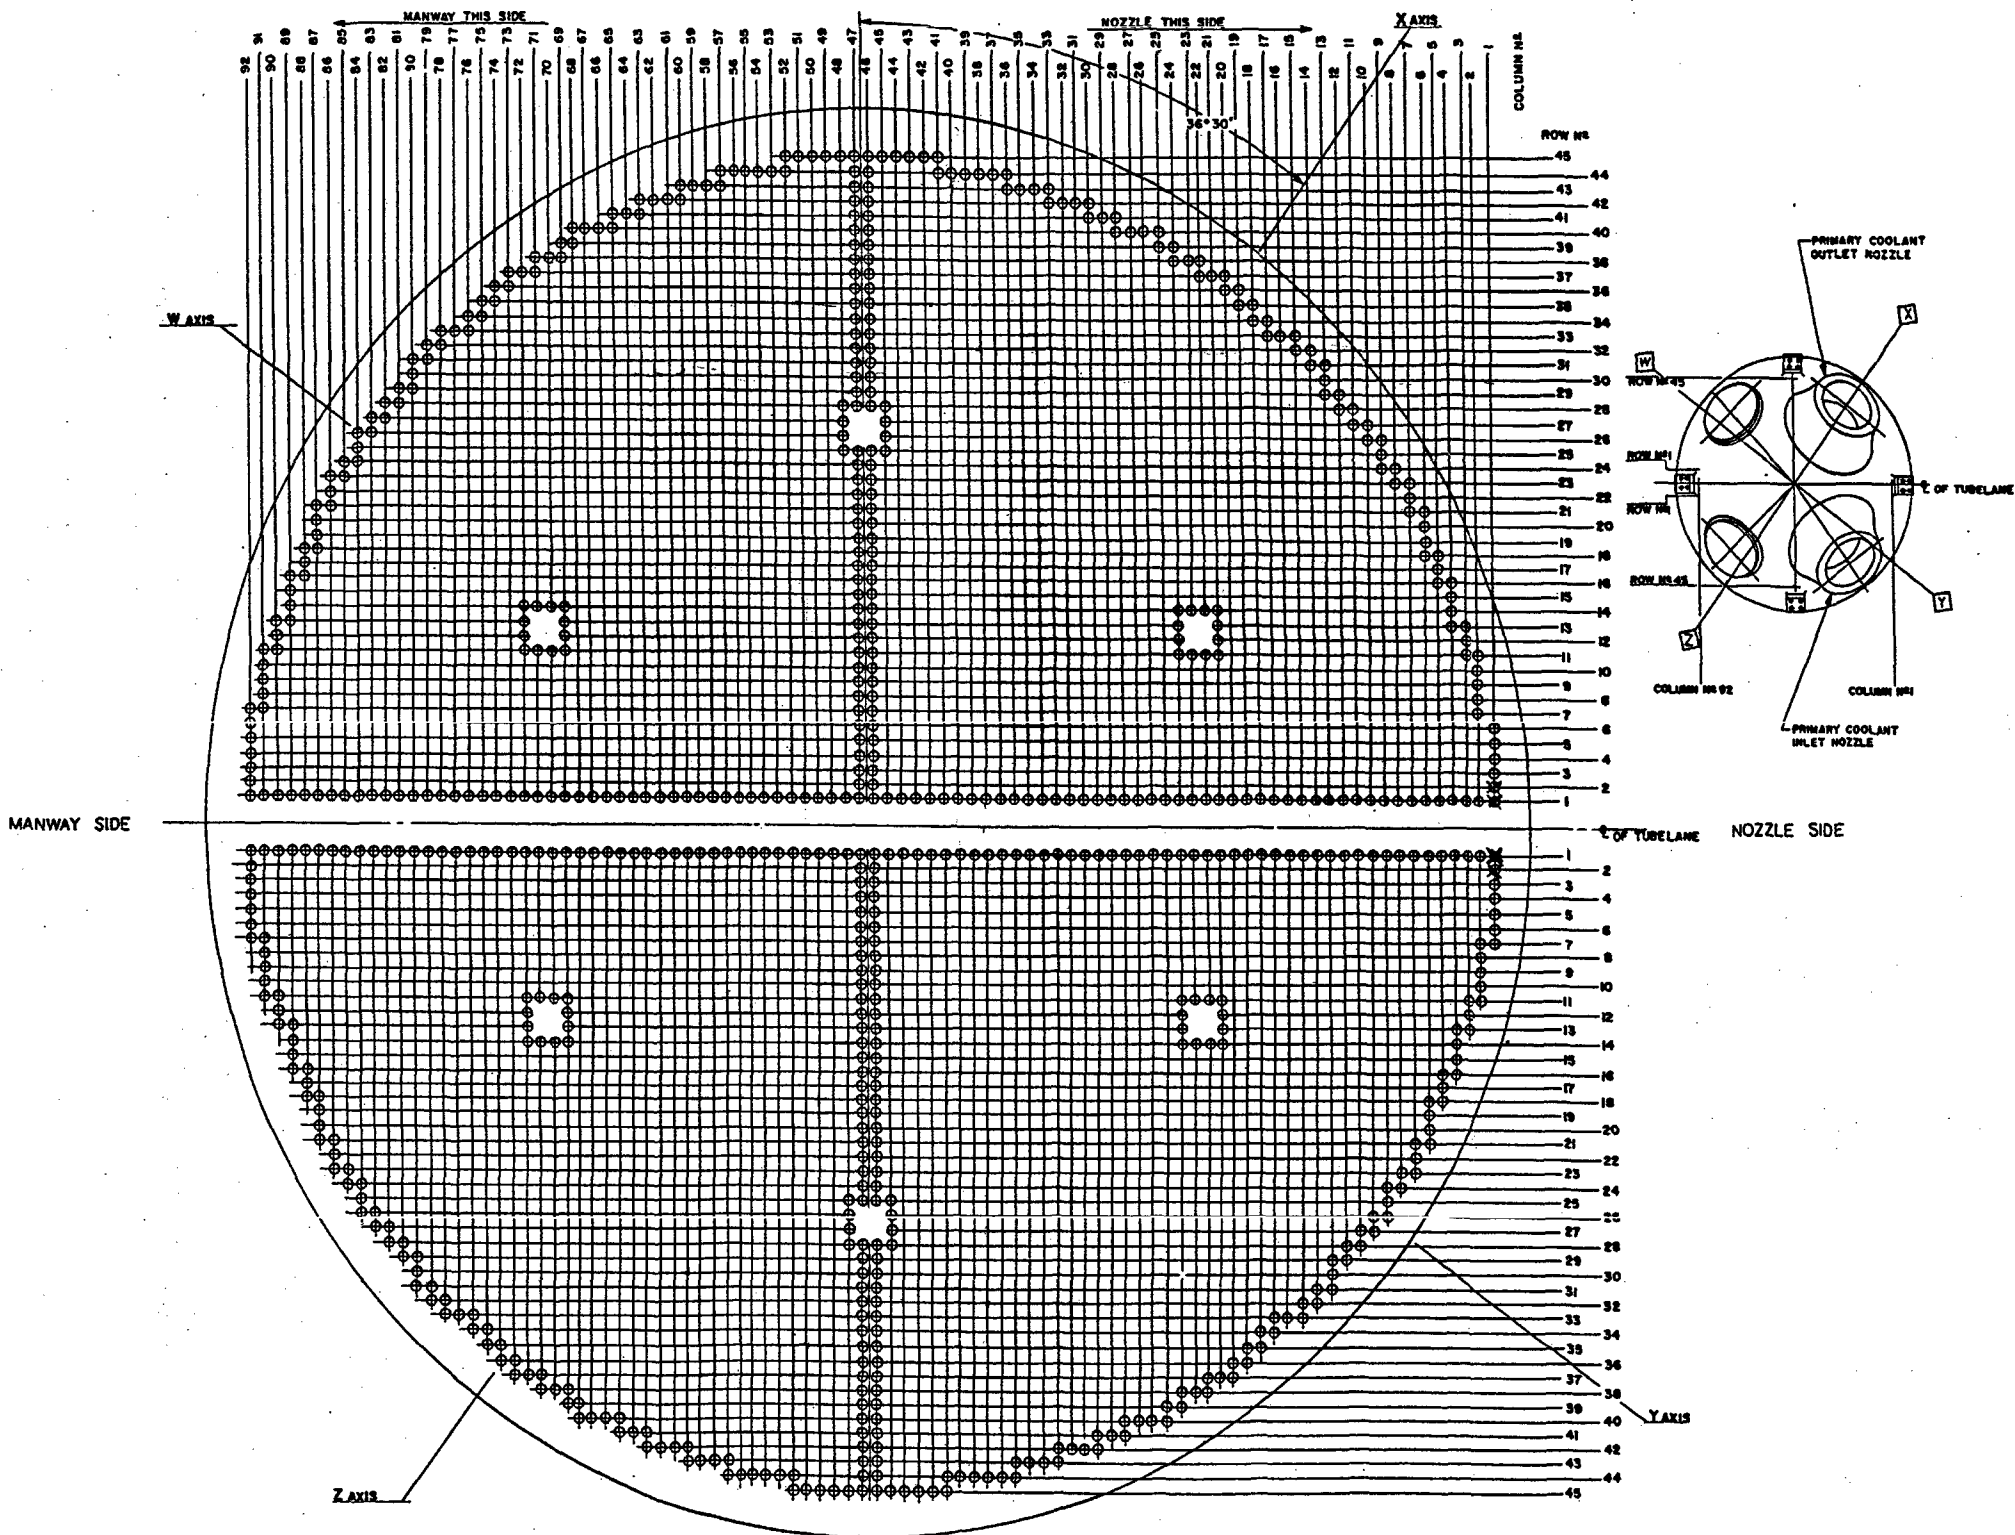
Fifty-two wear indications in 31 tubes were found in the 'A' SG anti-vibration bar area. None of these indications were required to be repaired, and all tubes remained in service. Table 1 shows all anti-vibration bar wear indications along with an historical comparison. Based on the growth rate of the wear indications, no indications are expected to exceed the plugging criterion during the next two cycles.

Nineteen wear indications in 16 tubes were found in the 'A' SG peripheral hot leg tubes at the top of tubesheet. Table 2 lists the percent through-wall of these indications. All of these indications were reported in 2004, except a 1% indication in row 33/column 78 and a 5% in row 41/column 28. Both of these minor indications were present in 2004 data but not reported by eddy current. These indications first appear in the U1R28 inspection data, and this wear was concluded to be the result of damage from maintenance equipment during U1R26. Secondary side visual inspection during U1R28 and the current inspection confirmed that no objects that could cause continued wear are present. Comparison of the 2004 and 2005 data supports this original conclusion. The depth of these indications is significantly below the plugging criterion, and since the source of the wear is no longer present, no growth is anticipated, and all tubes remained in service.

Four wear indications in 4 tubes were found in the 'A' SG at cold leg supports. Three of these were reported in 2004, but had never been reported previous to 2004. When compared to 1995 inspection data, these indications showed no significant change. Table 3 lists the percent through-wall of these indications. The depth of these indications is significantly below the plugging criterion, and all tubes remained in service.

The 'A' steam generator has one manufacturing anomaly. The tube at row 38/column 69 is not expanded the full length of the tubesheet. This tube is routinely inspected by rotating pancake coil from the tube end to the top of tubesheet and during U1R29, as in the past, no degradation was found. The tube remains in service.

One possible loose part indication was reported by eddy current in SG 'A' at 0.36 inch above the hot leg top of tubesheet in row 8/column 25. No degradation was observed in conjunction with the indication. However, all tubes adjacent to this indication were also tested with rotating pancake coil. Secondary side visual inspection verified that no loose part was present, and this indication was subsequently dispositioned, and the tube remains in service.

A small foreign object was found and retrieved during the secondary side visual inspection near cold leg row 1&2/column 78. The object was a small steel pin approximately 1-1/4" long by approximately 1/4" diameter. Subsequently, 18 tubes in the vicinity of this location were inspected with rotating pancake coil. No degradation was observed in conjunction with the loose part in any of the tubes. The site investigated possible sources of the part and concluded that the object was not transported to the steam generator, but may have been from steam generator maintenance equipment.

A steam generator tubesheet map is depicted on the next page to aid in the understanding of tube locations.
