**U.S. NUCLEAR REGULATORY COMMISSION
Office of Nuclear Material Safety and Safeguards
Spent Fuel Project Office**

**CONFIRMATORY ACTION LETTER 97-7-001
TECHNICAL EVALUATION**

Docket No: 72-1007

Certificate Holder: Sierra Nuclear Corporation
One Victor Square
Scotts Valley, CA 95066

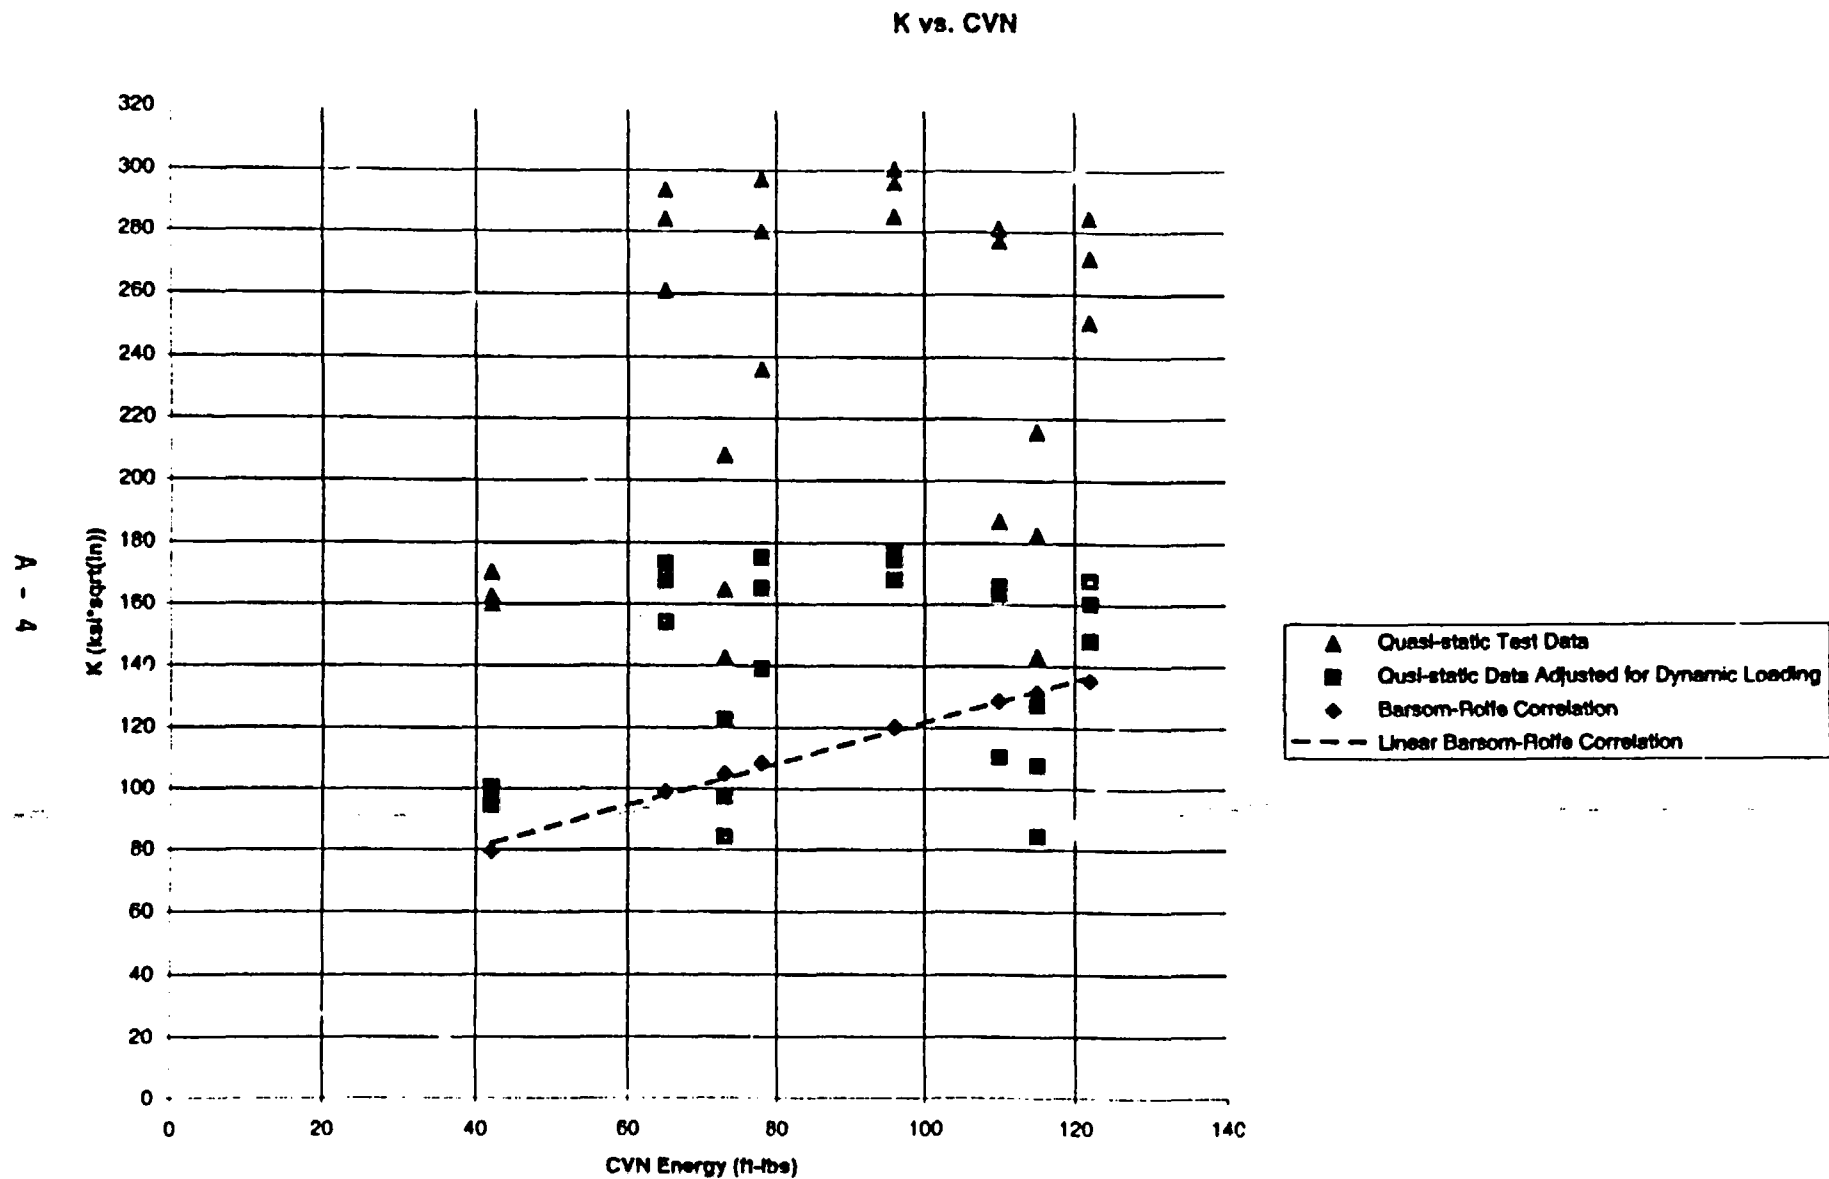
Figure A1

The staff plotted the data for fracture toughness and CVN provided by the Owners Group (Figure A1). The staff did not observe any relationship between K_{IC} and CVN in the data presented and concluded that the Barsom-Rolfe correlation for the MSB material was inappropriate. This staff position was documented in the May 21, 1998, letter from NRC to SNC.

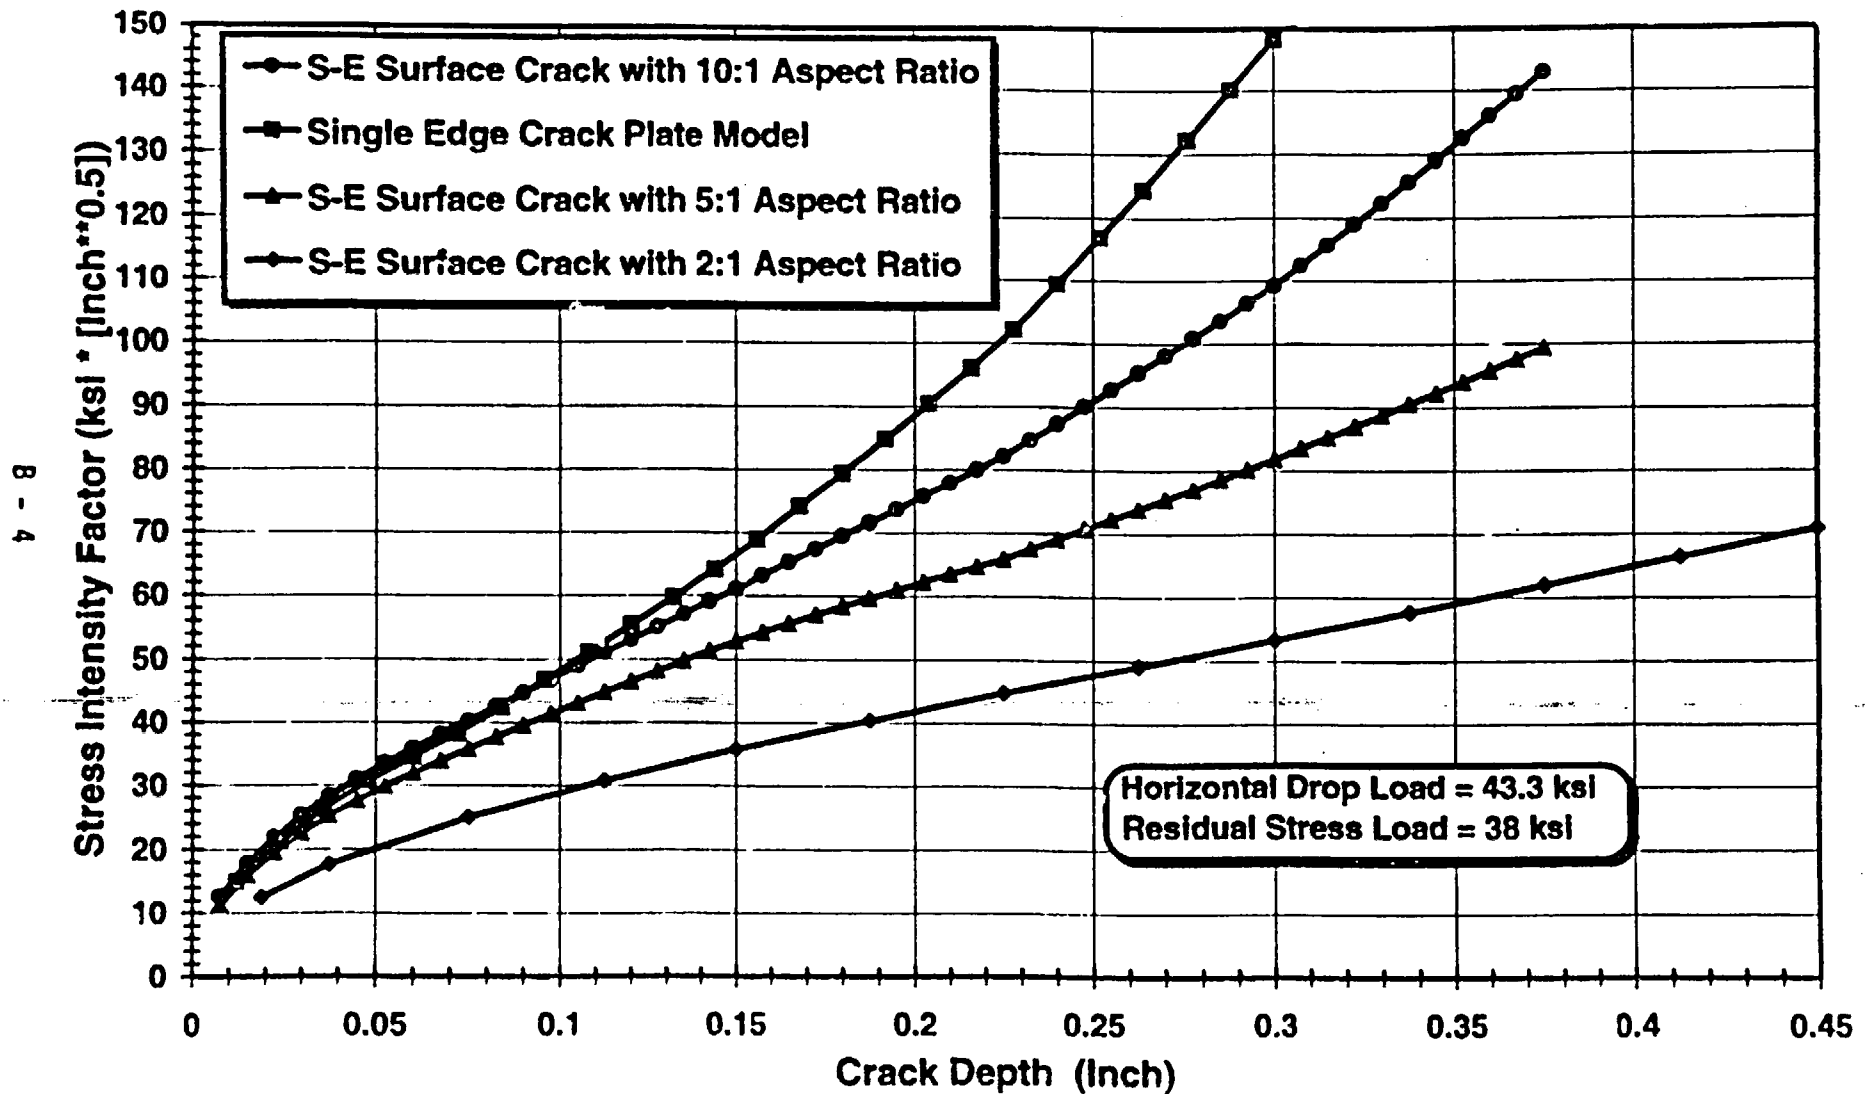
Figure B1

Applied K versus Crack Depth for (Horizontal Drop + 0.707*Weld Residual Stress)
Loading

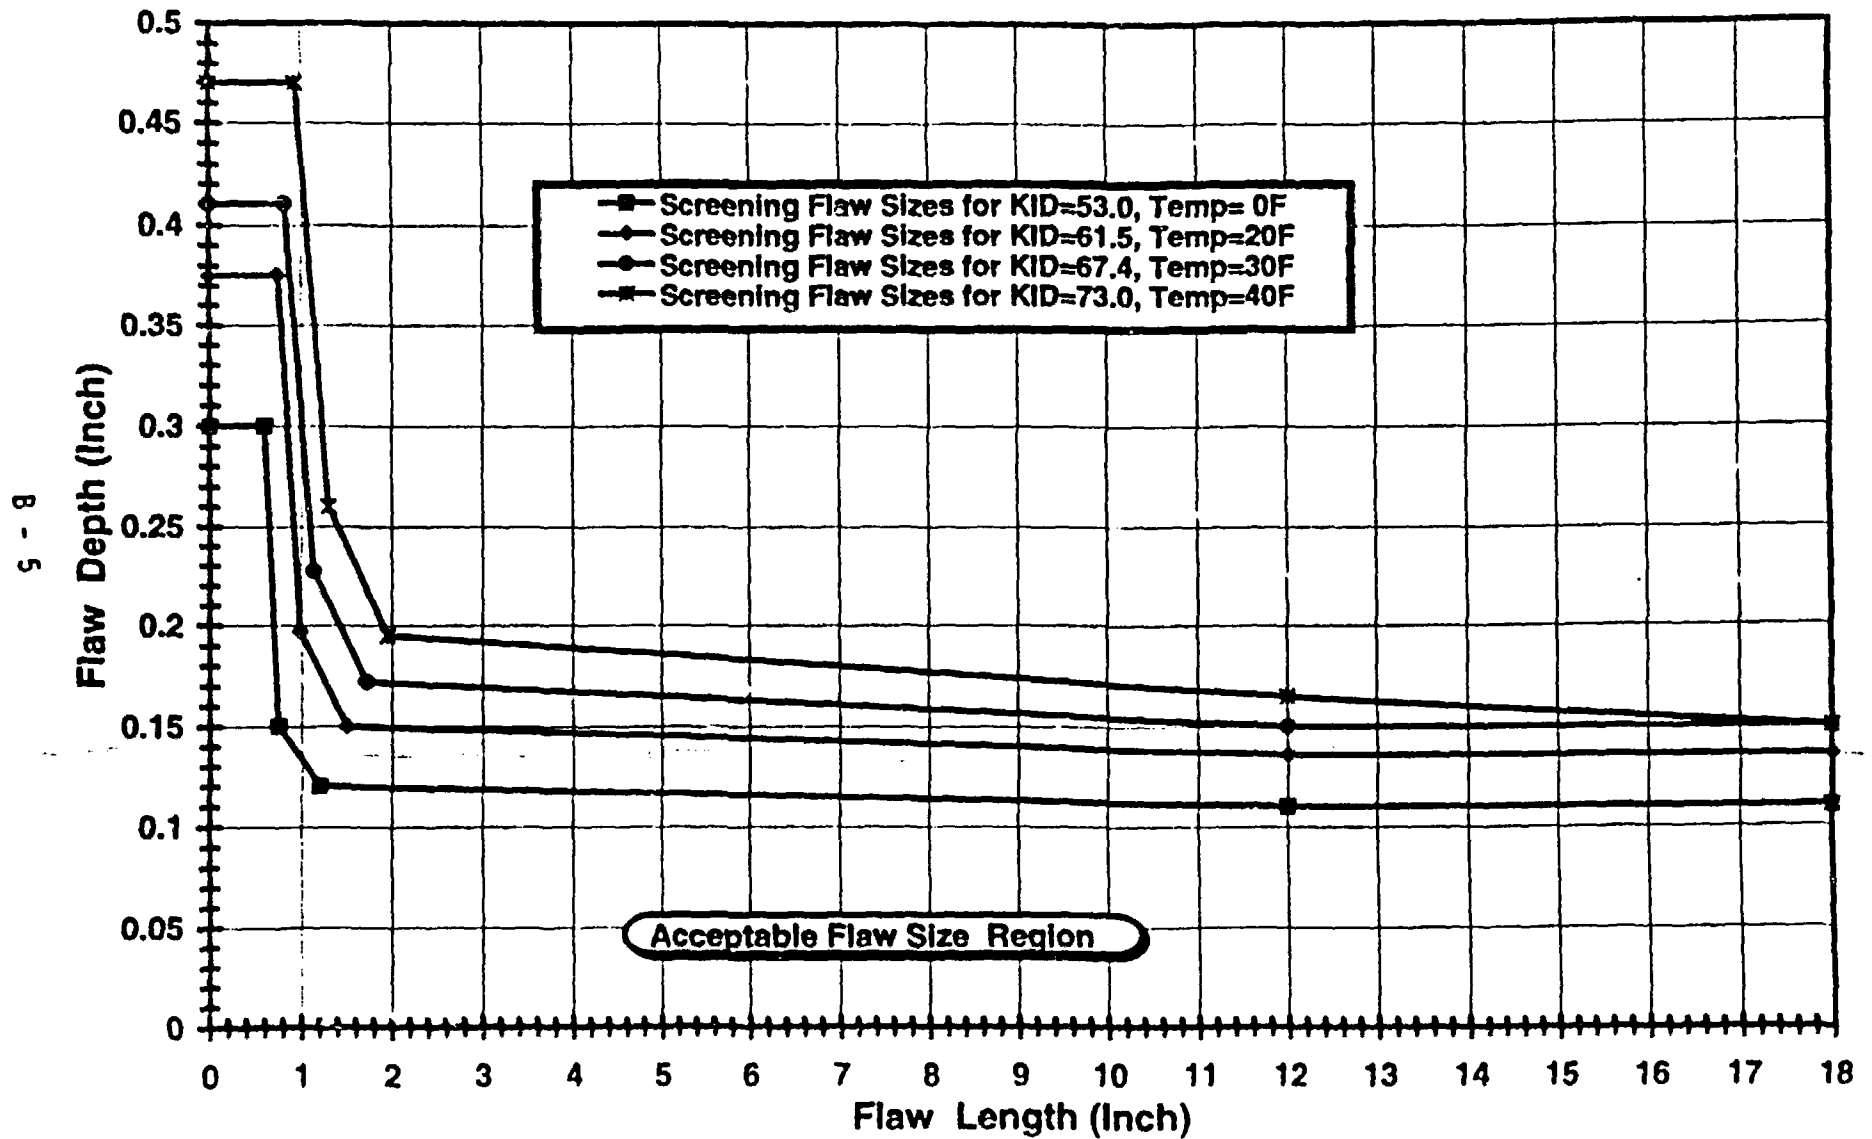
Figure B2

NRC Flaw Screening Criteria for VSC-24/MSB Lid-to-Shell Weld
