Braidwood Station, Unit 2
Facility Operating License Number NPF-77
NRC Docket Number 50-457

Subject: Response to Request for Additional Information Regarding the Braidwood Station
Unit 2 Spring 2005 Steam Generator Inspection

**Response to NRC Request for Additional Information Regarding the Braidwood
Station Unit 2 Spring 2005 Steam Generator Inspection**

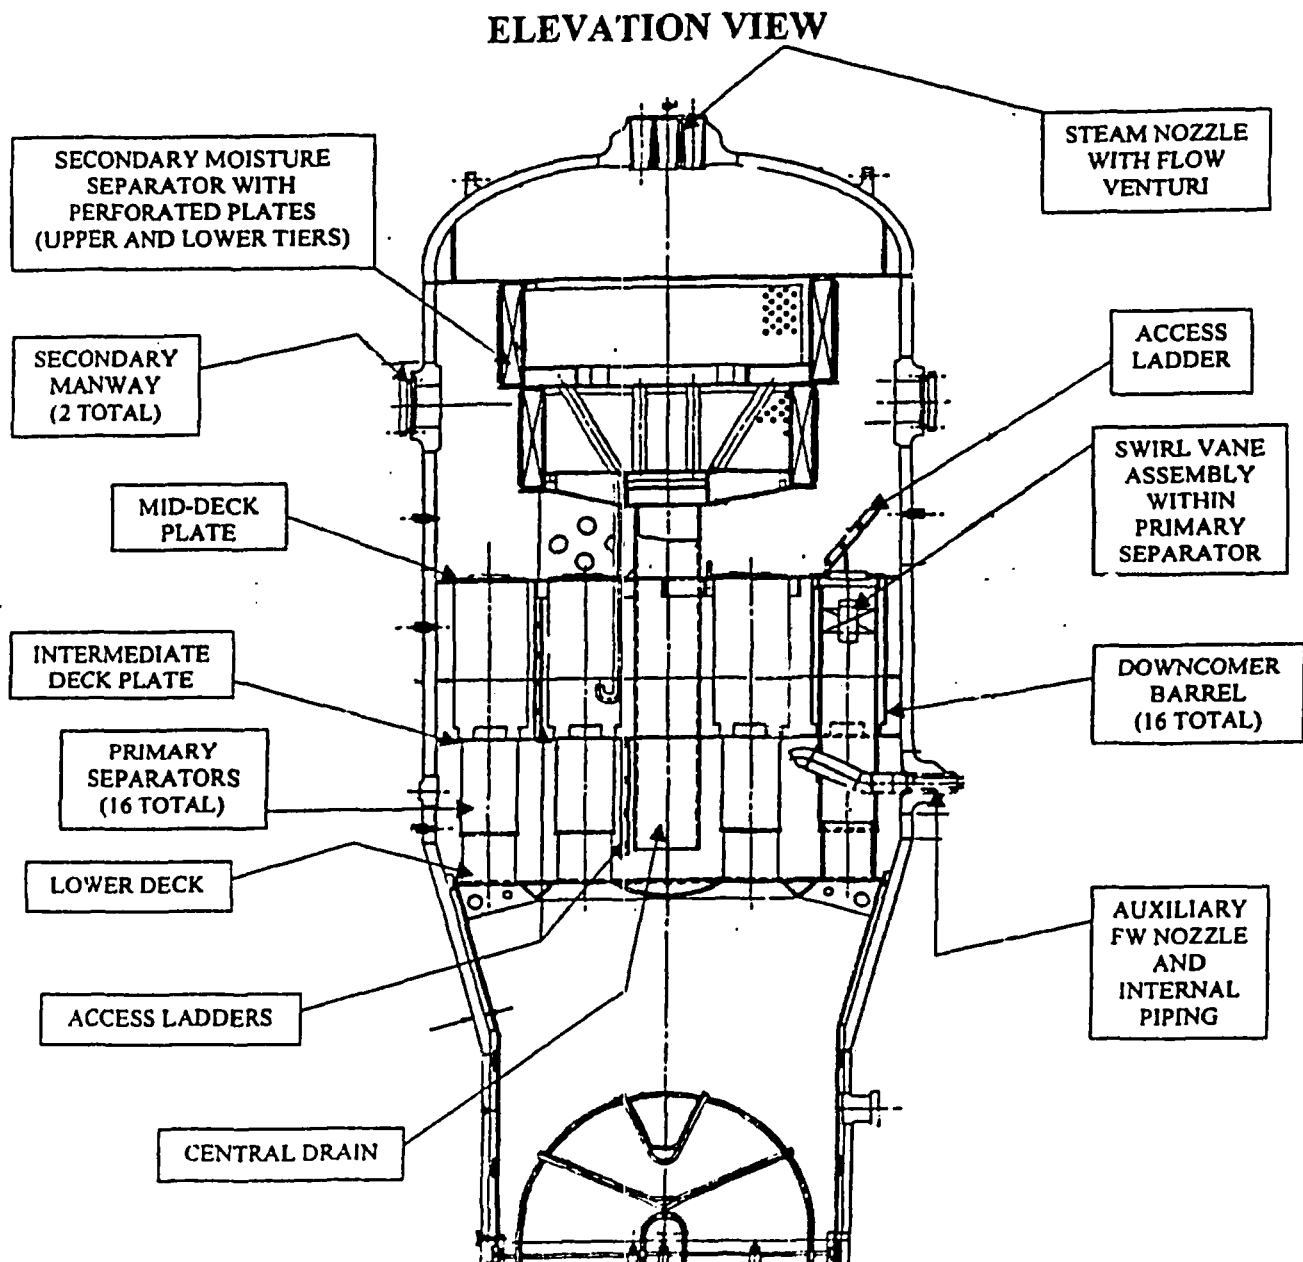
Figure 3a-1

During the Braidwood Unit 2 A2R11 refueling outage, visual inspection of the 2D SG secondary side moisture separator region was performed. All areas that are accessible through the upper manways were visually inspected down through the lower deck plate (refer to Figure 3a-1). No degradation, erosion, corrosion, deformation or weld cracking was observed other than the erosion identified in the primary moisture separator region as described below.

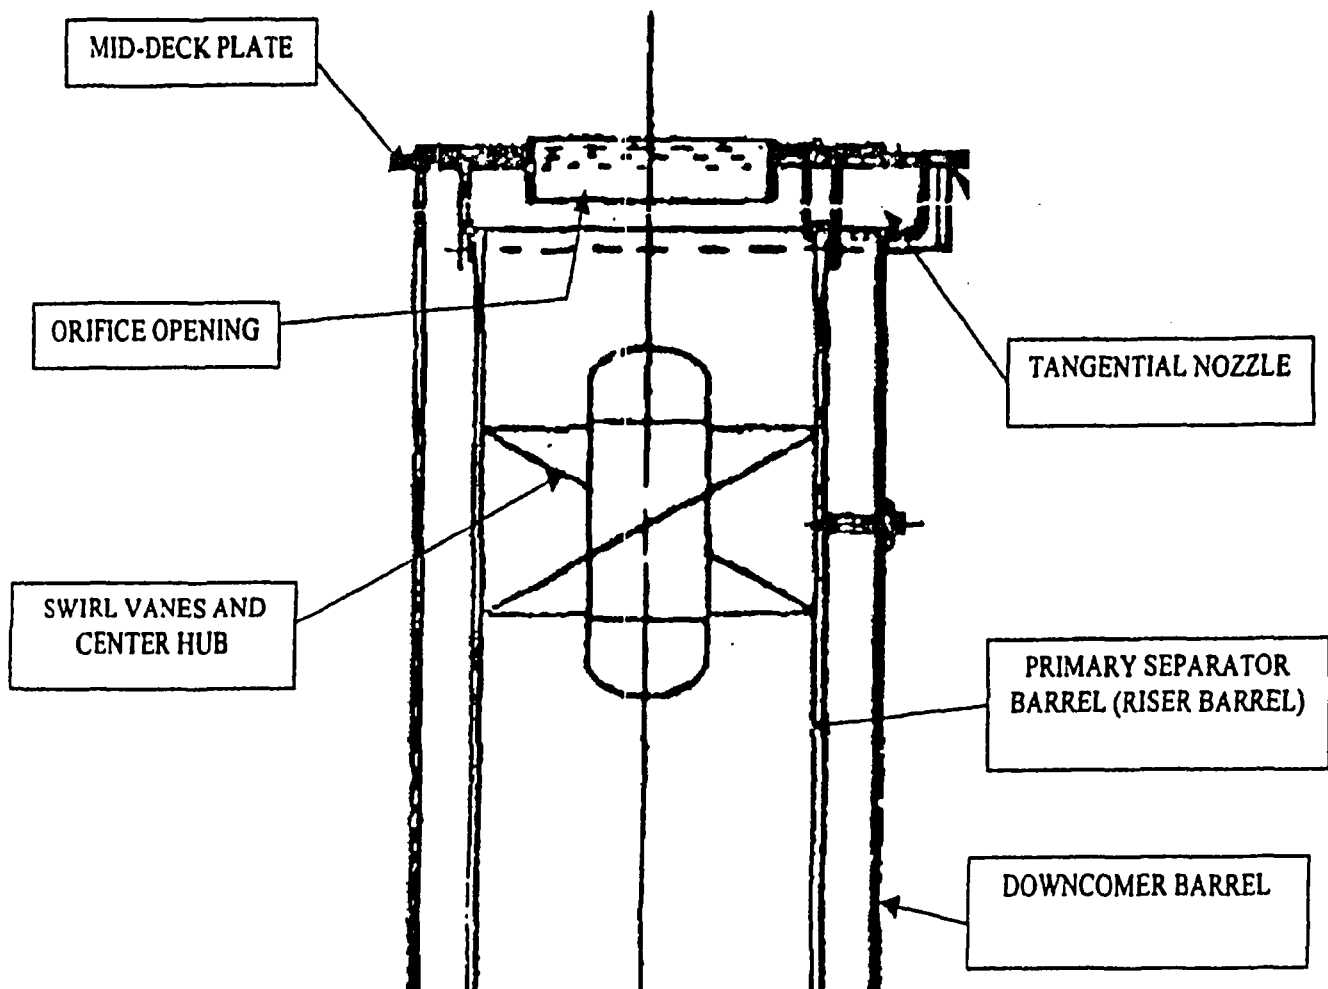
Figure 3a-2

During visual inspection of the primary separator assembly region, visual inspection identified that there were areas where the normally present magnetite layer was missing, thus providing areas for erosion to develop. The areas included portions of the tangential nozzles, portions of the inner surface of the primary moisture separator barrels and a number of swirl vanes within the primary separator assemblies (refer to Figure 3a-2). This condition existed in varying degrees on 12 of the 16 primary separators assemblies. The components identified with the magnetite layer missing are carbon steel, typically American Society for Testing and Materials standard specification A-285, "Pressure Vessel Plates, Carbon Steel, Low and Intermediate-Tensile Strength," Grade C, material. The manufacturing nominal wall thickness for these components was 0.250-inch. To supplement the visual inspection observations, ultrasonic (UT) thickness measurements were taken in areas of magnetite loss with most apparent erosion.

Two of the tangential nozzles with the most apparent erosion were UT inspected. The minimum thickness reading for the horizontal region of the tangential nozzles was 0.234-inch. The minimum thickness reading for the vertical region of the tangential nozzles was 0.177-inch.

Three of the riser barrels with the most apparent erosion were UT inspected. The minimum thickness reading was 0.183-inch.

Three of the swirl vanes with the most apparent erosion were UT inspected. The minimum thickness reading was 0.184-inch.

In summary, the overall nominal thickness value for the primary separators assemblies is 0.250-inch with a minimum UT thickness reading for the components inspected of 0.177-inch. No areas of through wall erosion were identified.

The current plan for the upcoming Braidwood Station Unit 2 refueling outage in the Fall of 2006 (A2R12) is to reinspect the 2D SG. This inspection will provide additional data points to develop a degradation rate and determine if scope expansion into the additional SGs is warranted. If unexpected degradation or unacceptable degradation rates are identified in the 2D SG, scope expansion into the remaining SGs will be evaluated. Inspection of the secondary moisture separator region of 2A, 2B and 2C SGs is currently planned for the Braidwood Station Unit 2 refueling outage in the Spring of 2008 (A2R13).
