**Subject: Docket No. 50-361
Licensee Event Report No. 2006-001
San Onofre Nuclear Generating Station, Unit 2**

4. TITLE
 Both trains of Shutdown Cooling Declared Inoperable Due to the Discovery of a Through Wall Pipe Crack in Common Header

Plant: San Onofre Nuclear Generating Station (SONGS) Unit 2
Discovery Date: January 11, 2006
Reactor Vendor: Combustion Engineering
Mode: Mode 5 – Cold Shutdown
Power: 0 percent

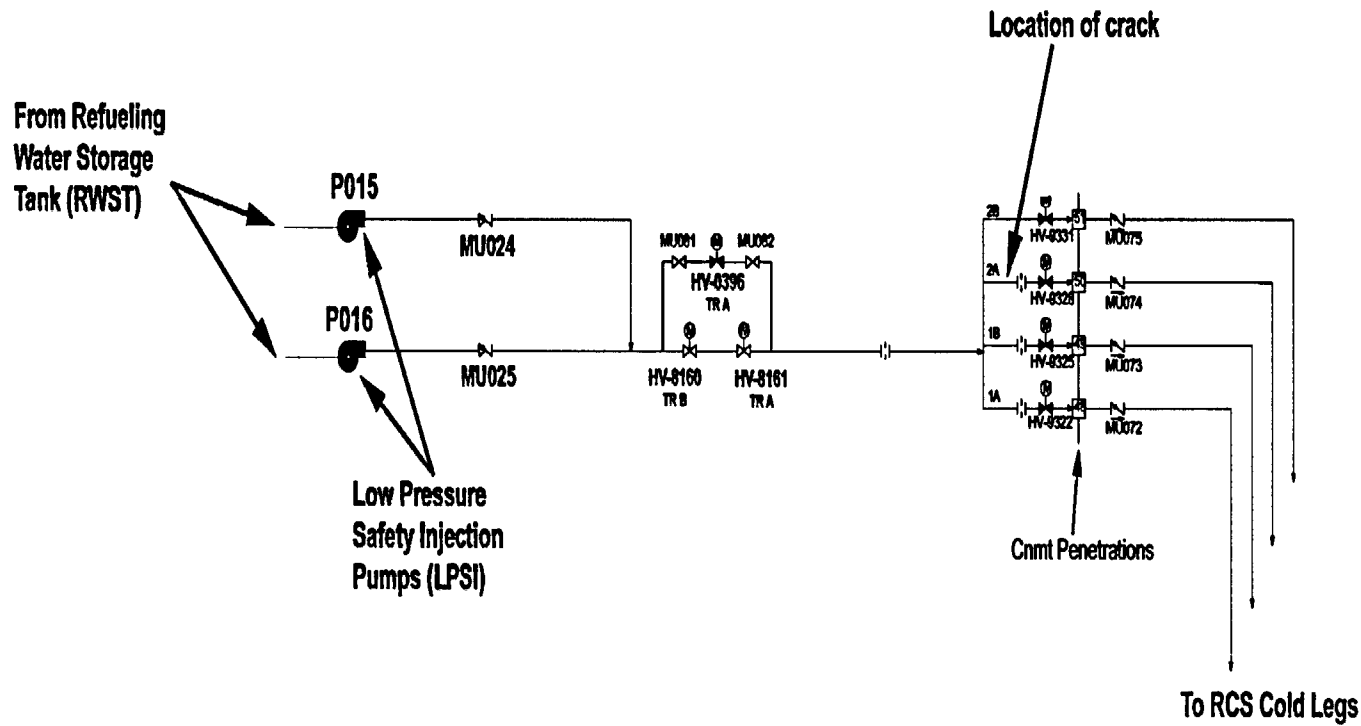
Low Pressure Safety Injection System & Shutdown Cooling System (Simplified Diagram)

The LPSI/SDC system contains two trains, each with its own pump [P], but sharing a common discharge line. This common line is then split into four individual pathways; each provides a flow path to one of the four RCS cold legs (see attached diagram).

On January 11, 2006, after removing the pipe insulation, SCE determined the source of the leak to be a small through-wall crack in the 8-inch LPSI system Class 2 pipe [PSP] at the toe of the weld to a 1-inch drain line, (just upstream of valve 2HV9328 [ISV] low pressure cold leg injection isolation valve for RCS branch line 2A). Since the crack was located in the common discharge header and could not be isolated, SCE declared both SDC trains inoperable. This action is consistent with the guidance in Regulatory Issue Summary (RIS) 2005-20, (Appendix C.12 of the NRC Inspection Manual Part 9900), which states in part,

Based on laboratory analysis, SCE determined the crack was caused by high cycle fatigue. The crack initiated at a small weld discontinuity on the outside diameter surface of the eight-inch LPSI discharge header pipe at a branch fitting that connects to a one-inch drain line. SCE is continuing to evaluate the cause of the high cycle fatigue (reference AR 060100463-12).

- The affected section of pipe was replaced with new pipe and the cracked pipe was sent offsite for analysis.
