Palo Verde Nuclear
Generating Station

**Subject: Palo Verde Nuclear Generating Station (PVNGS)
Unit 1
Docket No. STN 50-528
"APS' 60-Day after Plant Restart Letter in Response to First Revised
NRC Order EA-03-009, Item IV.E, NRC Bulletin 2003-02, Commitment
No. 3 and NRC Bulletin 2004-01, Commitment No. 2 – U1R12"**

**PVNGS' Unit 1 60-day after Outage Report
for the 12th Refueling Outage**

U1R12 60-Day After Outage Report

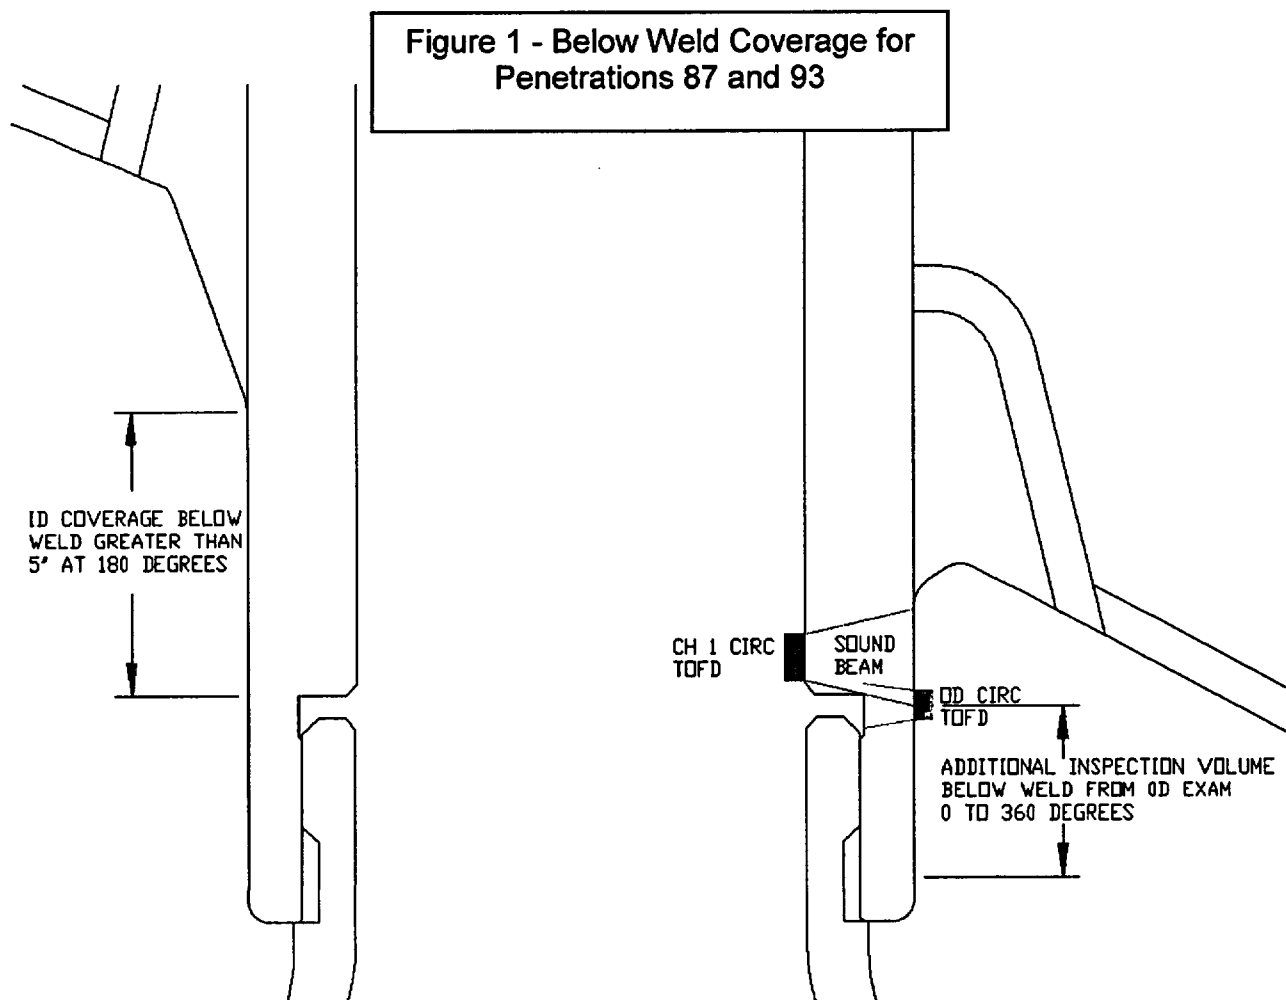
**Unit 1 Table of Examination Distances below the J-groove Weld
on the Downhill Side of the Nozzle and Below Weld Coverage of
Penetrations 87 and 93**

With the exception of penetrations 87 and 93, the minimum required inspection coverage was obtained for all nozzles from the inside diameter. For penetrations No. 87, and 93, the minimum required inspection coverage described in Table 1 of Reference 1 could not be obtained using ultrasonic or eddy current examination from the inside diameter. The examination of penetrations 87, and 93 did cover the available distance on the inside diameter of each nozzle leaving no additional distance for examination. In accordance with Reference 2 (repeated below), APS performed additional examinations as discussed with the NRC on April 26, 2004 and described in Reference 3.

The ultrasonic examination of penetrations 87 and 93 did cover the available distance on the inside diameter of each nozzle leaving no additional distance for examination. To meet this commitment, penetrations 87 and 93 were also examined from the outside diameter using a qualified surface exam. Penetration No. 87 was examined an additional 0.885" below the inside diameter chamfer and penetration No. 93 was examined an additional 1.000" below the inside diameter chamfer. Figure 1 in the attachment to this enclosure shows the overlap. No indications were identified.
