Mid-Inspection Questions with the NRC for
Waterford 3 Steam Generators during RF13

May 1 WF3 Steam Generator Inspection Report (Not Final)

Questions for NRC on SG Inspection at Waterford 3

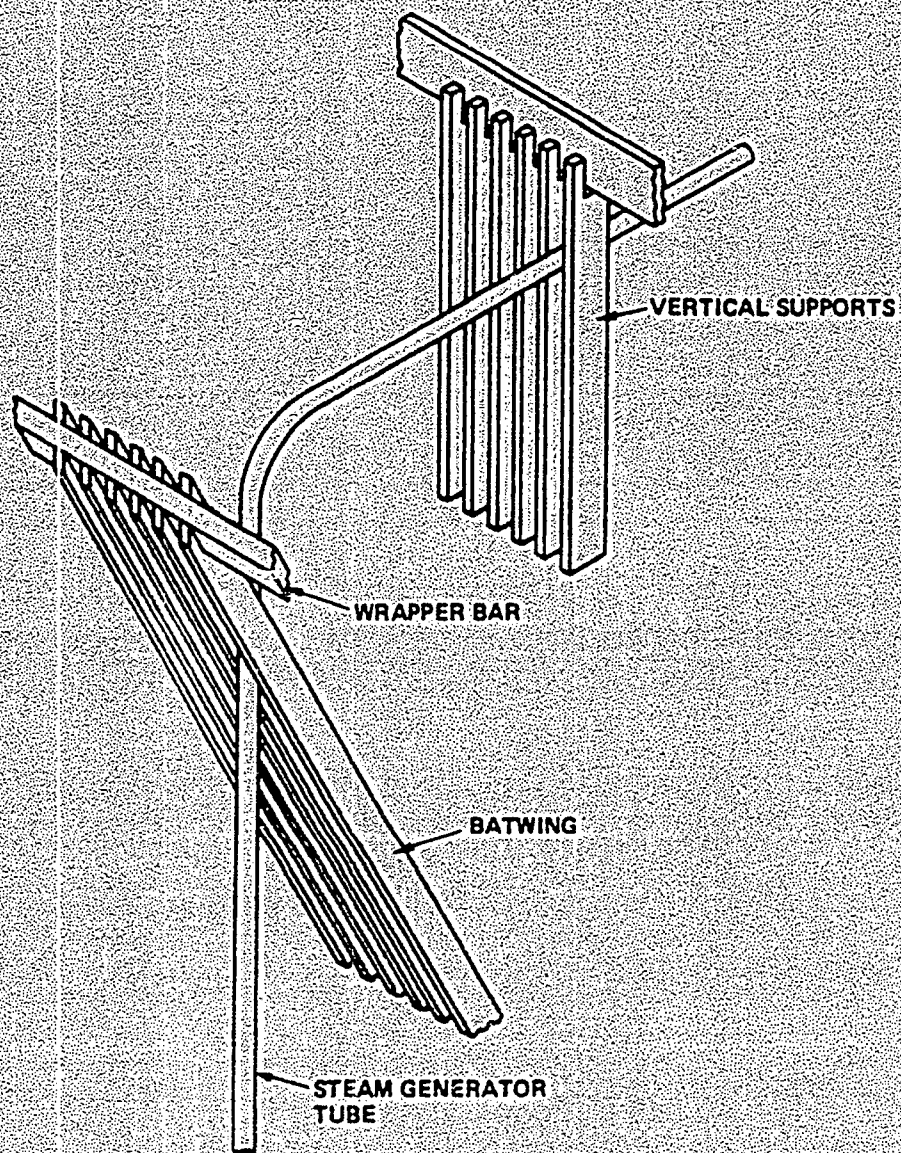
FIGURE 2.4.4
SONGS-2 STEAM GENERATOR UPPER "BATWING" ASSEMBLY

- Cracking in the vertical straps (axial)

There were 3 axial cracks identified in the vertical straps in the batwings.

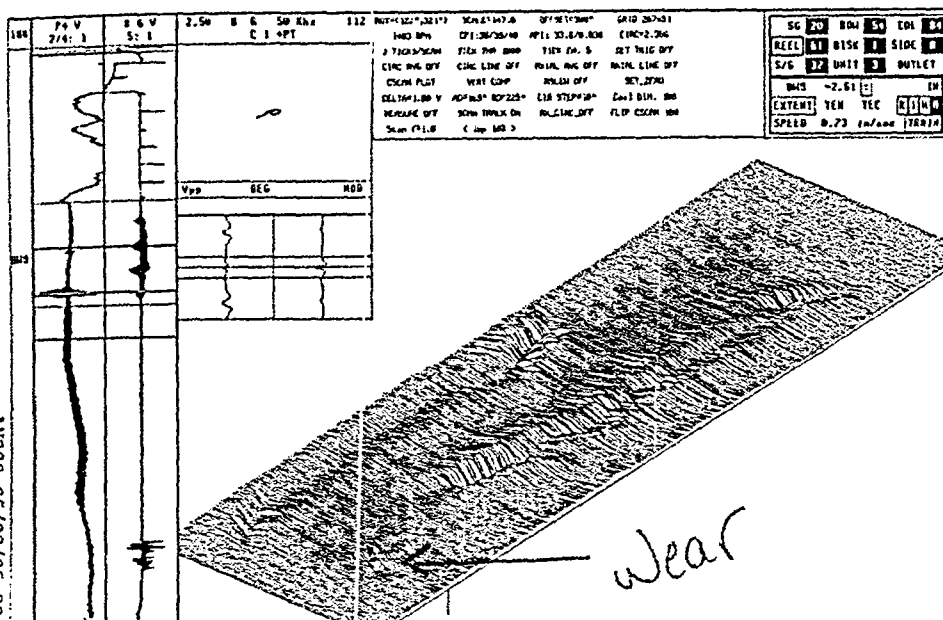
4/29/2005 OUTLET UNIT: 3 SG: 32 CAL: 61 RI

BW offset @ wear

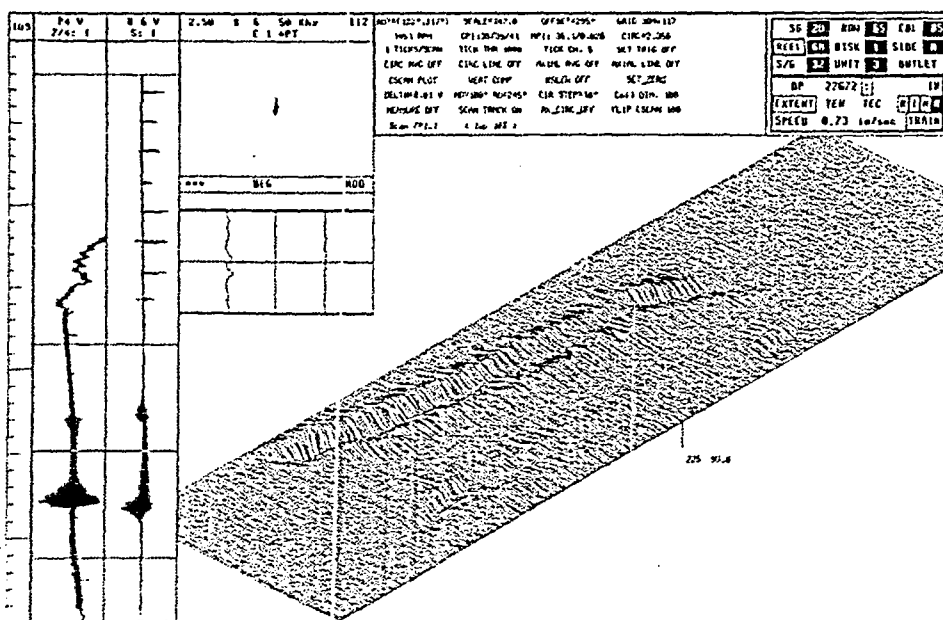
4/30/2005 OUTLET UNIT: 3 SG: 32 CAL: 68 RES

non-offset BW

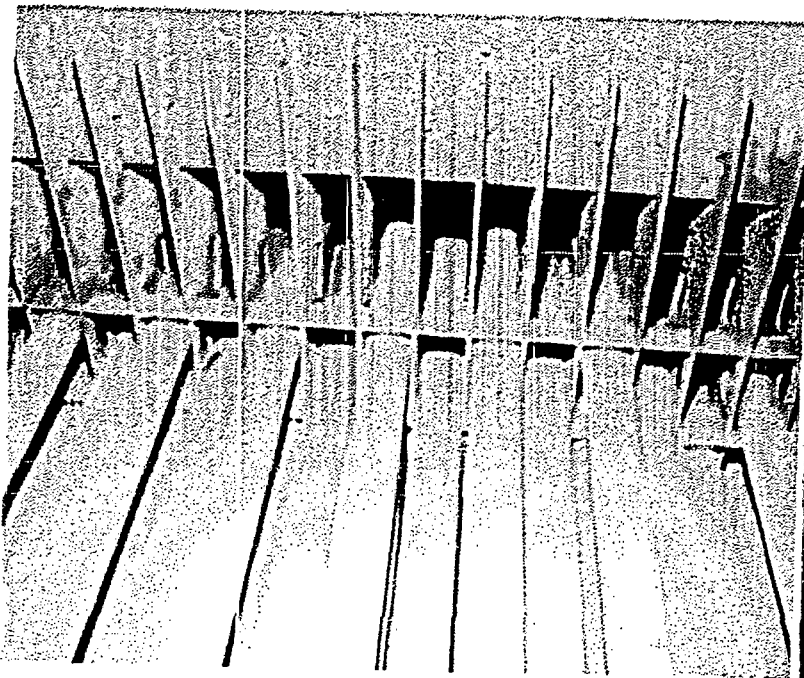
1-30 Closeup of vertical
supports.

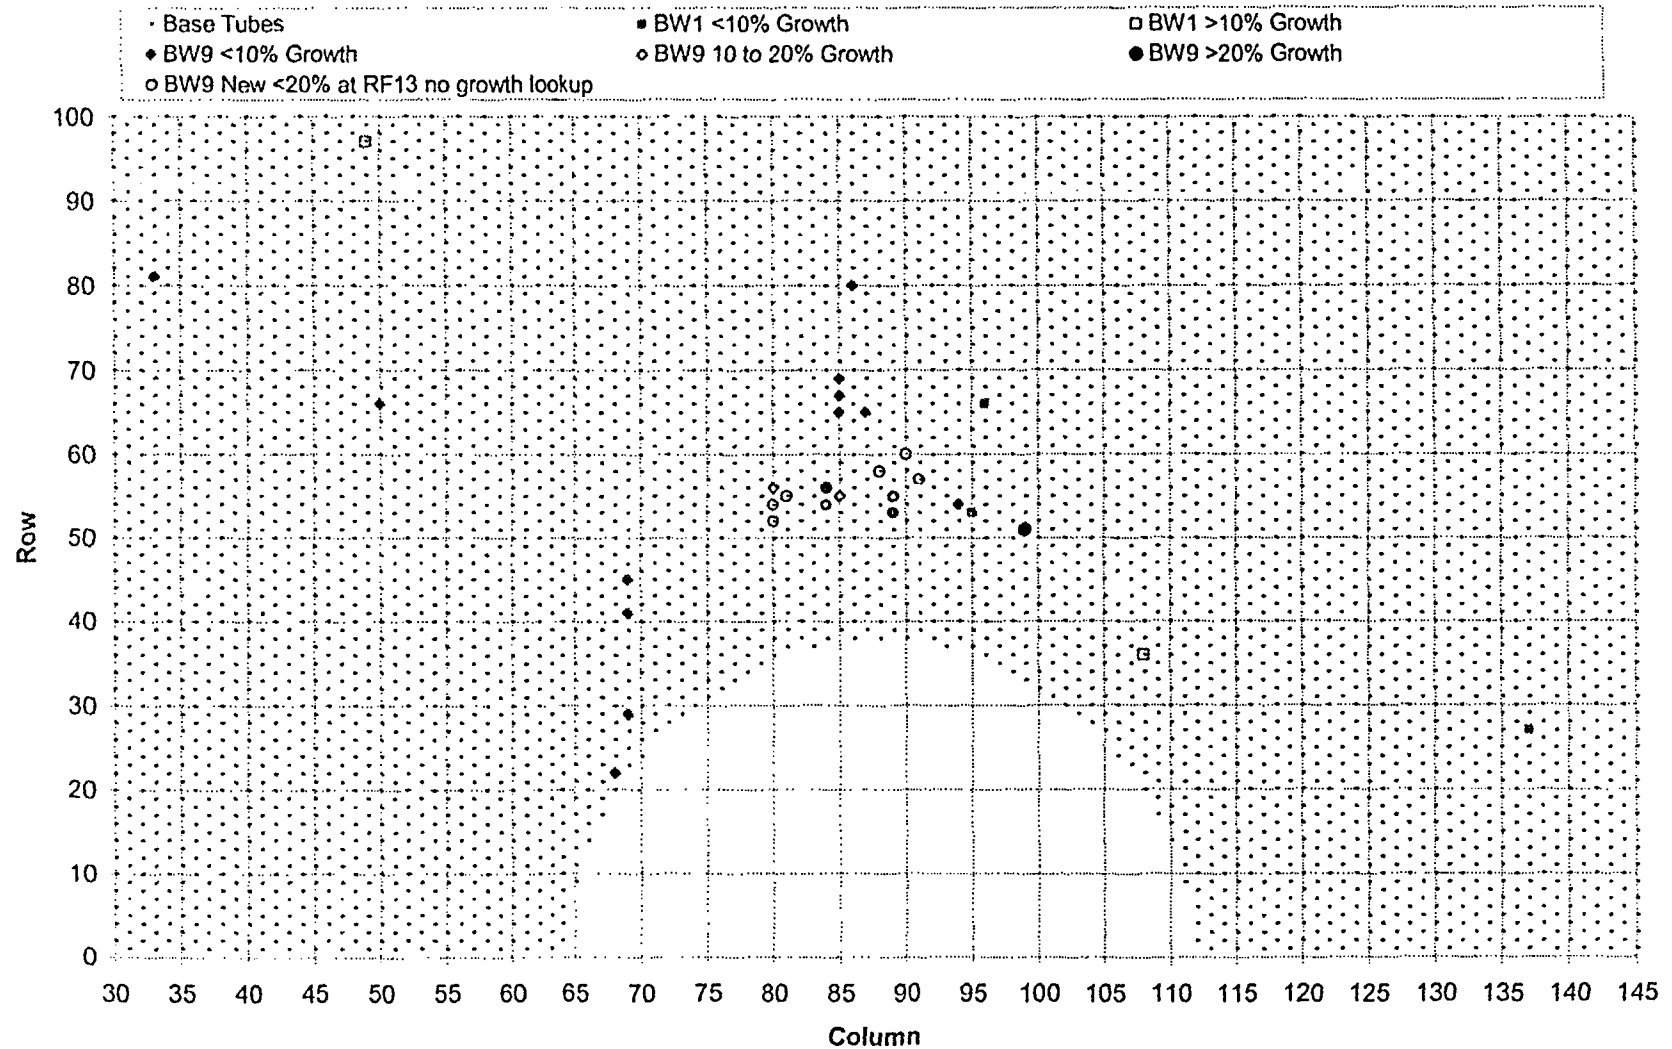
Waterford Tubesheet Map SG32: BW1 and BW9 Wear Growth (NDD assumed 5% in history)

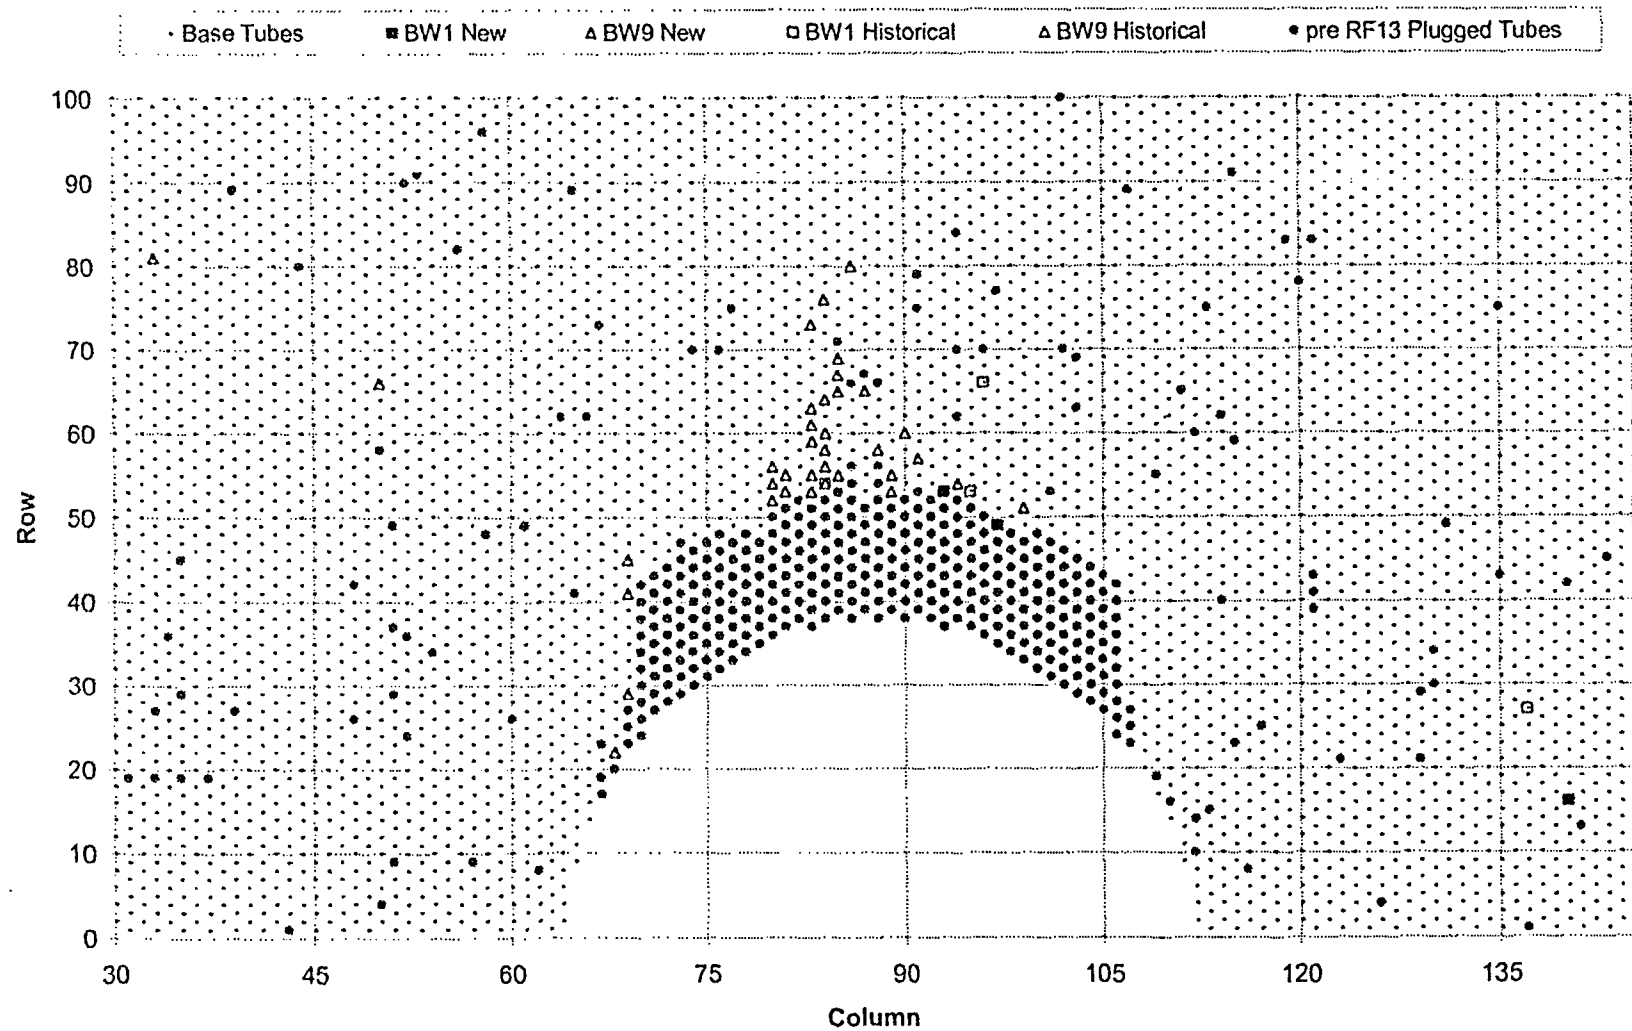
Waterford Tubesheet Map SG32 BW1 and BW9 New and Historical Wear
