Subject: Turkey Point Unit 3
Docket No. 50-250
Response to Request for Additional Information
Regarding Steam Generator Tube Plugging
Inservice Inspection Report (TAC NO. MC8112)

Response To Request For Additional Information
Regarding Turkey Point Unit 3 Steam Generator Tube Inspection Report

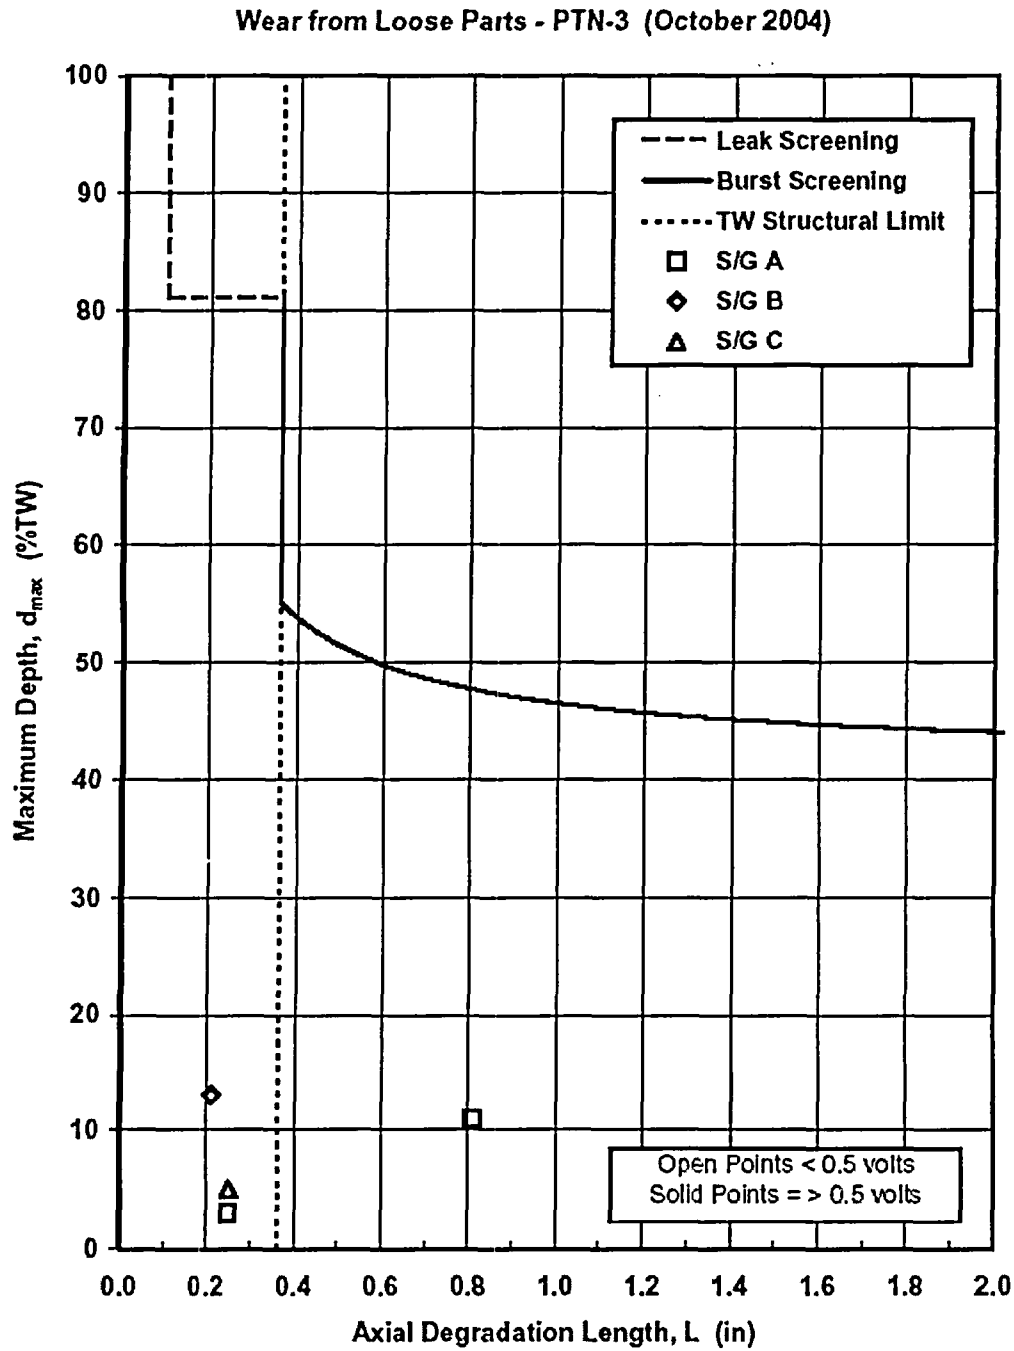
Figure 4-3 — Condition Monitoring Results for Loose Part Wear at EOC 20.

There were four indications detected associated with wear from foreign objects. A comparison of these wear indications with the CM structural limits is given in Figure 4-3. Three of these indications were detected at the top of tube sheet. The wear damage was shallow and there was no evidence that the loose part was still present. The other wear indication was detected at a TSP and is due to a probable loose part. All loose part wear met the NEI 97-06 structural limit performance criterion for burst and leak integrity. No tubes required to be plugged. These tubes remain in service and will be tracked during future inspections.

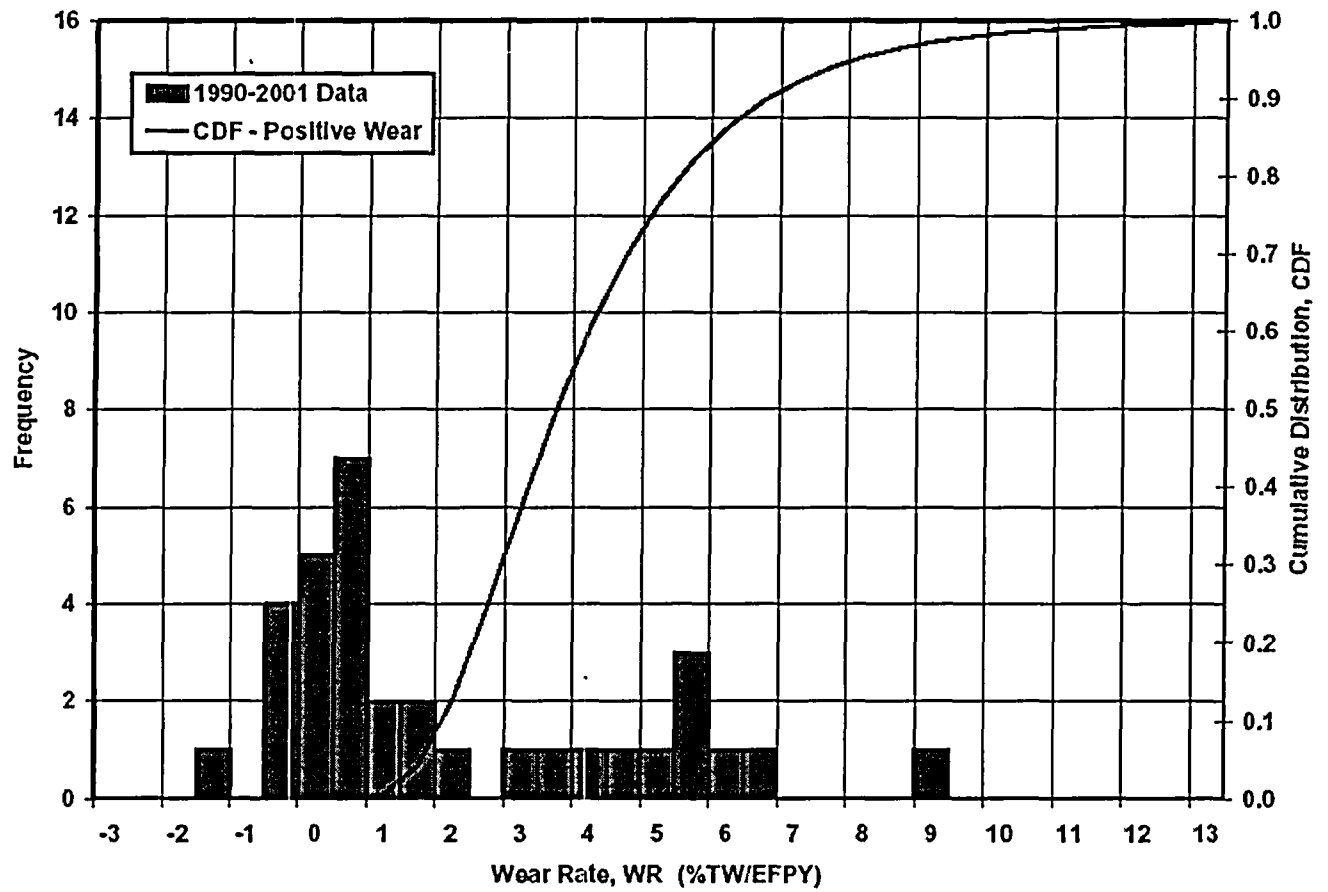
Figure 5-5 — Wear Rates at TSP Tube Intersections from PTN-3 October 2001 Examination Data.

The rates determined for wear at TSPs from the October 2001 are shown in Figure 5-5. These rates are based on two cycle calculations. Due to the limited data, the growth rates for all TSP indications (including those identified as wear from foreign object) were used to establish a wear rate by TSP contact. Lumping the apparent loose-part wear data with the other wear tube-to-TSP contact data is conservative. The average wear rate was about 2.7% TW/EFPY and a standard deviation of about 2.5% TW/EFPY. The tube exhibiting the largest wear rate was used to define the wear rate to apply in the OA. That wear rate is 8.8% TW/EFPY.
