WATTS BAR NUCLEAR PLANT (WBN) - UNIT 1 - FACILITY OPERATING LICENSE
NPF-90 - LICENSEE EVENT REPORT (LER) 50-390/2006-001

LICENSEE EVENT REPORT (LER)

4. TITLE Entrained Air in Essential Raw Cooling Water (ERCW) Piping
--

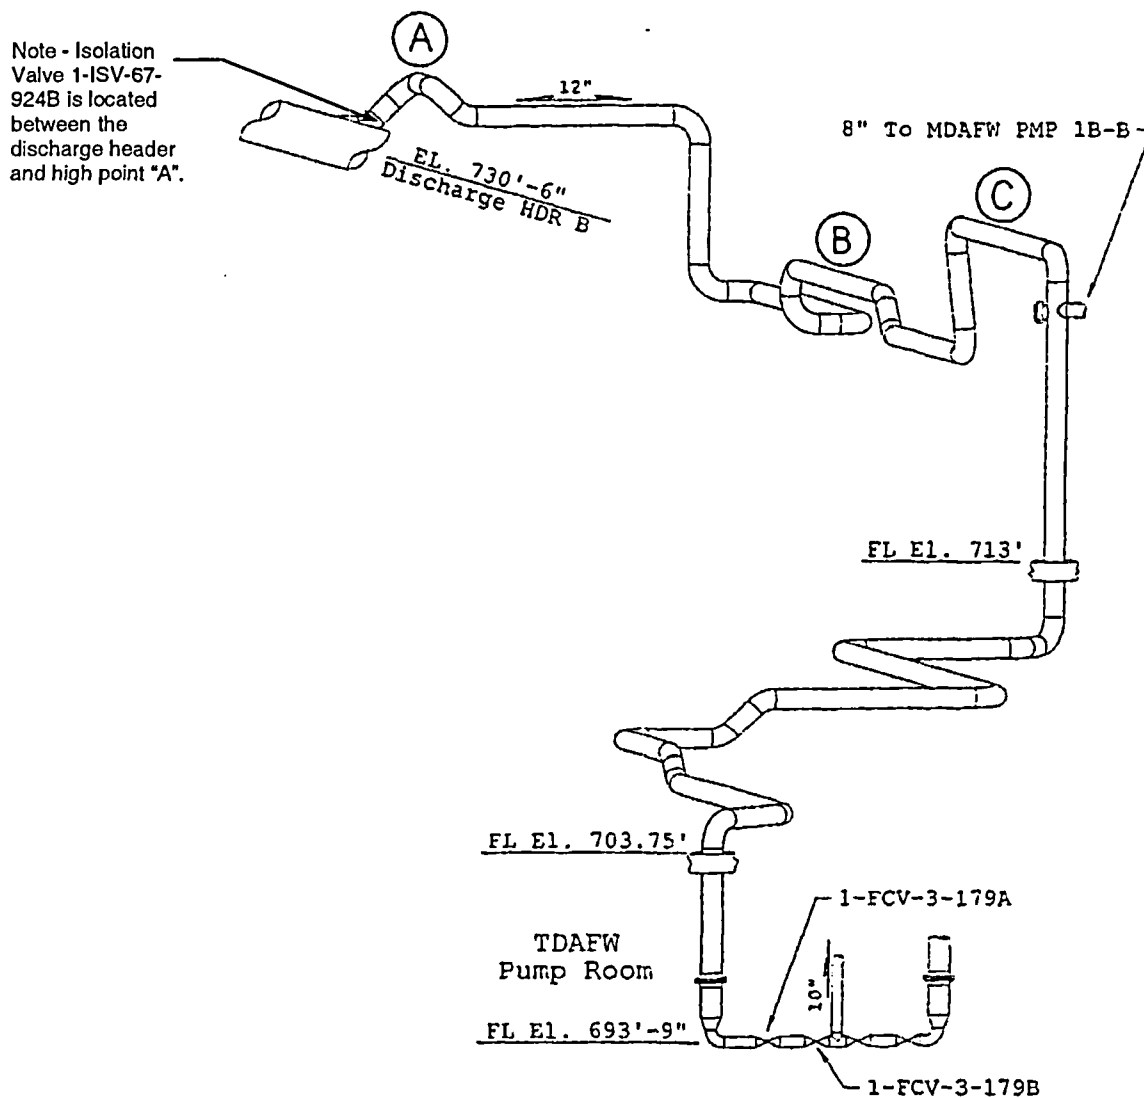
Diagram of Train B ERCW Supply Piping to AFW System

Provided on the following page is a diagram of the Train B ERCW supply piping to the AFW system. The three high points in this piping segment are marked as A, B, and C. Varying amounts of air were found at each of the three points. The evaluation of this condition determined the principal cause to be the inadequate filling and venting of the piping during the Cycle 6 refueling outage. The venting during the outage was performed after radiographic testing and the flushing of the pipe.

1. As stated previously, action was taken to vent the 12 inch supply line to the AFW pumps and to vent the 30 inch discharge header. UT measurements were taken of both lines to verify the piping was properly filled.
2. The Train A ERCW supply to the AFW system was verified to be operable.
3. Action was initiated to determine the cause of the gas voids and to establish the proper actions to prevent recurrence of voids.
