Palo Verde Nuclear  
Generating Station

**Subject: Palo Verde Nuclear Generating Station (PVNGS)  
Units 1, 2 and 3  
Docket Nos. STN 50-528, 50-529, and 50-530  
Response to NRC Request for Additional Information Regarding  
PVNGS Units 2 and 3 Steam Generator Tube Inspections**

**ARIZONA PUBLIC SERVICE COMPANY  
RESPONSE TO NRC REQUEST FOR ADDITIONAL INFORMATION  
REGARDING PVNGS UNITS 2 AND 3 STEAM GENERATOR TUBE  
INSPECTIONS**

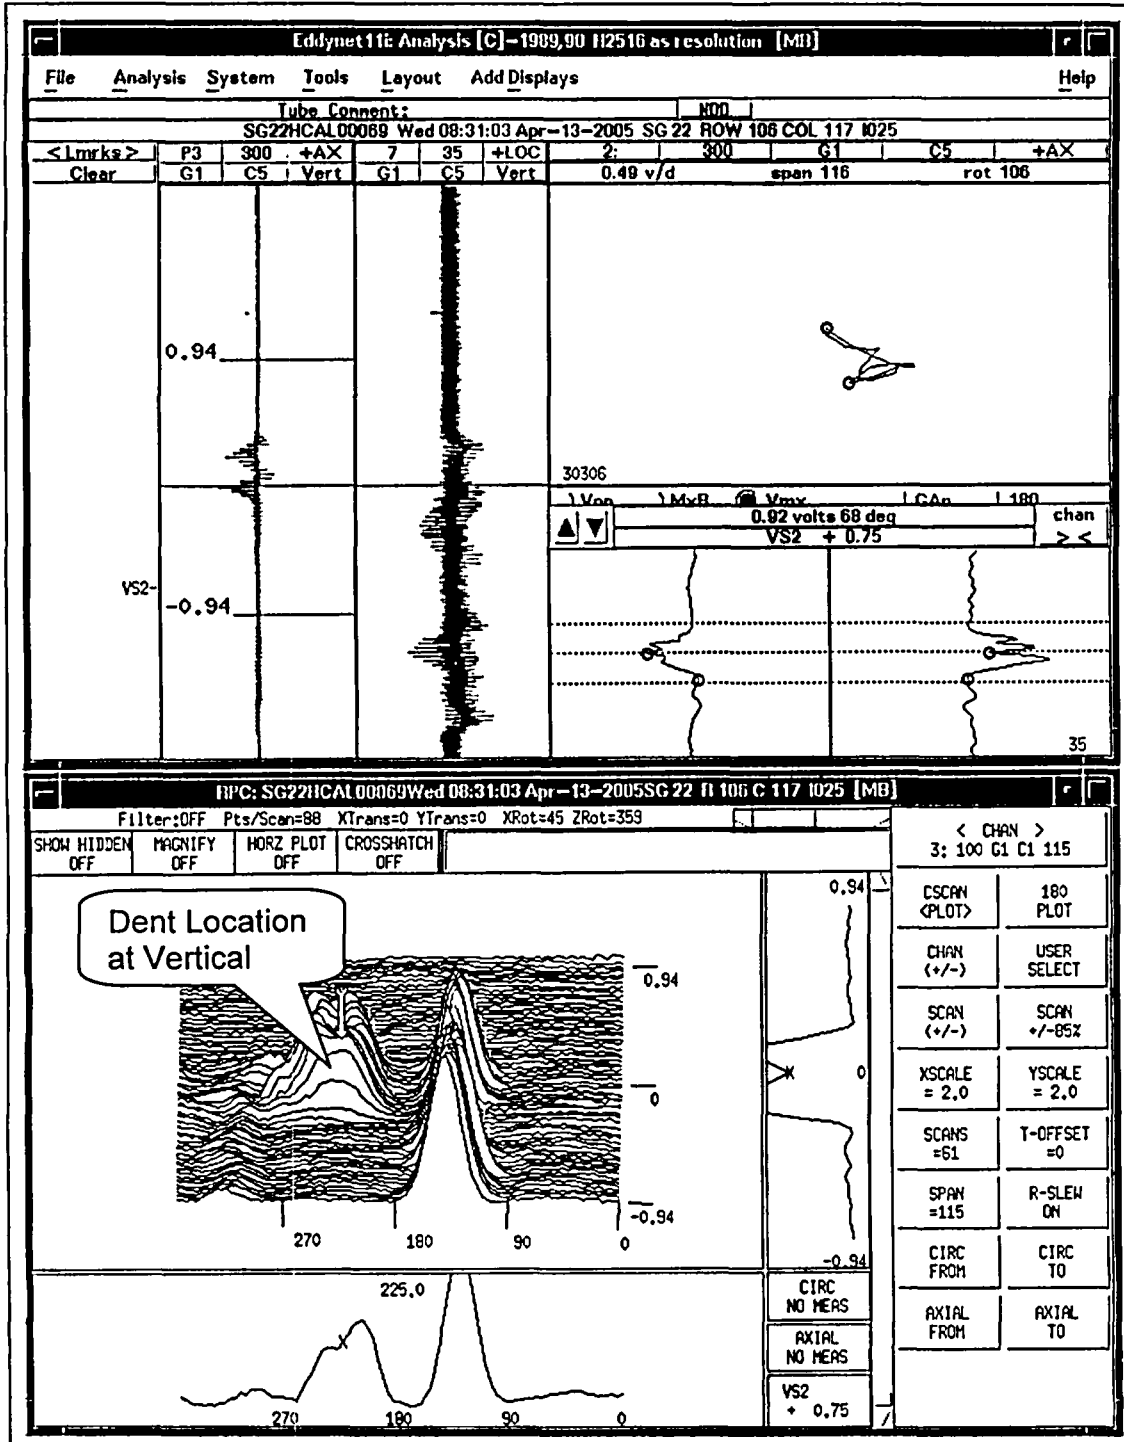
Figure 1  
MRPC Graphic "Abnormal" Dent

These dents were considered "abnormal" by APS because they exhibited vertical amplitudes higher than typical dent indications. This condition/classification is one of the lessons learned during the 2004 midcycle (leaker) outage and subsequent dent evaluations. The PVNGS Analysts' Technique Sheet for the +Point examination of dents requires the analysts to record any dent with a vertical amplitude over 0.2 volts with the +Point 300 kHz channel. These are then reviewed by the APS Level III for location, appearance, and the potential for masking of other types of flaw indications.

The abnormal dent indications were similar to the dent indication in SG 21 Row 156 Column 143 that leaked during Cycle 12 in that they had higher vertical voltage than other typical dent indications. Using the +Point 300 kHz channel, the vertical amplitude of the leaking tube was 0.94 volts compared to voltages of 0.29, 0.30, 0.67 and 0.92 for the tubes listed in Section 4.0. As indicated above, the four tubes in U2R12 were associated with a support bar, whereas the dent in the leaking tube was not directly associated with a support bar and the dent in the leaking tube was attributed to damage caused by a packing crate screw.

Although it is unlikely that these dents were caused by crate screw damage, APS took the conservative action and removed the affected tubes from service by plugging.

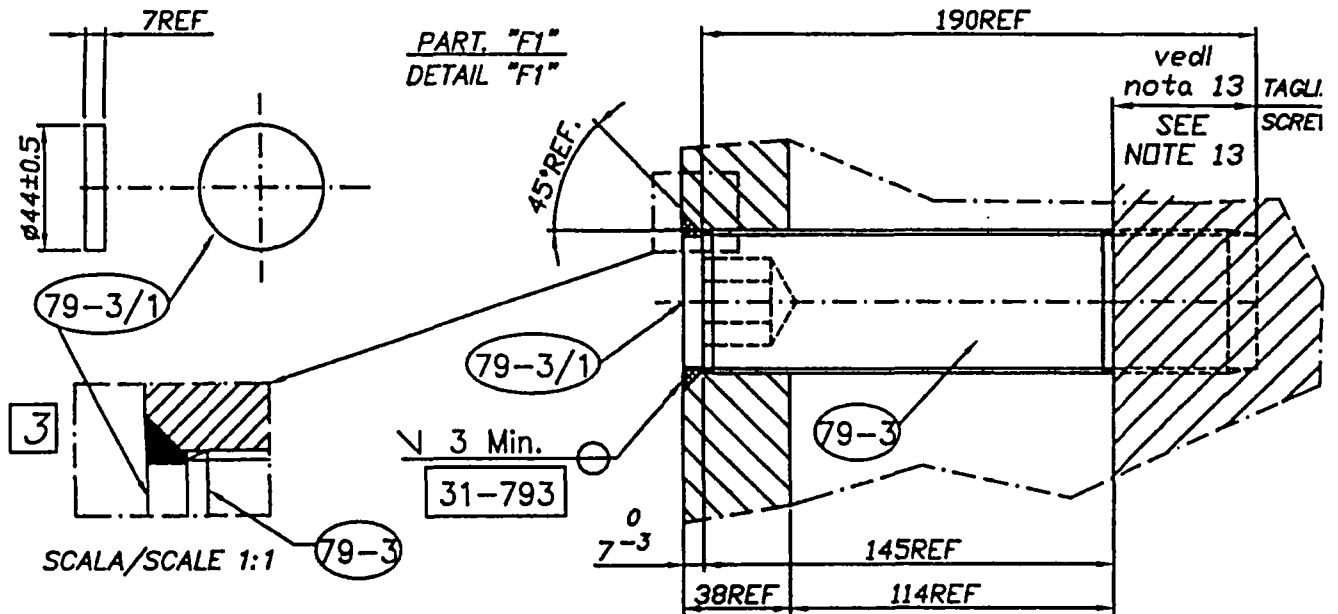
**Figure 2**  
**Set Screw Installation Unit 1 and 2 RSg**

conditions. Although not likely to help limit the erosion or wear of the feedwater box at the set screw location, if erosion does occur, the combination of the smaller gap and the seal plate on tube side of the feedwater box would limit the movement of the set screw. As a result, it is less likely that the same amount of erosion as seen in the Unit 3 OSGs would lead to a set screw failure.

The most significant difference between the OSGs and the Unit 1 and 2 RSGs is the installation of a seal plate. In the OSGs the set screws were welded to the tube-side face of the feedwater box then ground flush. Because of the hardness of the set screw material, very little of the weld metal adhered to the set screw. As a result, there was a small leak path through the threads that allowed water to leak from the feedwater box to the economizer region of the steam generator. Conversely, the Units 1 and 2 RSGs have a 0.25-inch carbon steel plate that is groove-welded flush to the tube-side face of the feedwater box (see attached Figure 2). This seal plate is a significant design improvement in the RSGs. Although the primary purpose of the seal plate was to avoid welding to hardened bolting material, it has the secondary effect of eliminating the jetting flow through the set screw hole if the set screw falls out. While this change might not significantly affect the probability of a set screw failure in Units 1 and 2, it will have a significant effect on the consequences of a failure.

Based on this evaluation, APS concluded that the probability of a set screw failure is marginally lower in the Unit 1 and 2 RSGs than in the OSGs. It should be noted that the erosion/corrosion that led to the set screw failure in the Unit 3 OSG occurred after 11 operating cycles. As such, the mechanism is not considered to be a near term issue. To ensure that the condition does not manifest itself in the Units 1 and 2 RSGs, a routine Preventative Maintenance Task to inspect the RSGs in this region on a 6Y (six year) frequency has been implemented for Units 1 and 2, and the condition has been incorporated into the PVNGS Degradation Assessment.

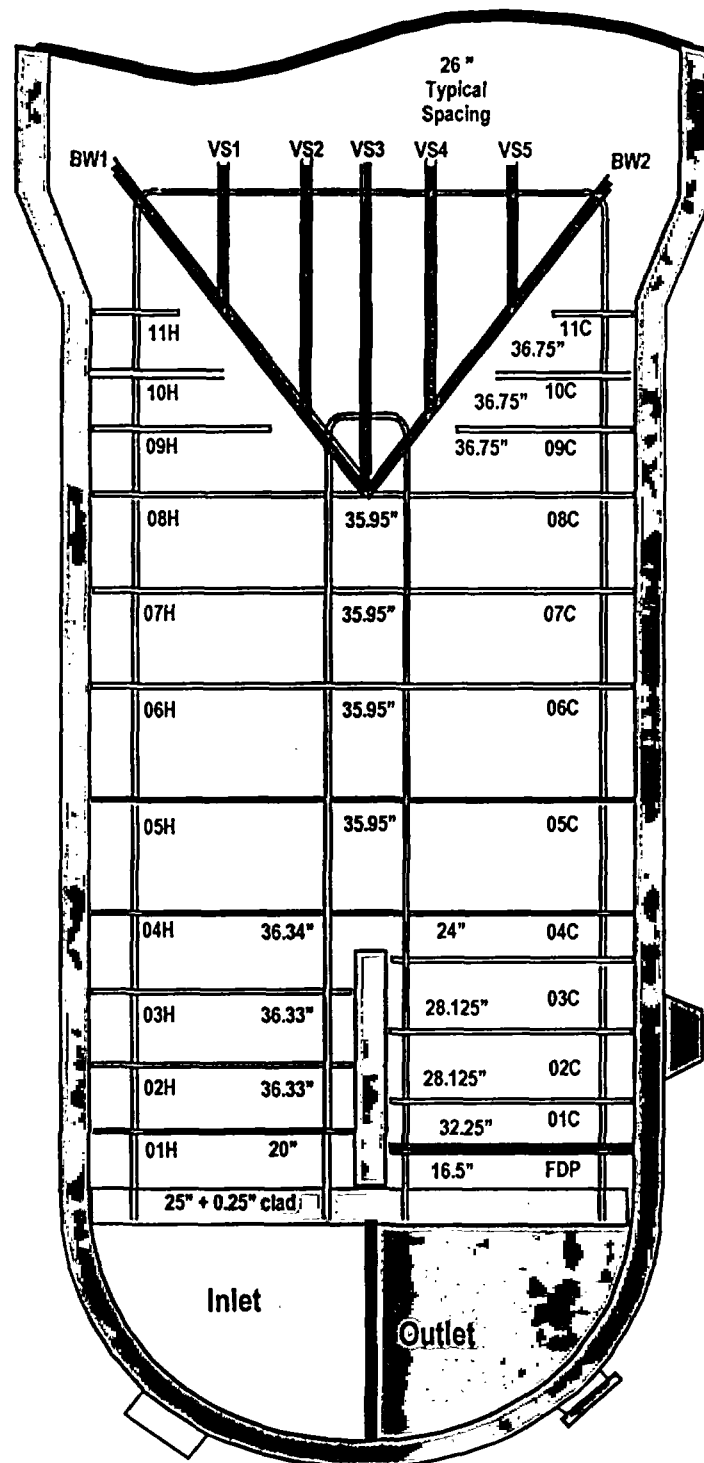
**Figure 3**  
**Support System - PVNGS Replacement Steam Generators**

The horizontal tube supports located along the vertical section of the tubes are of an eggcrate design. The eggcrates are comprised of alternating one and two inch strips, 0.090 inch thick, arranged in two directions that intersect at 60°. The bend and horizontal regions of the tubes are supported by batwing and vertical lattice supports, respectively. The primary difference from the OSG design are that the batwing and vertical lattice supports are perforated to improve thermal-hydraulic conditions in the upper bundle region to prevent crevice dryout and reduce secondary fouling. The batwing and vertical support structures are now unitized and fabricated from two inch wide, 0.090 inch thick 409 SS strips. The batwing supports which minimize out-of-plane movement have been relocated to bisect the tube bends.

The RSG design also differs from the OSG in terms of the flow distribution plate(s). The RSGs do not have a hot leg flow distribution plate, which was eliminated to improve hot-side circulation. The cold leg flow distribution plate is an approximately one inch thick, 405 stainless steel plate with 0.776 inch circular holes.
