**U.S. NUCLEAR REGULATORY COMMISSION  
Office of Nuclear Material Safety and Safeguards  
Spent Fuel Project Office**

**CONFIRMATORY ACTION LETTER 97-7-001  
TECHNICAL EVALUATION**

Docket No. 72-1007

Certificate Holder: Sierra Nuclear Corporation  
One Victor Square  
Scotts Valley, CA 95066

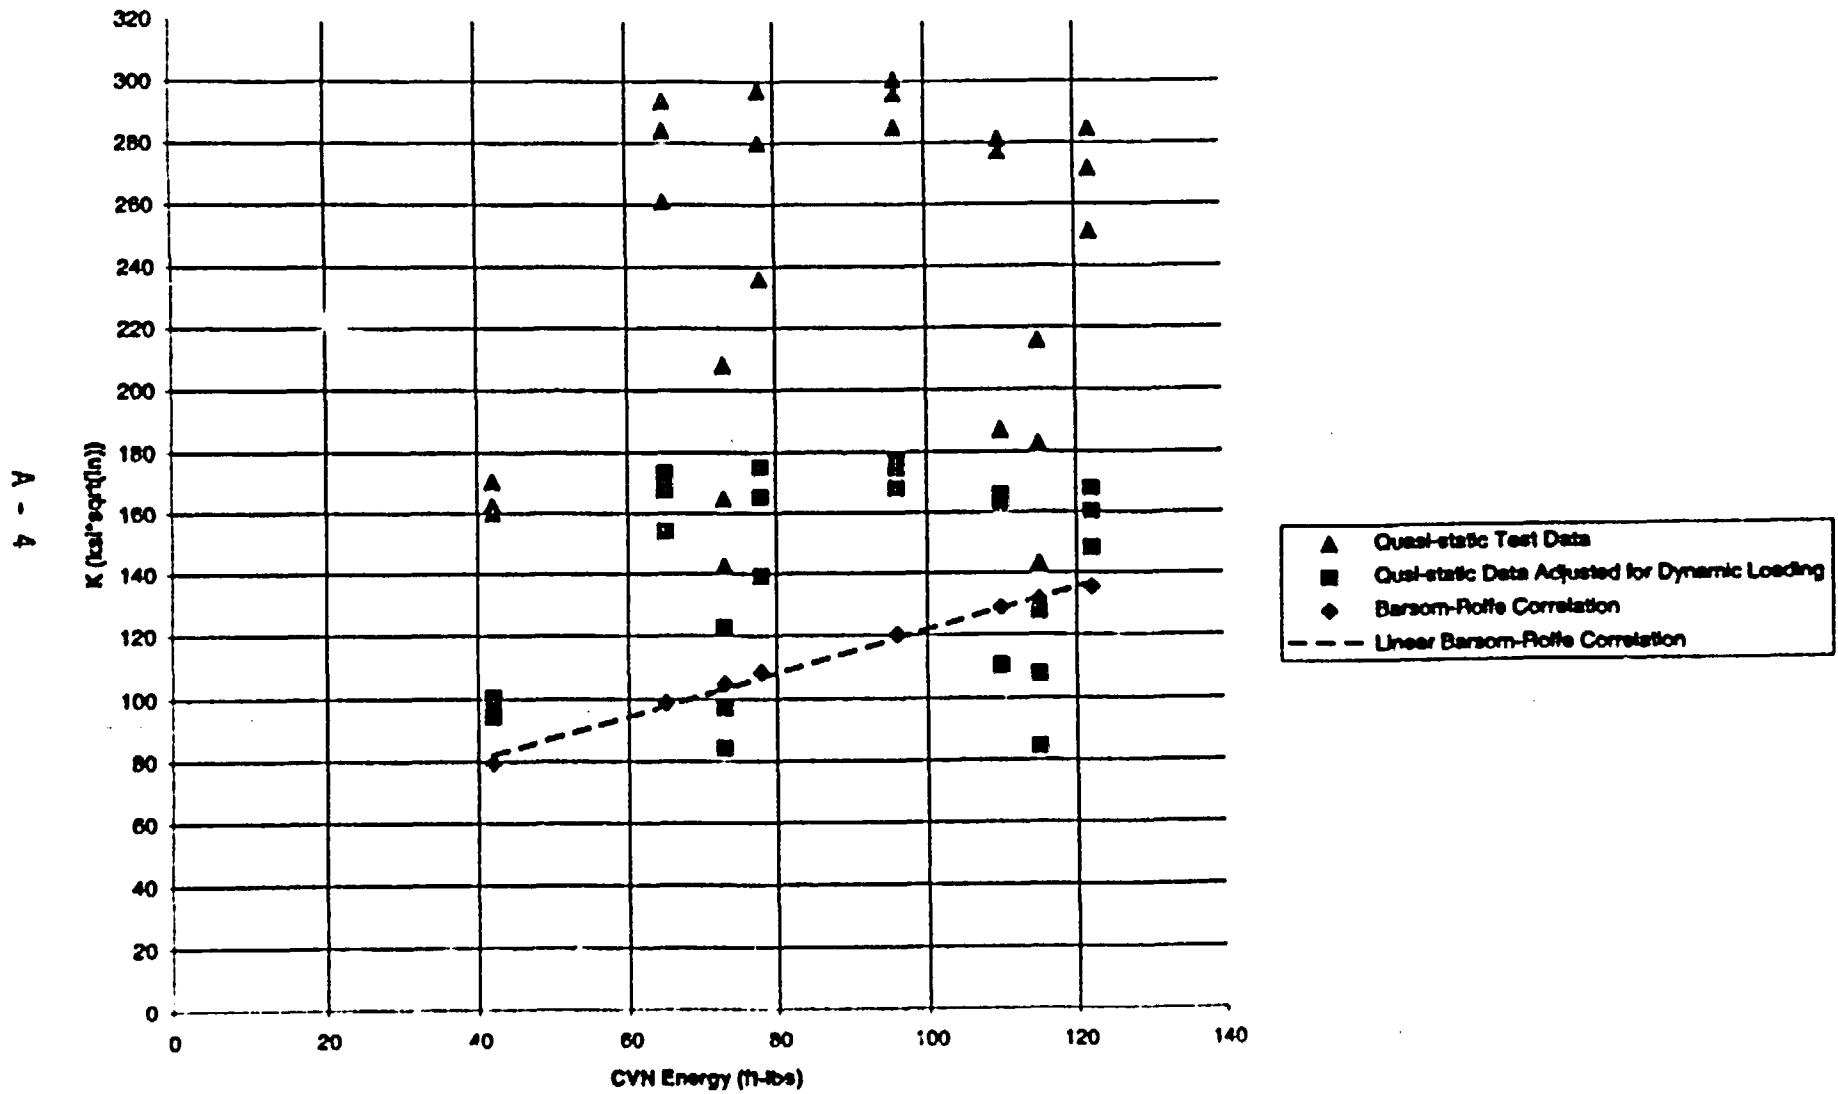
Figure A1

The staff plotted the data for fracture toughness and CVN provided by the Owners Group (Figure A1). The staff did not observe any relationship between  $K_{Ic}$  and CVN in the data presented and concluded that the Barsom-Rolfe correlation for the MSB material was inappropriate. This staff position was documented in the May 21, 1998, letter from NRC to SNC.

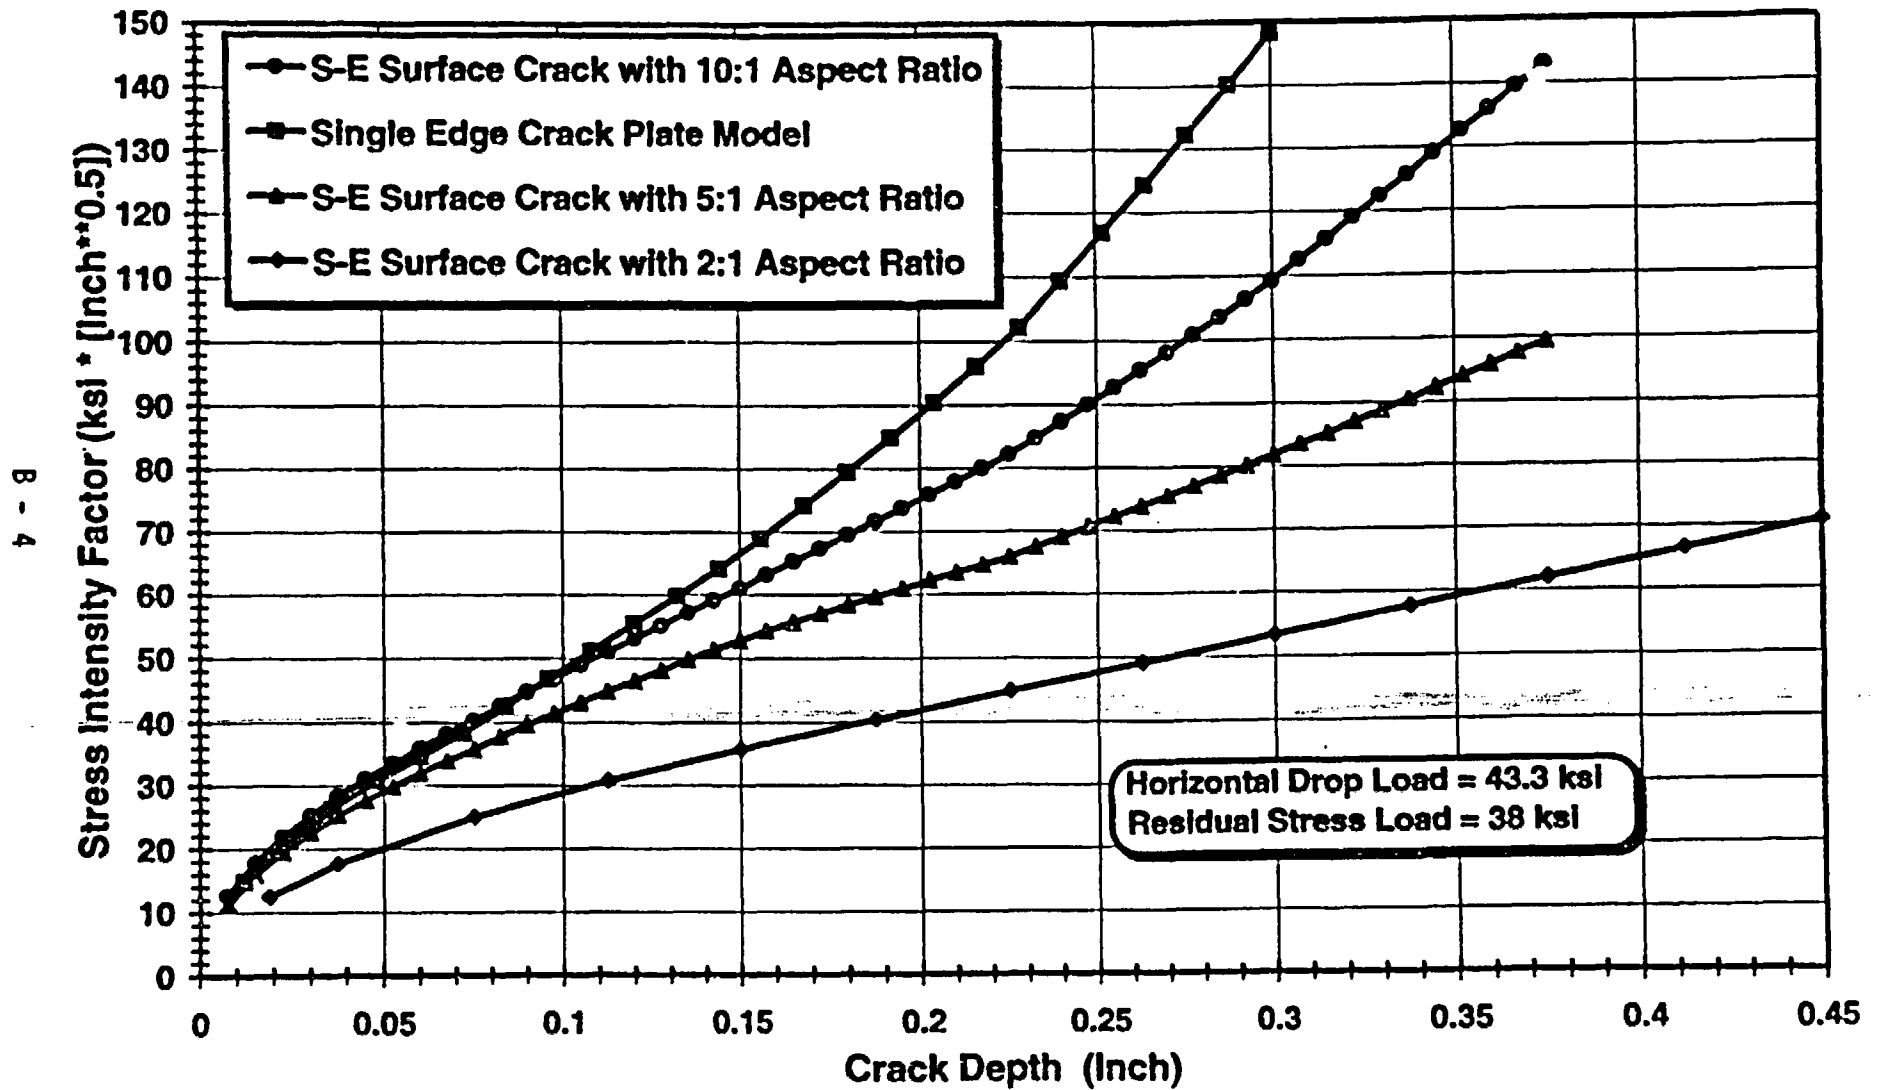
Figure B1

Applied K versus Crack Depth for (Horizontal Drop + 0.707\*Weld Residual Stress)  
Loading

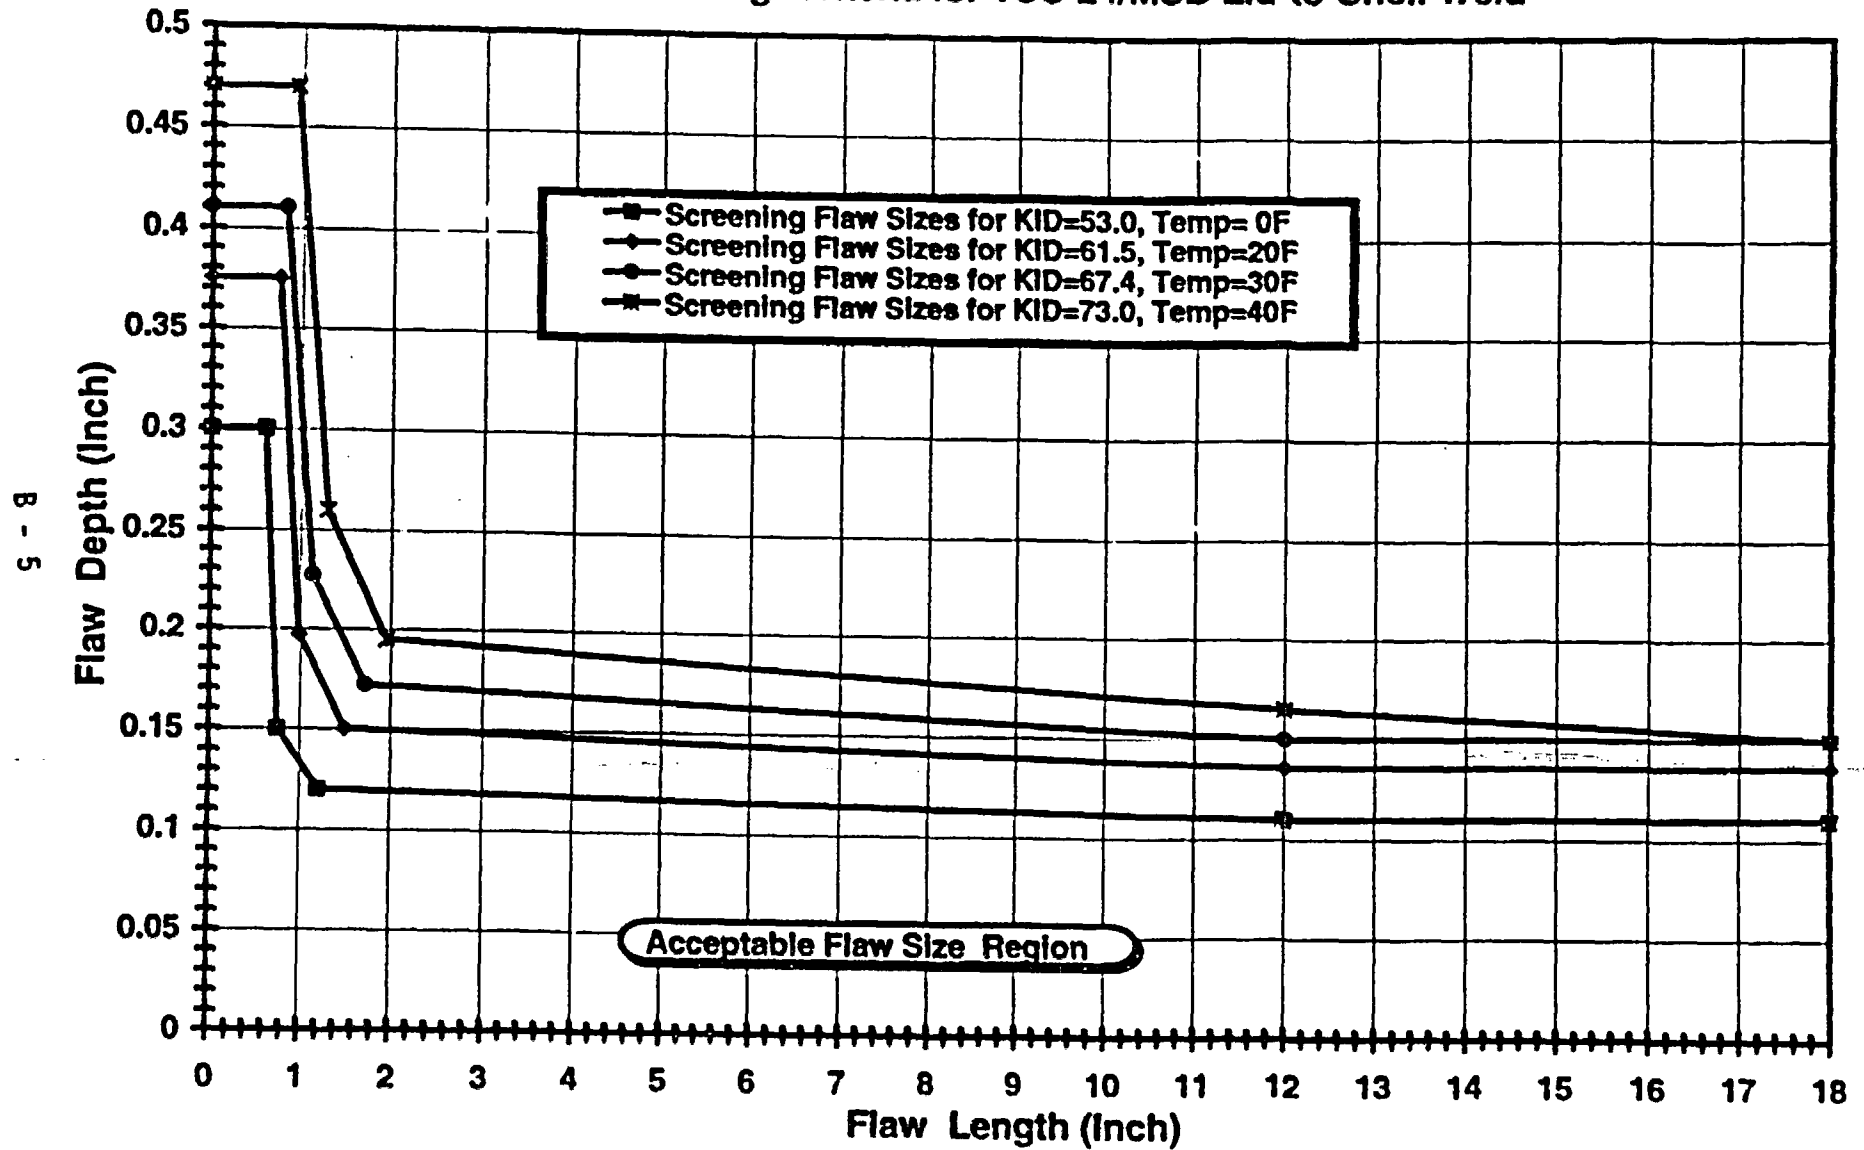
Figure B2

# NRC Flaw Screening Criteria for VSC-24/MSB Lid-to-Shell Weld
