**U.S. DEPARTMENT OF ENERGY
NEVADA OPERATIONS OFFICE**

**REPORT OF THE INVESTIGATION
OF THE ACCIDENT AT THE
MIDAS MYTH/MILAGRO TRAILER PARK
ON RAINIER MESA AT NEVADA TEST SITE
ON FEB. 15, 1984**

**DATE OF INVESTIGATION REPORT
APRIL 9, 1984**

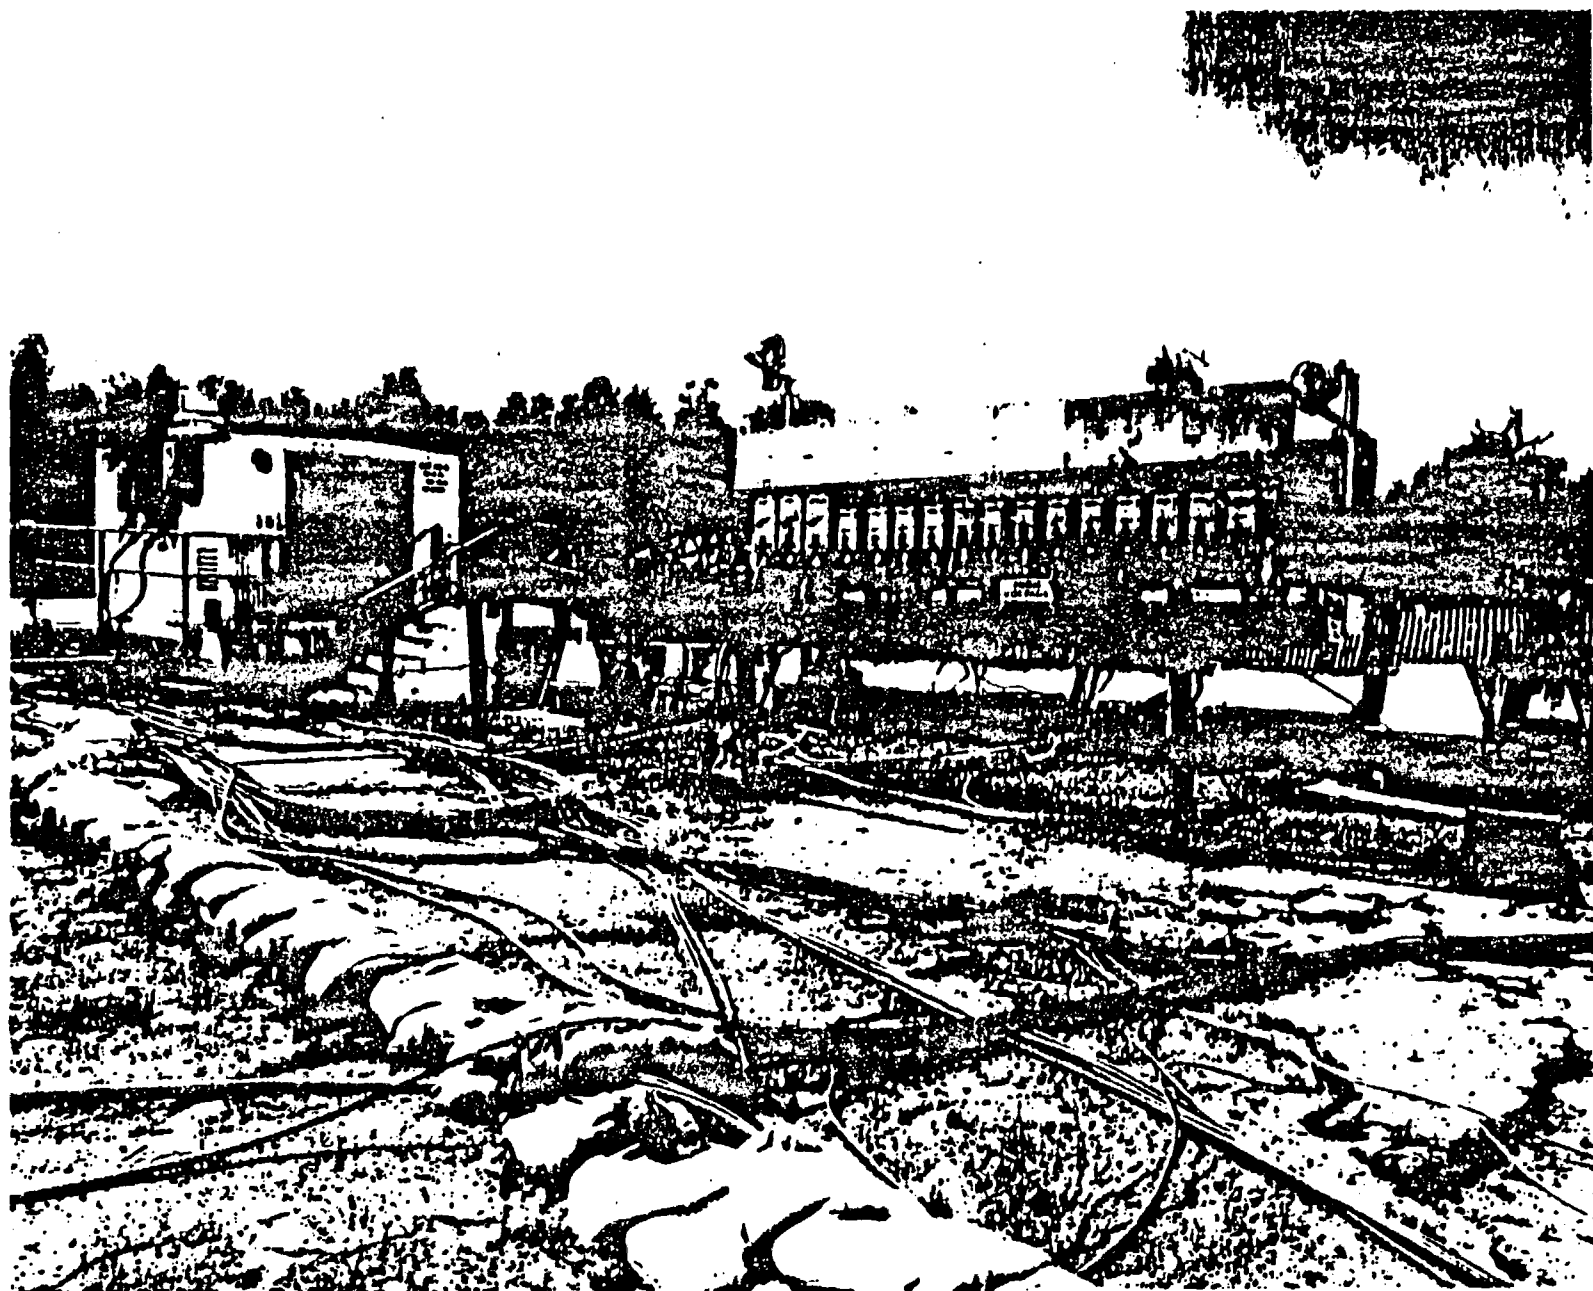
Figure 10 — MILAGRO Trailer Park Power Panel,
West End of Trailer P-14-101, Postshot, Prior to Collapse

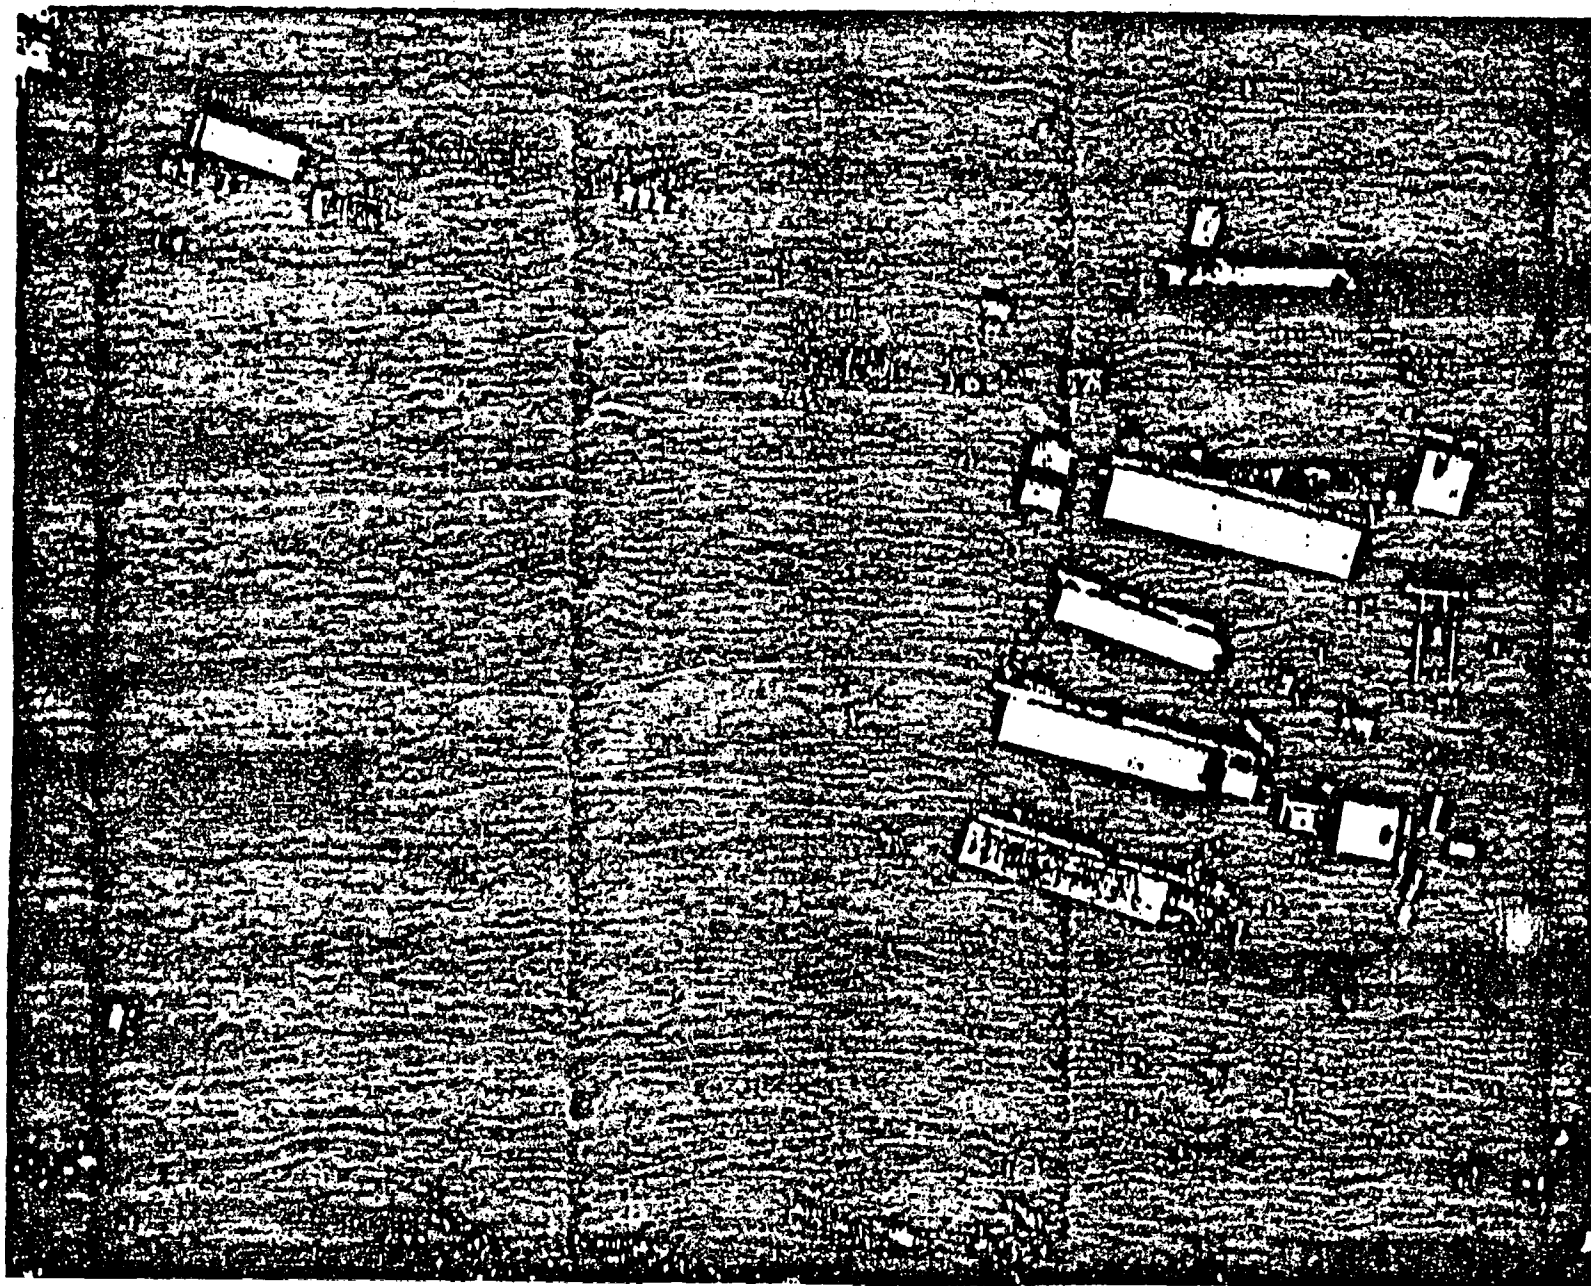
Figure 13 — MILAGRO Trailer Park Collapse Area

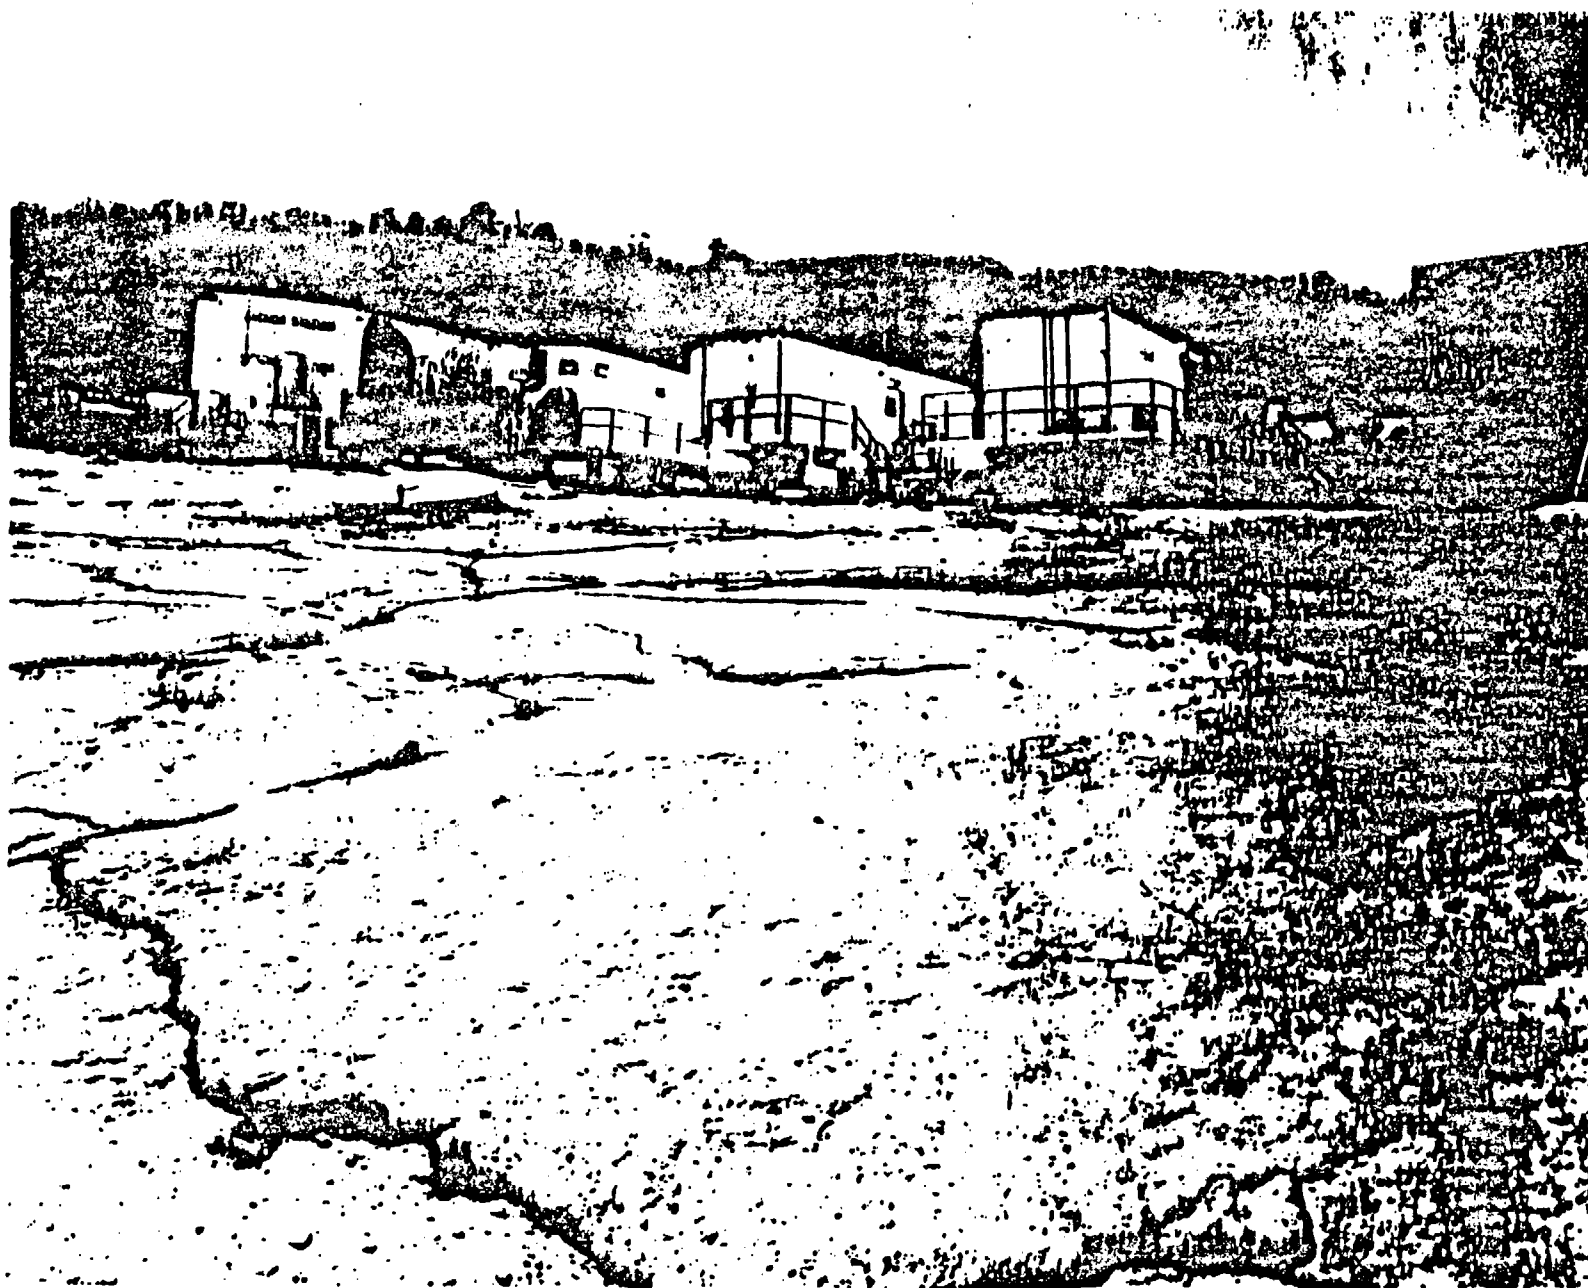
Figure 17 — MILAGRO Trailer Park,
Post Collapse Damage, East Ends of Trailers

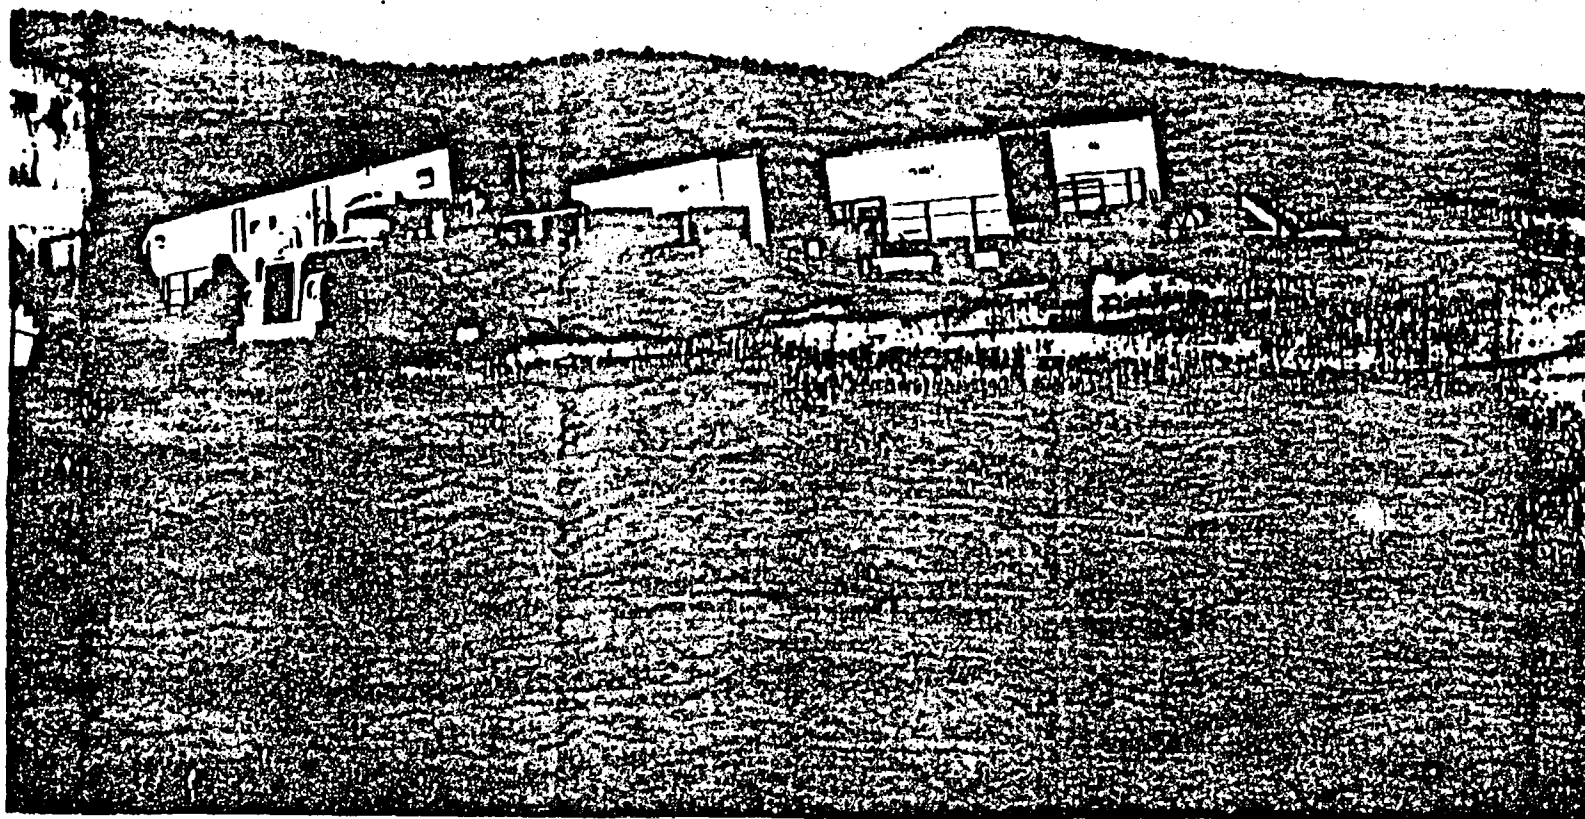
Figure 18 — MILAGRO Trailer Park, Post Collapse Damage,
Surface Cracks, Southeast Ends of Trailers

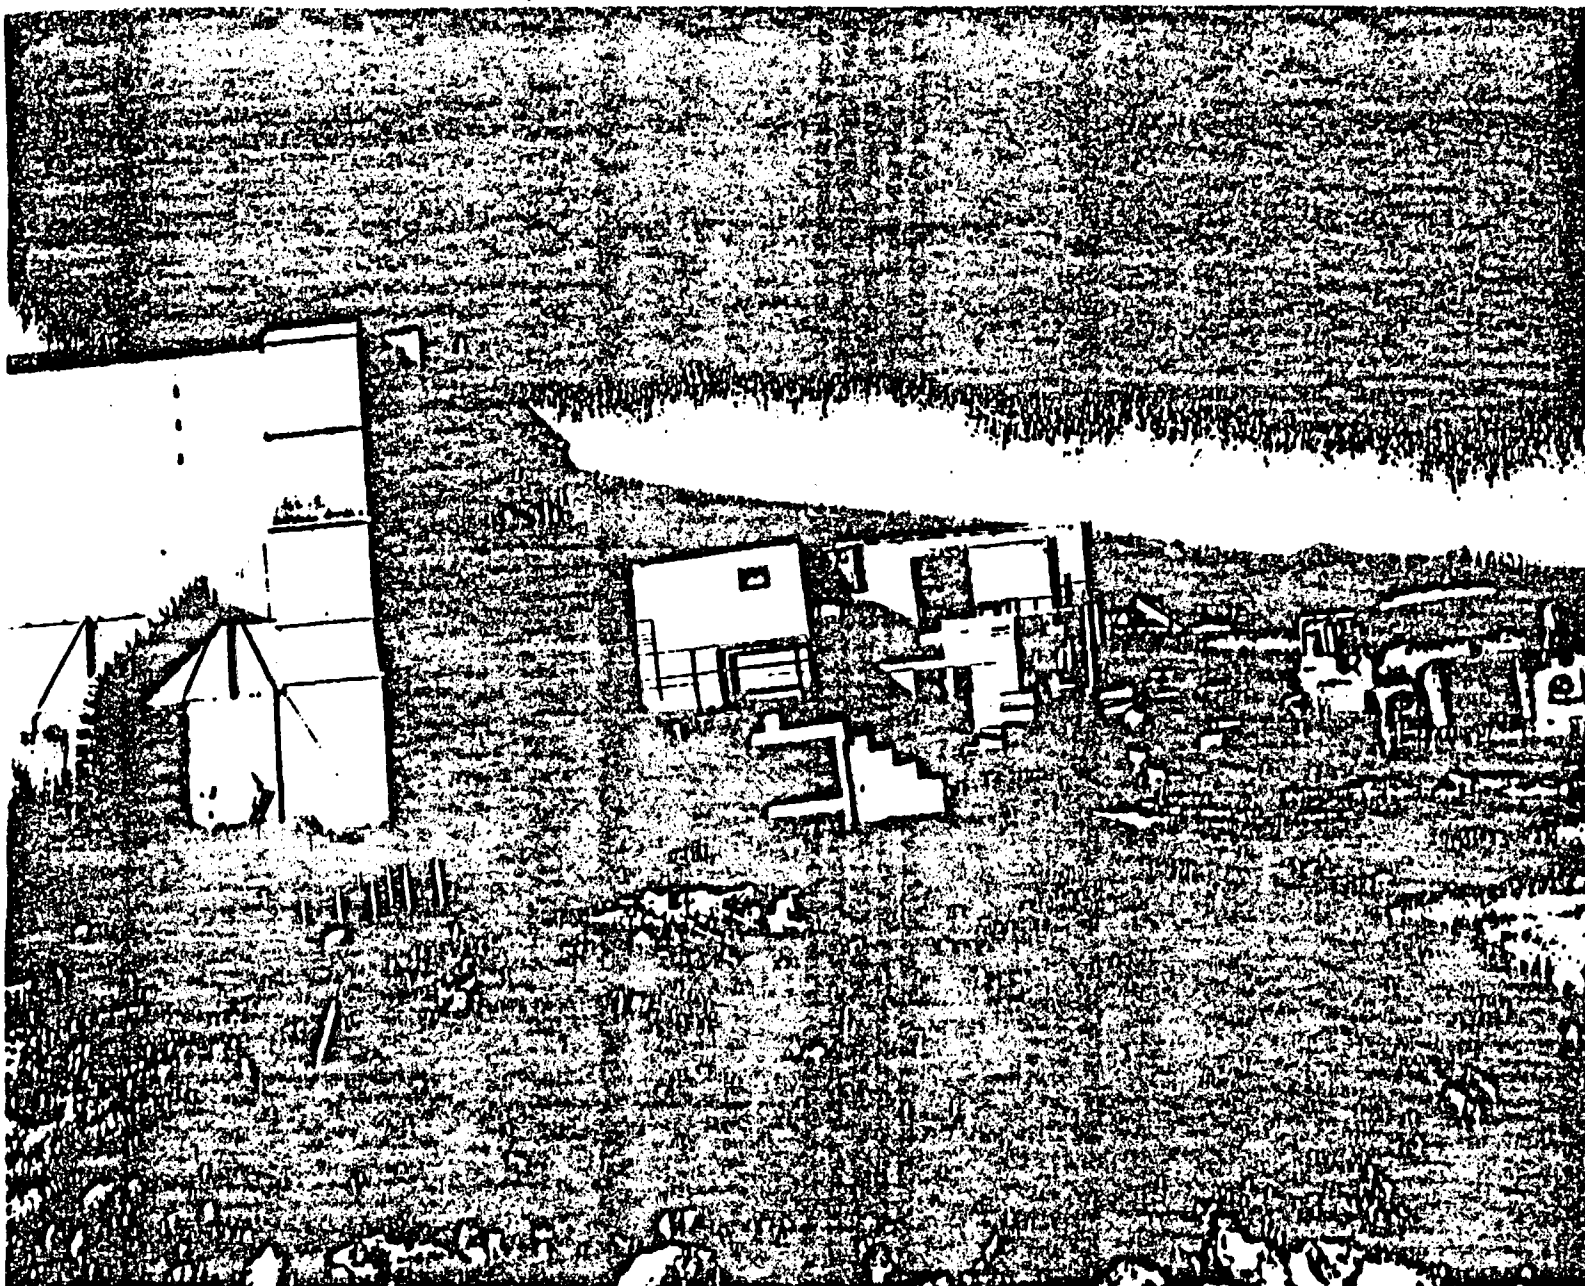
Figure 19 — MILAGRO Trailer Park, Post Collapse Damage,
Southeast Corner of Anchor Station

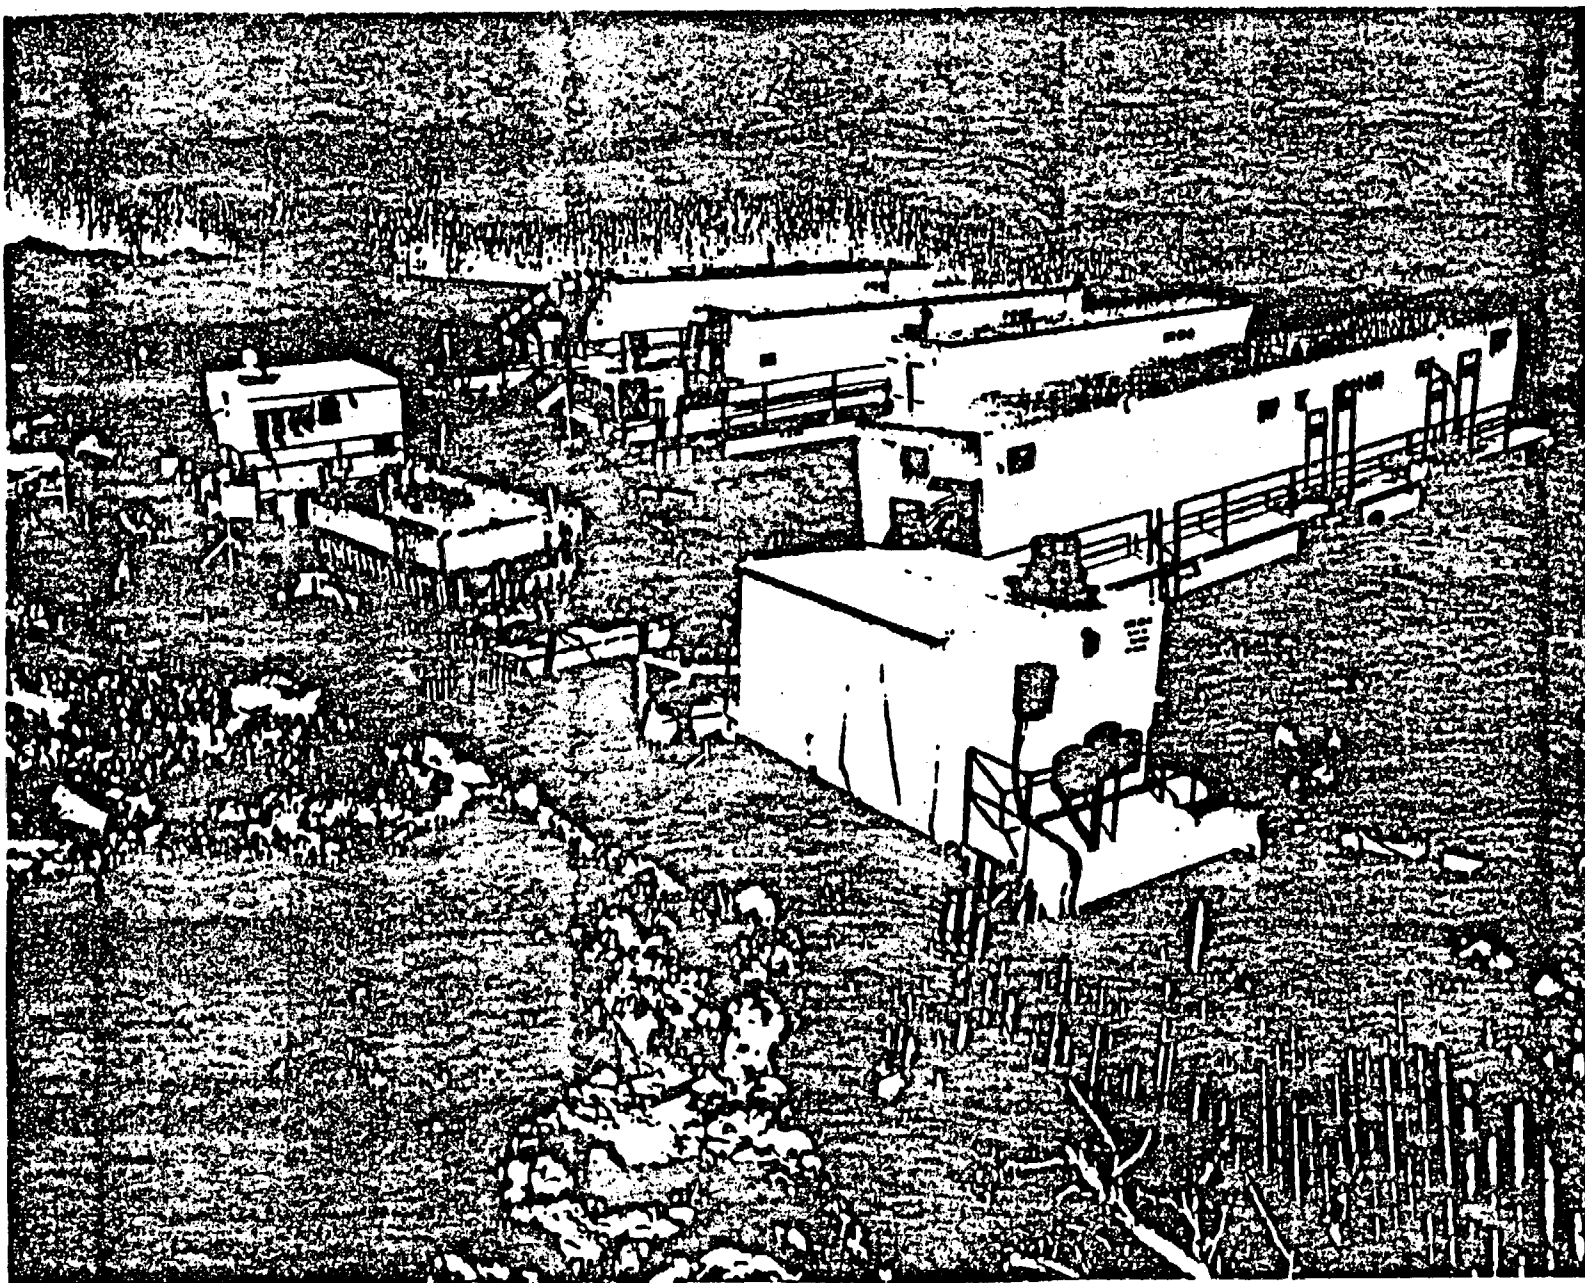
Figure 20 — MILAGRO Trailer Park, Post Collapse Damage,
West Ends of Trailers and Cable Hole Area

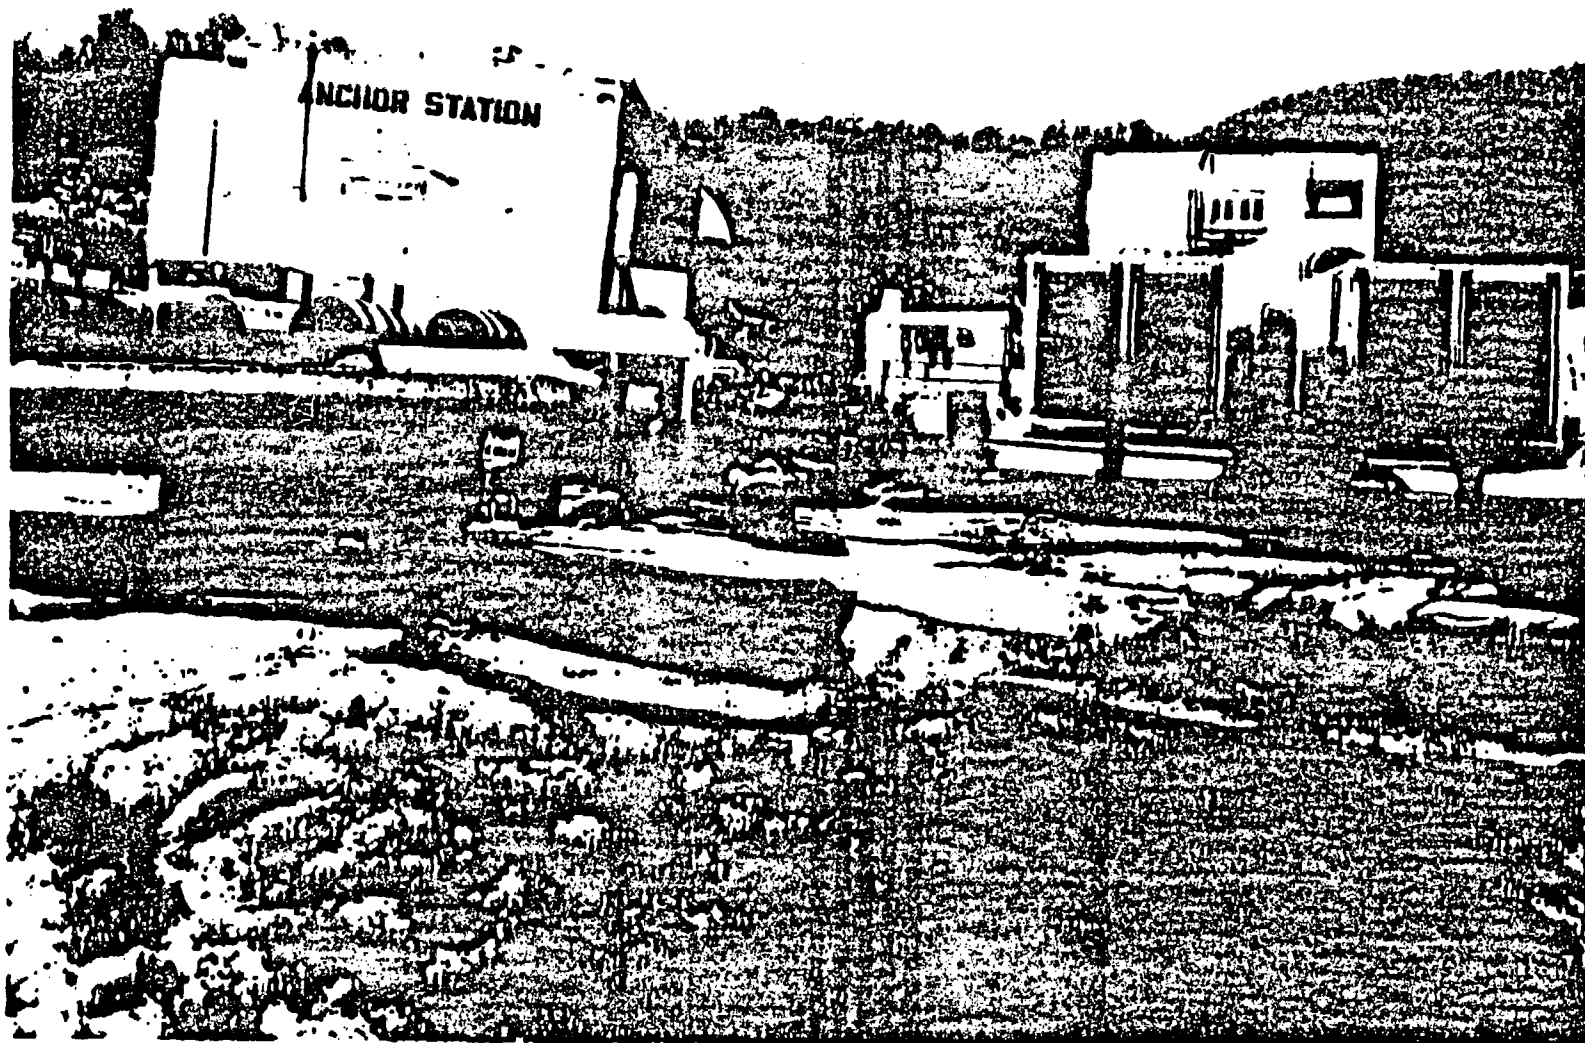
Figure 21 — MILAGRO Trailer Park, Post Collapse Damage,
Cable Hole Area Between Anchor Station and P-14-101

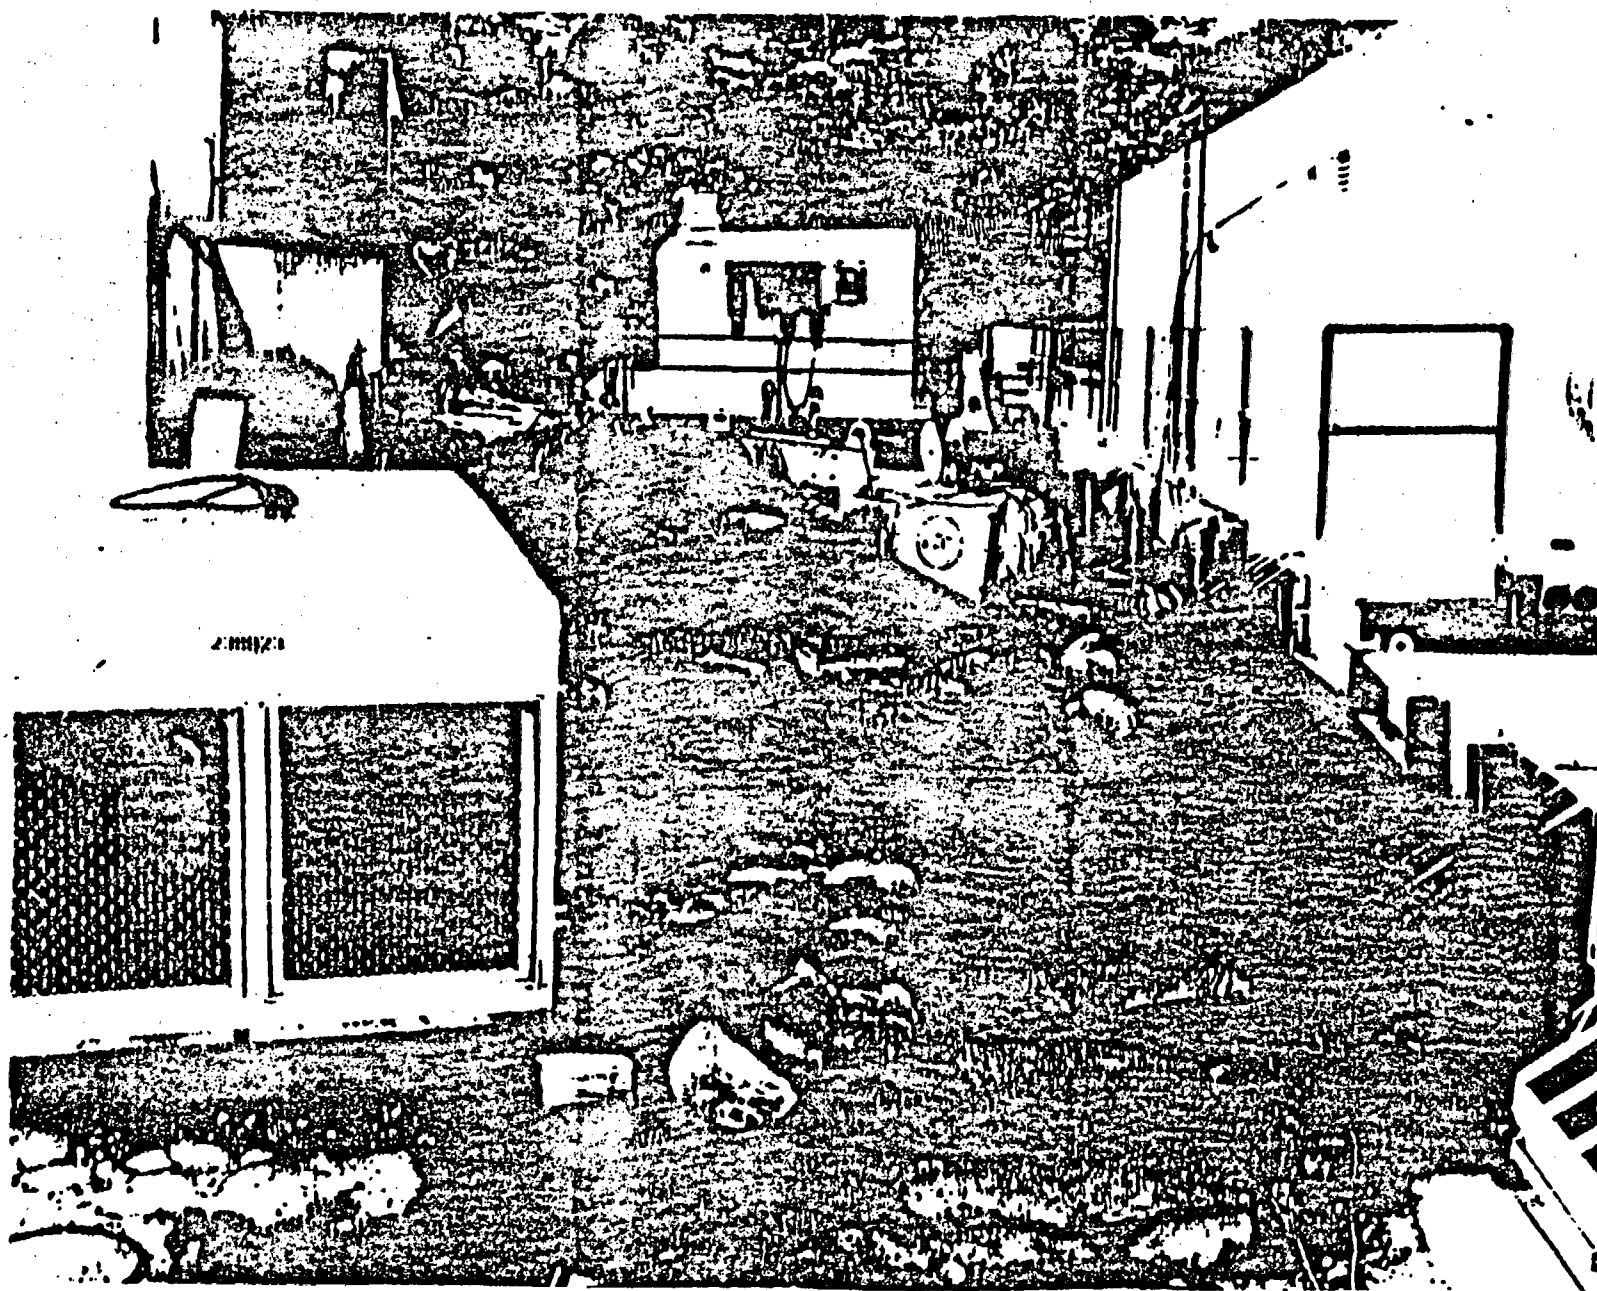
Figure 22 — MILAGRO Trailer Park, Post Collapse Damage,
Cable Hole Area

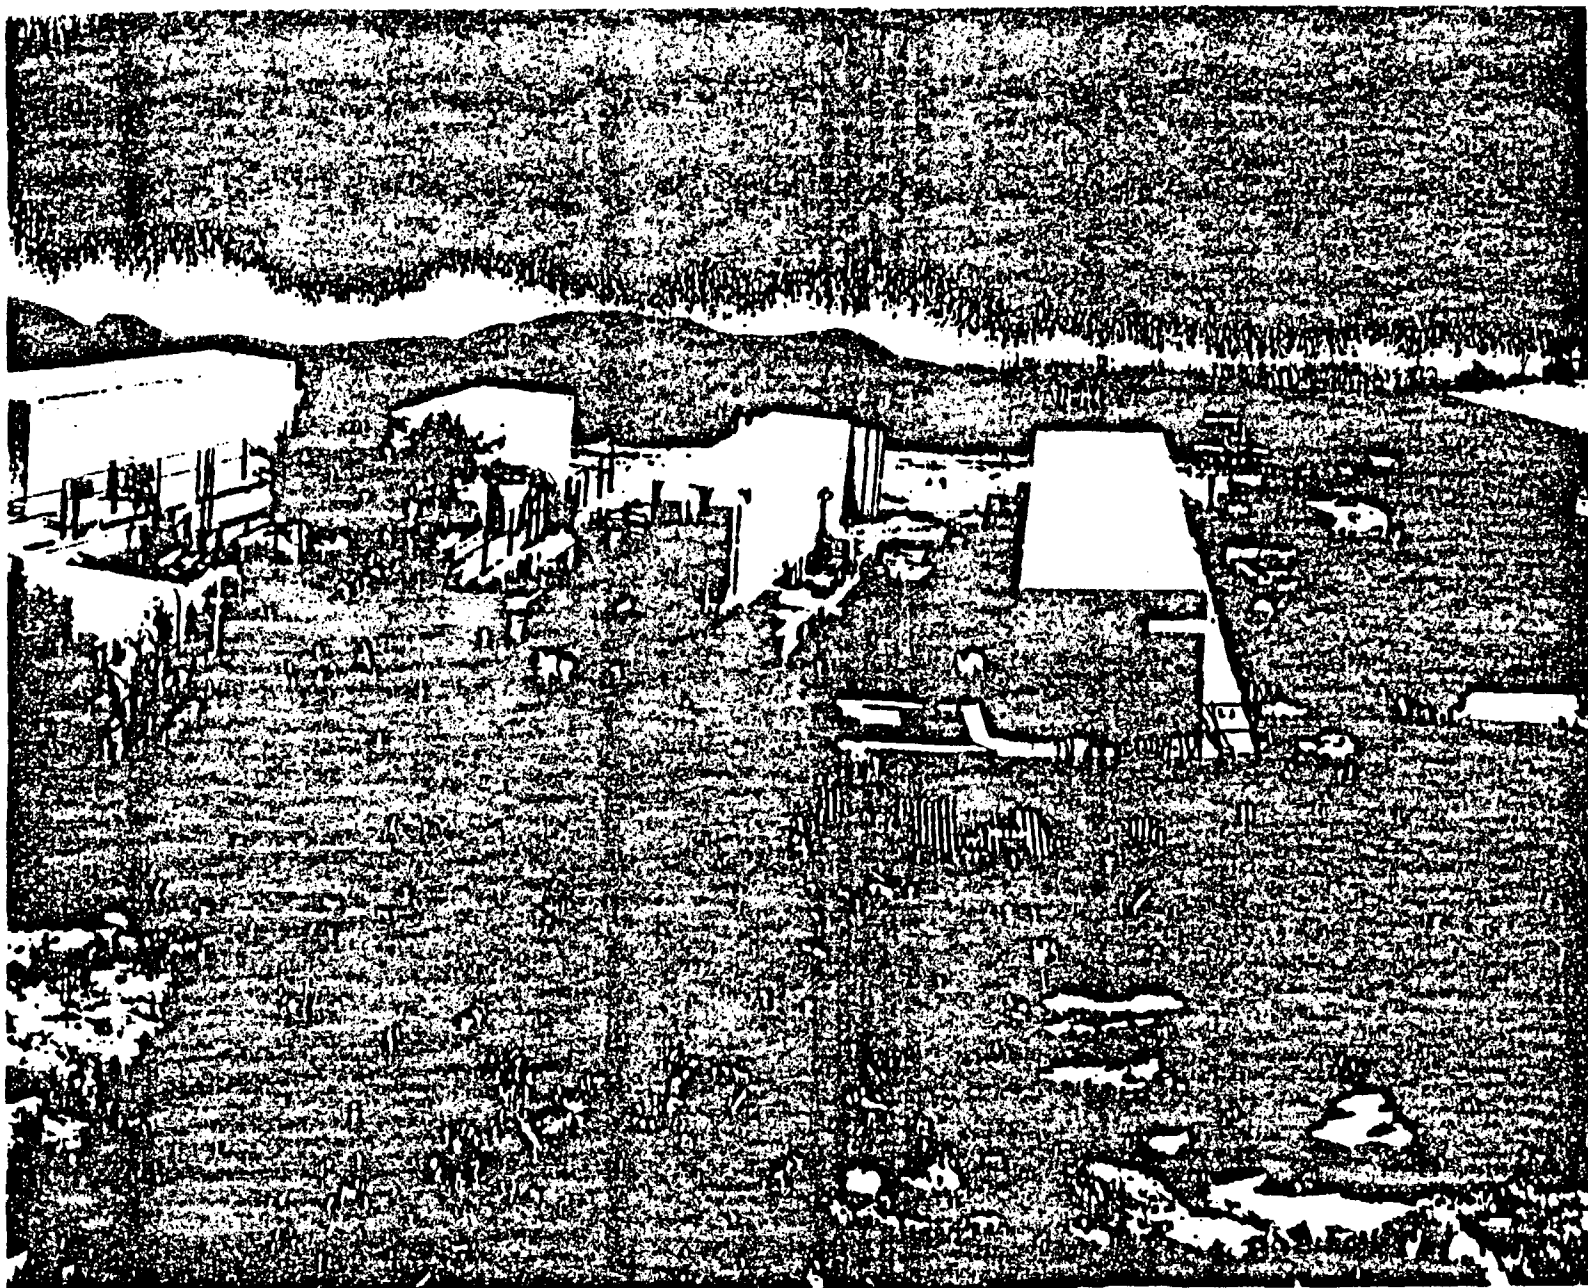
Figure 23 — MILAGRO Trailer Park, Post Collapse Damage,
View from SGZ

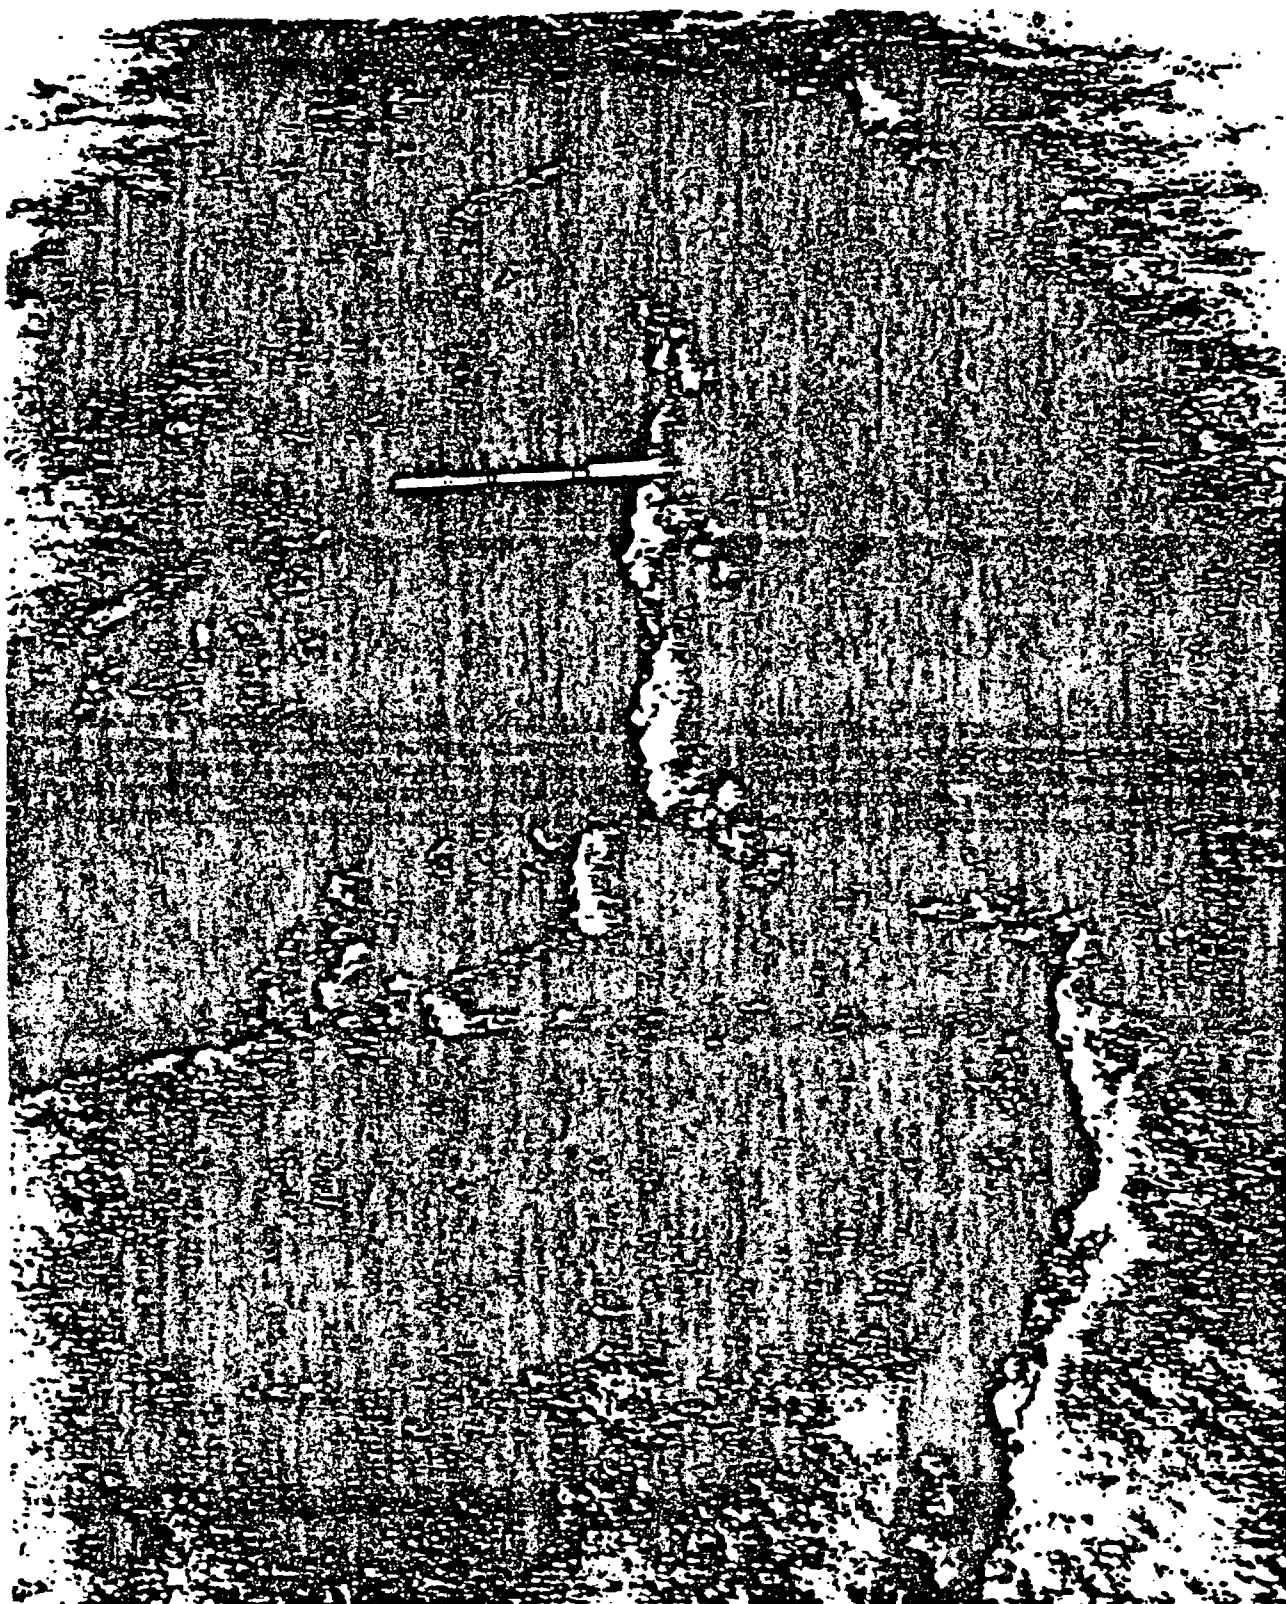
Figure 25 — MILAGRO Trailer Park, Post Collapse Damage,
N-S Trending Crack Near Center

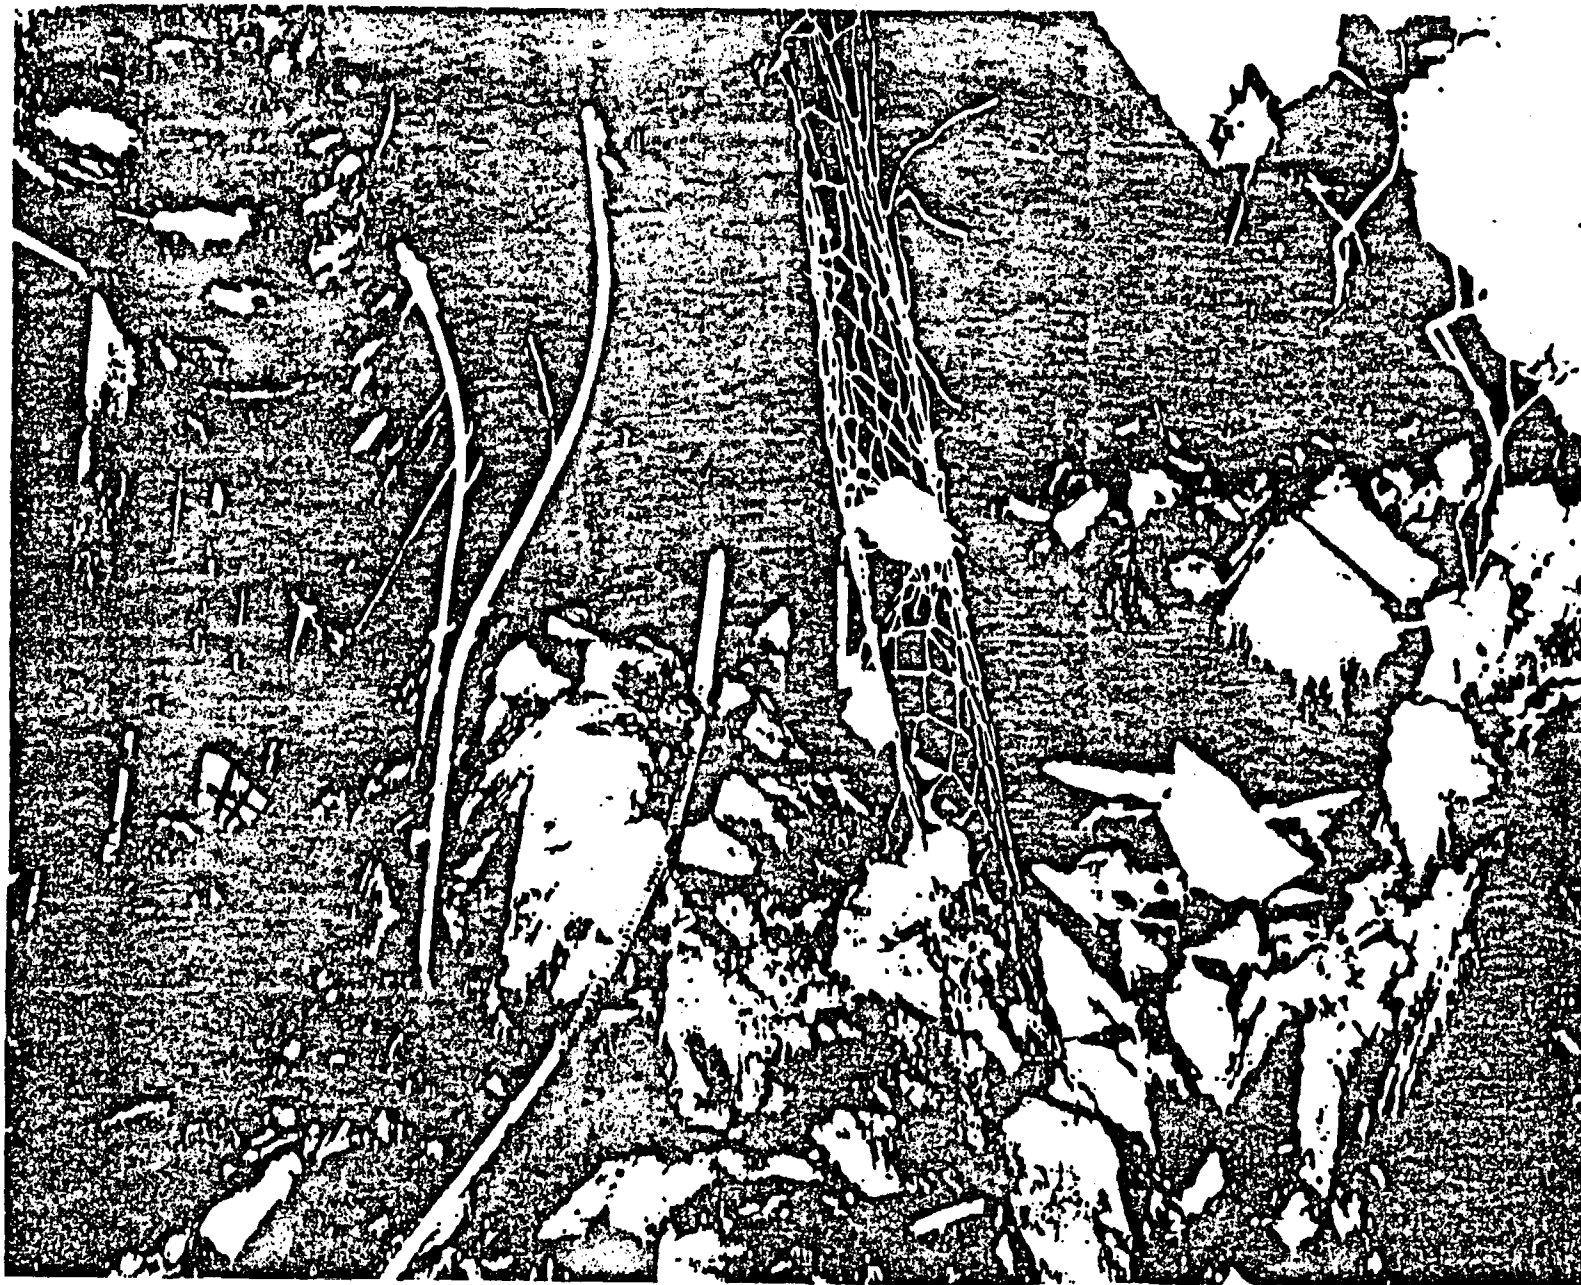
- o Observed damage in the tunnel was much greater than anticipated based on all prior tunnel experience. A comparison was made of MIDAS MYTH underground damage to that experienced on previous events (Figures 33-42). The nearly saturated zeolitized tuff beds in the MIDAS MYTH tunnel have the lowest gas filled porosity (1.2-1.7%) ever measured for an effects test in Rainier Mesa. This could be expected to result in greater coupling of energy into ground motion (Exhibit 5). These observations are not inconsistent with formation of a somewhat larger cavity than normally expected. A larger cavity would tend to result in higher chimney growth.

Figure 33 — MIDAS MYTH Underground Tunnel Damage,
U121.04 Bypass Drift
