**U.S. DEPARTMENT OF ENERGY
NEVADA OPERATIONS OFFICE**

**REPORT OF THE INVESTIGATION
OF THE ACCIDENT AT THE
MIDAS MYTH/MILAGRO TRAILER PARK
ON RAINIER MESA AT NEVADA TEST SITE
ON FEB. 15, 1984**

**DATE OF INVESTIGATION REPORT
APRIL 9, 1984**

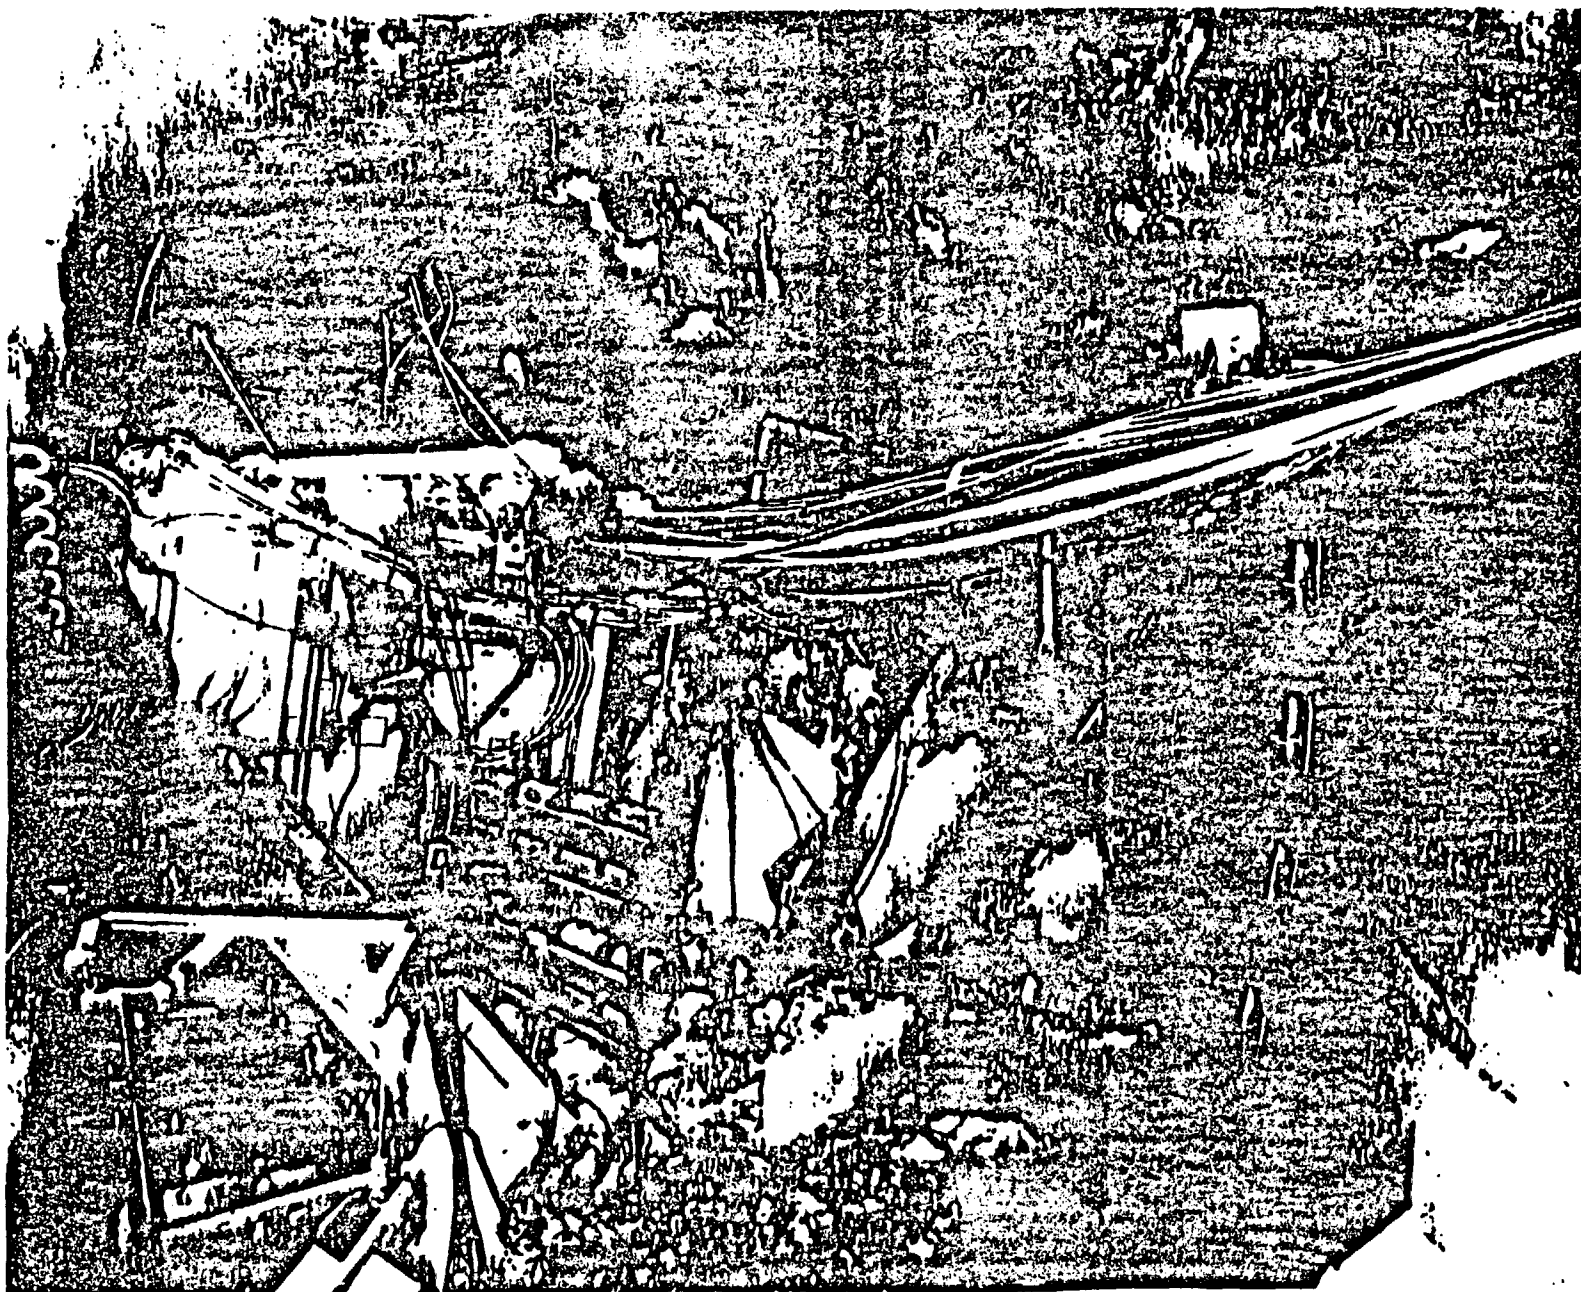
Figure 34 — MIDAS MYTH Underground Damage,
U121.05 Drift and Alcove

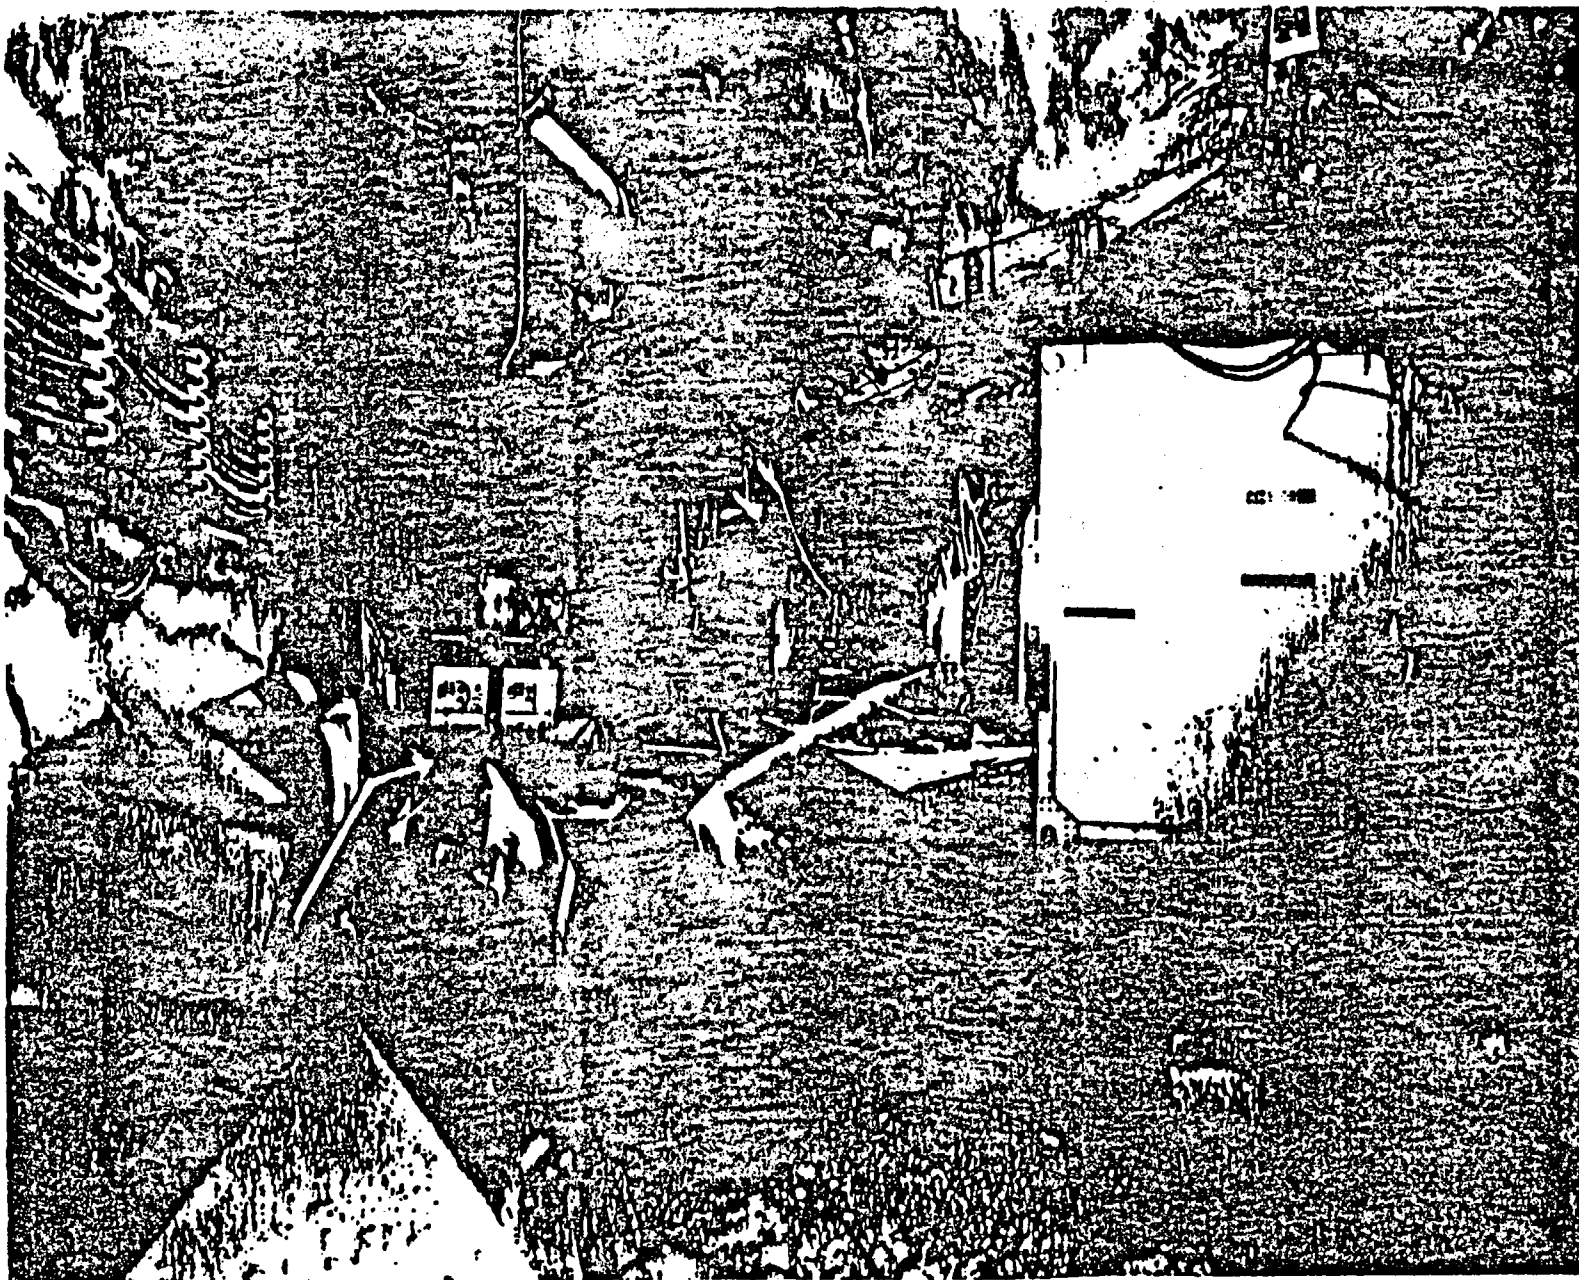
Figure 35 — MIDAS MYTH Underground Damage,
U121.04 Main Alcove Entrance

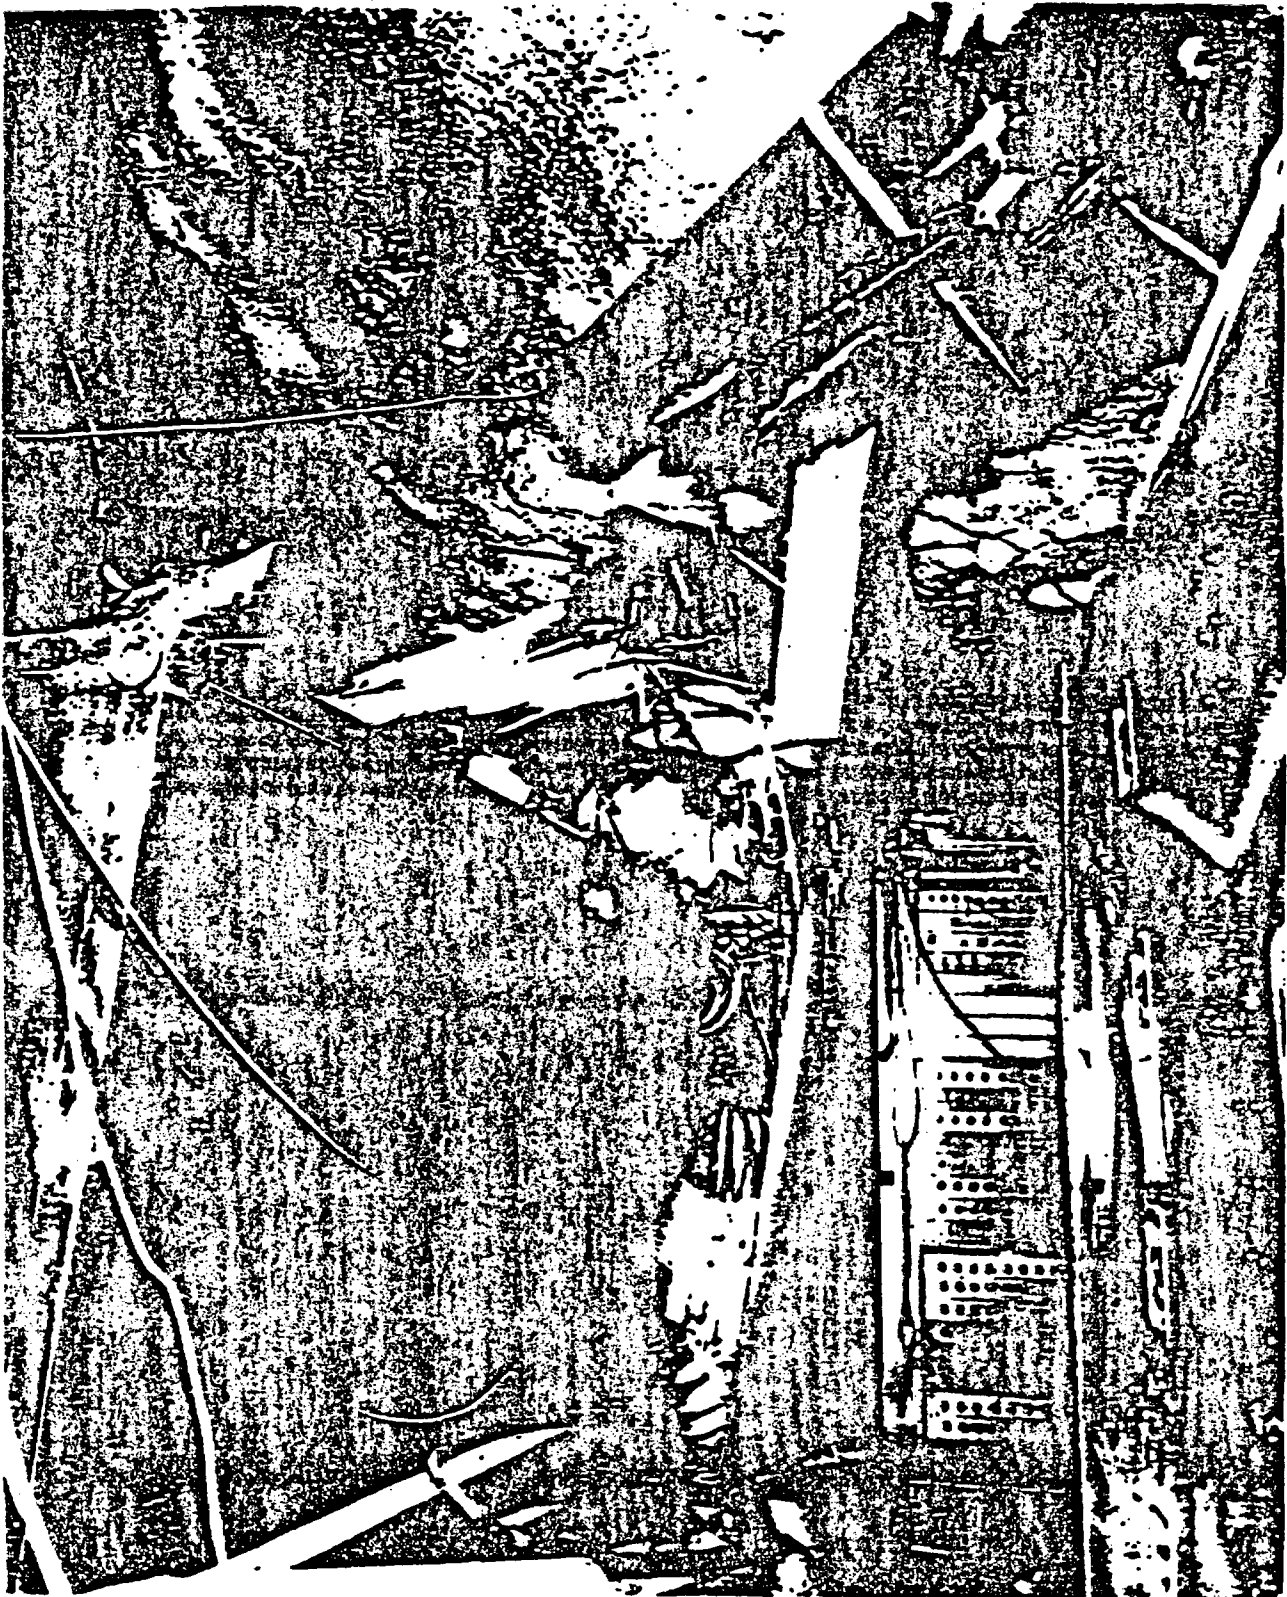
Figure 36 — MIDAS MYTH Underground Damage,
Portal End of Main Alcove

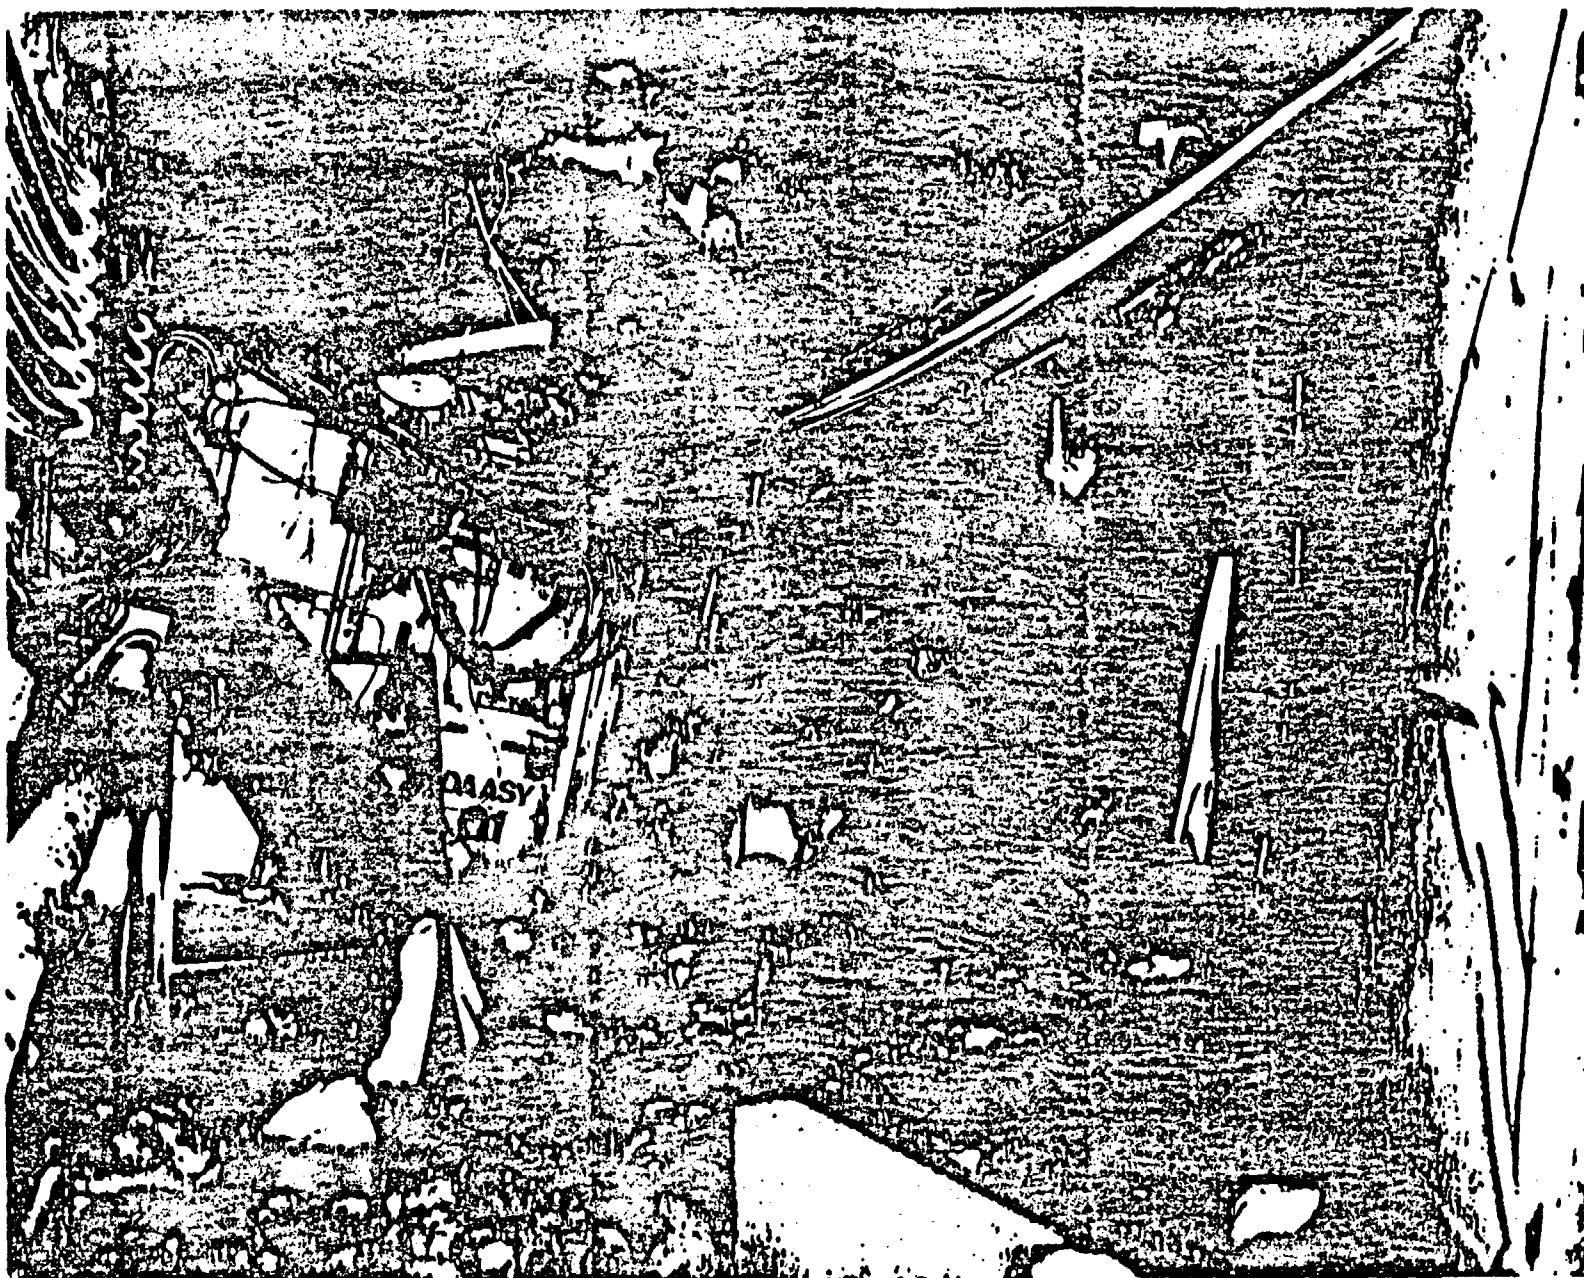
Figure 37 — MIDAS MYTH Underground Damage,
Pillar between 05 Drift and Main Alcove

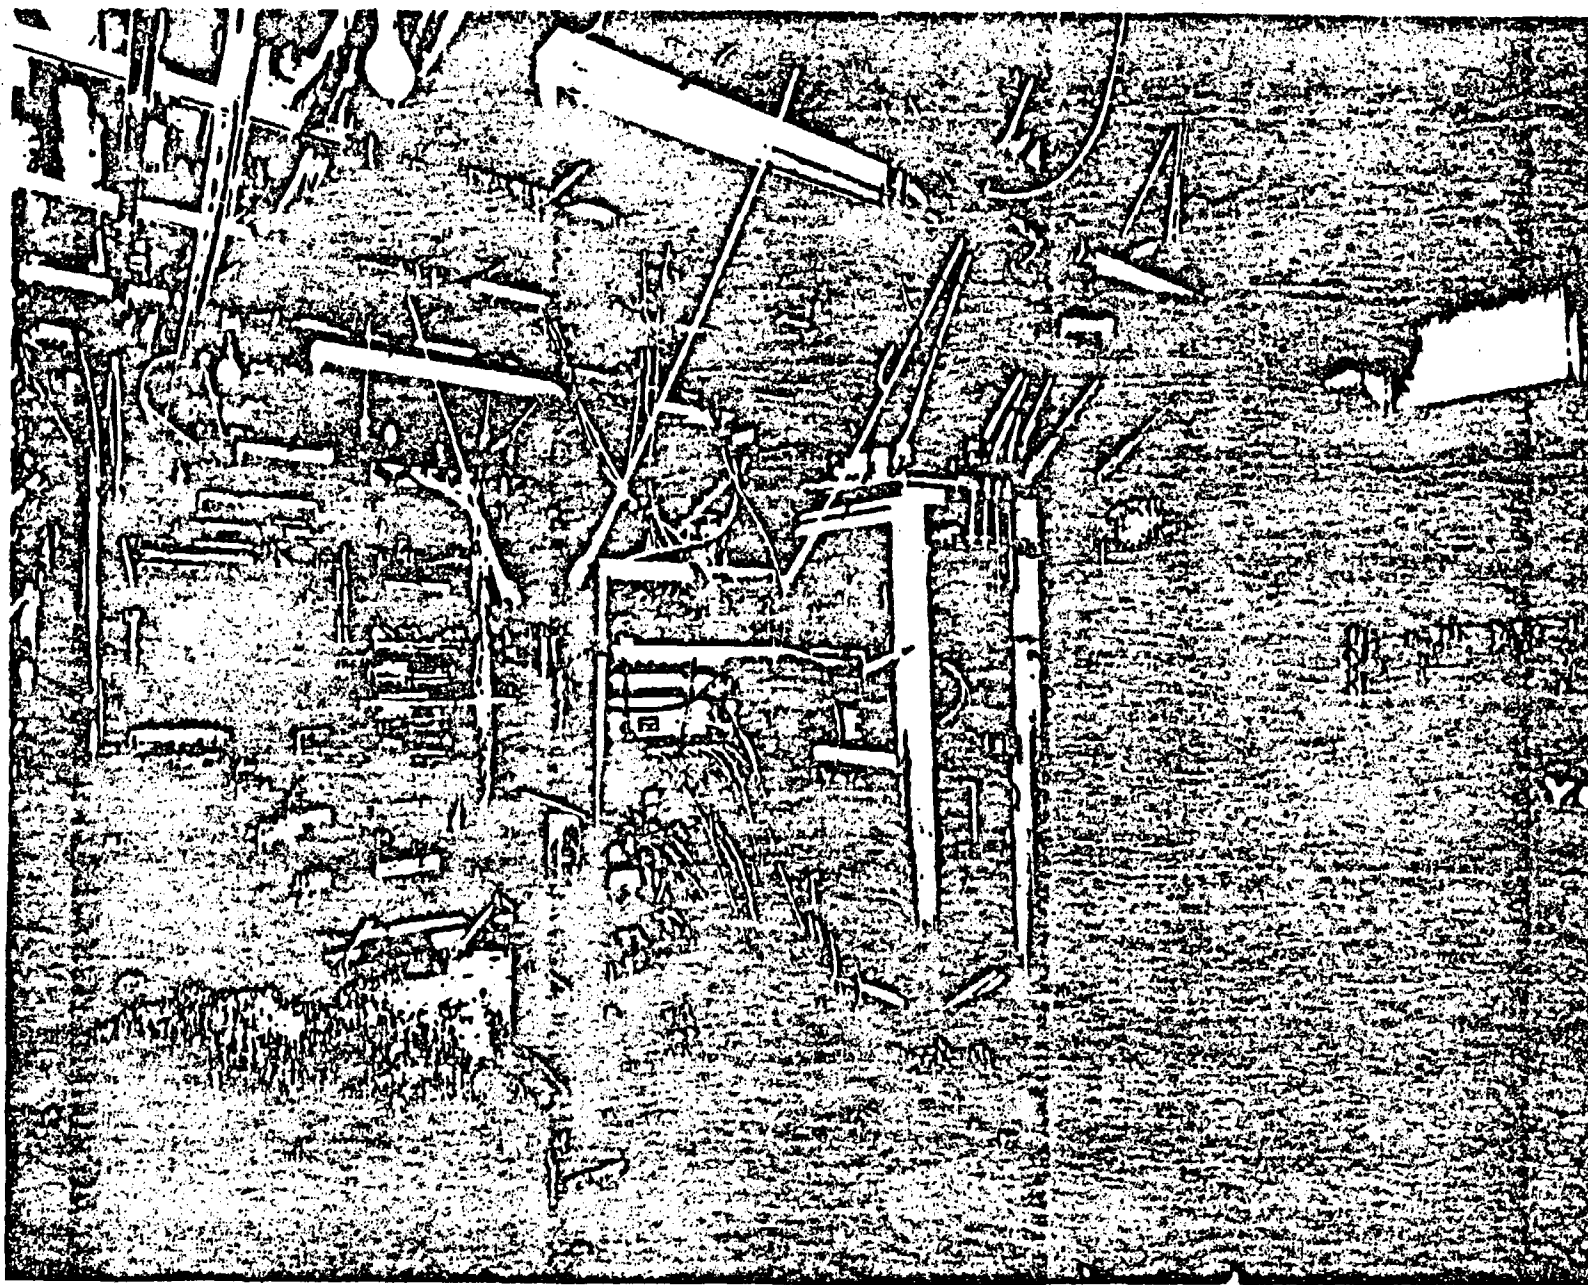
Figure 41 — Previous Tunnel Event Postshot Damage,
MINERS IRON Instrumentation Alcove

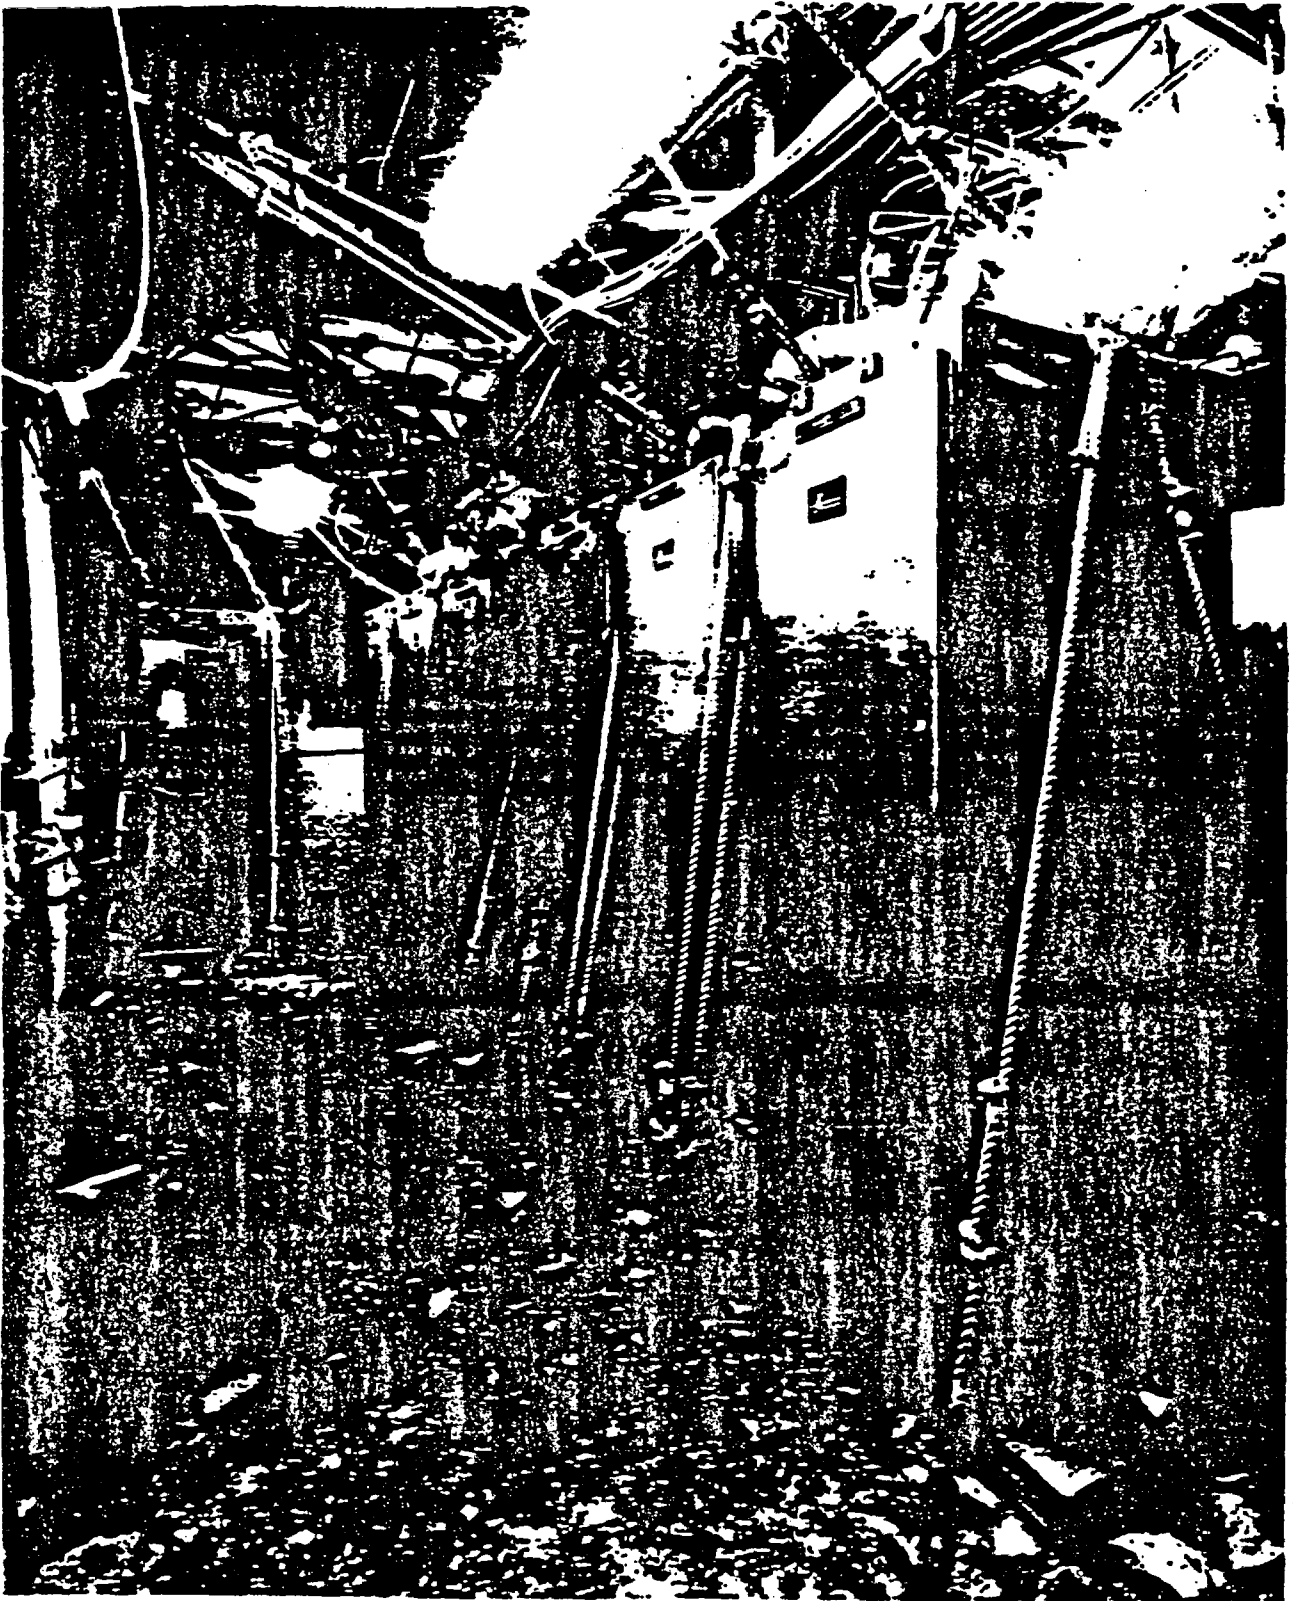
Figure 42 — Previous Tunnel Event Postshot Damage,
HURON LANDING Instrumentation Alcove

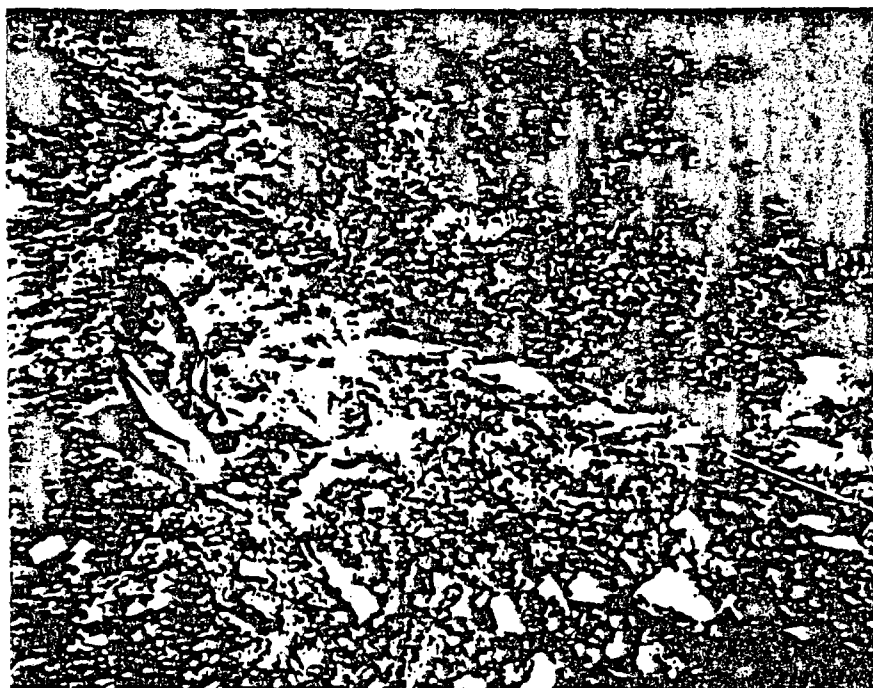
PHOTO F. Disturbed ground 122m east of SGZ. View looking east.

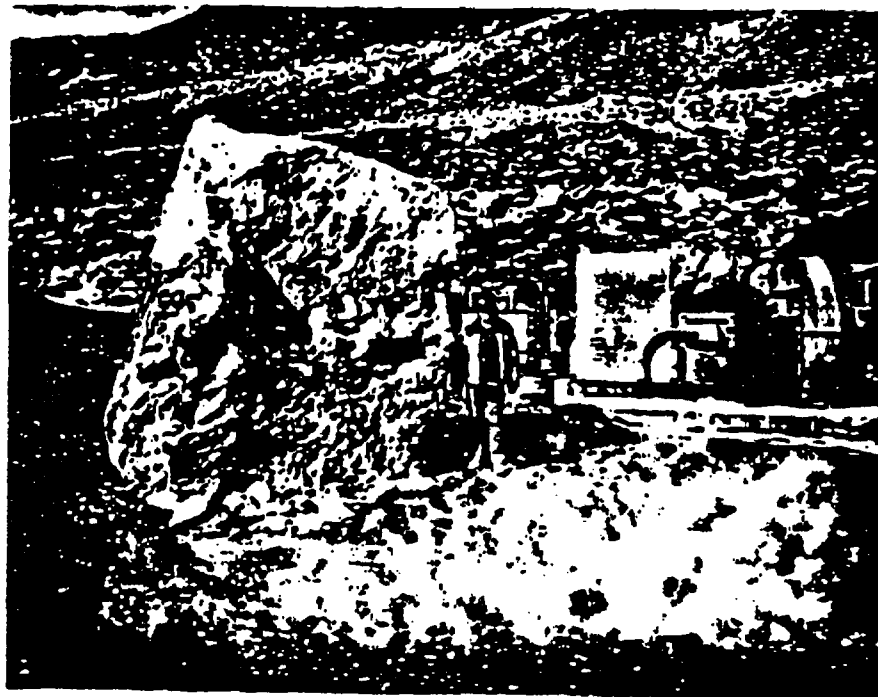
PHOTO B.—Large boulder of welded tuff on ventilation pad approximately 25m above the "T" tunnel portal.

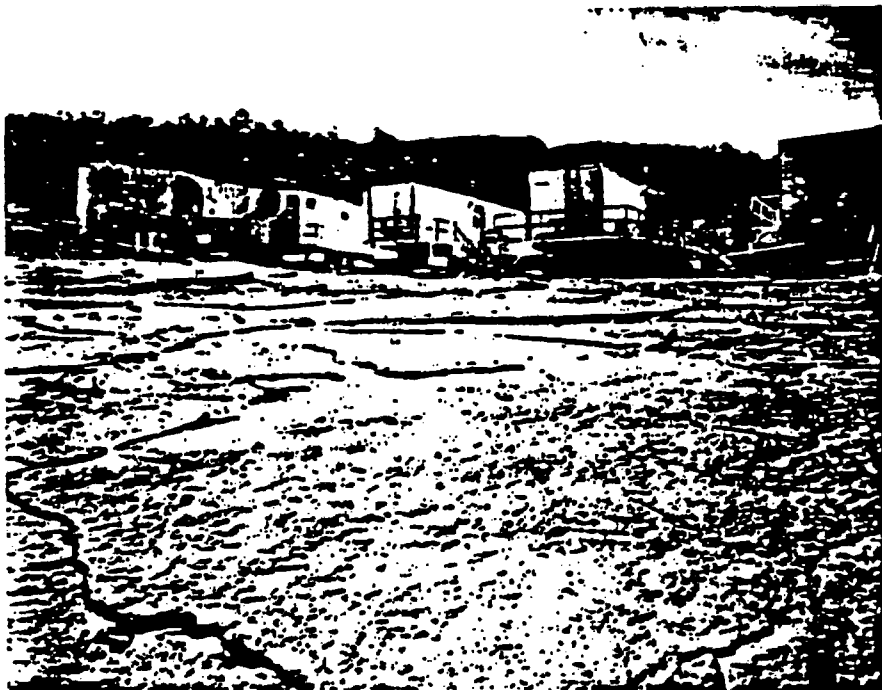
Some of the non-concentric fractures have a west-northwest trend which parallels the trends of other fractures formed off the pad. Figure 5, Photo F shows a typical view of non-subsidence-related

PHOTO F.— Non-subsidence-related cracks on the *MILAGRO* pad. View looking west.
