Quad Cities Unit 2 (QC2) Dryer Update

April 10, 2006

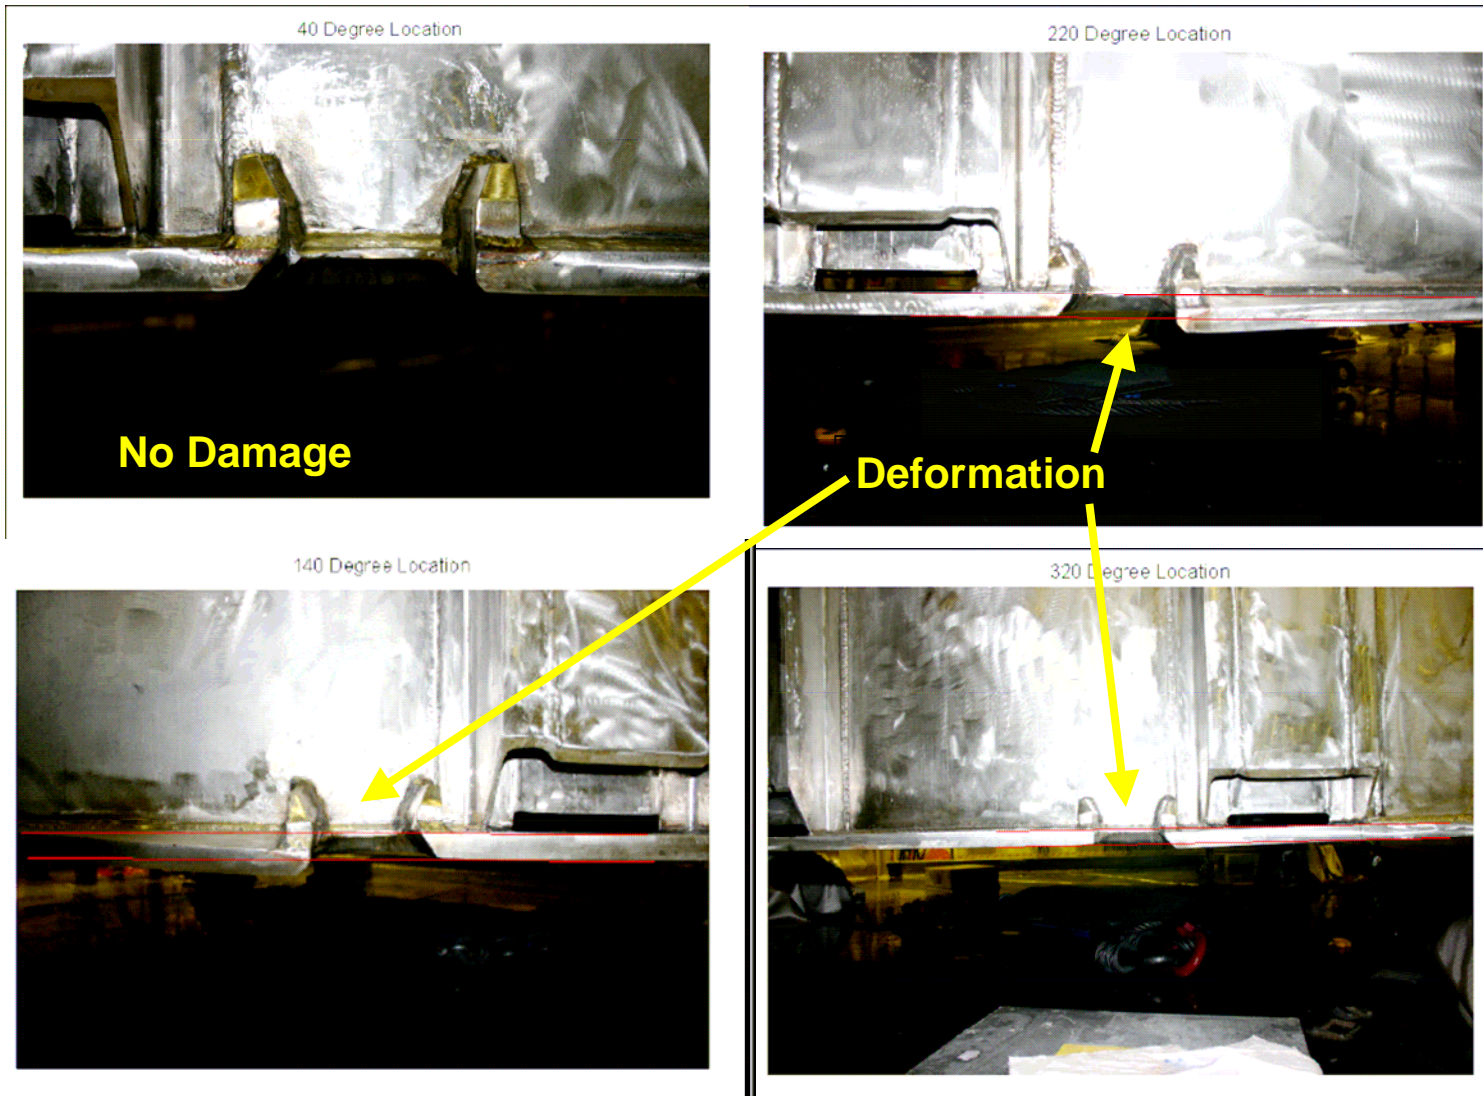
Original Deformation

- During the removal of the dryer to correct the interference the dryer impacted the dryer support lugs that are attached to the inside of the reactor vessel at the 140°, 220°, and 320° locations

- Cause: lack of clearance between the skirt base ring/reactor vessel support lugs and excessive clearance between dryer guide rods/dryer
- Indications of deformation at 140°, 220°, and 320° locations were observed at this time

- Subsequent inspections during the current refueling outage revealed additional indications at these locations
 - Deformation of the skirt base ring on the ID at 140° and 220° locations

- Skirt panels dimpled at 140° and 220°
 - Neither of these conditions were observed at the 320° location

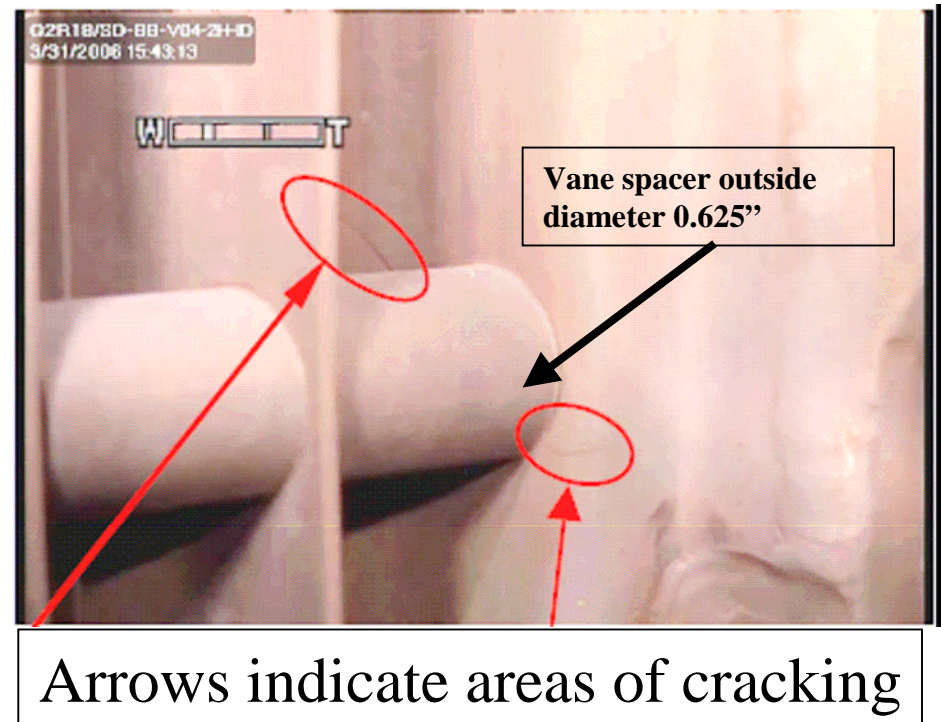
Dryer Vane Bank Assembly

- INRs 06-06, 06-08, and 06-10 document minor indications in the vane bank assemblies for dryer banks F, D, and B, respectively

- Small cracks in the end vane in various vane assemblies (INRs 06-06, 06-08, and 06-10)
 - Characterized as fatigue cracking
 - Located in the end vane in their respective vane assembly which is wrapped around and welded to the end plate (non-structural)
 - Indications appear to have initiated from the hole in vane that accepts 5/8" tie rod protector
 - Dispositioned as no repair required - will be inspected during the next refueling outage
 - Missing material cannot be confirmed to be lost in the vessel – conservatively captured by lost parts program
- Applicability to QC1
 - Not a concern due to the small size of the cracks and lack of a driving force at that location
 - Cracks expected to be self relieving
 - Will be inspected during the upcoming planned outage

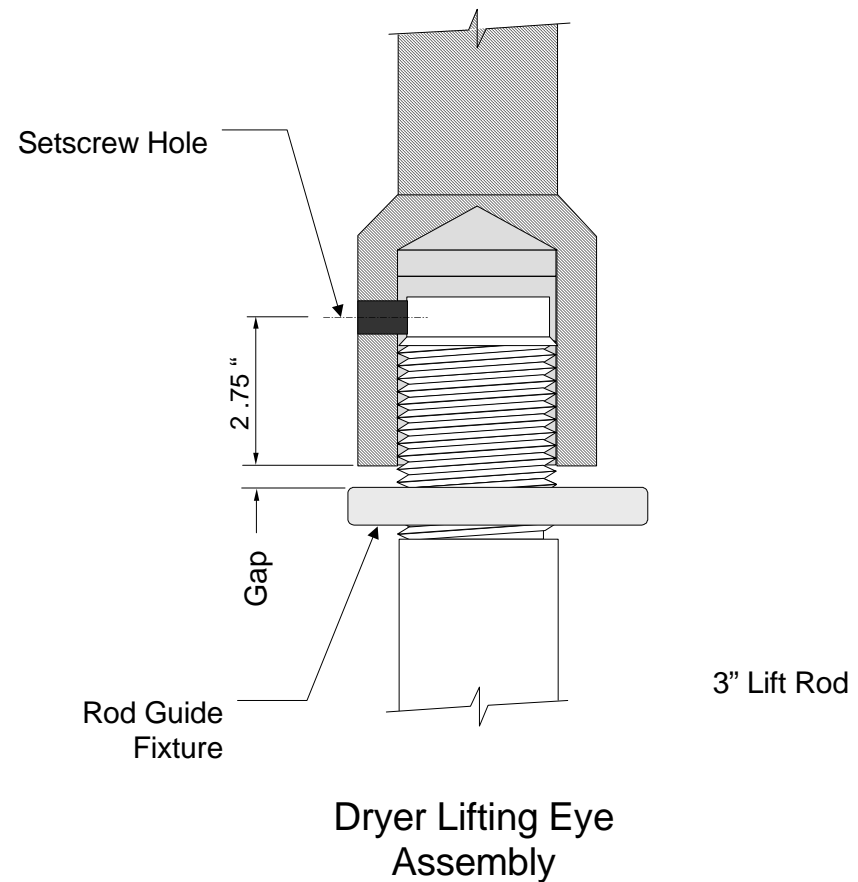
Dryer Lifting Eye Assembly

- INR 06-01 documented lifting eye rotation and lifting rod thread damage

- Rotation of the lifting eyes and damage to the lifting rod threads (INR 06-01)
 - Four lifting eyes were found rotated out of alignment
 - Damage to the threads in the lifting rod at the 45° location

- Cause – installation issues with the setscrew in addition to an inadequate setscrew design that allowed the eyes to rotate with setscrew in place and tack weld intact

- Corrective action – unthreaded stock at the top of the lifting rod is being ground flat and a longer set screw is being added to ensure positive engagement

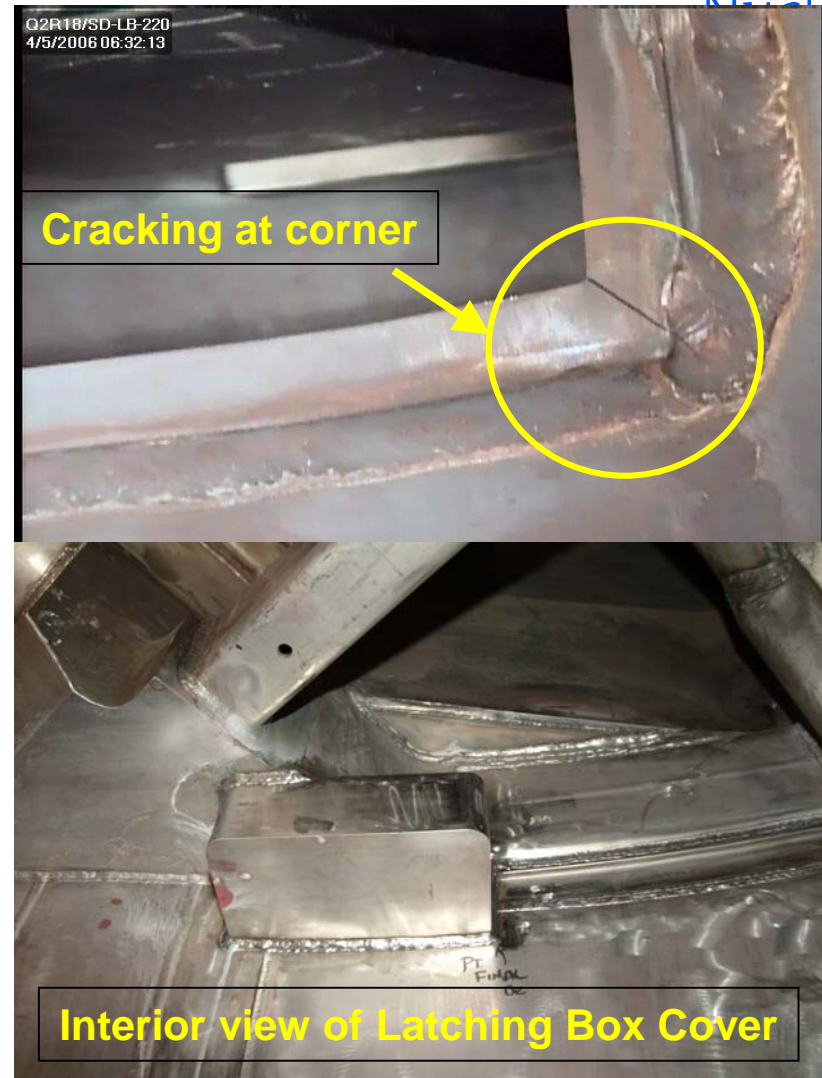
Latch Box

- INR 06-29 identified crack in latch box

- Crack in the latch box at 220° location (INR 06-29)
 - Function of the latch box is to limit bypass flow from the inside of the dryer skirt to the downcomer region
 - Non-structural component
 - Located on the same azimuth that was stressed during the impact event
 - Characterized as fatigue cracking
 - Other three latch boxes and welds were inspected with no issues identified
 - Repair consists of excavating cracked area and re-welding
- Applicability to QC1
 - QC1 dryer did not experience an impact event
 - Non-structural
 - Will be inspected during the upcoming planned outage

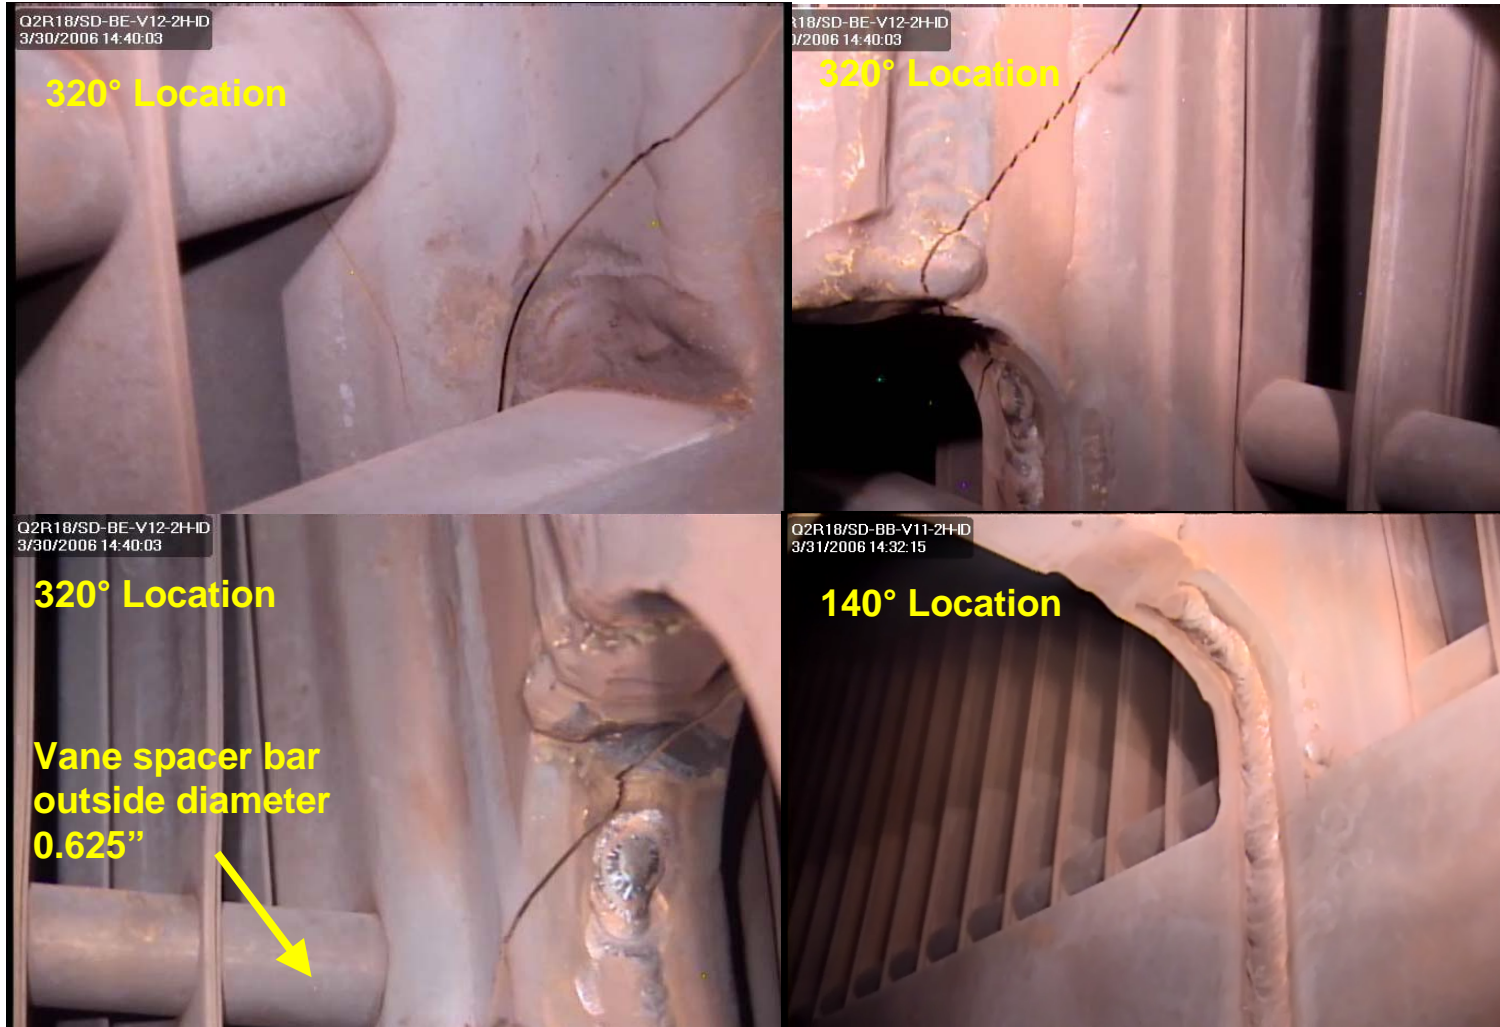
INR 06-04

- Crack in the vane assembly end plate near the 320° location (INR 06-04)
 - Located on same azimuth of the dryer that experienced skirt base ring damaged during the impact event
 - Crack is in the bottom 2 inches of a ~6 foot weld
 - Characterized as fatigue cracking with a combination of bending and torsional loading
 - Inspection identified an abrupt change in weld thickness at the crack location
 - Similar locations inspected with no cracks identified nor were any other cases of abrupt changes in weld thickness identified
 - Not a loose parts concern due to attachment to other dryer members
 - Dispositioned as no repair required - re-inspect during the next refueling outage
- Applicability to QC1
 - QC1 dryer did not experience an impact event
 - Isolated to this one location in QC2
 - Not a lost parts concern
 - Will be inspected during the upcoming planned outage

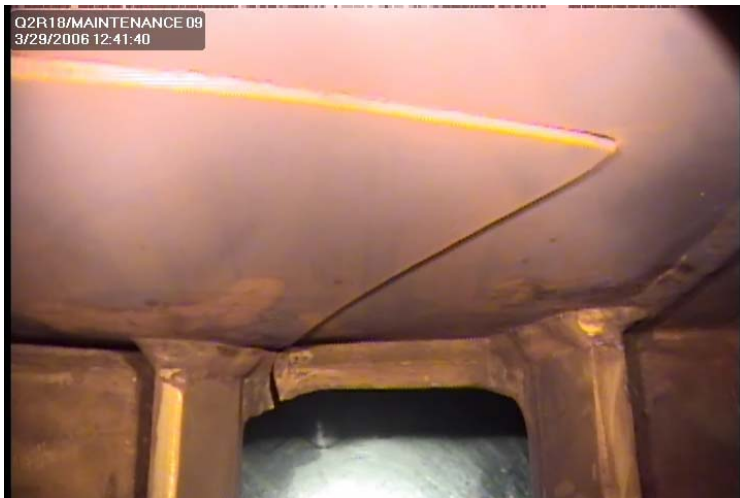
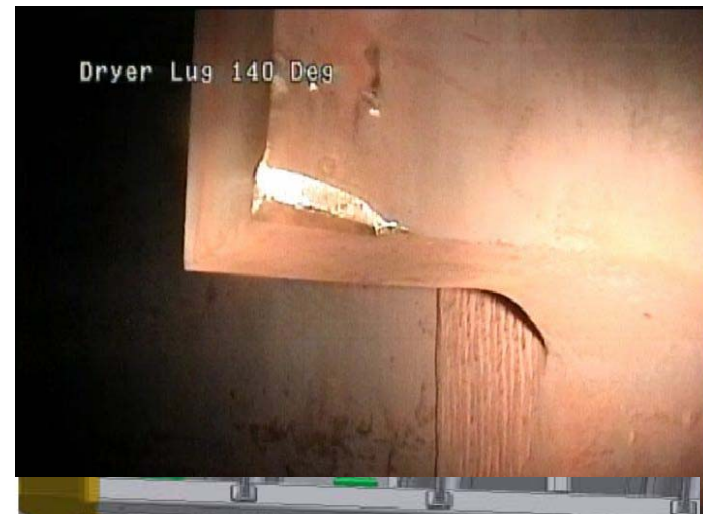
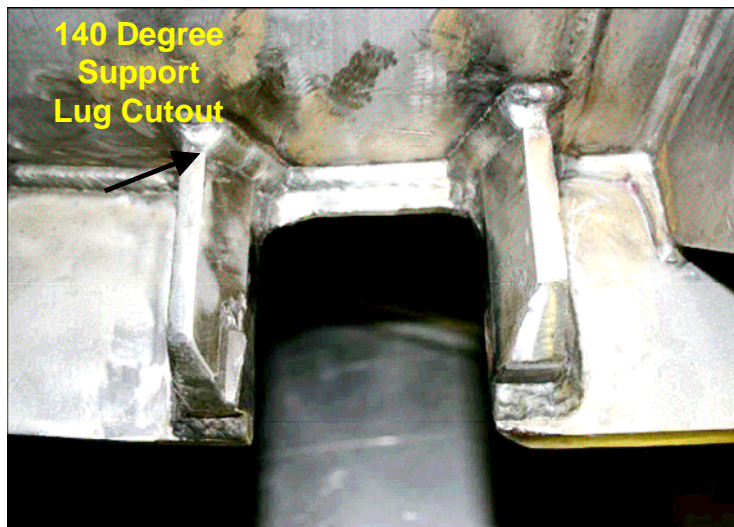
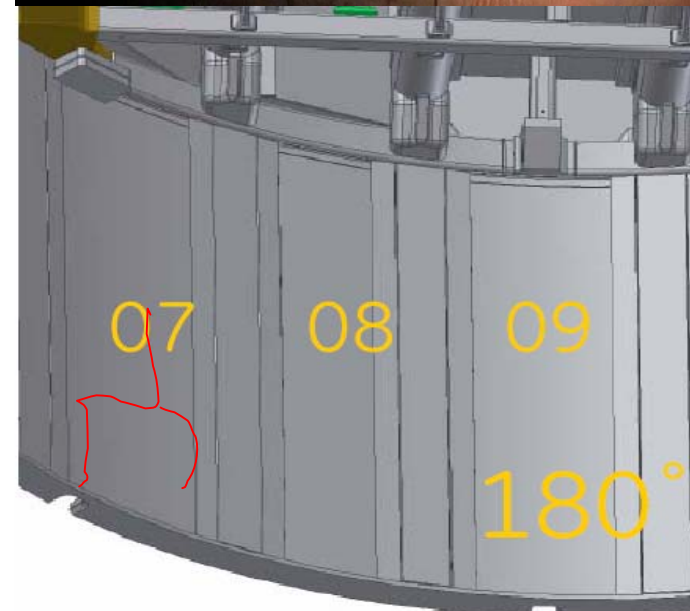
INR 06-02

- Crack in the dryer skirt and base ring at the 140° location (INR 06-02)
 - Approximate 6 foot crack extends from a cutout in the base ring into the adjacent skirt
 - Crack affected area was below the normal reactor water level
 - Boat samples taken in four locations for analysis
 - Preliminary cause indicates impact event key contributor
- Applicability to QC1
 - QC1 dryer did not experience an impact event
 - Ovality issues were addressed prior to manufacturing
 - Lost parts analysis concluded that if a lost part were generated would not compromise a safety function

- 140° and 220° locations
 - Removed a portion of skirt base ring and skirt panel and replaced with plates of the original dimensions
 - Cutout size: ~26" by ~40" for the 140° skirt section
 - Similar repair was made at the 220° location; however, height is only 12 inches, which removes all deformation that was measured in the dryer skirt
 - Restores dryer to as close to original design configuration as possible
- 320° location
 - Major portion of the deformed base plate was already being removed at the 320° location as part of the original modification to address the cause of the impact event
- Removing skirt ring gussets at all four locations
- These changes to the dryer have been independently reviewed by a third party

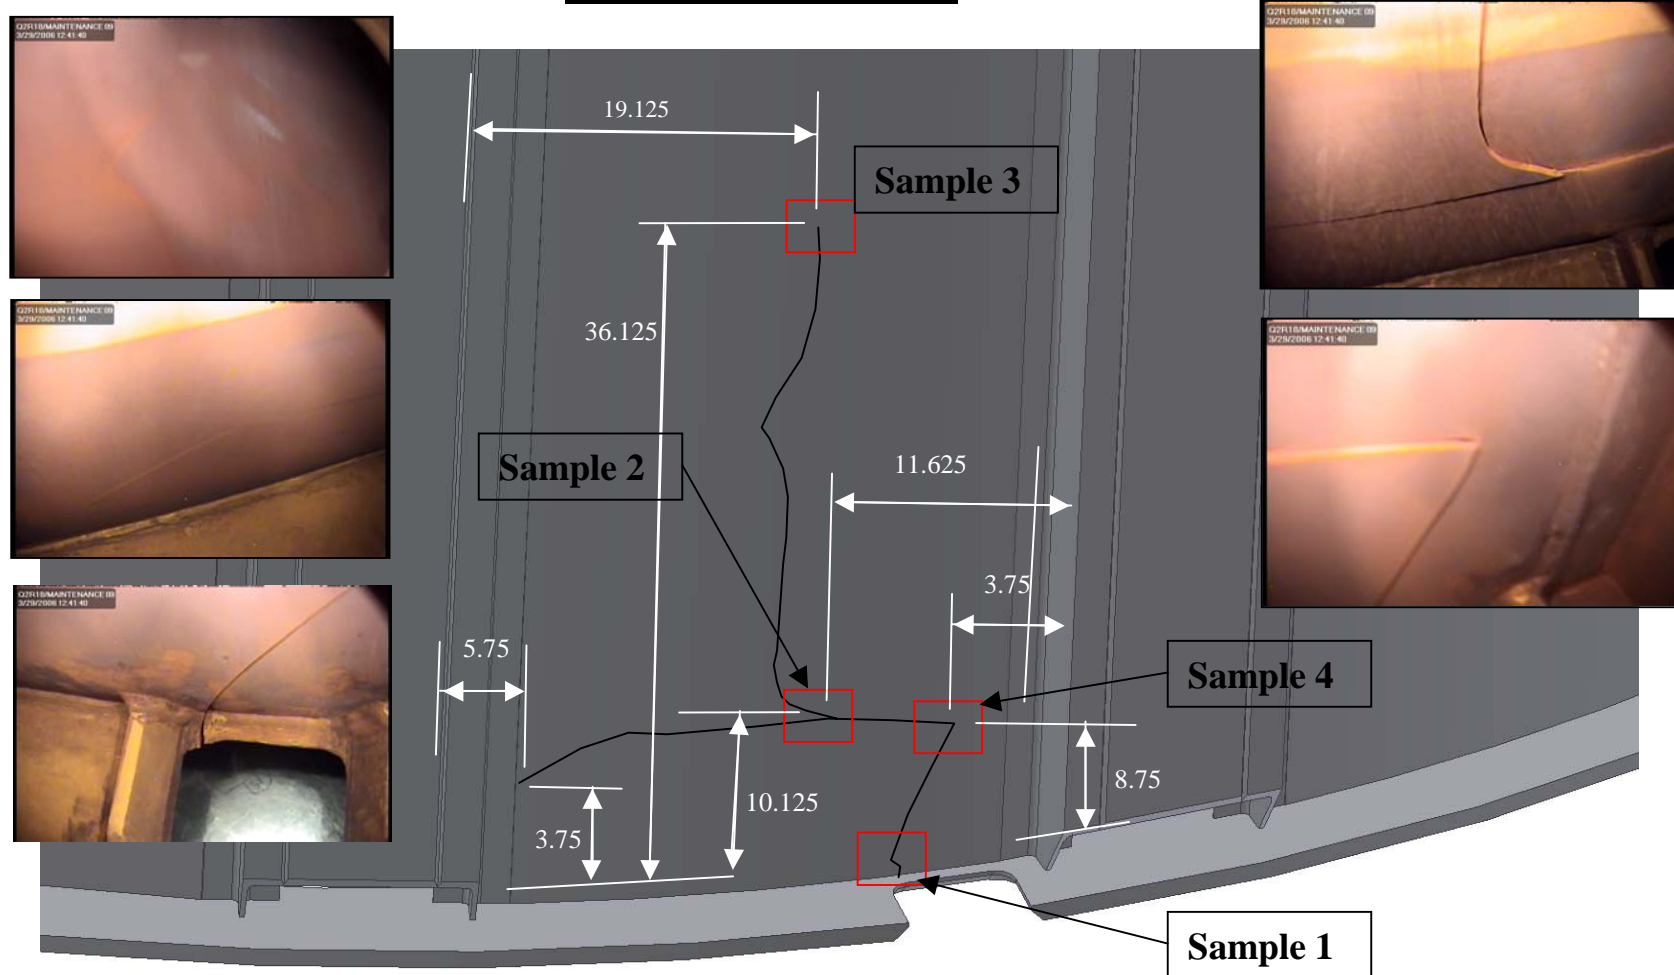
140° Location

- Sample analysis results
 - Scanning Electron Microscope (SEM) results show surfaces are characteristic of fatigue
 - Fracture surface near the ID of the skirt base ring is consistent with torsional fatigue
 - No evidence of cold work induced stress corrosion cracking
 - No evidence of ductile tearing
 - Initiation site has not been identified
 - Secondary cracks that connect with the main fracture emanate out of weld root

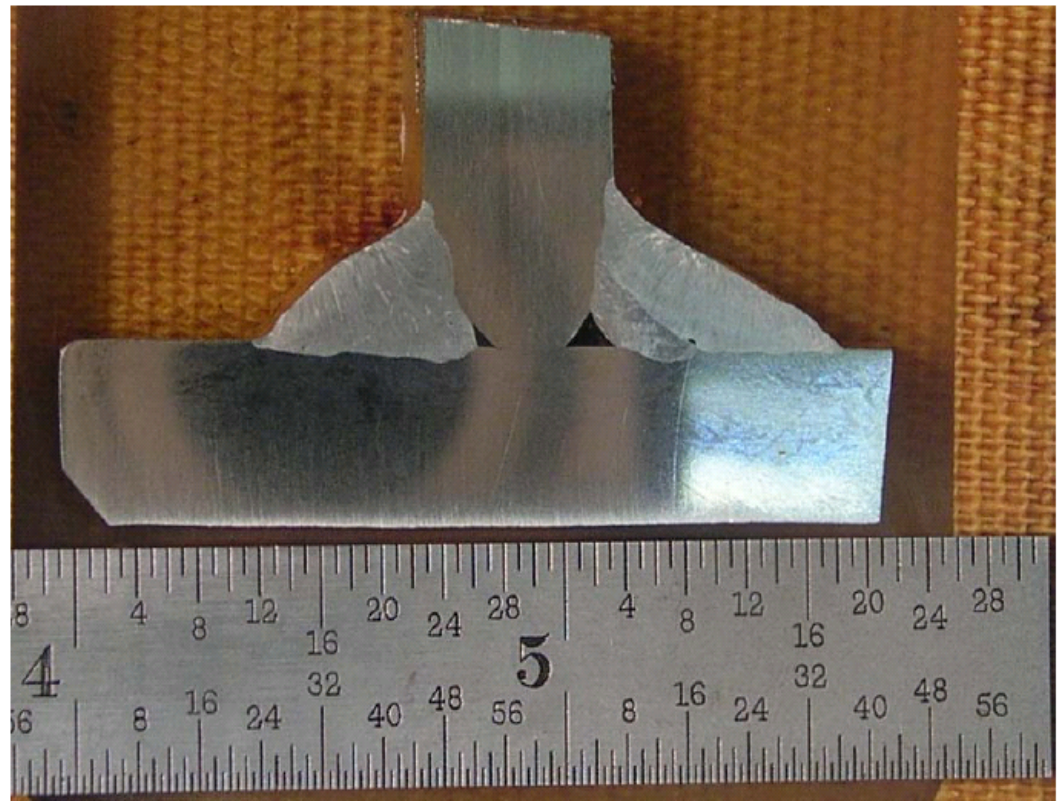
Figure 2: Weld cross section of Sample 1-1 (in cut-out)
(~2 inches from fracture)

- Weld details require ID and OD penetration of 0.16" with 0.1" fillet reinforcement
- As built configuration has significant fillet reinforcement and weld size not cause of failure
