Title: Q2R18 Concerns Related to Steam Dryer

Unit(s): Quad Cities Unit 2

Report Date: 05/16/2006

Table of Contents

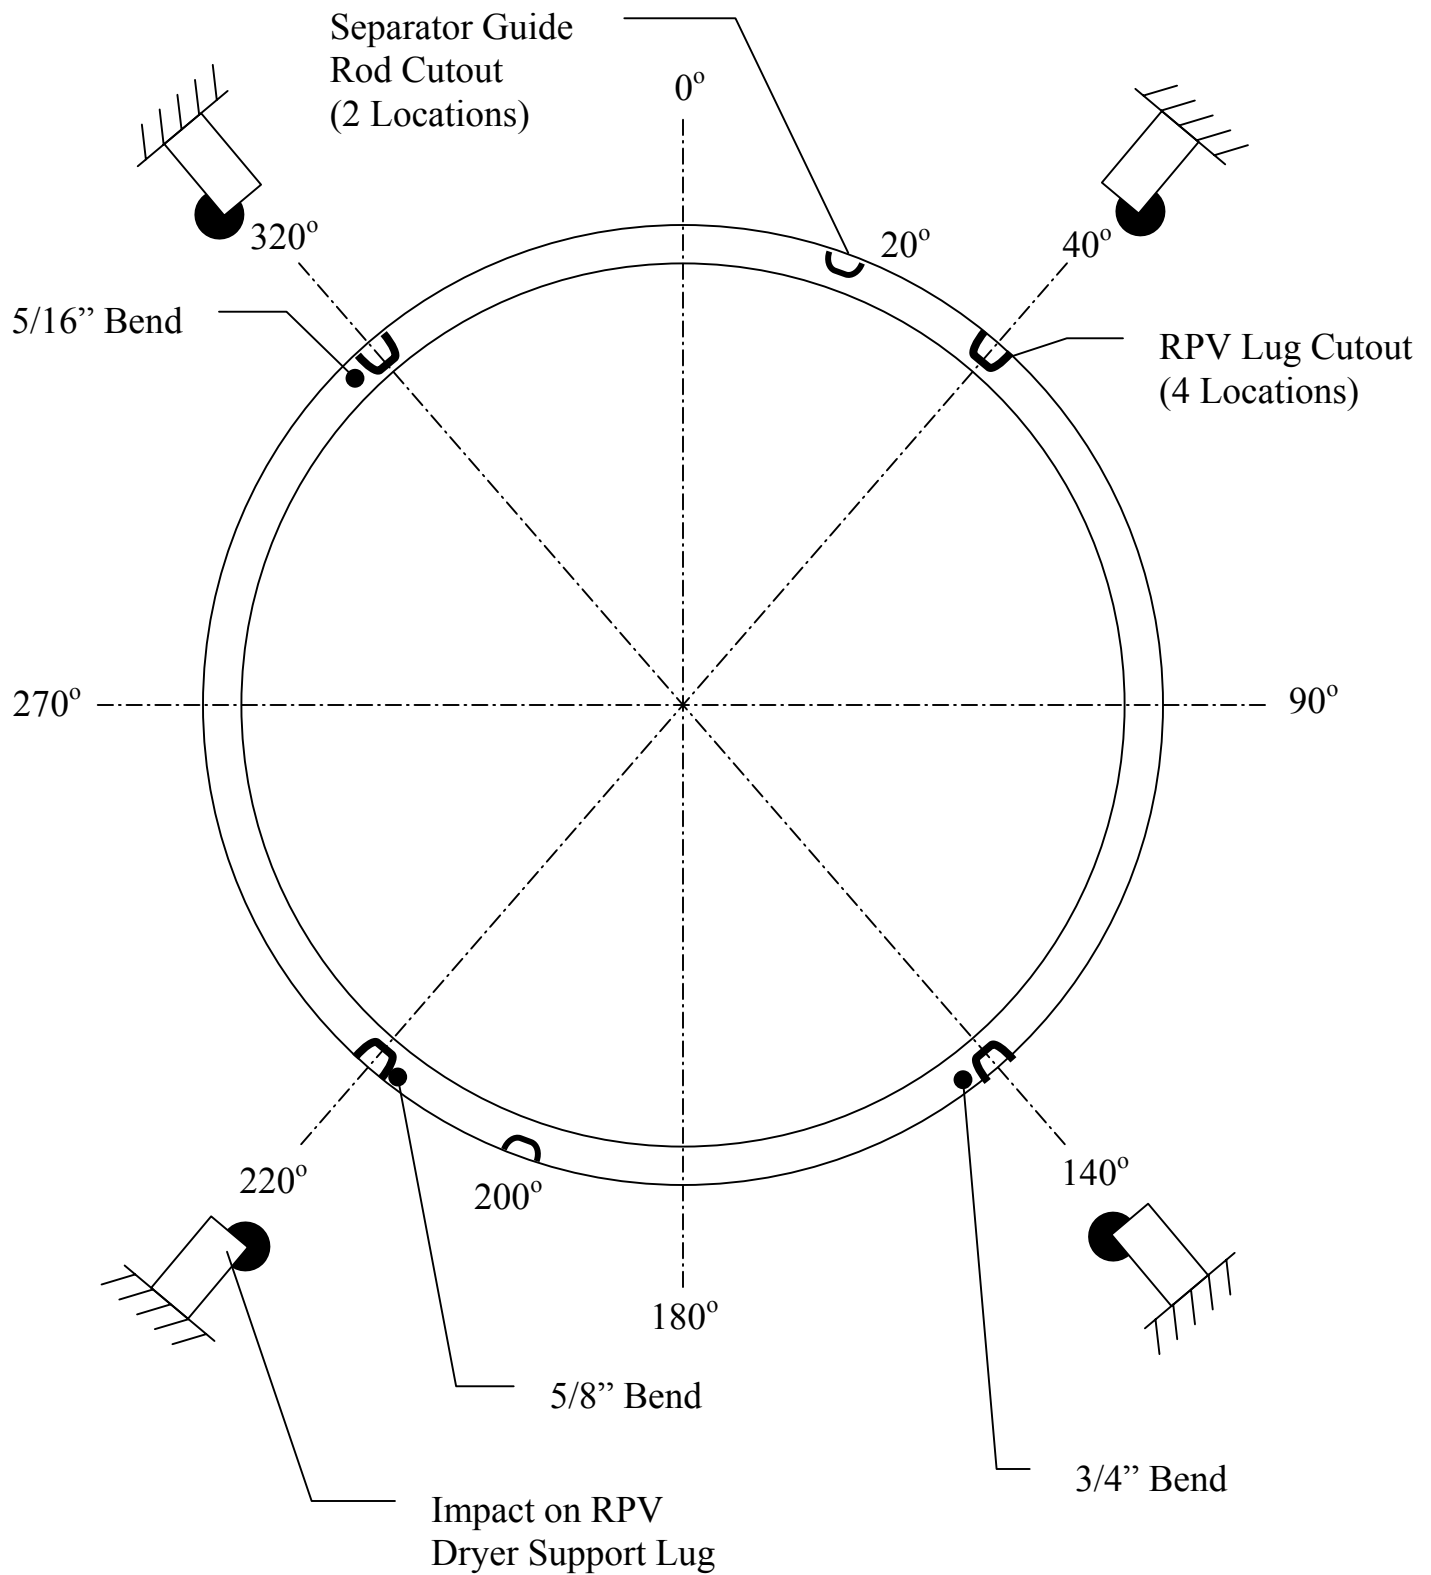
Figure 1
Steam Dryer Plan – Impact Locations

8. Dryer rotates and swings into the 140 and 40° lug.
9. Dryer impacts the 140° lug below the right lower edge of the lug.
10. This impact results in a sharp crease in the dryer support lug and the formation of an edge on the base plate gusset. The corner of the 140° lug is pushed in and partially shears off.
11. During the tilt/rotation, the dryer impacts the right bottom corner of the 40° lug, shearing off the corner.
12. The dryer lift is completed without further incident.

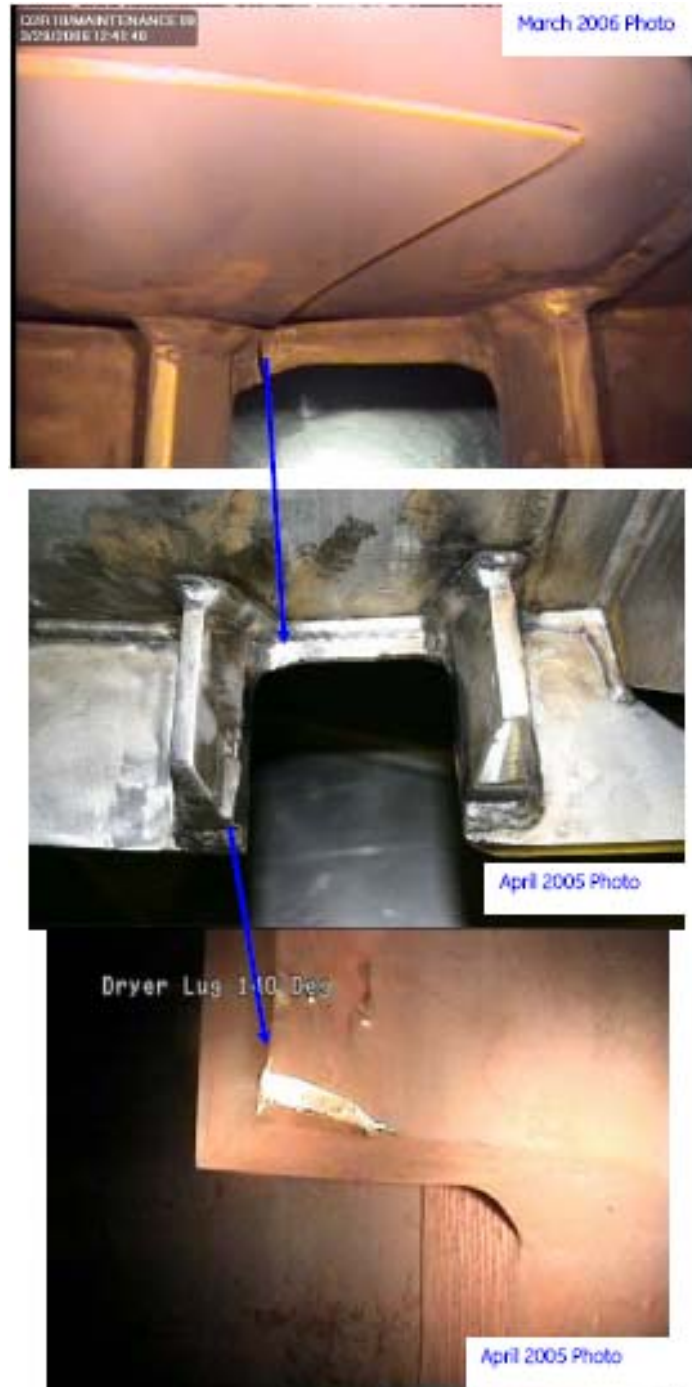
Figure 2

1. Steam Dryer Lower Skirt Crack at 140°: The root cause for this cracking is related to deformation caused when the dryer skirt base ring caught on the reactor pressure vessel (RPV) dryer support lugs in May 2005 (referred to as the “lifting event”). The exact mechanism of initiation of the cracks could not be determined, however the RCA concludes that this event introduced significant plastic strains that reduced the material’s fatigue endurance properties. When combined with the cyclic loadings that the dryer experiences during normal operation, fatigue cracking propagated through the skirt base ring and into the dryer skirt panels. The lifting event occurred as a result of changes in design of the installation hardware used in the replacement dryer. This change in installation hardware is considered a root cause. These changes, combined with widened installation clearances introduced during dryer fabrication (referred to as “ovality”) allowed for enough movement for the dryer to become damaged on the RPV support lugs during removal. The widened installation clearance introduced from fabrication ovality is also considered a root cause for the dryer skirt cracking.

General Relationship Between Dryer Cracking (Top), Dryer Guide Slot Cutout at 140 Degrees (Center), and Dryer Support Lug at 140 Degrees (Bottom)

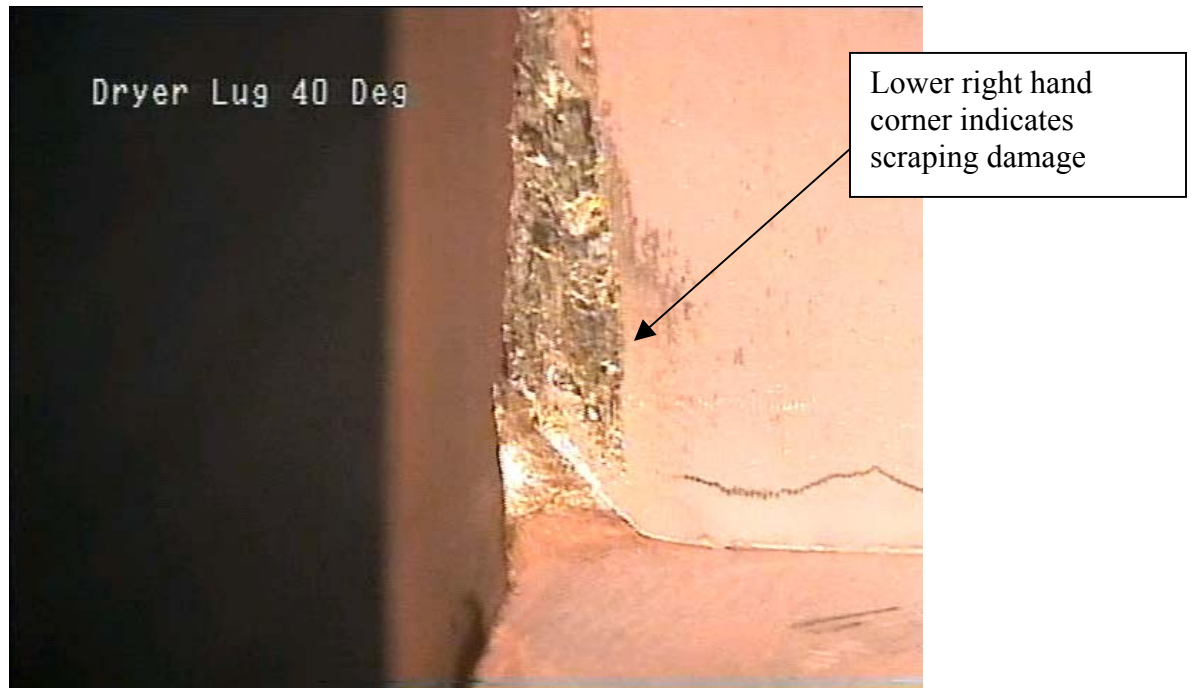
Figure 3

Damage to 40 Degree Lug, Lower Right Hand Corner Damaged During Impact

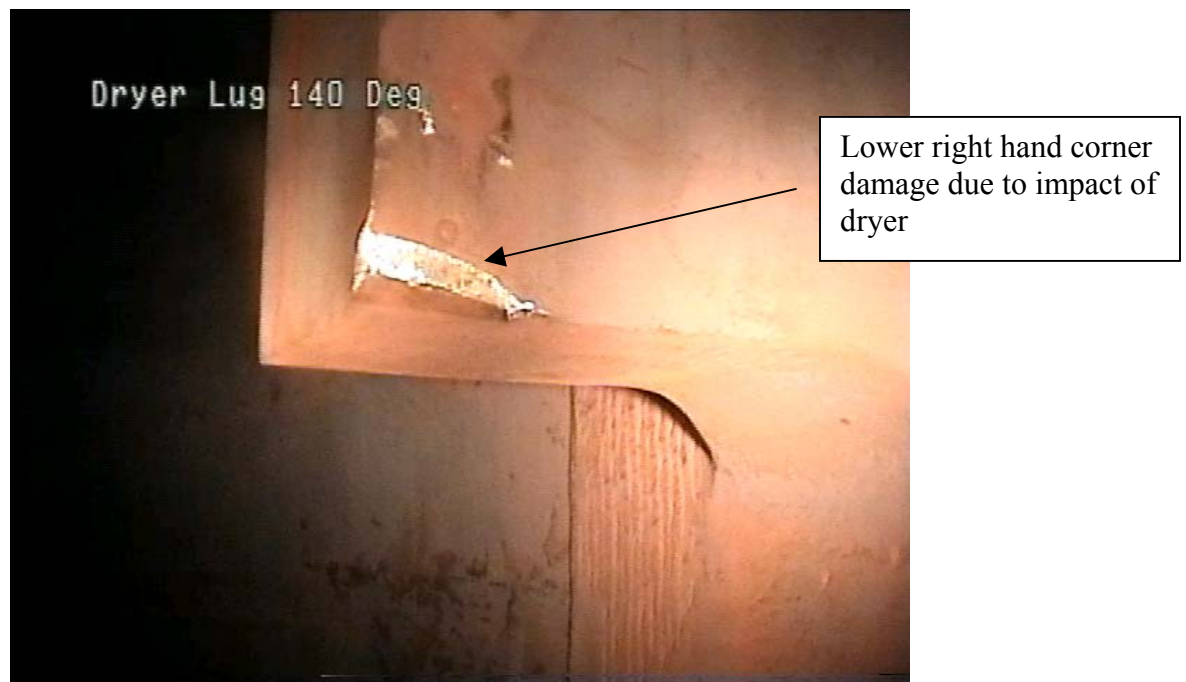
Figure 4

Damage To 140 Degree Lug, Lower Right Hand Corner Damaged Due to Major Impact

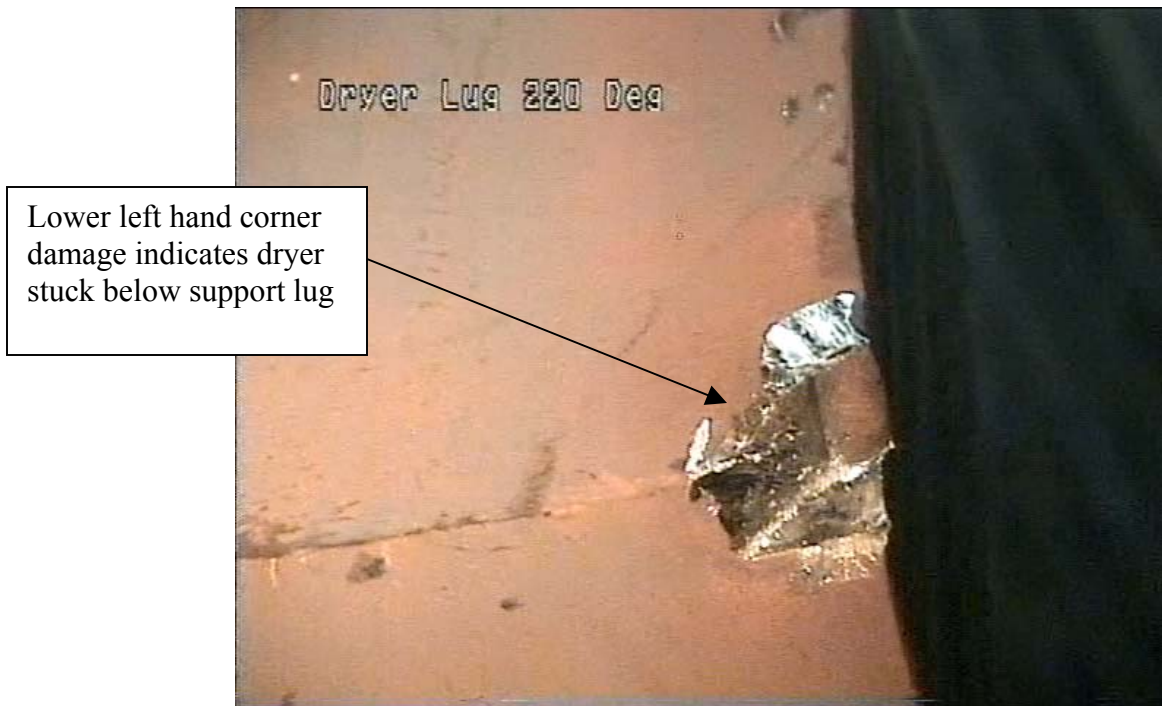
Figure 5

Damage To 220 Degree Lug, Lower left hand Corner

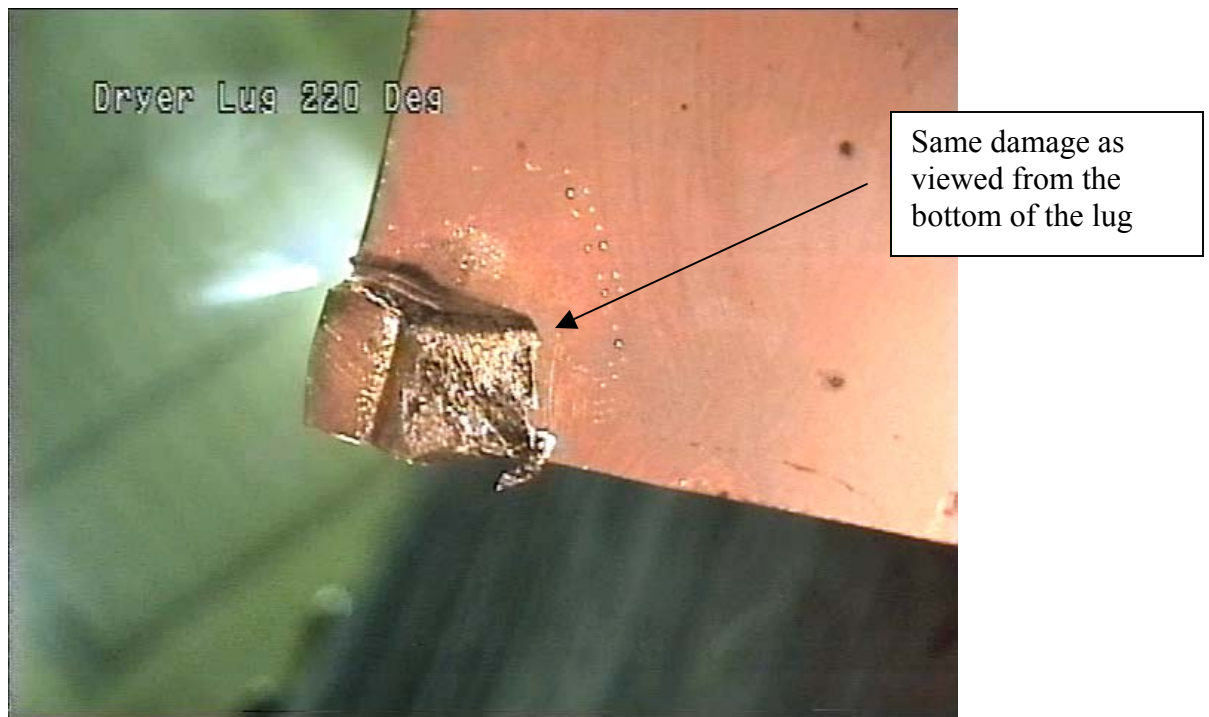
Figure 6

Damage To 220 Degree Lug, Lower left hand Corner (View from Bottom)

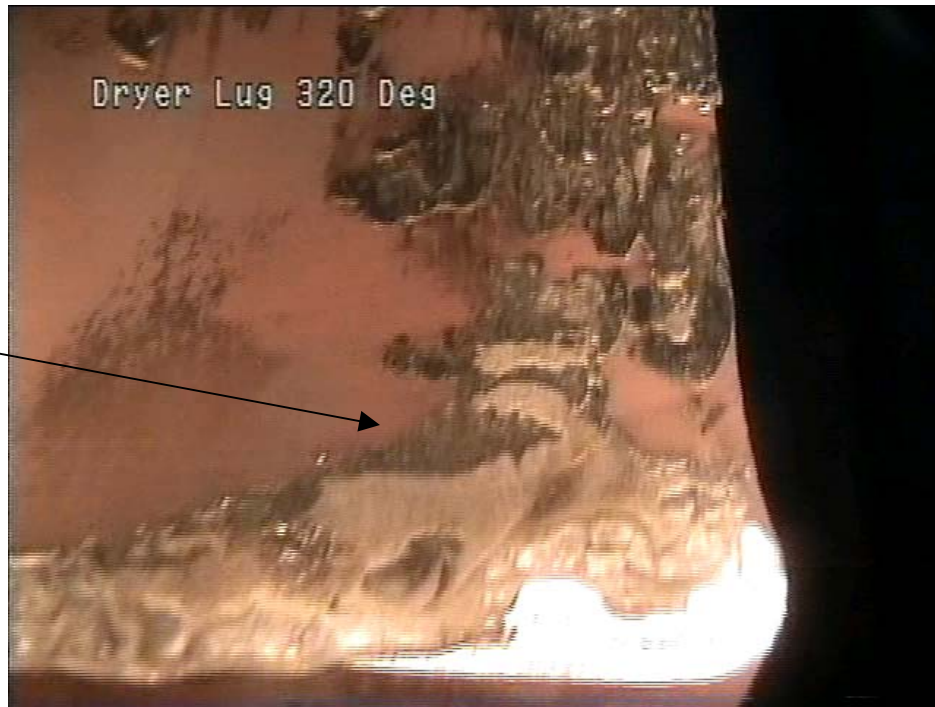
Figure 7

Damage to 320 Degree Lug, Lower Left Hand Corner

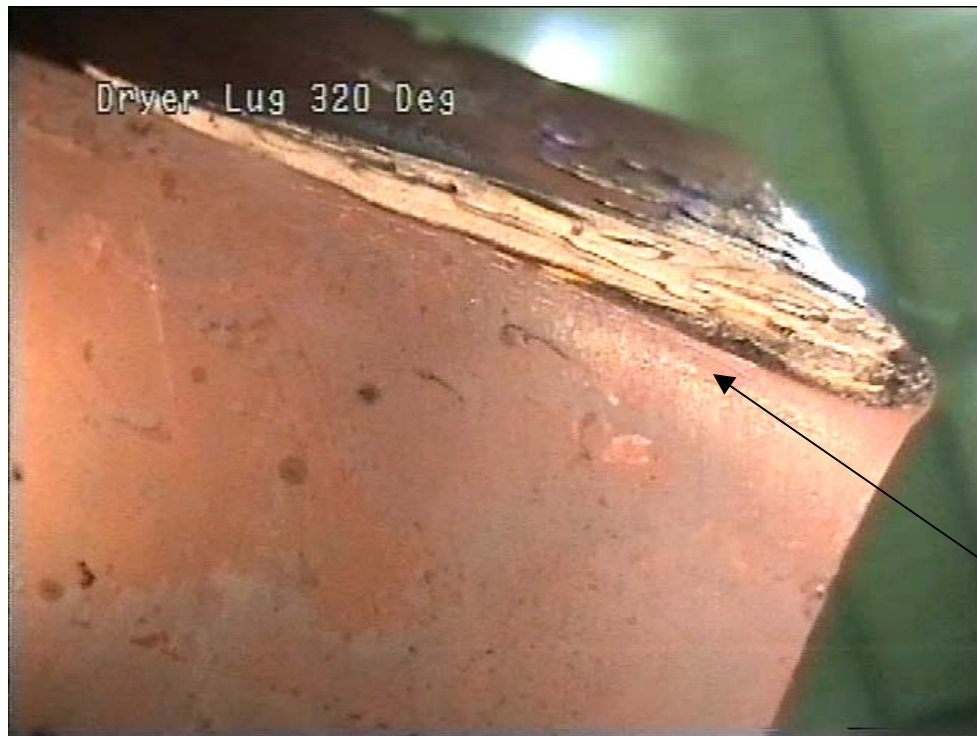
Figure 8

Damage to 320 Degree Lug, Lower Left Hand Corner (View From Bottom)

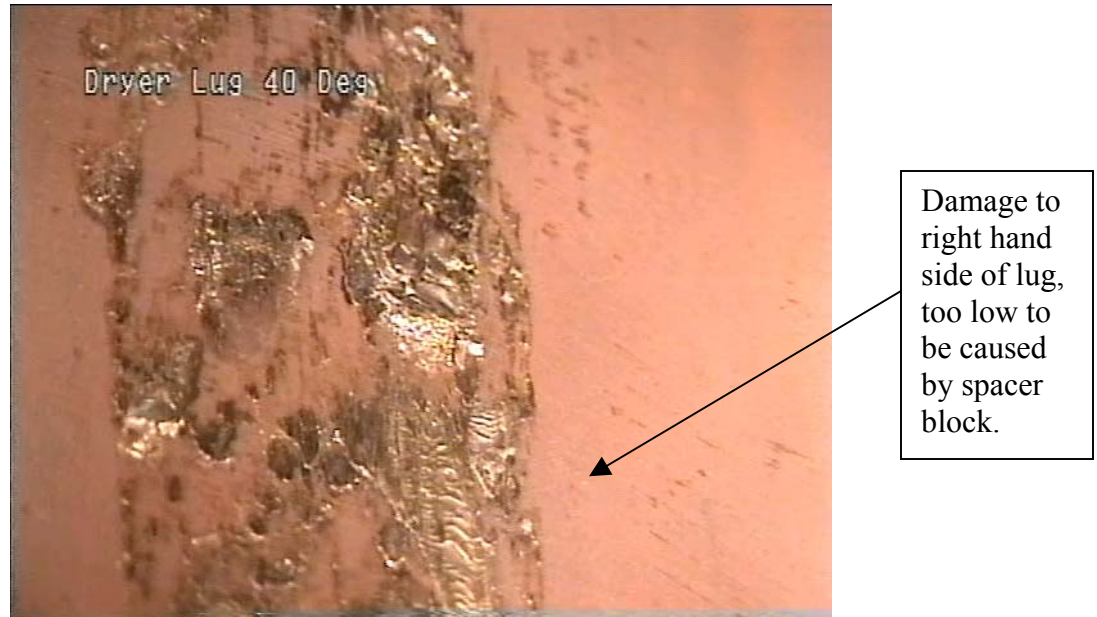
Figure 9

Damage to Right Hand Side of 40 Degree Lug, Due to Base Plate When Lowering
