UNITED STATES
NUCLEAR REGULATORY COMMISSION

SUBJECT: SPECIAL INSPECTION TEAM REVIEW OF THE APRIL 4, 2006 PLANT
EMERGENCY (INSPECTION REPORT NO. 40-03392/2006-003)

SPECIAL INSPECTION TEAM (SIT) CHARTER
UF₆ LEAK ON APRIL 4, 2006, AT HONEYWELL INTERNATIONAL

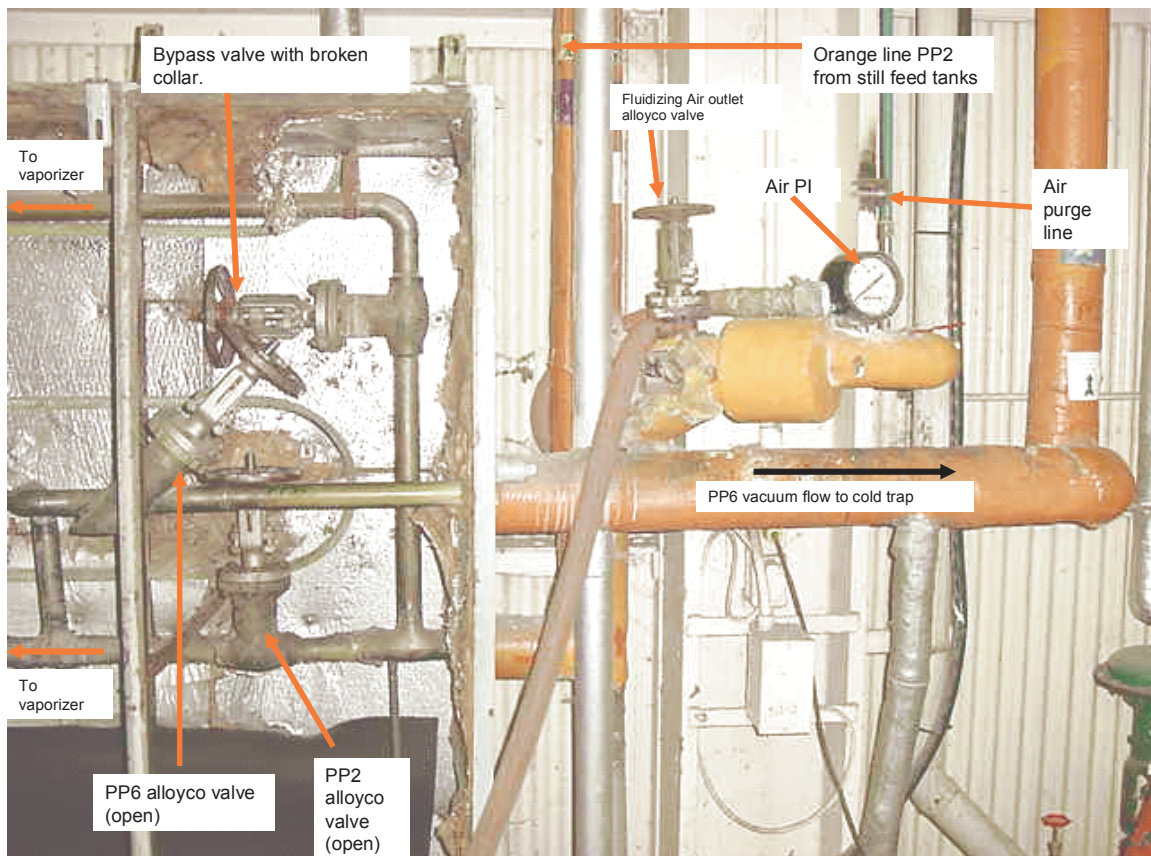
Figure 1: Air Line and Process Piping

The utility air line is isolated from the UF₆ line running from the still feed tanks to the vaporizer by a single Alloyco block valve. The utility air line is used on an occasional basis to provide dry fluidizing air to purge UF₆ lines prior to system maintenance. Interviews of licensee personnel and review of "as built" drawings indicated that this was the only instance in the distillation system where a single valve isolated a UF₆ line from a non-UF₆ line. The valve apparently leaked permitting UF₆ to enter the utility air line where it would have been available to interact with any available moisture in the air to create UO₂F₂. While the precise mode of failure for the valve was not determined, licensee personnel stated that tear down of the valve revealed the presence of yellow material on the seating surfaces of the valve which may have allowed UF₆ to leak into the utility air line.

Located upstream from the isolation valve and the pressure indicating gauge were a pair of quarter-turn ball valves (most of these valve's structure is covered in insulation and they are not visible in Figure 1). Interviews of licensee personnel indicated that these valves were normally closed. After use of the air line for purging activities, it was licensee practice to close the isolation valve, pressurize the line to 90 psi, then close the two quarter-turn valves. This pressure is greater than the approximately 70 psi nominally found in the UF₆ line leading from still feed tanks to the vaporizer and the differential pressure would notionally serve as a secondary barrier to prevent the intrusion of UF₆ into the utility air line. However, interviews of licensee personnel indicated that the amount of air pressure forming this secondary barrier was not routinely inspected or examined to ensure that positive pressure was in place upstream of the isolation valve.

The inspectors determined that the pressure boundary formed by dry fluidizing air isolated between the single Alloyco valve and the two quarter-turn ball valves apparently decreased over time diminishing the positive pressure barrier that prevented the leakage of UF_6 beyond the Alloyco valve. As the pressure barrier diminished over time, a negative pressure relative to the UF_6 line would have been created increasing the possibility of UF_6 intrusion into the utility air line.

As previously discussed, the inspectors determined that at some time prior to the release, the heat trace power supply failed, allowing the temperature of the utility air line to decrease to the point that any UF_6 that may have leaked into the line would potentially freeze and create a blockage.

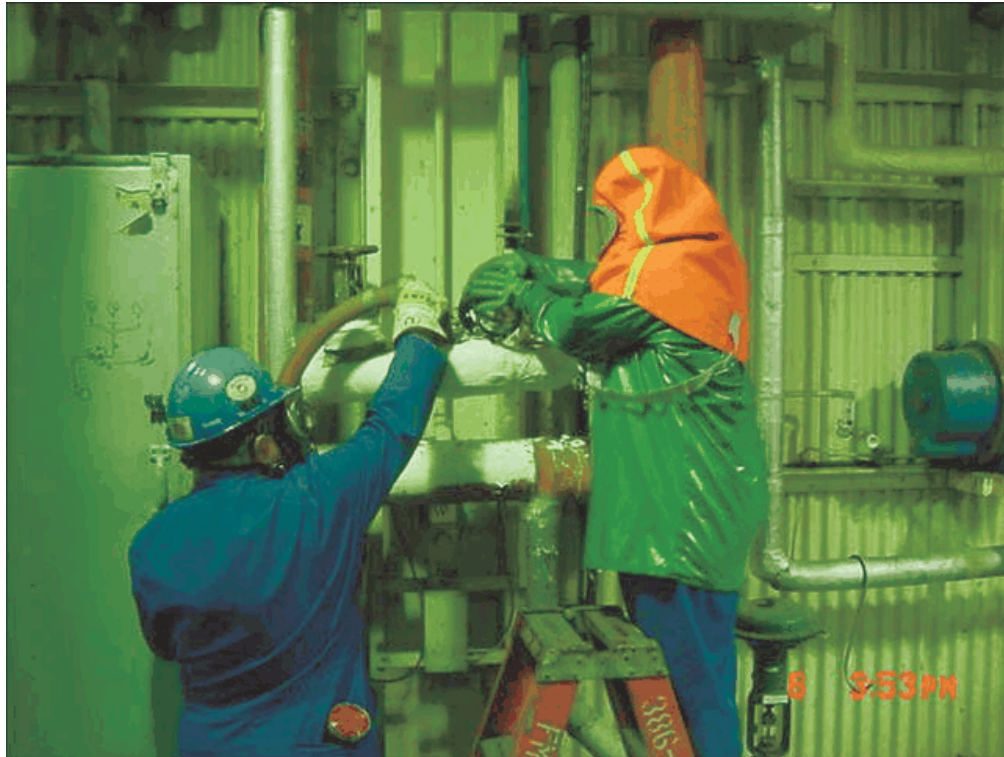
Figure 2: OP1 and OP 2 removing gauge (from reenactment)

At about 12:20 p.m., OP1, stood on a short ladder to facilitate access to the gauge, and began removing it as planned with OP2 assisting with the vacuum hose (see Figure 2). Both operators noticed wisps of “smoke” after each half turn and then further observing the vapor release stop, decided to continue removing the gauge. When nearly all of the six threads of the gauge’s fitting were disengaged, a third distillation operator (OP3) approached OP1 and OP2 with a new replacement gauge. OP3 was wearing a half-face respirator, safety glasses, coveralls, and a hard hat and before approaching the operators, had been standing about 10 feet away with the DOS. Licensee procedures allow the use of half face respirators for escape only and under circumstances when a UF₆ release is not expected. Licensee procedures require personnel involved in any activity that poses a possibility of a UF₆ release wear at a minimum, a full-face respirator.

OP1 then continued to remove the gauge until it was thrown from her hands as air and UF_6 contained in the utility line were rapidly expelled by the pressure in the line. Although OP1 had no specific memory of doing so, her next memory was that of being on the floor on her hands and knees after she apparently fell from the ladder.
