SUBJECT: CATAWBA NUCLEAR STATION - NRC AUGMENTED INSPECTION TEAM  
(AIT) REPORT 05000413/2006009 AND 05000414/2006009

Report Nos.: 05000413/2006009 and 05000414/2006009

Facility: Catawba Nuclear Station, Units 1 & 2

IR 05000413/2006009, 05000414/2006009; 5/23-31/06; Catawba Nuclear Station, Units 1 and 2; Augmented Inspection.

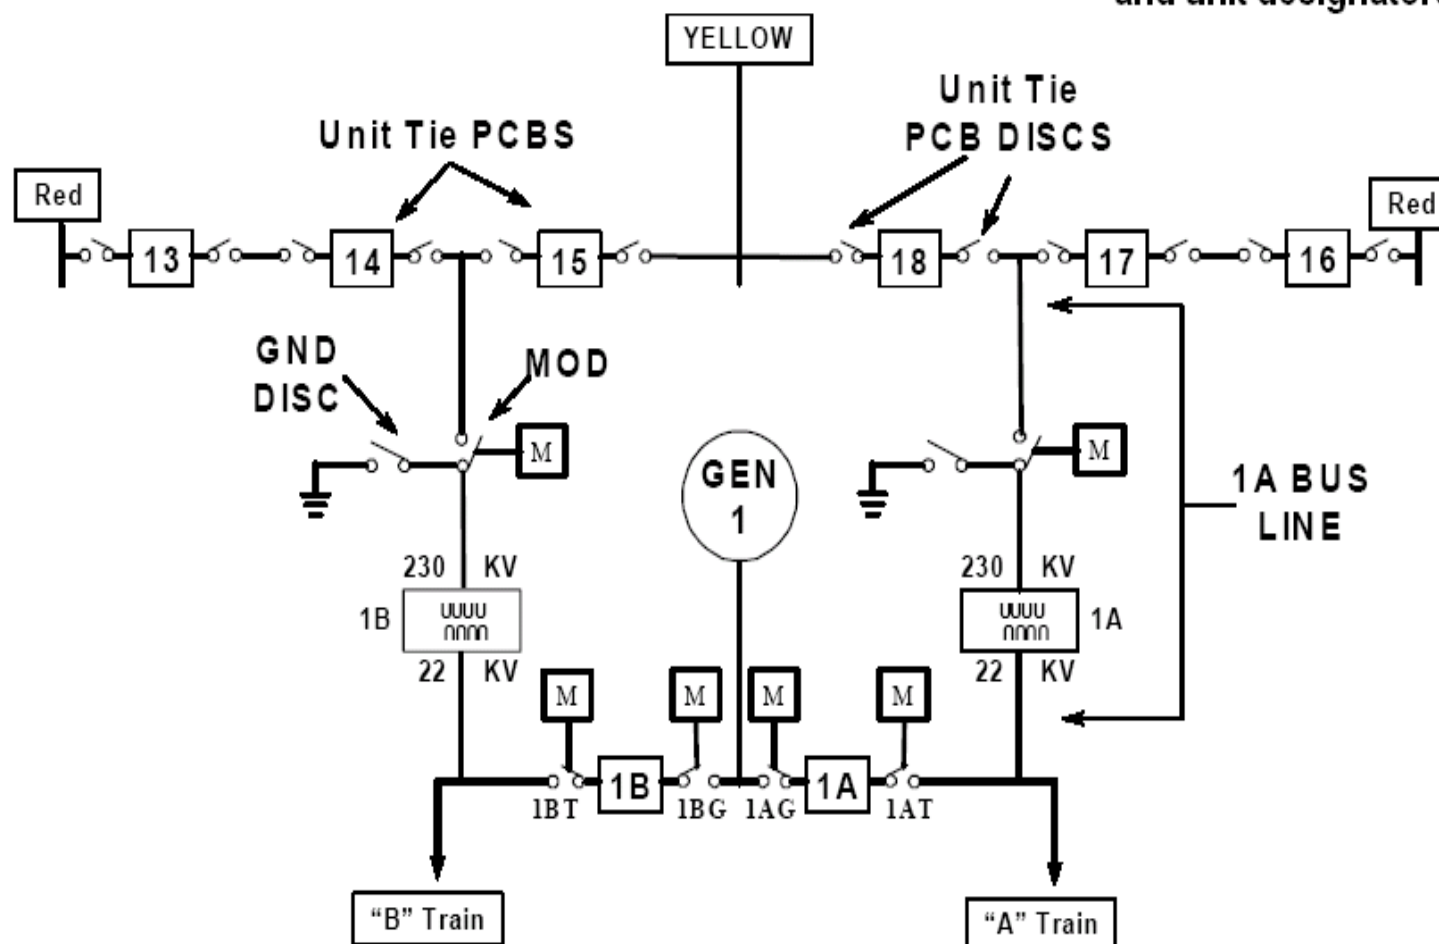
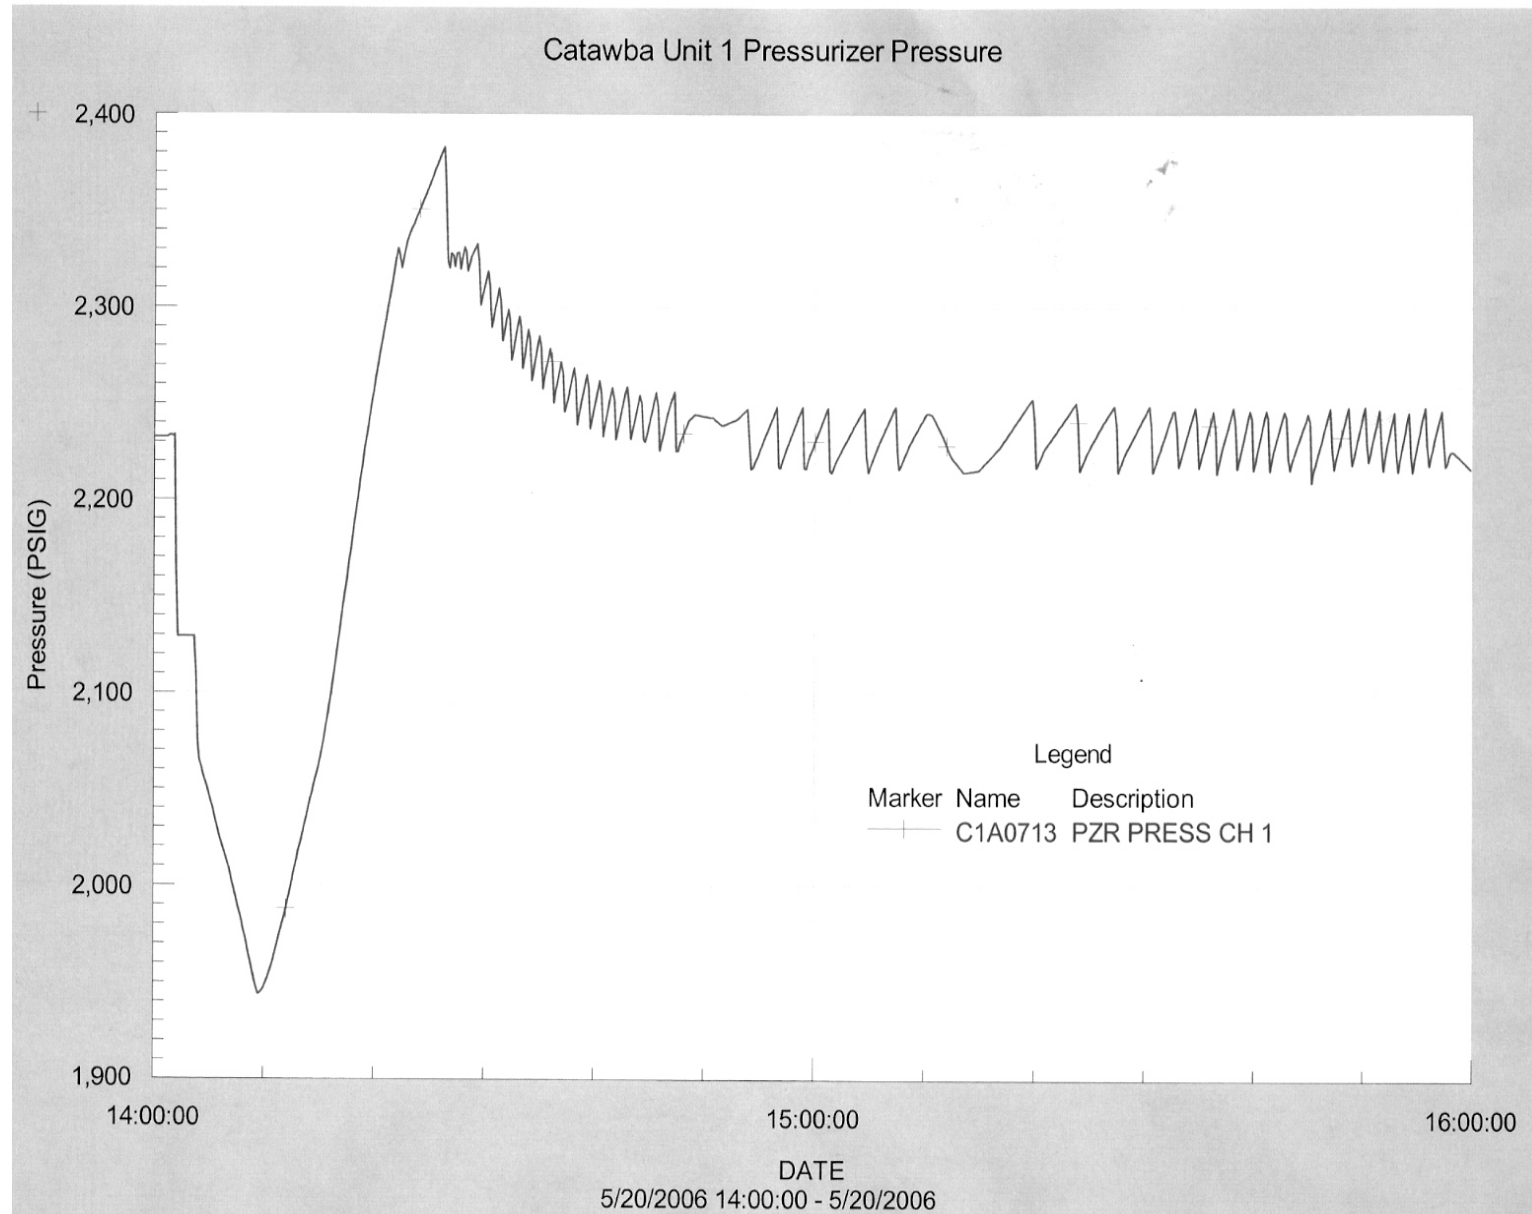
## 230/22 KV System

Unit 1 shown; Unit 2 is identical except for PCB #'s and unit designators
