Nine Mile Point License Renewal NMP1 Drywell

Presentation to NRC LR Staff

March 27, 2006

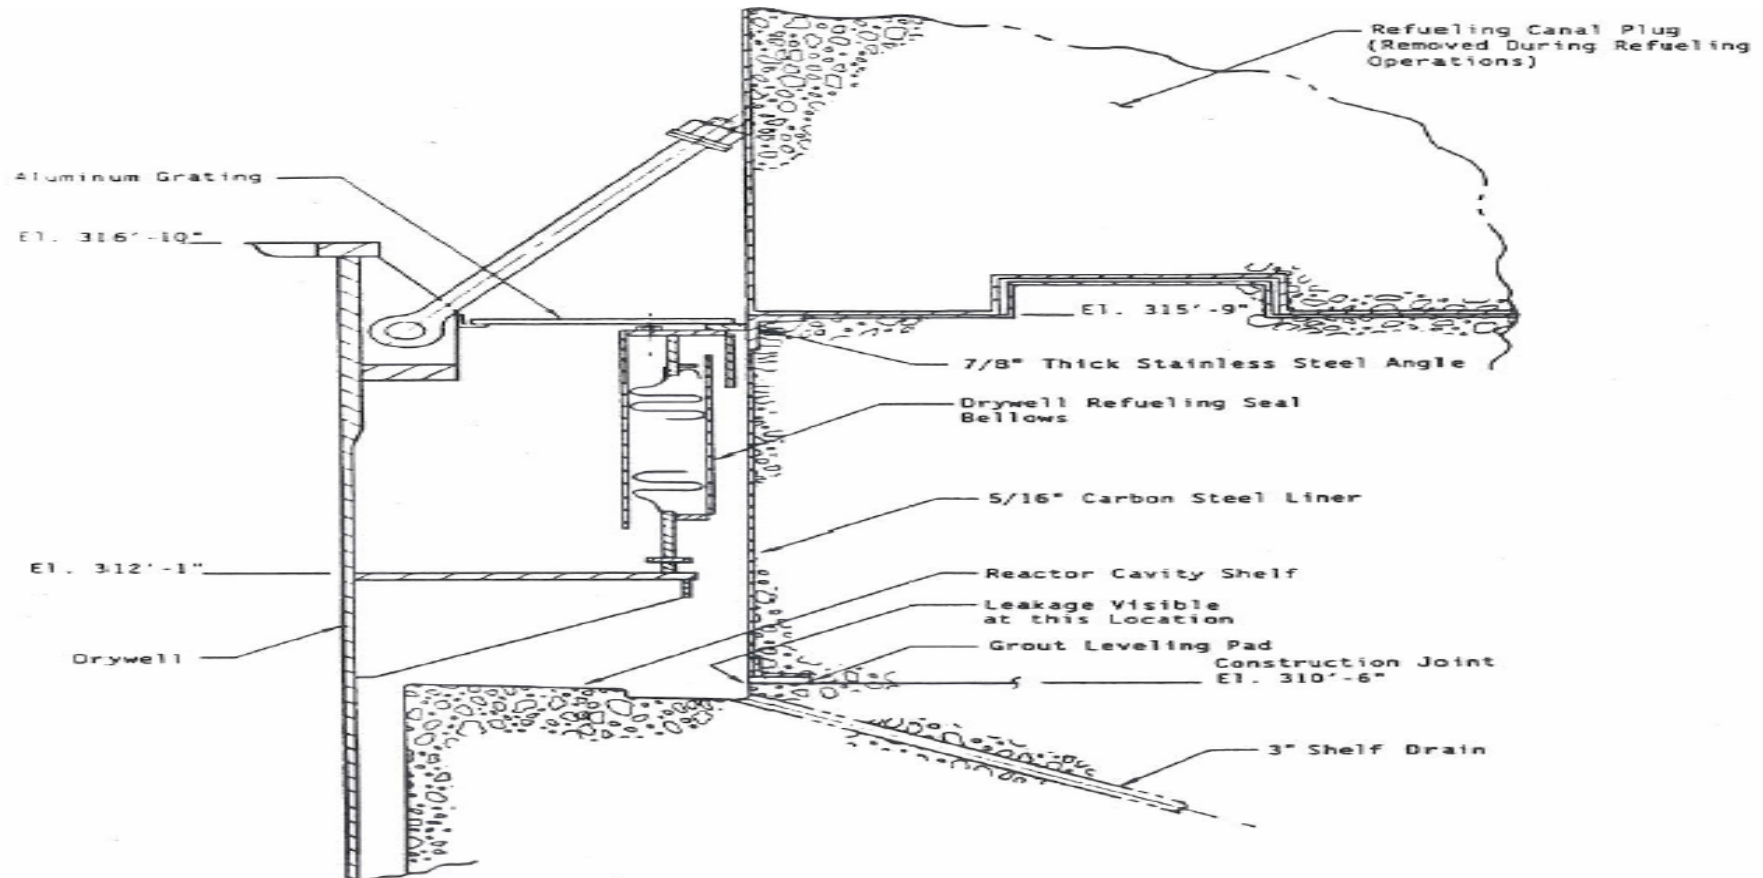
FIGURE 3

NINE MILE POINT UNIT 1
REACTOR HEAD CAVITY REFUELING SEAL
AND SHELF AREA

- NMP Actions for GL 87-05 (Remote Visual Inspections)
 - Sand Cushion Drain Lines (10)
 - Portion of Drywell External Surface and Air Gap Adjacent to 2 Sand Cushion Drain Lines
 - Reactor Head Cavity Seal Leakage Drain Area
- Results
 - Sand Cushion Drain Lines Unobstructed
 - Air Gap Dry and No Evidence of Water Intrusion
 - Reactor Cavity Drain Lines Function Properly

- NMP1 Differences from GL 87-05 Event
 - Refueling Seal Drain Welded vs. Gasket
 - Drain Lines Unobstructed
 - Leakage from Reactor Cavity Repaired
- Confirming Activities
 - Periodic Visual Inspection of Sand Cushion Drain Lines (located in Torus Room)
 - No leakage from Reactor Cavity Shelf Drains
