NUCLEAR LOGISTICS INC

Letter #QA-2044

Subject: 10CFR21 notification

Technical Bulletin TB-0948431-02 PCP Firing Board P.C. Assemblies

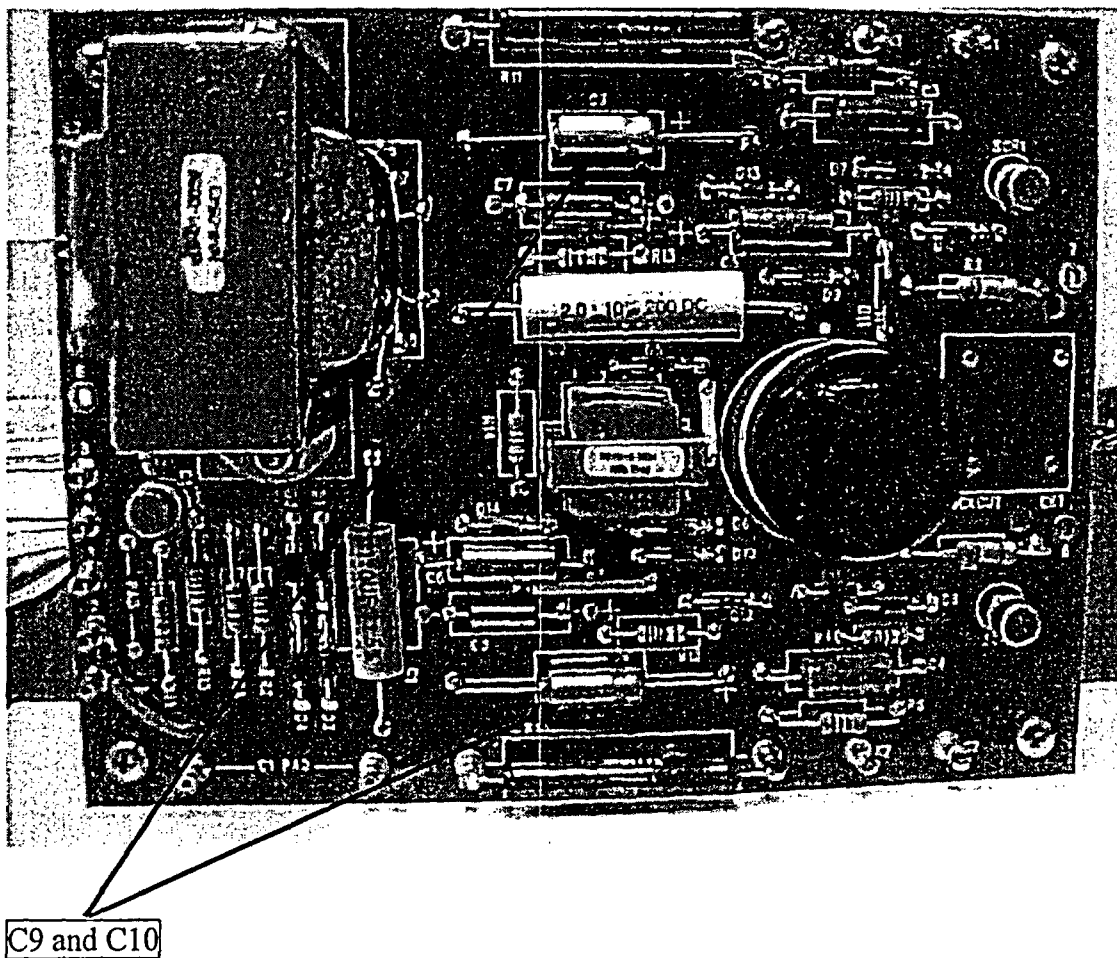
Figure 1

The capacitors are identified as Vishay 109D silver cased wet tantalum electrolytic capacitors. They are used in the C9 and C10 position on the 3 tiers of the printed circuit assembly (6 capacitors total). The circuit boards with the underrated capacitors will fail prematurely. The accelerated degradation of the capacitors is due to the level of the ripple current on the firing board.

The applicable in-service circuit boards identified above are to be inspected at the C9 and C10 location containing the Vishay 109D capacitors. In-service circuit boards can be visually inspected to determine the extent of the capacitor degradation. The capacitors will be discolored, indicating a degraded condition.

- Examine C9 and C10 on all three tiers of the firing board assembly (6 capacitors total) as follows:
 - Inspect the C9 and C10 capacitors (refer to figures 1 and 2 for location and identification). The capacitors with the shortened life are labeled with 109D. If the capacitors are labeled other than 109D, they are acceptable and the circuit board can be used.
 - While examining the circuit boards, inspect the capacitors for evidence of degradation (yellow color or black/brown burn spots). Discoloration is a

good early indication of capacitor degradation. Discoloration will appear on the capacitors before the capacitance starts to decrease.

- If there is evidence of capacitor degradation, the circuit board should be replaced.
- If there are not burn spots on the capacitors, the capacitor is acceptable for continued use. The capacitors on the circuit boards that are in service should be inspected monthly until the boards can be removed and the capacitors replaced.

Firing board assemblies with capacitors labeled 109D should be returned to NLI for rework and retesting. As an alternative, NLI can supply the replacement capacitors for installation on the circuit board by the plant.

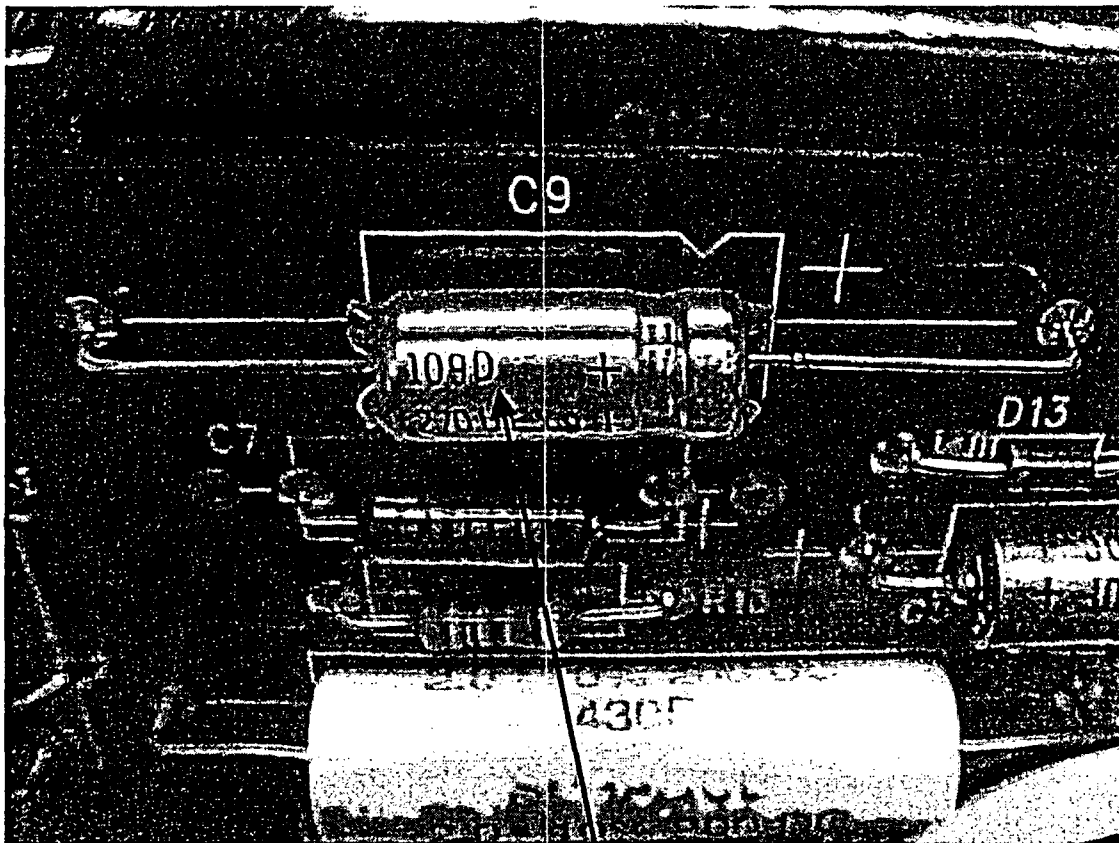
Figure 2

Note case markings
