SUBJECT: COLUMBIA AREA SAMPLING PLAN

SAMPLING LOCATIONS
WESTINGHOUSE-COLUMBIA

PRELIMINARY NOTIFICATION OF EVENT OR UNUSUAL OCCURRENCE PNO-11-92-01

SUBJECT: URANIUM CONTAMINATION IN SOIL BELOW RECOVERY AREA FLOOR

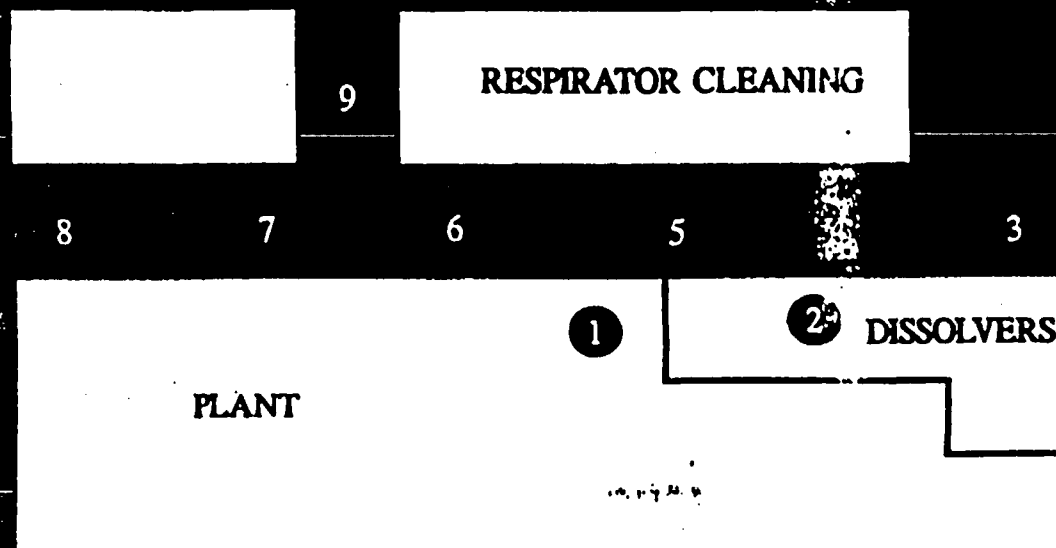
SAMPLE LOCATIONS WITHIN FACILITY

SOIL SAMPLING RESULTS

SAMPLE NUMBER	SAMPLE ACTIVITY(PCI/GM) @ VARIOUS DEPTHS(IN)						
	6"	12"	18"	24"	30"	36"	42"
1	203	195	311	328	193	213	326
2	434	631	831	776	737	956	828
3	2	1	—	—	—	—	—
4	314	141	—	—	—	—	—
5	9	2	3	—	—	—	—
6	2	2	—	—	—	—	—
7	12	3	—	—	—	—	—
8	30	41	—	—	—	—	—
9	4	3	5	3	—	—	—

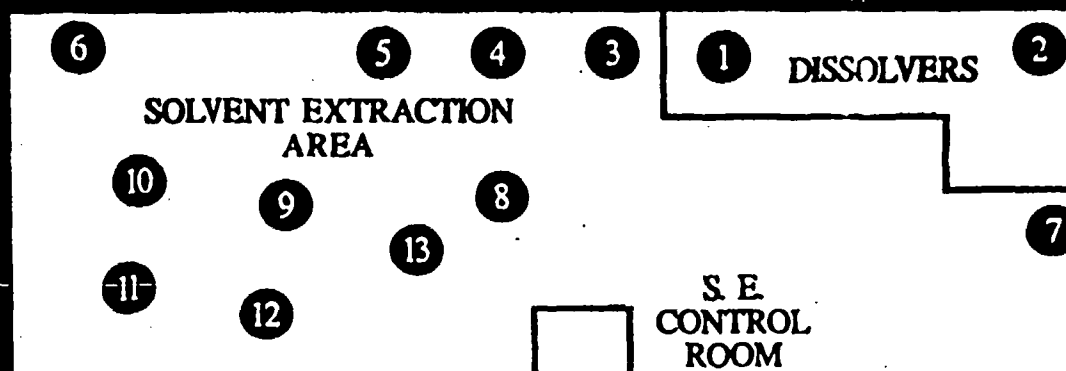
SAMPLE LOCATIONS WITHIN FACILITY

SOIL SAMPLING RESULTS

SAMPLE NUMBER	SAMPLE ACTIVITY(PCI/GM) " VARIOUS DEPTHS(FT)					
	2'	4'	6'	8'	10'	12'
1	645	2068	2711	2584	2412	—
2	752	549	184	—	—	—
3	385	69	811	328	3	—
4	1962	1601	2045	—	—	—
5	44	11	—	—	—	—
6	3	5	—	—	—	—
7	208	8	—	—	—	—
8	9	10	5	4	6	2
9	3	5	—	—	—	—
10	24	5	—	—	—	—
11	24	27	11	34	3	—
12	16	5	3	3	2	—
13	252	183	—	—	—	—
