**FPL REPLY TO:**  
**STEAM GENERATOR TUBE INSPECTION DISCUSSION POINTS**  
**PREPARED BY THE OFFICE OF NUCLEAR REACTOR REGULATION**  
**FLORIDA POWER AND LIGHT COMPANY**  
**SAINT LUCIE NUCLEAR PLANT UNIT 2**  
**DOCKET NO. 50-389**

**Status of inspections as of 0800 on 5/5/06 for SL2-16.**

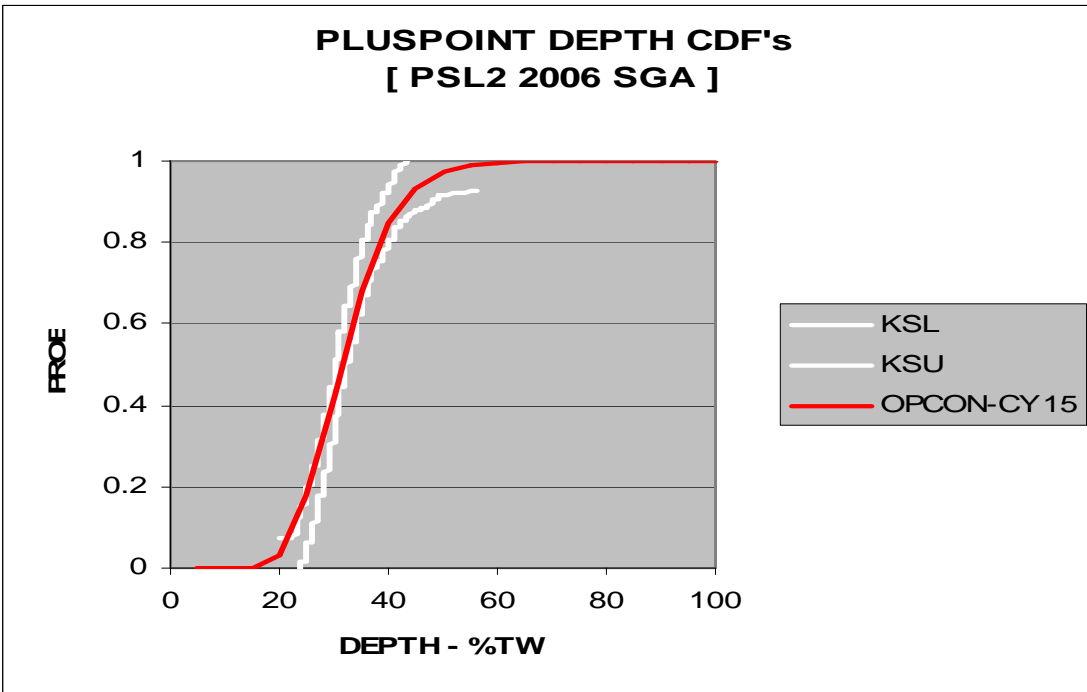
Reply – The only unexpected results is that the number of indications observed in the SGs is lower than expected. The voltage, depth and length distributions are consistent with observations from prior inspections and within expectations (Refer to Figures 1-5).

Figure 2 – Plus Point Depths

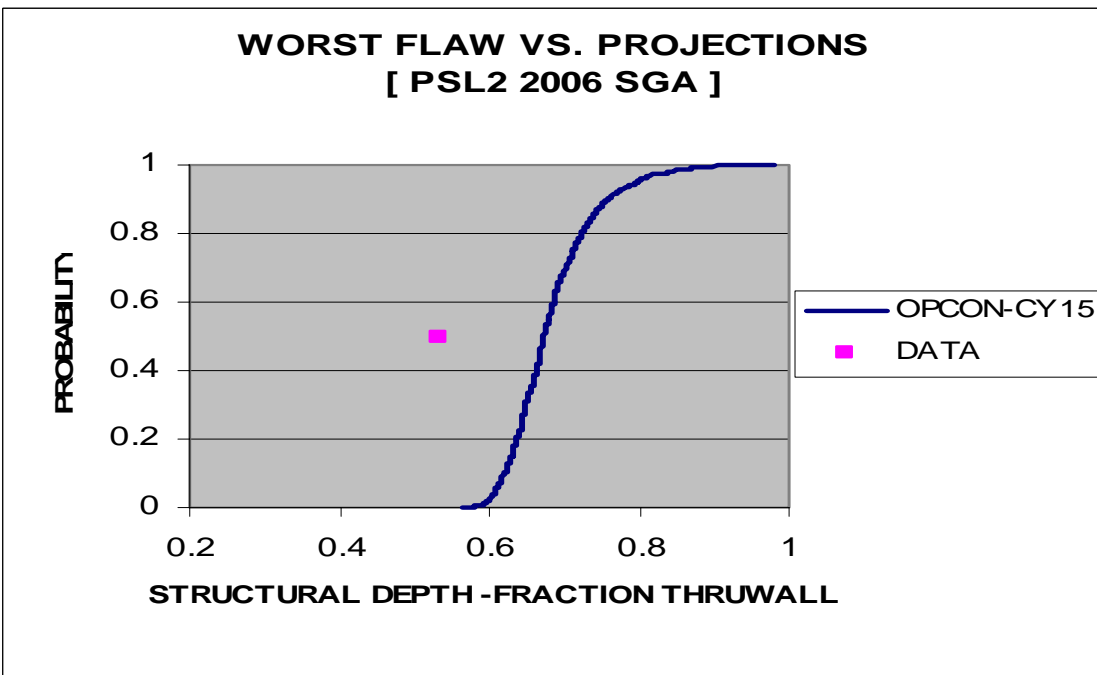
Figure 3 – Worst Flaw vs. Projections
