Subject: Duke Power Company LLC d/b/a Duke Energy Carolinas, LLC  
(Duke)  
Catawba Nuclear Station, Units 1 and 2  
Docket Nos. 50-413 and 50-414  
Licensee Event Report 413/06-001

Attached is Licensee Event Report 413/06-001 titled "Loss of Offsite Power Event Resulted in Reactor Trip of Both Catawba Units from 100% Power."

Loss of Offsite Power Event Resulted in Reactor Trip of Both Catawba Units  
from 100% Power

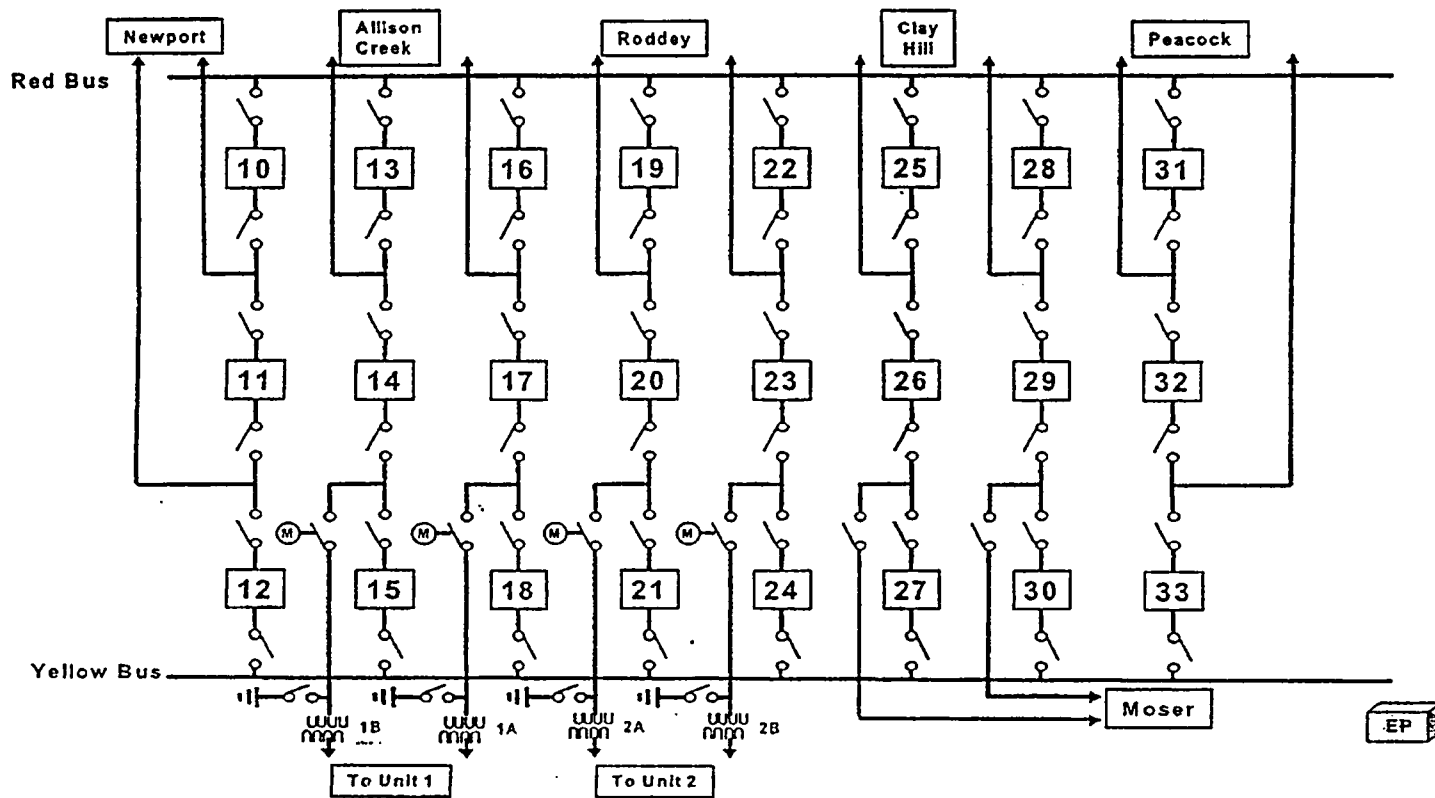
The Catawba 230kV switchyard [EIIS: FK] is designed in a breaker-and-a-half scheme which allows any one of the switchyard power circuit breakers (PCB) [EIIS: 52] to be isolated from the grid without deenergizing any transmission line or affecting the integrity of the switchyard. Six double-circuit transmission lines from the primary transmission system terminate in the switchyard. Additionally, each Catawba unit is tied to the 230kV switchyard by two separate and independent overhead lines. The entire switchyard, including the power circuit breakers, cabling system, ac and dc auxiliary power systems, protective relaying system, and control system is also divided into two power trains. Additionally, the incoming transmission lines are also assigned to power trains in such a way as to separate the associated cabling, protective relaying, and controls for each circuit of the double-circuit transmission lines into two distinct sources of offsite power. The Catawba 230kV switchyard design assures the independence of the redundant offsite power feeders to each nuclear unit. Refer to Figure 1 for a visual depiction of the Catawba 230kV switchyard and offsite power arrangement.
