SUBJECT: PALO VERDE NUCLEAR GENERATING STATION, UNIT 3 - SUMMARY OF
CONFERENCE CALL REGARDING 2006 STEAM GENERATOR TUBE
INSPECTION RESULTS (TAC NO. MD1240)

SUMMARY OF CONFERENCE CALL
REGARDING 2006 STEAM GENERATOR TUBE INSPECTION RESULTS
PALO VERDE NUCLEAR GENERATING STATION, UNIT 3
DOCKET NO. 50-530

Steam Generator Tube Inspection Discussion Points – Briefing Paper

ASSESSMENT OF STEAM GENERATOR TUBE DEGRADATION MECHANISMS
RECOMMENDED SG INSPECTION, TESTING & REPAIR SCOPE – U3R12

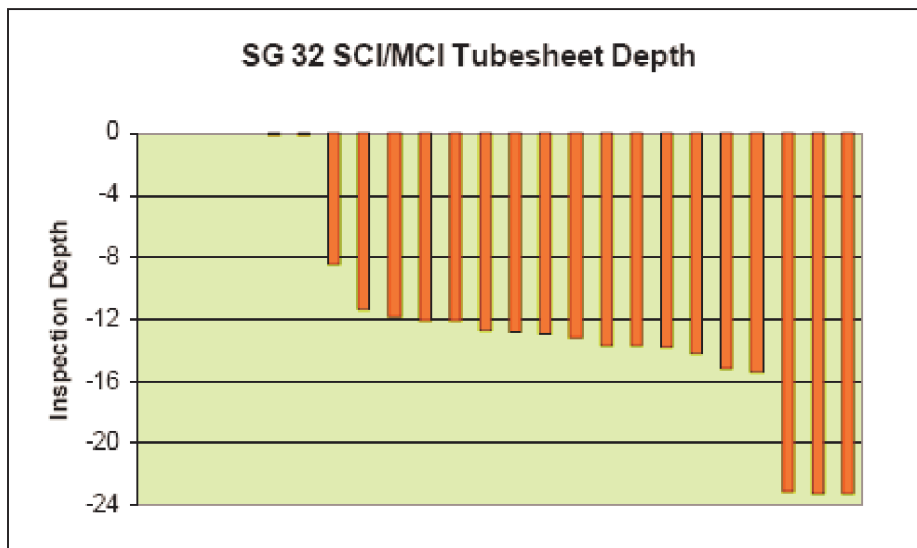
As reported previously, in general, tubesheet SCC is not a progressing damage mechanism. That is, most of the defects detected are outside previously inspected elevations. Additionally, in the case of SG 31, no circumferential SCC was found outside the tubesheet transition region. For SG 32, the distribution of circumferential SCC indicates that most of the detected flaws are beyond the inspection depth performed in U3R11 (i.e., 12 inches). See below.
