**UNITED STATES
NUCLEAR REGULATORY COMMISSION
REGION IV
611 RYAN PLAZA DRIVE, SUITE 400
ARLINGTON, TEXAS 76011-4005**

August 7, 2006

**SUBJECT: CALLAWAY PLANT - NRC INTEGRATED INSPECTION
REPORT 05000483/2006003**

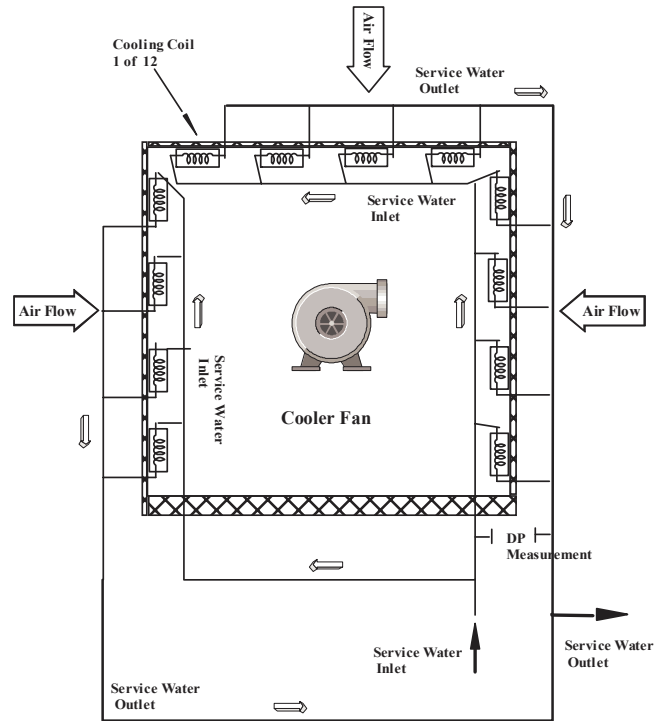
Figure 1
Containment Heat Exchanger

1. Less Than Adequate Evaluation of Containment Heat Exchanger Postmodification Tests Results and Self-Assessment Recommendations

Description: The inspectors identified that AmerenUE had not adequately demonstrated, through performance, flow and differential pressure testing, that the containment heat exchangers would perform acceptably following installation. The Callaway Plant has two containment heat exchangers in each containment cooling train. Each train is required to remove 141×10^6 British thermal units per hour (BTU/hr) under accident conditions. AmerenUE performed containment heat exchanger replacements during Refuel Outages 11 and 12. Each new containment heat exchanger consisted of 12 parallel coils, 8 coils arranged across one service water supply header, and 4 coils across a second header (Figure 1). The postmodification testing requirements, established by Testing Requirements Determination Record 00-1018, Revision A, included:

The performance test used the Temperature Effectiveness Method to verify that the new containment heat exchangers were capable of removing the required postaccident heat load. The flow verification test used the Differential Pressure Method to verify the service water tube side was free of flow obstructions. The in-service test verified minimum service water flow was available for each containment heat exchanger. The inspectors identified that the performance test acceptance criteria was not met for two containment heat exchangers. Procedures ETP-GN-0001A and B established a minimum of 80 percent heat transfer effectiveness. The inspectors identified that the test conditions for the other two containment heat exchanger performance tests were not appropriate. In both cases the air leaving the containment heat exchangers was warmer than the air entering the containment heat exchangers. The absence of a heat load across the containment heat exchangers invalidated the test results. AmerenUE

entered the failure to meet acceptance criteria and inadequate test conditions in the corrective action program as Callaway Action Request (CAR) 200605143.

Electric Power Research Institute Guideline NP-7552 established the testing methodology and requirements for the Temperature Effectiveness Method. Guideline NP-7552 required that the flow conditions during the test be within ± 5 percent of the accident flow conditions. The inspectors identified that AmerenUE performed all four performance tests with the heat exchanger fans passing 140,000 SCFM (standard cubic feet per minute) on the fin side. The fans are expected to operate at 67,000 SCFM during accident conditions. The inspectors also identified that service water flow on the tube side during each test was significantly less than the expected ESW accident flow rates. The inspectors concluded that the postmodification tests failed to demonstrate any of the four heat exchangers were capable of removing the required heat loads. AmerenUE entered the failure to perform the test under appropriate conditions in the corrective action program as CAR 200509450.

The inspectors identified that AmerenUE failed to establish acceptance criteria for the flow verification test. The flow verification test used the Differential Pressure Method to verify no tube side flow obstructions existed for the new heat exchangers. Plant engineers measured the pressure drop across the header that supplied 8 of the 12 coils. Figure 1 indicates the location where AmerenUE measured differential pressure. The measurement was performed at the same static head on all four new containment heat exchangers. The pressure drop test results, corrected for flow variances, ranged from 20 pounds per square inch differential (psid) to 31.4 psid. The expected value from the manufacturer was 14.5 psid. AmerenUE did not perform an evaluation to address why the test results varied between the newly installed coils or from the manufacturer's expected value. The inspectors identified that AmerenUE did not include differential pressure acceptance criteria into the postmodification test. AmerenUE entered the failures to perform an evaluation of the flow verification test results and provide test acceptance criteria into the corrective action program as CAR 200600012.
