NUREG/CR-5580  
SAND90-1507  
Vol. 2

# Evaluation of Generic Issue 57: Effects of Fire Protection System Actuation on Safety-Related Equipment

Appendices A, B, and C

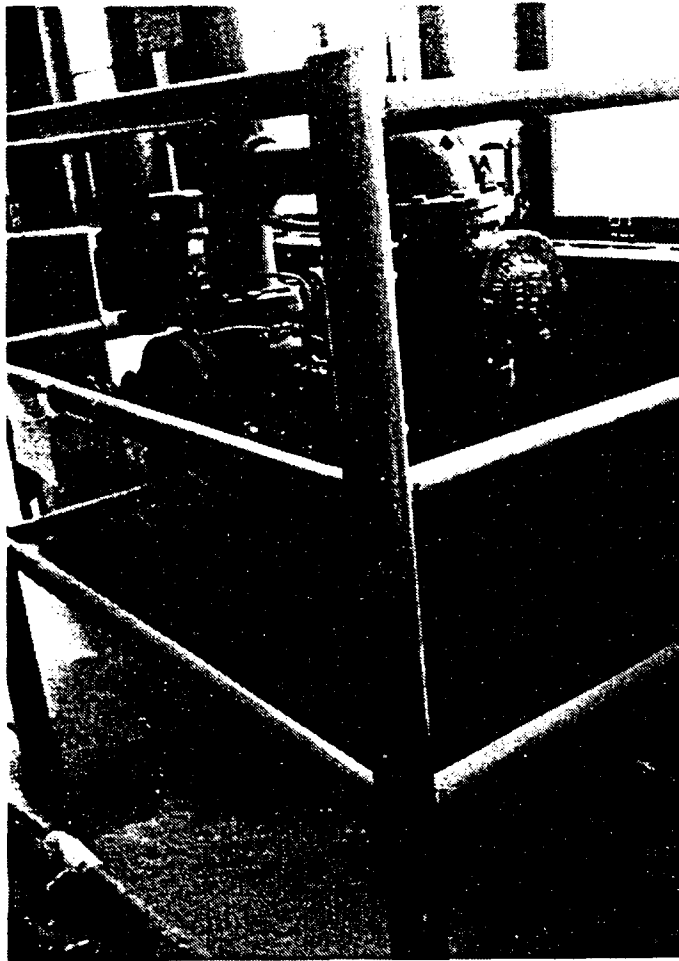
Soil liquefaction contributed to the fire protection system problems. It was reported that virtually all of the 8-inch feed lines broke at the floor penetration flange connection (Figure 3.8). The flange connection is about 6 inches from the floor. Reportedly, the pipe was forced up through the penetration causing shearing of the flange bolts. The resulting displacement caused the lower flange to be 6 inches above the interior feed line flange.

The forces produced by the pipe uplift also contributed to failures in threaded elbow joints at the top of the feed line risers.

Figure 3.8. Typical Valve Station Riser at Oakland Naval Supply Center Which Suffered Soil-Induced Displacement Damage

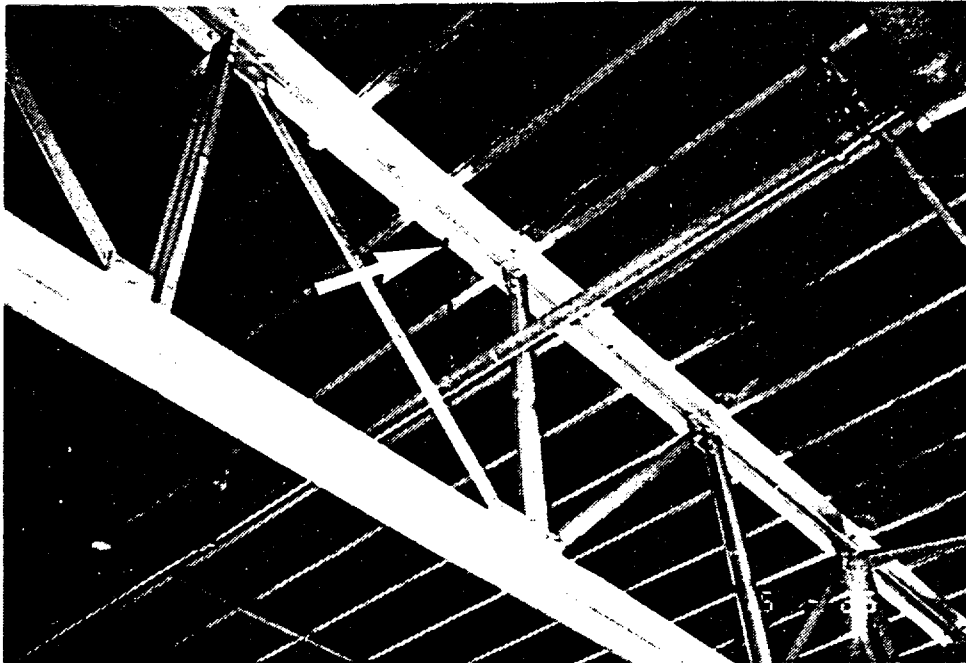
Figure 3.9. C-Clamp Support Used at Oakland Naval Supply Center

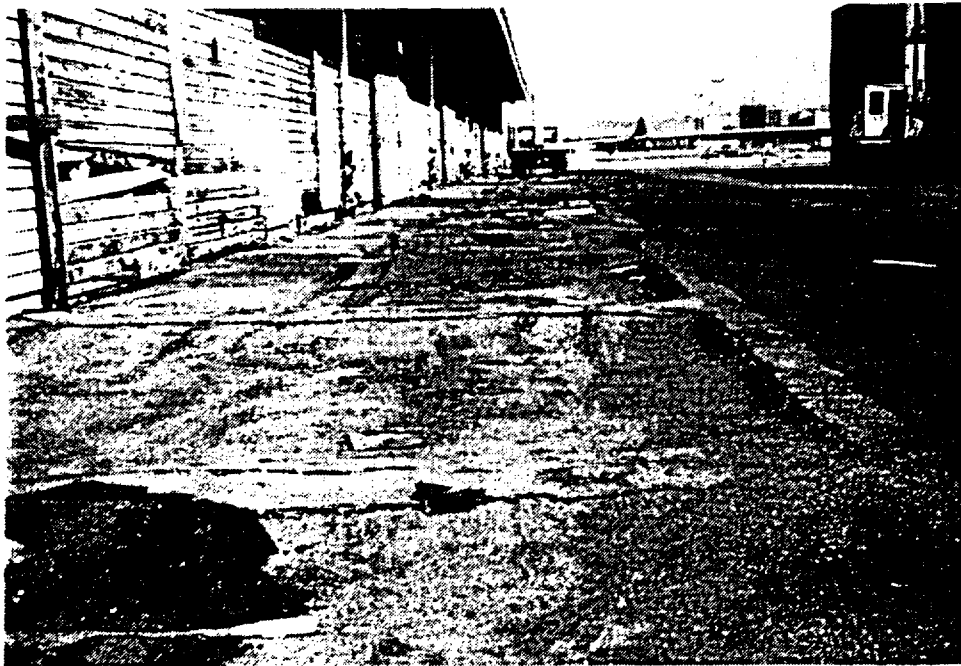
Figure 3.11. Severe Ground Subsidence at Port of Oakland

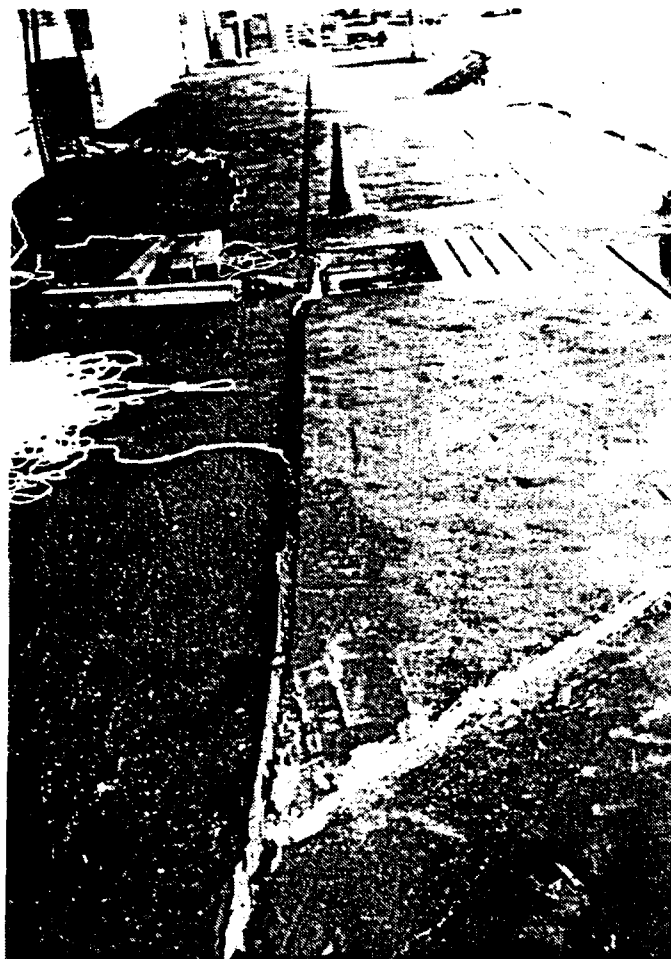
The building is founded on piles driven into the harbor and sits over water. The building rests partially on shore on two adjacent sides. The piles settled during the earthquake and caused the building to pull away from the shore by two to three inches in one direction and approximately one inch in the other direction (Figure 3.12).

Figure 3.12. Settlement at Port of Oakland Warehouse Caused Building to Pull Away From Shore

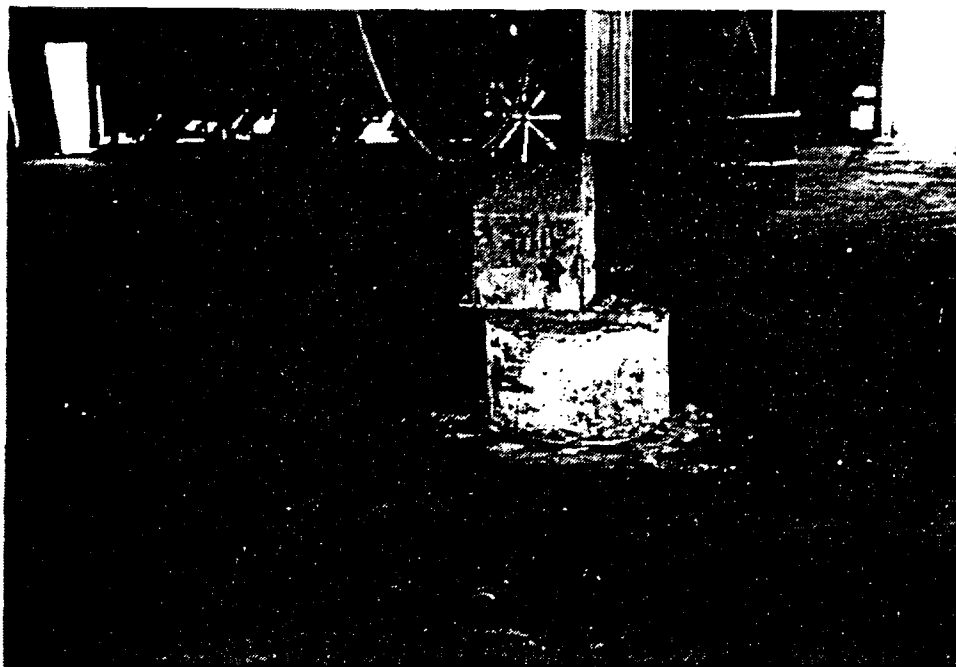
Figure 3.14. Displaced Column at Port of Oakland Wood-Frame Warehouse.  
Building is scheduled for demolition.

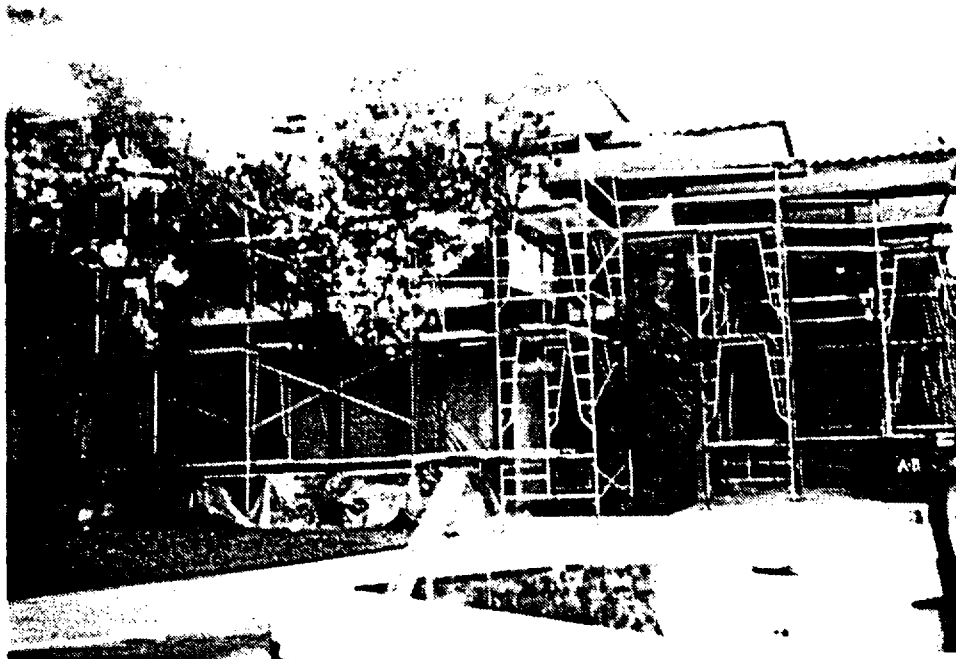
Figure 3.15. Lockheed's Palo Alto Building Experienced Structural Damage in Addition to 6-Inch Diameter Threaded Elbow Failure

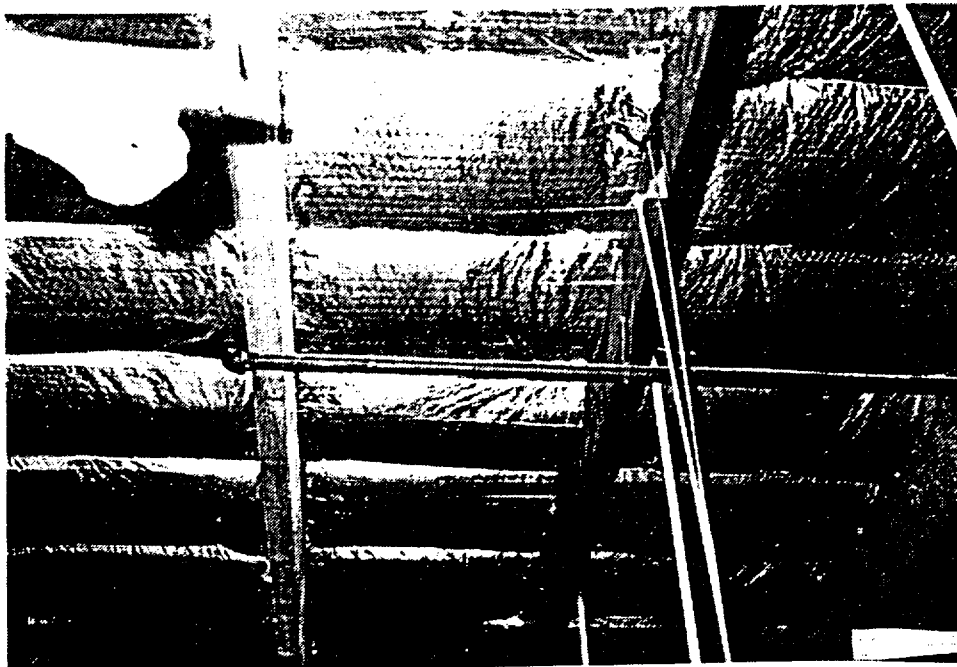
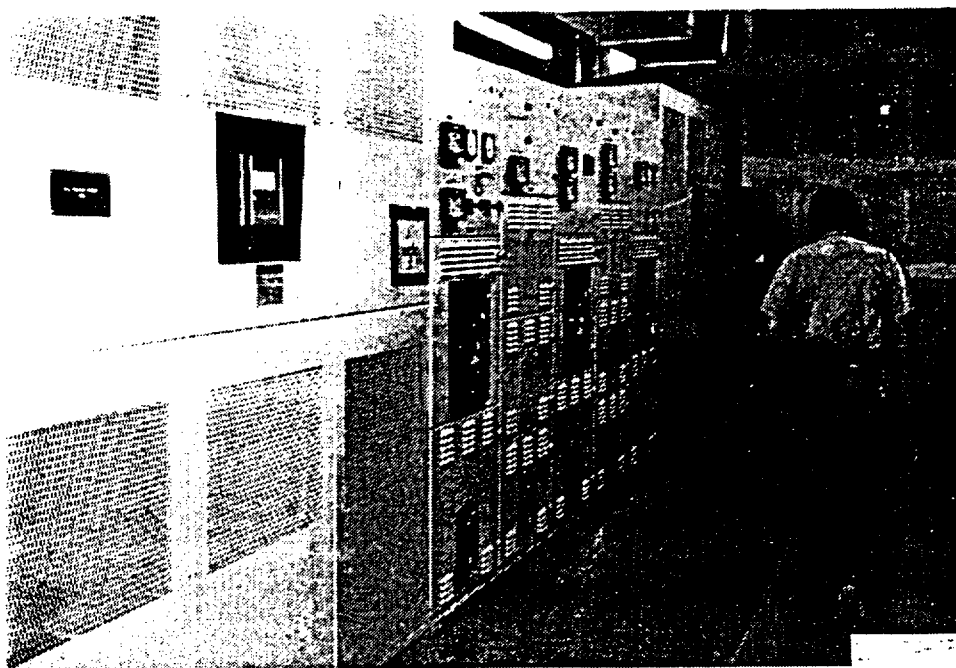
**Figure 3.17.** In One of the Auxiliary Substation Rooms, a Fire Sprinkler Head Failed Upon Impact with Nearby Ceiling Beams (upper photo). Water sprayed into the unit substation below (lower photo), which required disassembly and dry out.

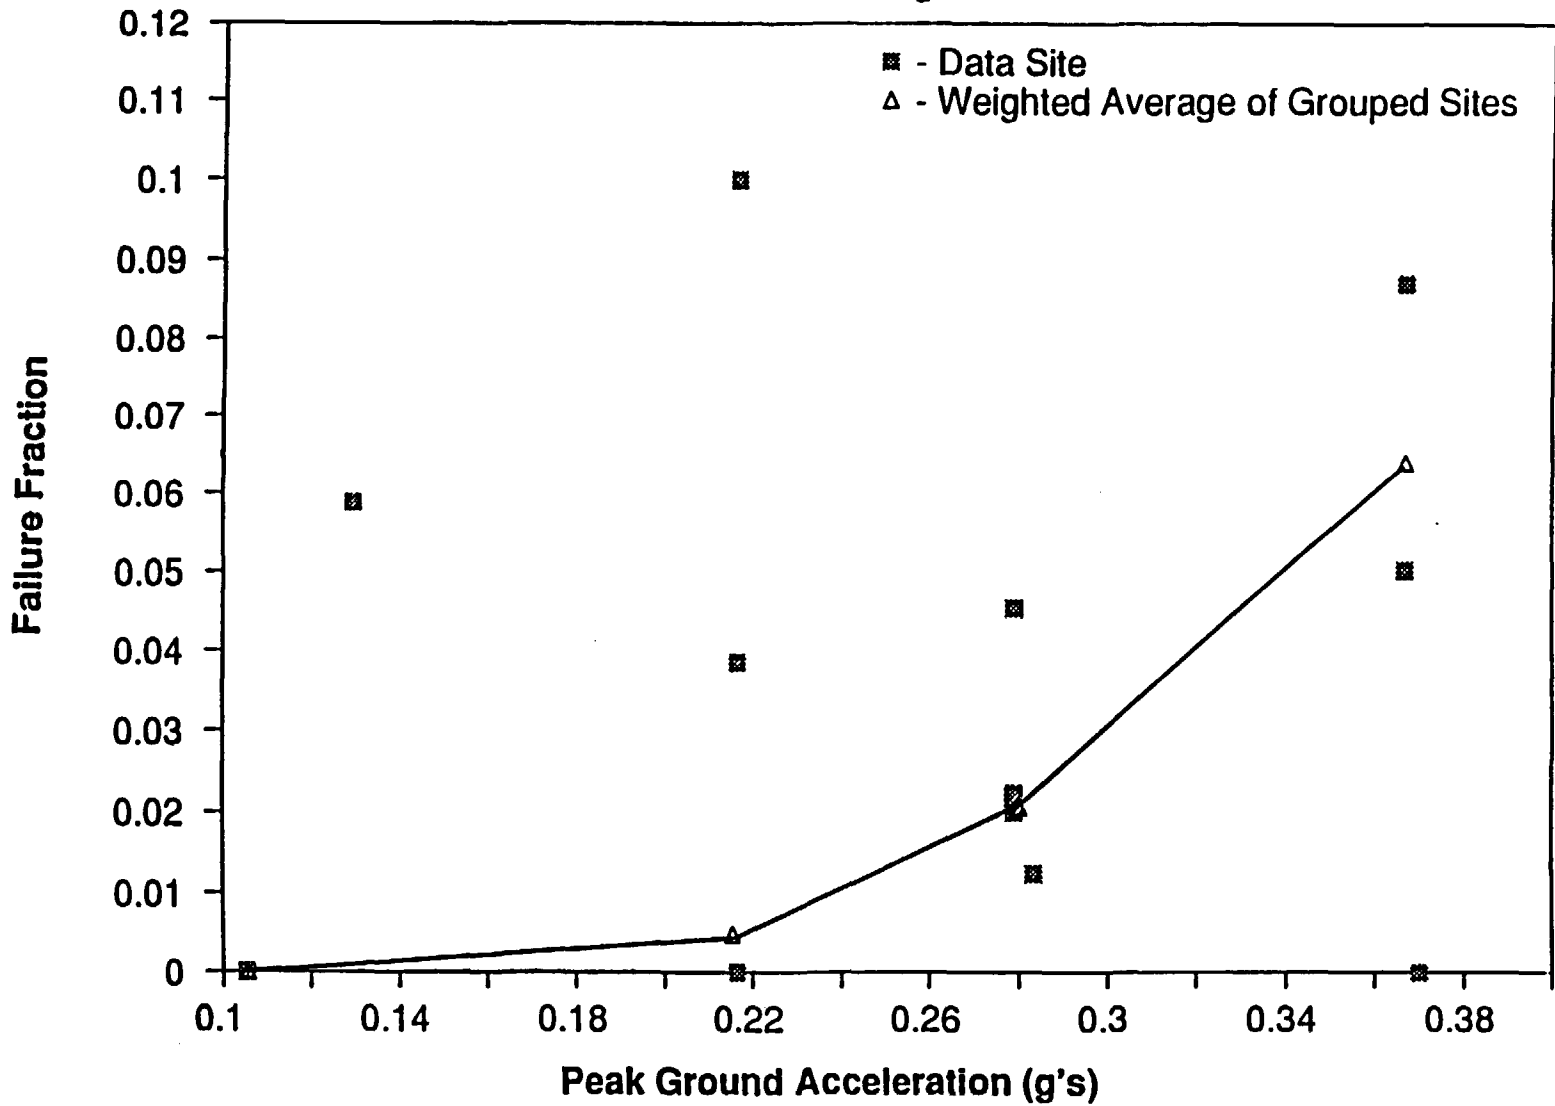
Figure 4.7. Loma Prieta Fire Protection Piping Correlation of Damage to PGA
