SUBJECT: TURKEY POINT NUCLEAR PLANT - NRC INSPECTION REPORT
05000250/2006015; PRELIMINARY WHITE FINDING

U.S. NUCLEAR REGULATORY COMMISSION

Facility: Turkey Point Nuclear Plant, Unit 3

IR 05000250/2006-015; 08/06/2006 - 08/17/2006; Turkey Point Nuclear Power Plant, Unit 3; Other Activities.

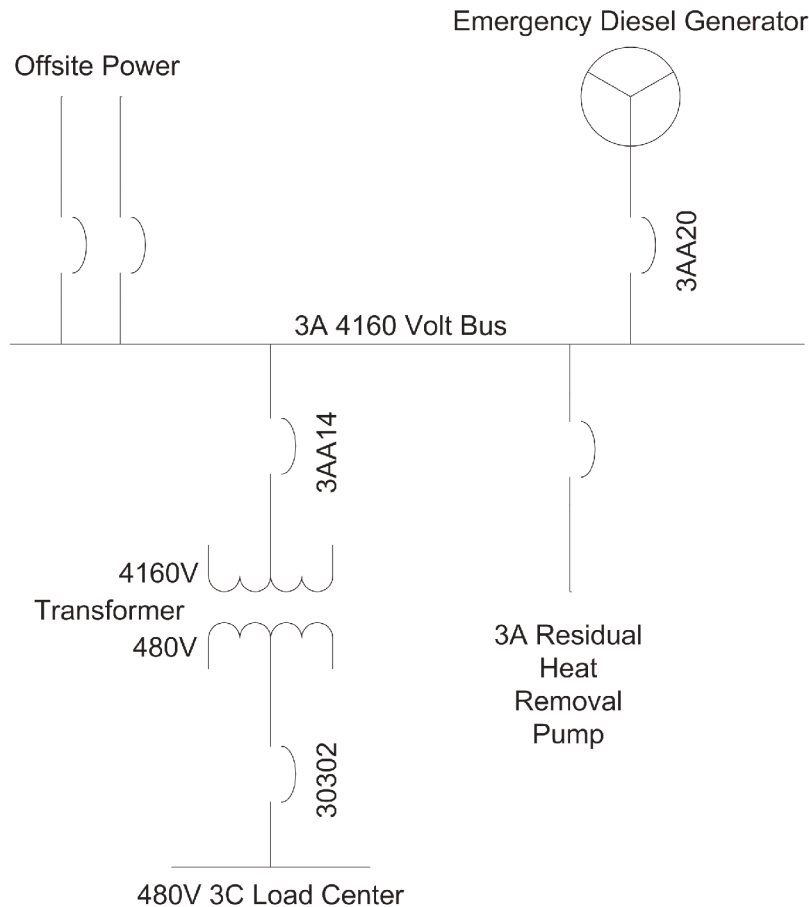
Turkey Point
3A 4160 Volt Bus (Simplified)

Description: On March 8, 2006, following the early completion of electrical bus maintenance, the licensee initiated an electrical restoration to the 3C 480 volt load center from the A 4160 volt safety bus (See figure below).

The 480 volt supply breaker to the 3C Load Center (breaker 30302) had been replaced (like for like) with a refurbished breaker, and unknown to the operators, the auxiliary switch of the breaker was installed such that the breaker open contact was "off" with the breaker shut and "on" with the breaker open, while the opposite was desired. The auxiliary contact made up logic for the 3A bus sequencer which used 3C load center

voltage and breaker (30302) position as an indication of proper electrical status of the safety busses. After breaker 30302 was installed (in the open position), the operator shut 4160 volt breaker 3AA14, "3C Load Center Feed from 3A 4160 Volt Bus" (See Figure). The 3C Load Center remained de-energized, as intended, but because of the reversed auxiliary contacts, the lineup made up sequencer logic that the 3C load center power supply breakers were both shut (while breaker 30302 remained open) and the load center had no voltage, which initiated a sequencer load shed of the 3A 4160 volt bus. The load shed stopped the running A RHR pump, which resulted in a loss of decay heat removal. The sequencer started the 3A emergency diesel generator and re-energized the bus. As expected the A train intake cooling water pump and A train component cooling water pump (both part of the decay heat removal train) were sequenced on. The RHR pump was not restarted and operators entered 3-ONOP-004.12, "Loss of 3A 4KV Bus While on Backfeed", which assured proper electrical sequencing. Had proper sequencing not taken place, the procedure would have directed actions to restore power to the 3A bus. Because the sequencer had worked properly, 3-ONOP-004.12 directed transition to 3-ONOP-004.10, "Loss of Offsite Power While on Backfeed", which assured proper starting and loading of the diesel generator. Because decay heat removal had stopped, 3-ONOP-004.10 directed the operators to 3-ONOP-050, "Loss of RHR", which was used to restore decay heat removal. During the loss of cooling, the coolant system temperature increased from an estimated 113 degrees F to 140 degrees F.

The loss of shutdown cooling could have been prevented by any one of the following risk management actions: 1) The 3B RHR pump could have been started prior to the switching evolution to provide core cooling while performing the restoration activities on the A 4160 volt to 480 volt load center; 2) The 3A sequencer could have been disabled to prevent load shed should a sequencing or other problem with the restoration operations occur; and 3) The 480 volt breaker being installed could have been appropriately tested or inspected prior to placing the breaker in service to detect the improper auxiliary switch status.
