August 29, 2006

L-2006-199
10 CFR 50.4

RE: St. Lucie Unit 2
Docket No. 50-389
Response to Request for Additional Information on
SL2-15 Steam Generator Inspection Reports

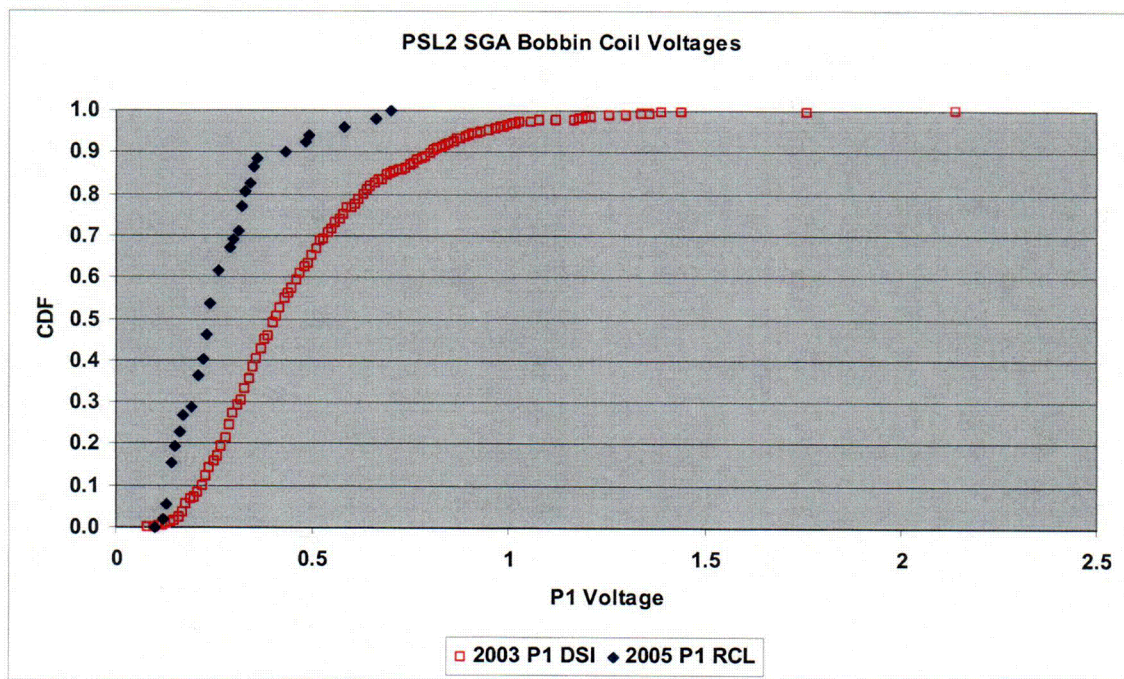
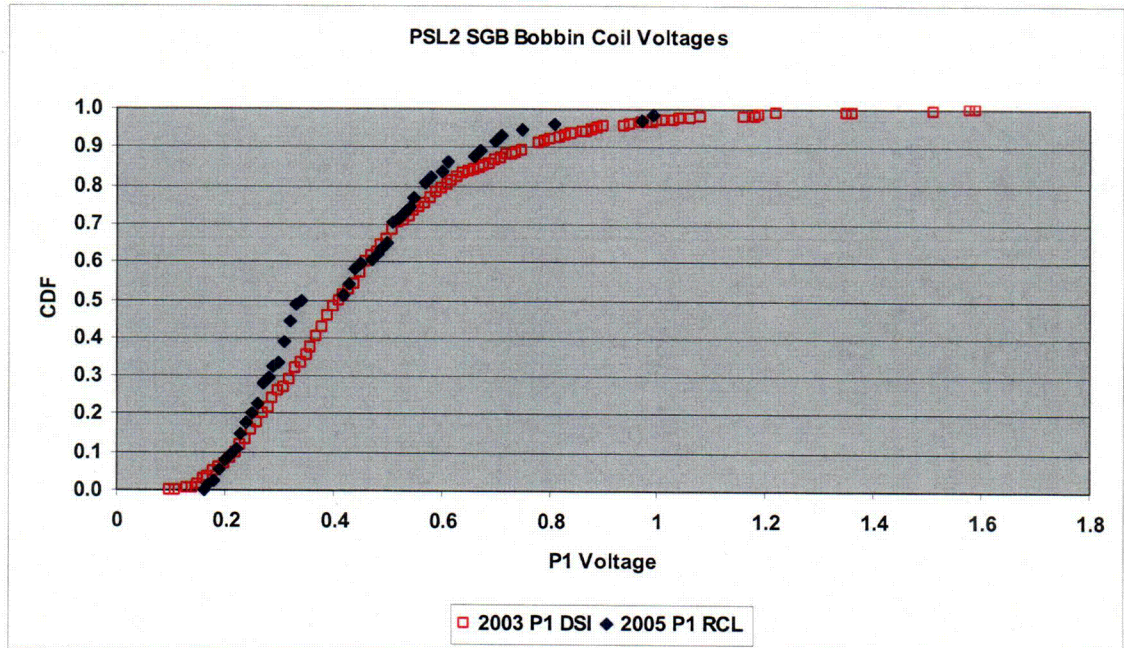
Reply to Observation a. - Comparison of voltages for 2005 RCL bobbin coil indications and 2003 bobbin coil associated with 2005 confirmed DSI indications are shown in the following 2 figures. Note that the bobbin coil voltages for the 2005 RCL indications fall to the left of the look back bobbin coil voltages (i.e., 2003 voltage) for the confirmed DSI indications identified in 2005. The smaller voltages for the RCLs supports the probability of detection used in the OPCON model for axial ODSCC eggcrate degradation.

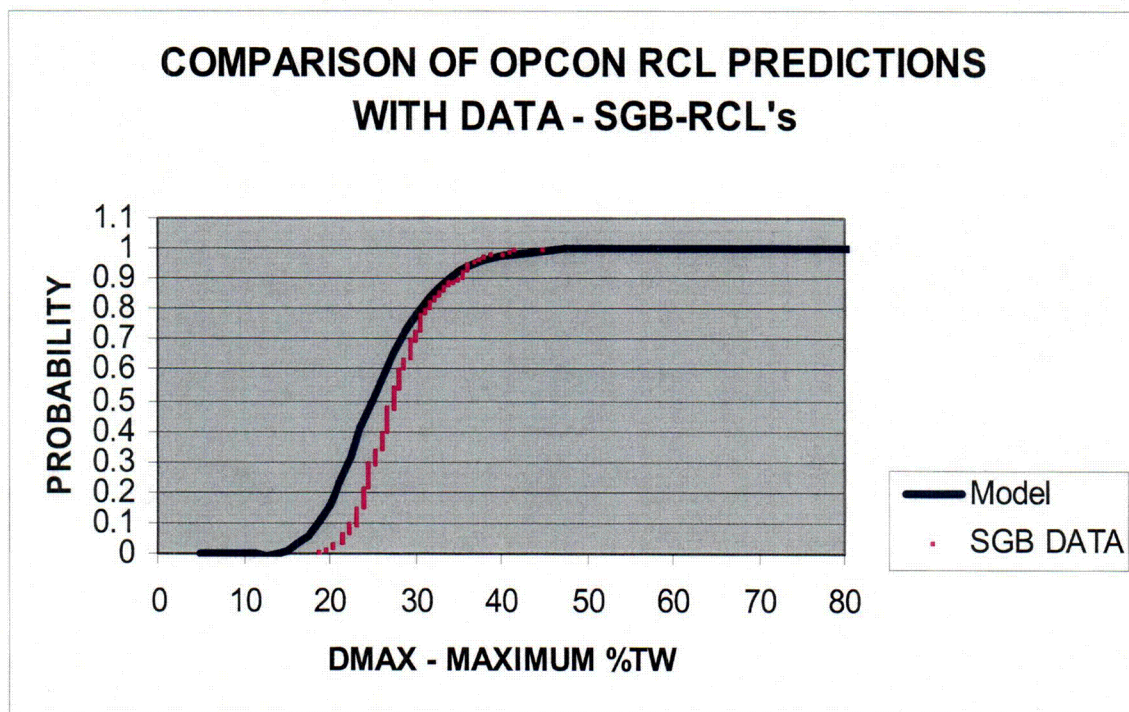
Reply to Observation b. – A comparison between observed RCL's and OPCON model predictions for the 2005 outage is shown in the figure below. The depth distribution for RCL's predicted by OPCON agrees well with the data, particularly in the more critical upper region. The estimated number of RCL's predicted by the model is approximately 220. This is somewhat conservative by comparison with the 200 observed in the 2005 outage for SG-B. The 220 flaws predicted by the model are based on a limited inspection corresponding to the number of 2005 DSI pull-out scans.

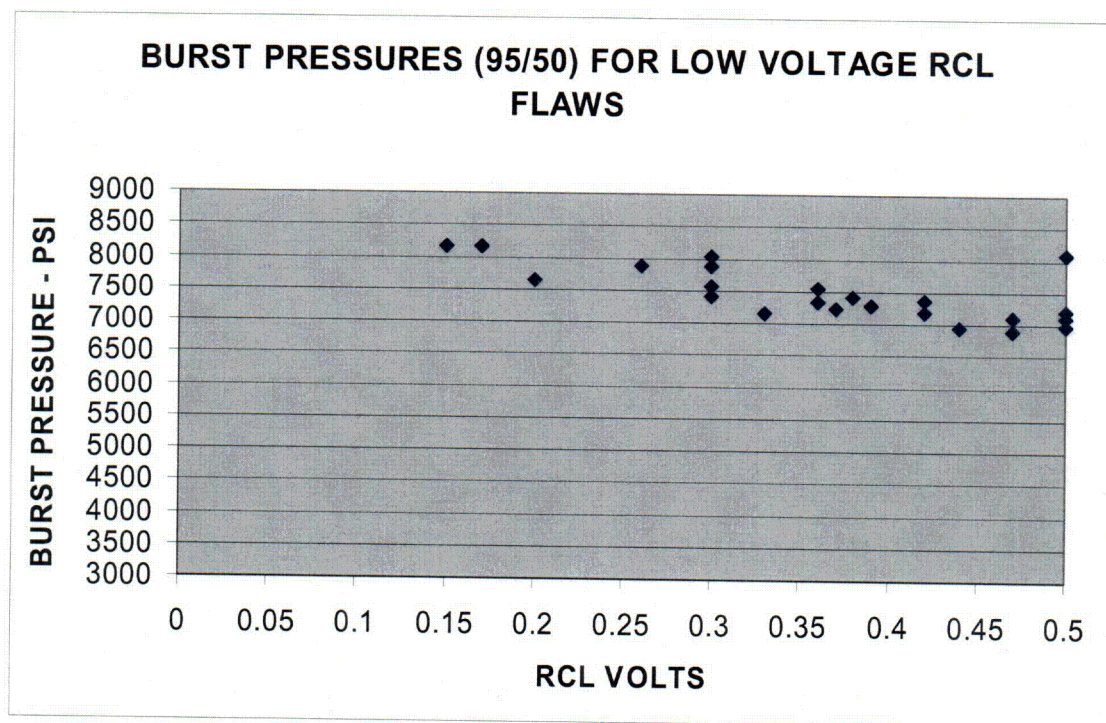
Reply to Observation e. - Computed burst pressures for lower voltage RCL's are shown in the following figure. It can be clearly seen from the figure that RCL's with voltages less than 0.35 volts do not challenge the structural limit.

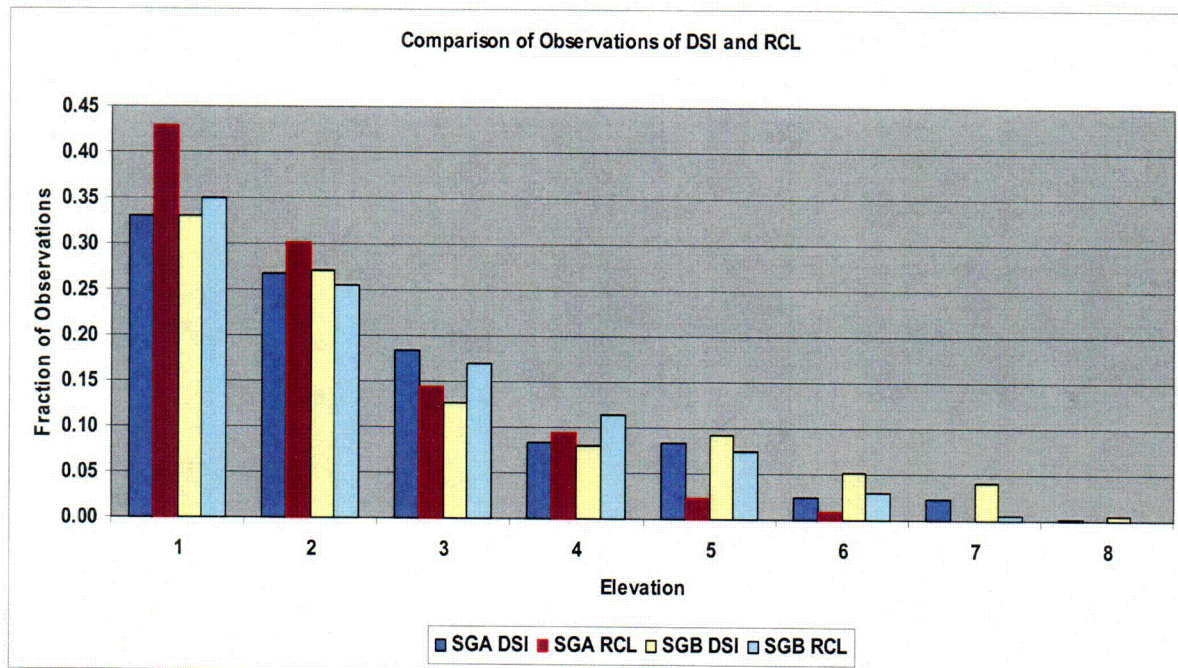
Reply to Observation f. - The frequency of occurrence of DSI and RCL per elevation are shown in the following figure. Note that the distributions are quite similar, reinforcing the impact of the Probability of Detection function.
