**Subject: Licensee Event Report 2006-002 Revision 0 for the Fort Calhoun Station**

Fort Calhoun Station

Inadequate Design Control Results in Potentially Insufficient Auxiliary Feedwater Flow

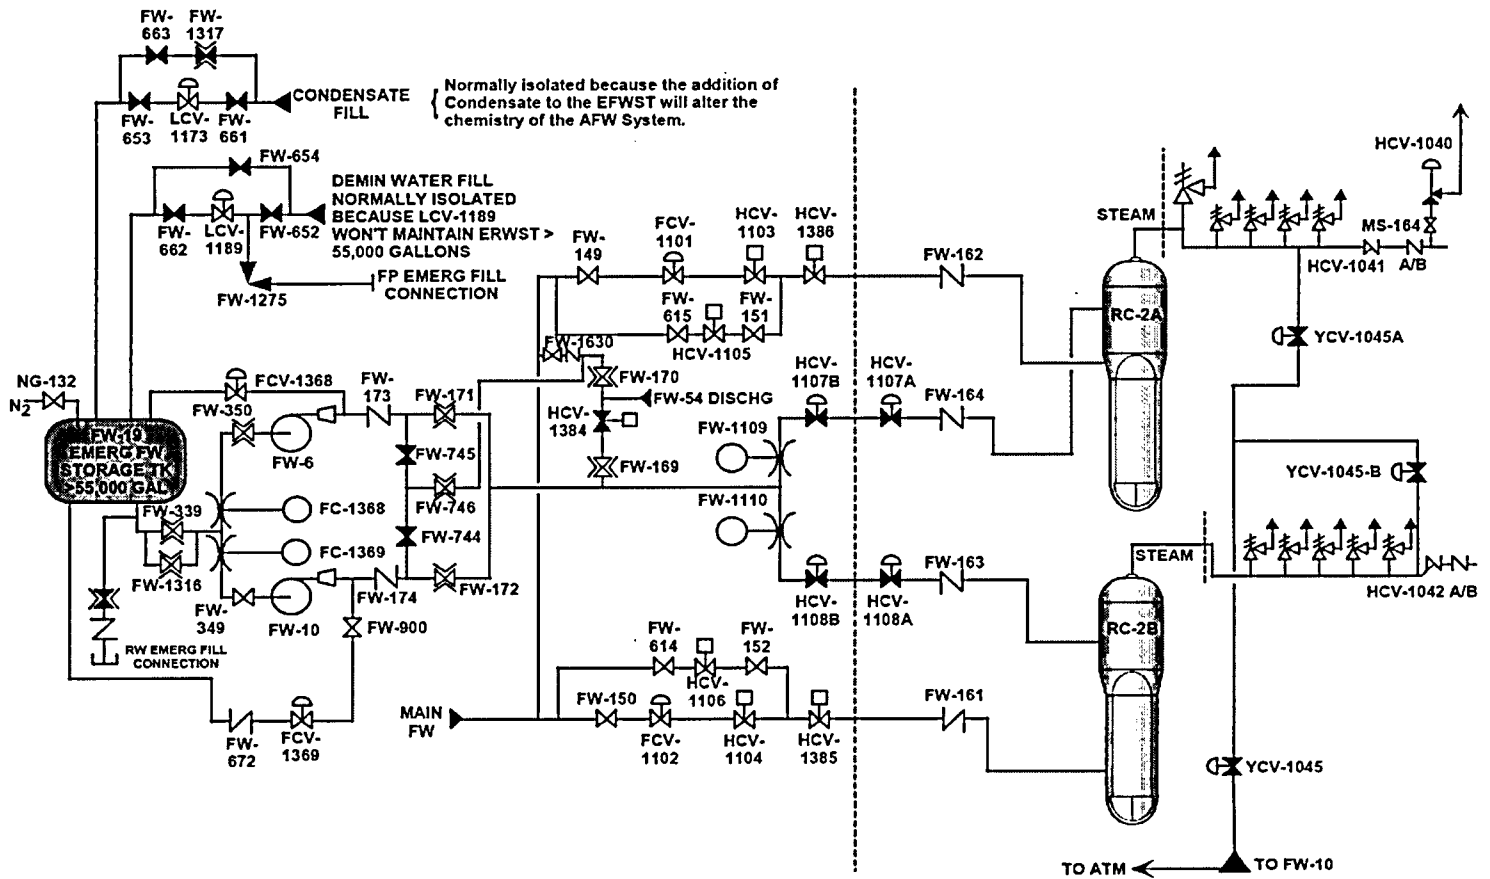
Figure 1

The system is designed to add feedwater to either or both steam generators under any condition, including the loss of all electrical power along with the loss of the MFW system and the loss of the main steam piping downstream of the main steam isolation valves. The AFW system fulfills both safety-related and non-safety-related functions. See Figure 1.
