Byron Station, Unit 2  
Facility Operating License Nos. NPF-66  
NRC Docket Nos. 50-455

Subject: Response to Request for Additional Information Regarding the Byron Station,  
Unit 2 Fall 2005 Steam Generator Inspection

**Additional Information Regarding the Byron Station Unit 2  
Fall 2005 Steam Generator Inspection**

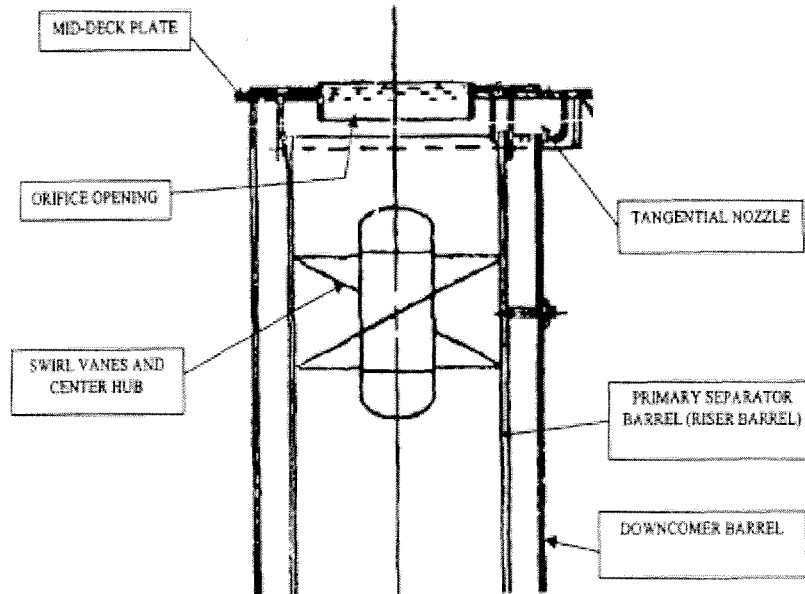
**FIGURE 3-2**  
**Westinghouse Model D-5 Generator**  
**Byron Station Unit 2 Primary Separator Assembly**

During the visual inspection of the primary separator assembly region, areas were identified where the normally present magnetite layer was missing, thus providing areas for erosion to develop. The areas included portions of the tangential nozzles, portions of the inner surface of the primary moisture separator downcomer barrels, a number of primary separator swirl vanes, spacer tabs and orifice rings. Refer to Figure 3-2 for a sketch of these components. This condition existed on 12 of the 16 primary separator assemblies. The components identified with the missing magnetite layer are fabricated from carbon steel, typically American Society for Testing and Materials standard specification A-285, "Pressure Vessel Plates, Carbon Steel, Low and Intermediate-Tensile Strength," Grade C, material. The manufacturing nominal wall thickness for these components was 0.250-inch. To supplement the visual inspection observations, ultrasonic (UT) thickness measurements were taken in areas of magnetite loss with most apparent erosion.

In a few instances, some of the welds that join the primary separator assembly sub-parts contained very localized material loss of not more than an estimated 25%. Additionally, on several primary separator barrel ID wall surfaces where magnetite was missing, a narrow localized depression (scallop) was observed to exist at the junction with the trailing edge of the swirl vane blades. The depression was too narrow to obtain a UT thickness measurement, but the worst-case location was estimated to have a 40% wall loss in a very localized area. There were no areas of through wall erosion observed in any of the components inspected.
