***Beaver Valley Power Station, Unit No. 1***  
***Docket No. 50-334 License No. DPR-66***  
***LER 2006-003-00***

LER 2006-003-00, 10 CFR 50.73(a)(2)(i)(B), "Inadvertent Technical  
Specification Noncompliance Due to Inoperable Containment Isolation Valve."

Inadvertent Technical Specification Noncompliance Due to Inoperable Containment Isolation Valve

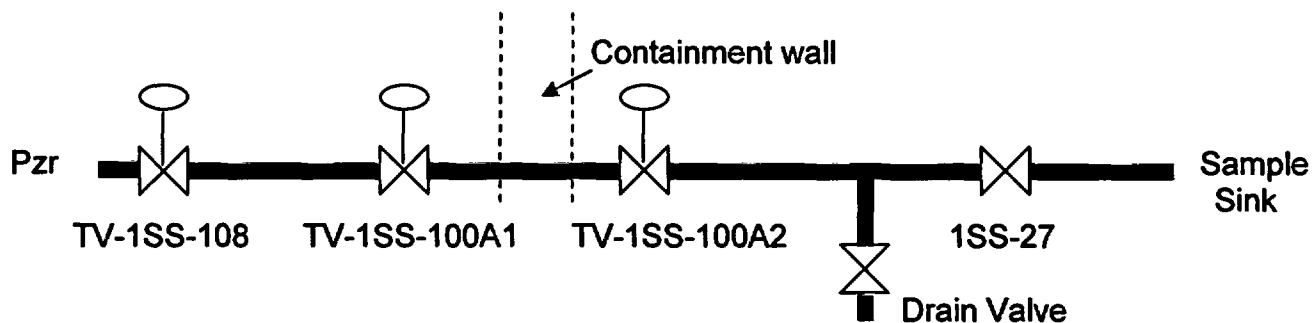
## Simplified Sketch of Valves

At approximately 1300 hours, a maintenance clearance was initiated to isolate sample system manual valve 1SS-27 just downstream of the outside containment isolation valve, TV-1SS-100A2. The air supply to TV-1SS-100A2 was isolated shortly thereafter. Since the valve's actuator was not vented, the valve remained open, and was inoperable due to it not being capable of automatic closure. The upstream inside containment isolation valve (TV-1SS-100A1) remained in its normally open position during this time (which was not intended to be closed). Although the next further upstream valve inside containment, TV-1SS-108, remained in its normally closed position, it did not have its power removed.

Since there was no closed and de-energized automatic valve, no closed manual valve, no blind flange or a check valve with flow secured, then BVPS Unit 1 did not comply with Action a within 4 hours of TV-1SS-100A2 becoming inoperable and was not in Hot Standby within the following 6 hours since TV-1SS-100A2 was not closed and de-energized until approximately 10.6 hours after its air supply was initially isolated. Thus, this was an inadvertent non-compliance with Technical Specification 3.6.3.1, and is reportable pursuant to 10 CFR 50.73(a)(2)(i)(B) as a condition prohibited by the plant Technical Specifications.

There were two root causes for this event. Human performance errors (inattention to detail) occurred during the development, review/approval and implementation process that resulted in inadequate/incomplete clearance instructions. Two independent reviews and a final Operations department approval failed to identify that the clearance did not provide adequate information to ensure desired execution, and failed to recognize the potential technical specification applicability to this evolution. These failures were attributed to various mindsets about the sequence of instructions, and a lack of a questioning attitude.

1. Upon discovery, actions were immediately taken to close and de-energize the affected containment isolation valve.
2. The causes of this event and the related ineffective human performance behaviors will be reviewed with BVPS Unit 1 and Unit 2 Operations personnel involved with the clearance process.
3. A repetitive administrative task will be developed for Operations supervision/management to perform field observations that focus on the use of human performance tools during clearance activities to ensure Technical Specification references are provided. Operations Management will reinforce expectations for clearance development.
