VERMONT YANKEE NUCLEAR POWER CORPORATION

REFERENCE: Operating License DPR-28
Docket No. 50-271
Reportable Occurrence No. LER 91-14

TITLE (4) Reactor Scram Due to Loss of 345KV Switchyard Caused by Defective Off-Site Carrier Equipment

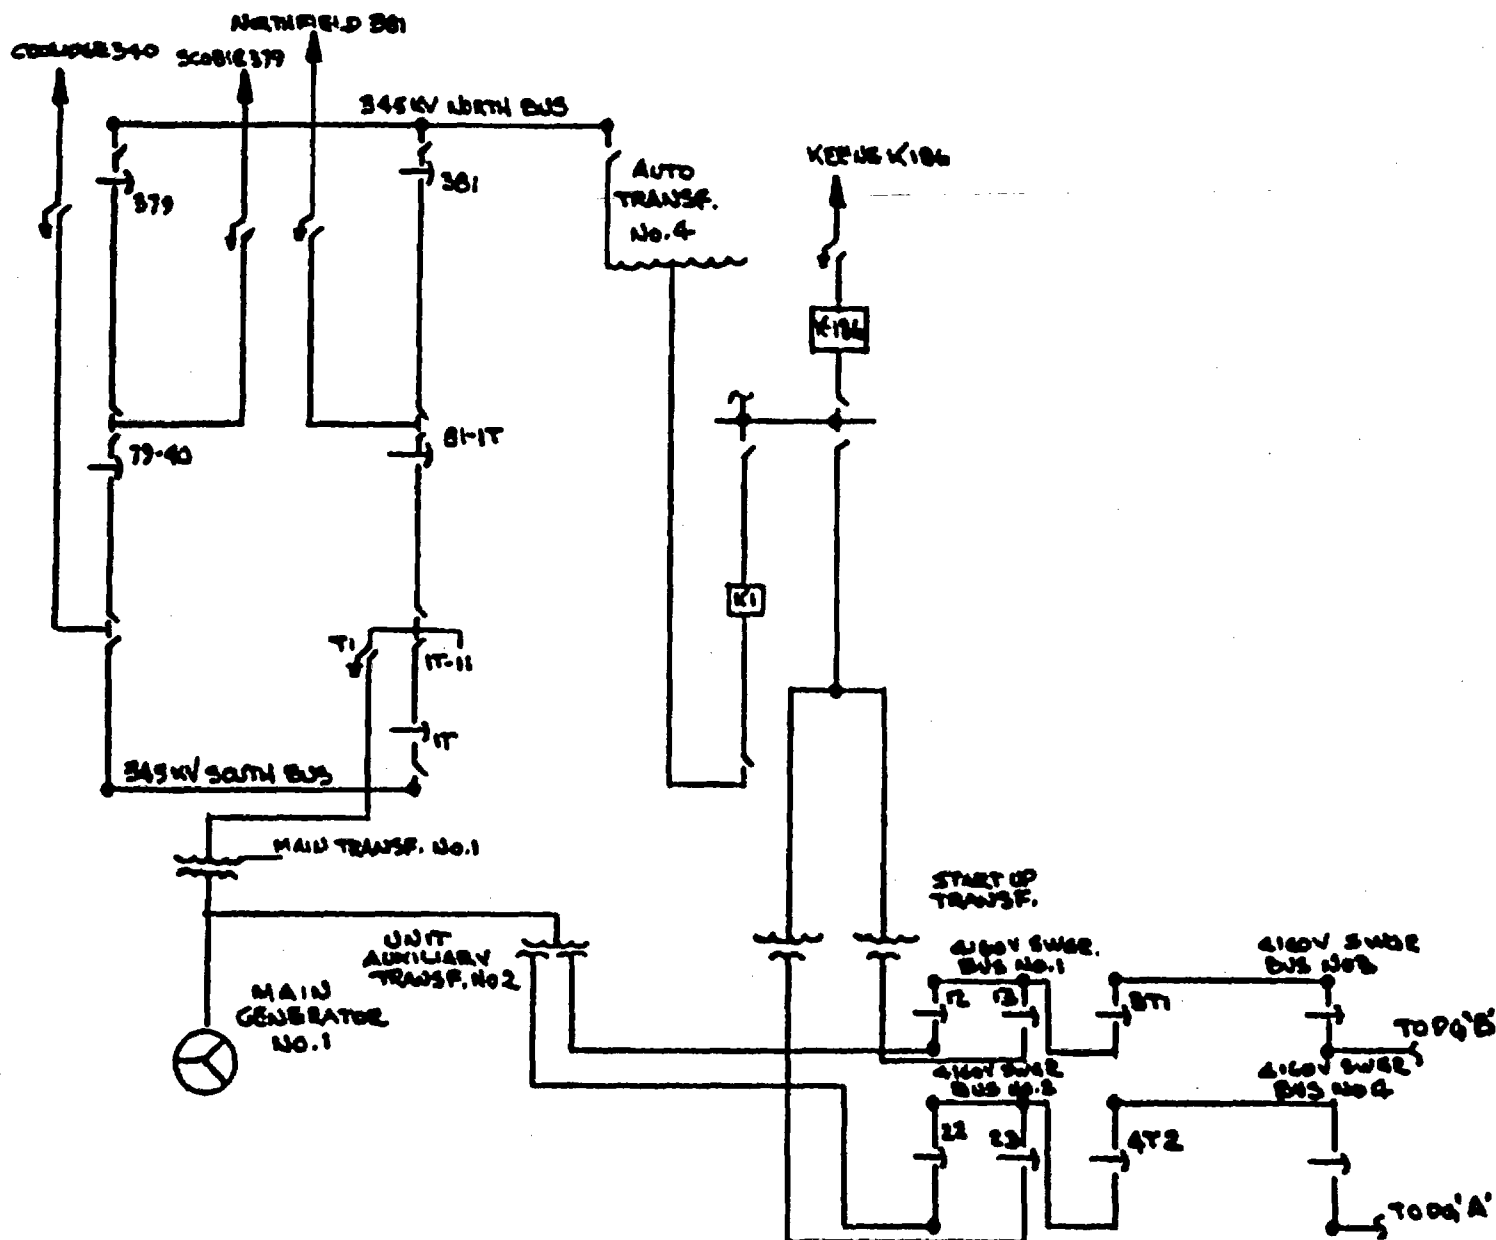
SWITCHYARD DISTRIBUTION

The Root Cause of this event is a defective (shorted) transistor in offsite (Scobie Pond) Protective Relaying System Carrier equipment. The lightning strike which occurred on the "B" phase of the 381 Transmission line between VY and Northfield, Ma. would normally have only resulted in an isolation of the 381 line. However, the defective component in the Scobie Pond Carrier equipment caused a subsequent loss of the 379 line. This routed the full Generator output through the 340 (Coolidge) line. The Coolidge line cannot handle full generator output and tripped out on overload which resulted in a loss of the 345KV yard and caused the Reactor to Scram on Generator Load Reject.

After the plant Scram, an extensive testing and troubleshooting effort was performed by Vermont Yankee and New England Power Service Co. (NEPSO) to determine the cause of the Scobie Line Carrier trip. It was found that the the equipment on the VY end operated as designed and sent a Carrier block signal to Scobie to prevent tripping. Although the signal was received at Scobie Pond, the trip signal was not blocked. A failed transistor in the Carrier equipment logic section prevented the blocking signal from reaching the tripping logic. Since the tripping logic did not see a blocking signal it caused the Scobie line to trip at Scobie Pond and Vermont Yankee.

Immediate corrective actions included recovering from the reactor scrams, troubleshooting and repair of the Scobie Pond equipment, and reactor stabilization utilizing appropriate plant procedures.

VY Maintenance Department and VELCO Switchyard Engineers will evaluate testing requirements for Switchyard Carrier systems.
