SUBJECT: Tub replacement for main condenser at Columbia Generating Station

Columbia Generating Station

Main Condenser

By W. Scott Oxenford, VP Technical Services

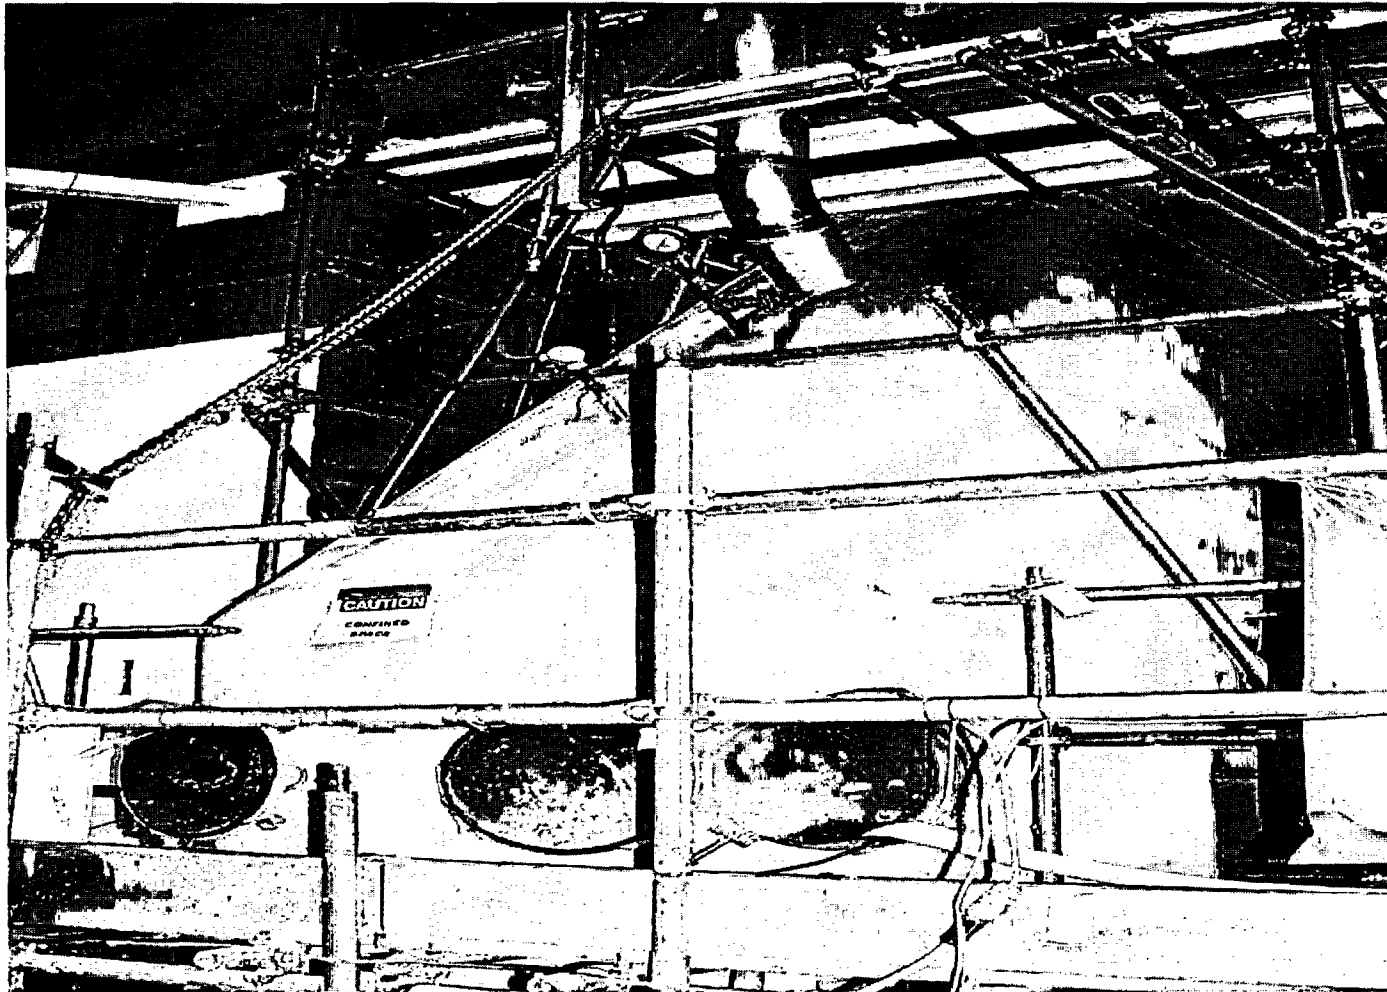
FIGURE 2A, Main Condenser Waterbox

Entry into the condenser waterboxes at power is a challenge to personnel safety. Single isolation valves (some eight feet in diameter) provide worker protection from system pressure. Entry is through small manways as shown in the picture.

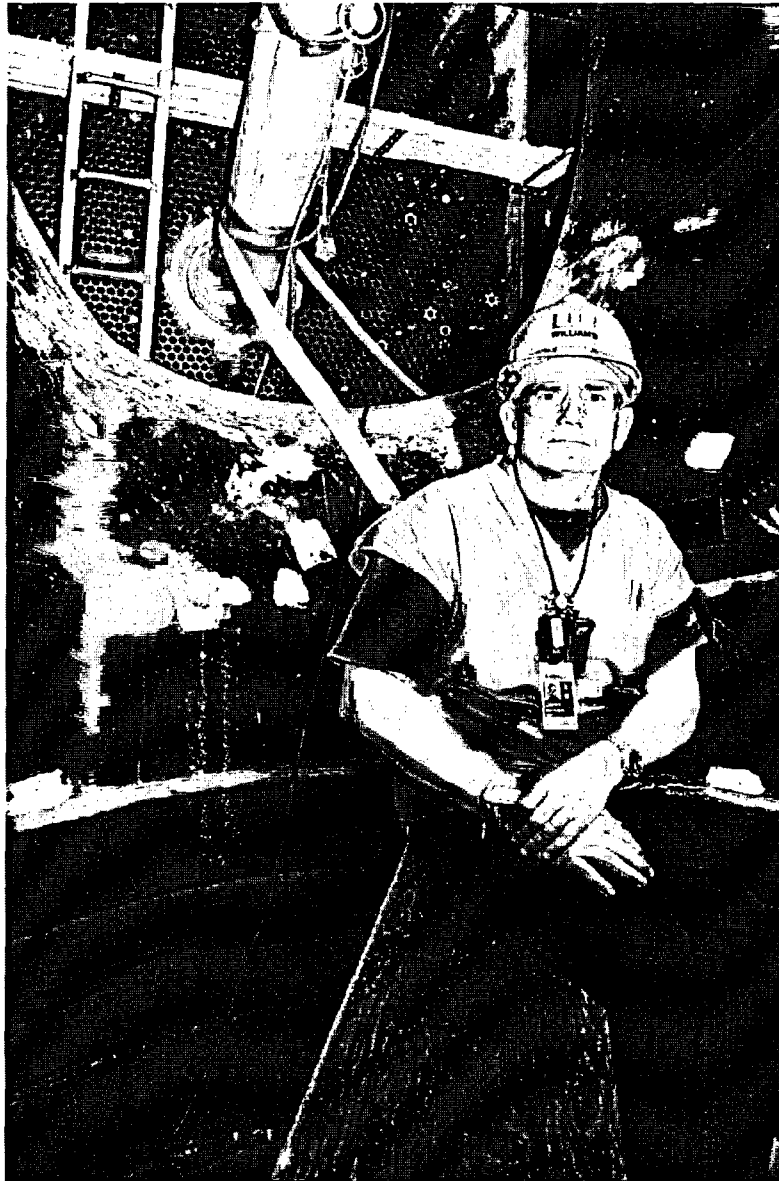
FIGURE 2B, Main Condenser Waterbox
This shows a worker inside the condenser waterbox.

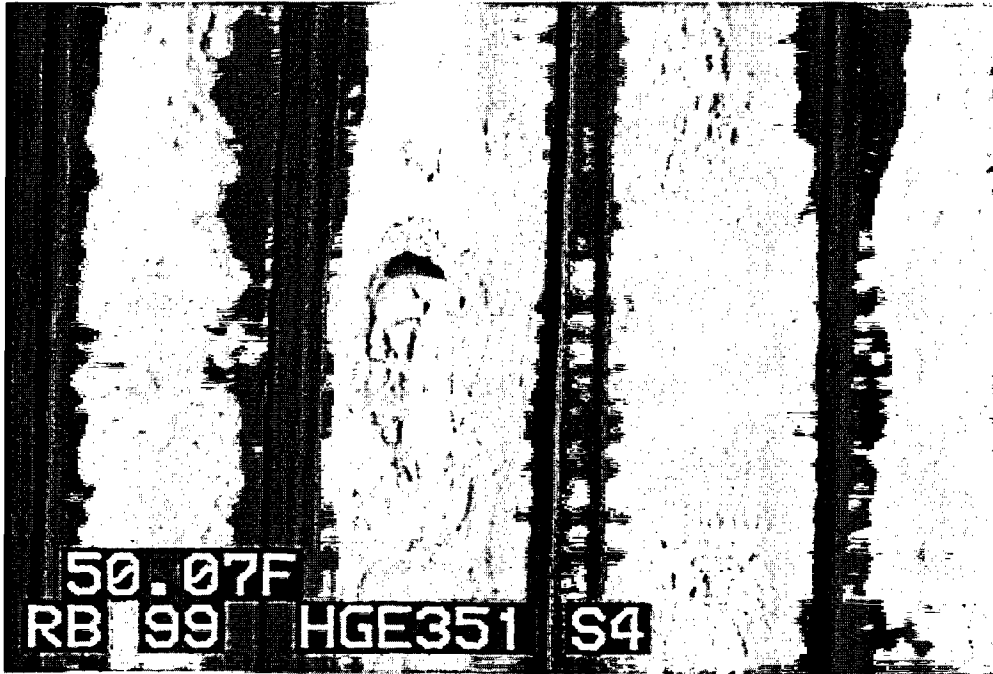
FIGURE 4, Failed fuel due to crud and accelerated corrosion.
This fuel was exposed to anomalous primary coolant chemistry, resulting in a heavy
oxide layer and accelerated corrosion in 1999. It was fresh fuel.

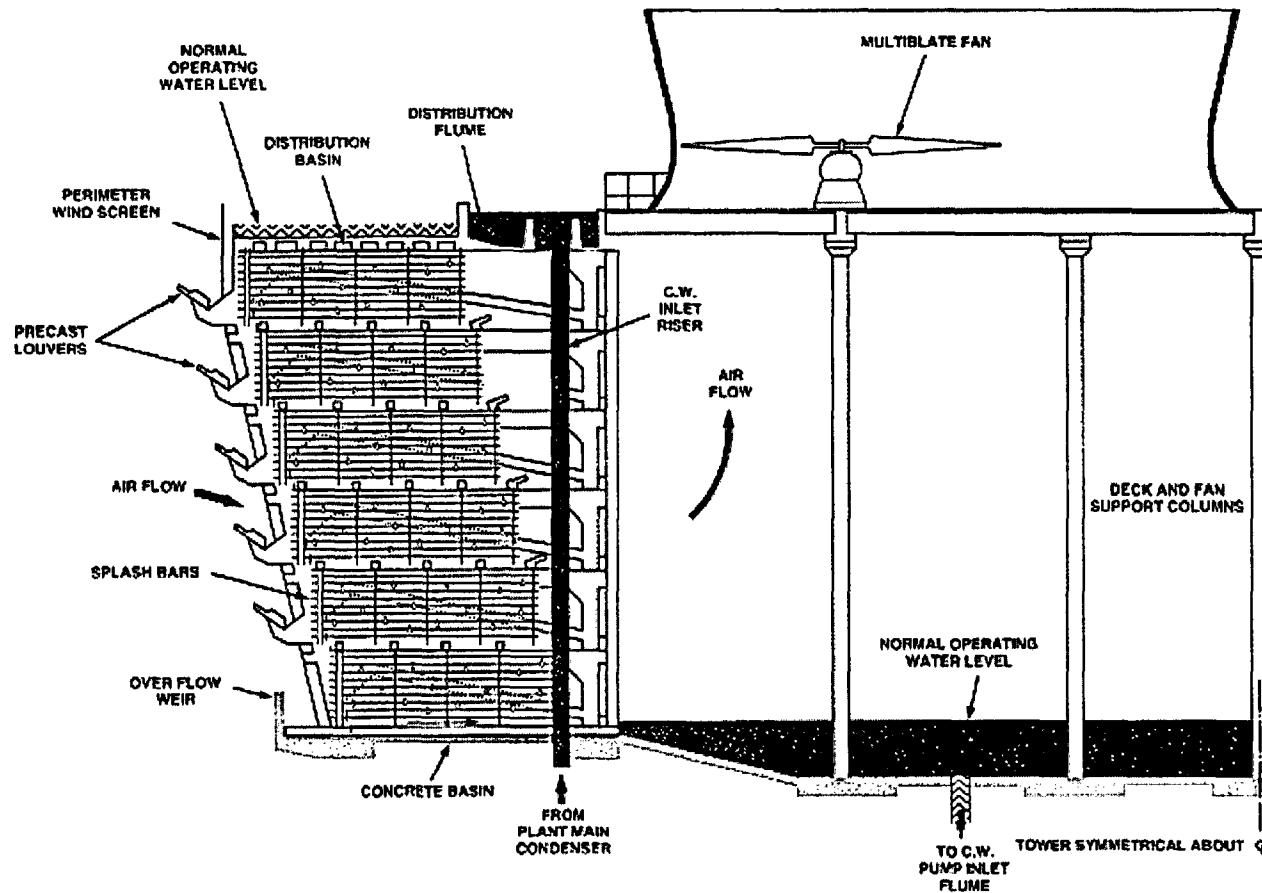
FIGURE 6A, Cooling Tower

Cooling towers, due to their design purpose of transferring heat to the environment, are open and susceptible to items being blown in, dropped in from animals, and dropped in during work under adverse conditions. Additionally, the extreme weather variations, water flows, chemical additives, and ice build-up cause corrosion and damage that create debris. Any raw water screen system can reduce debris intrusion, but none appear to be 100% effective.

As illustrated, the cooling towers have many openings to the environment that allow debris entry.

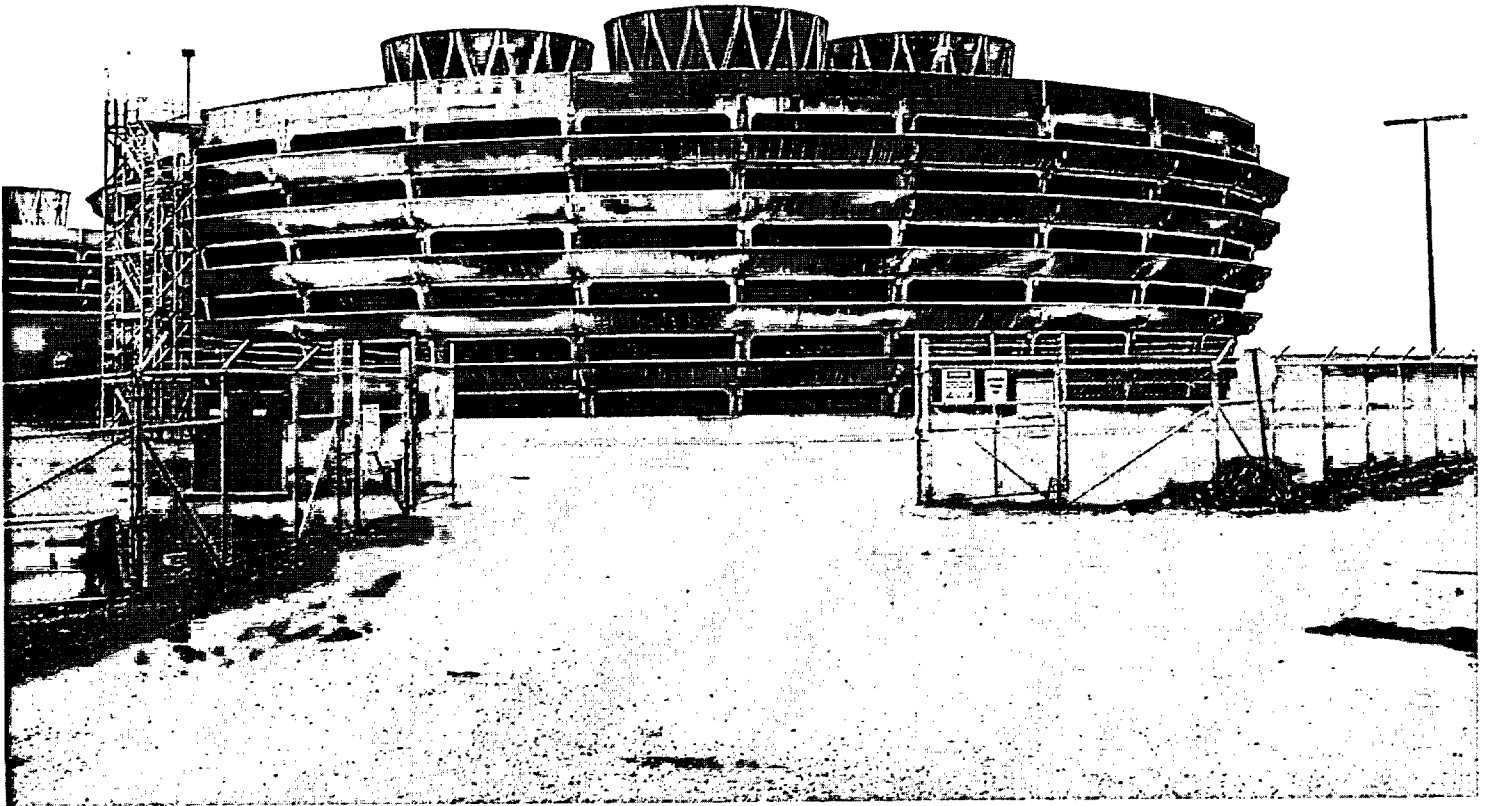
FIGURE 6B, Cooling Tower.
Large fans and vertical louvers allow debris entry pathways.

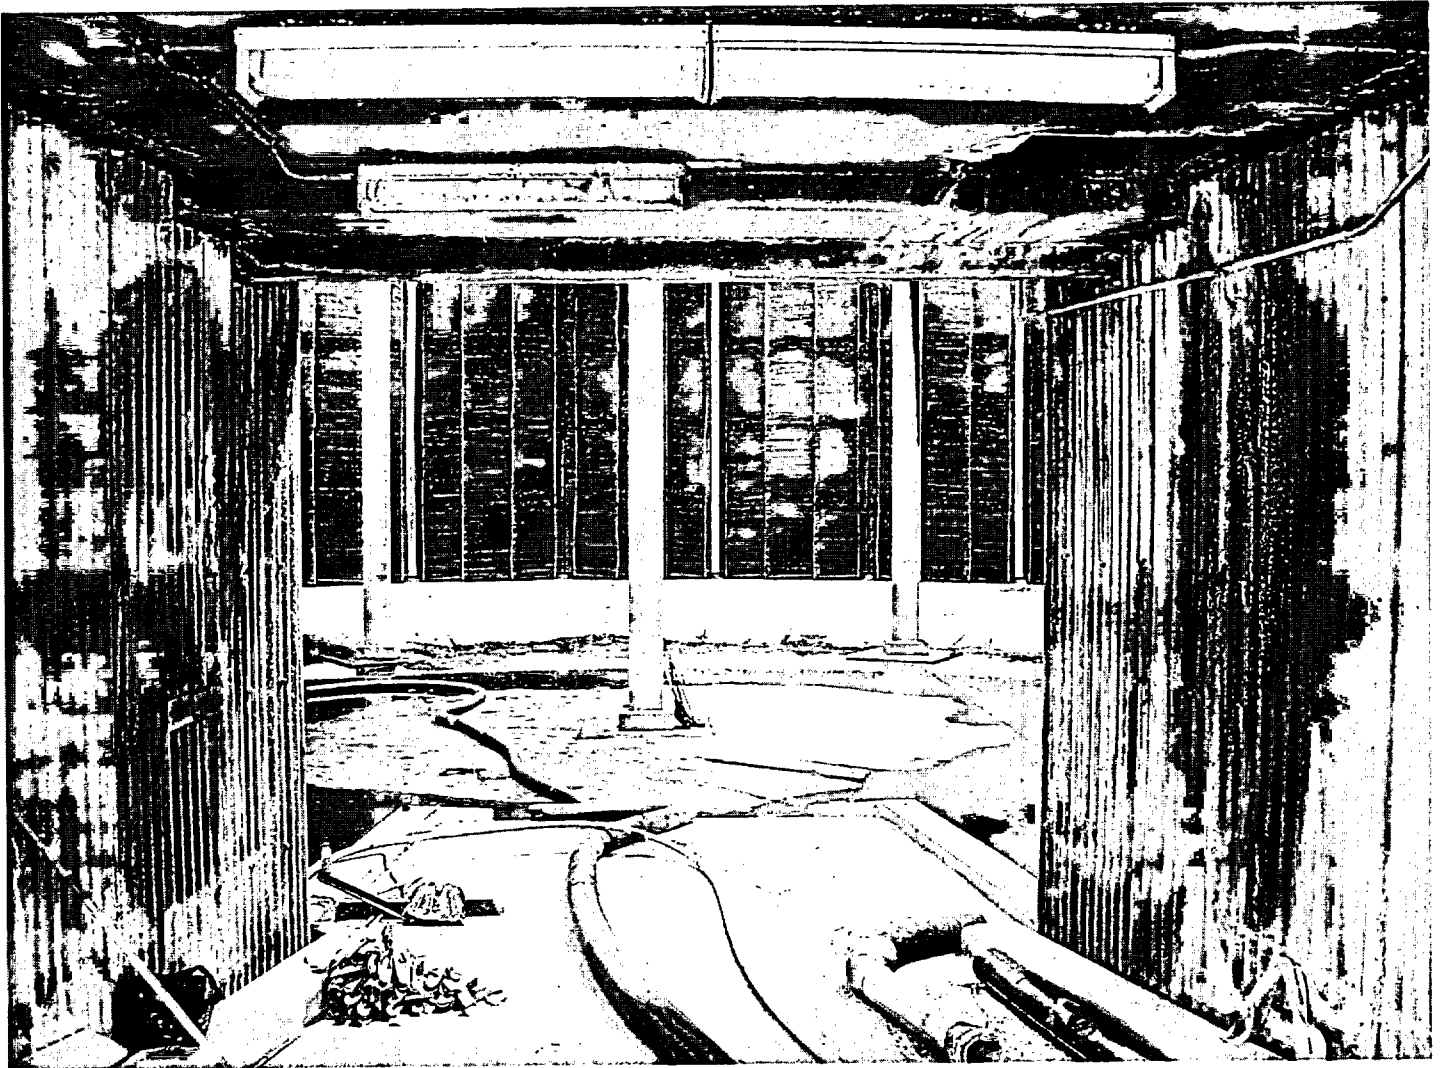
FIGURE 6C, Cooling Tower

Inside a drained Cooling Tower. Workers are careful to remove debris prior to returning it to service.

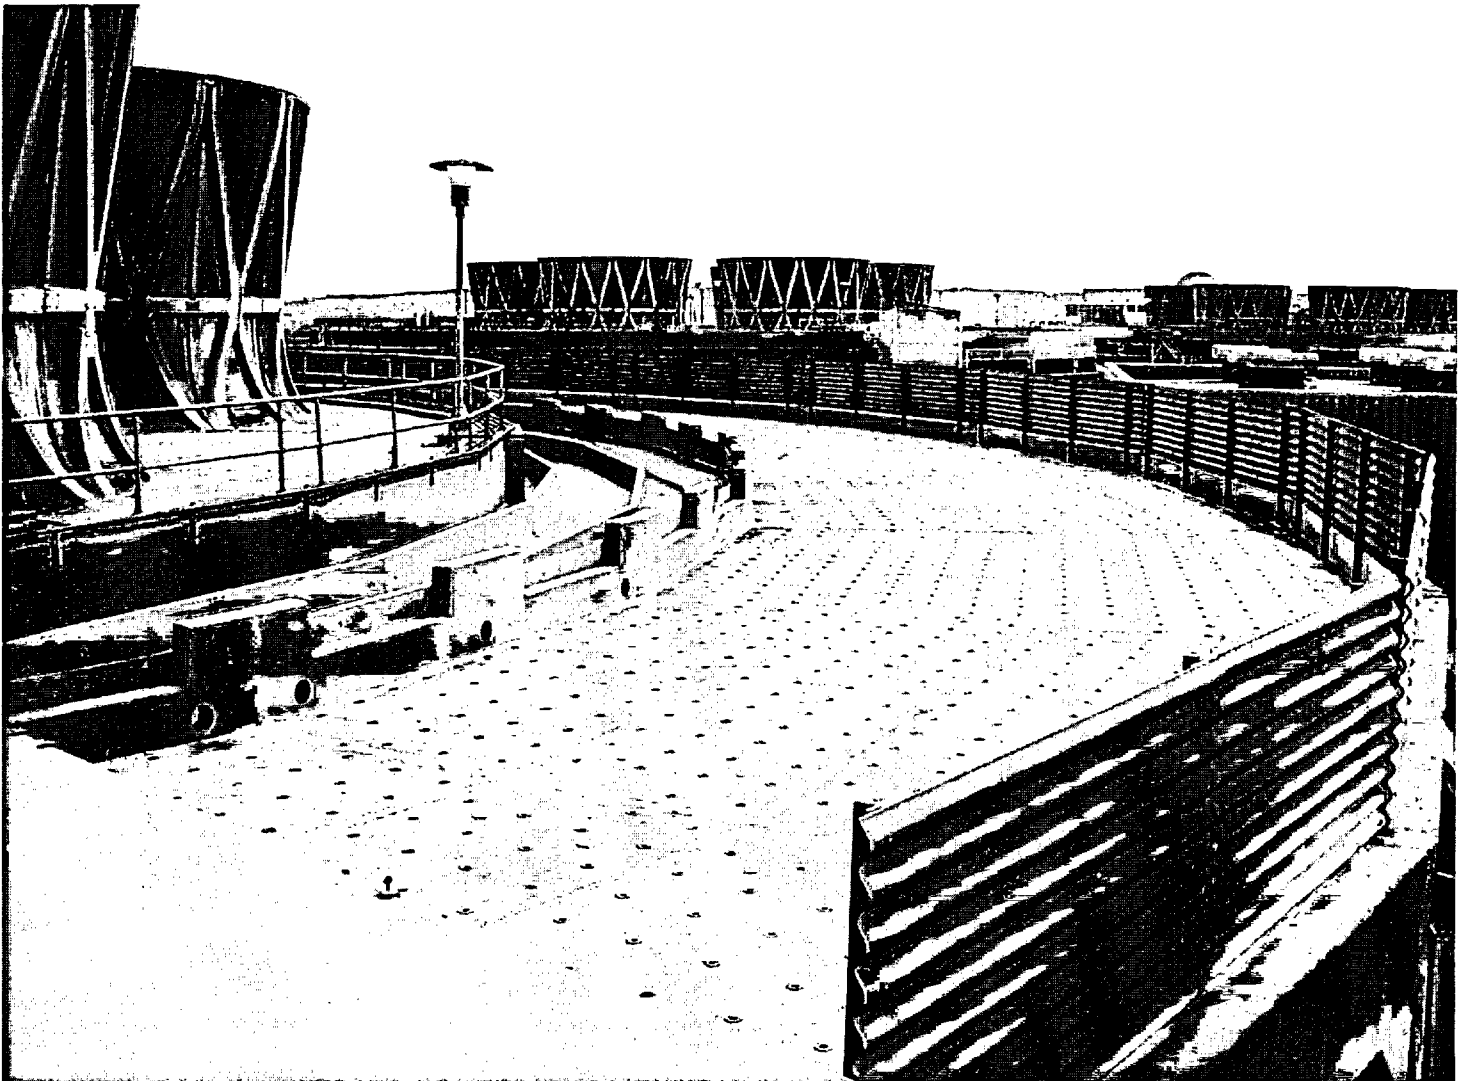
FIGURE 6D, Cooling Tower.

This drained Cooling Tower demonstrates how open to the environment they are. When in service, water fills these passages and falls to the basin below.
