Subject: **Docket No. 50-361**
Licensee Event Report No. 2006-003
San Onofre Nuclear Generating Station, Unit 2

Unit 2 LER No. 2006-003

1. FACILITY NAME				2. DOCKET NUMBER		3. PAGE		
San Onofre Nuclear Generating Station (SONGS) Unit 2				05000361		1 OF 4		
4. TITLE								
Potential emergency diesel generator trip after a seismic event due to an electrical ground fault in a non-seismic circuit

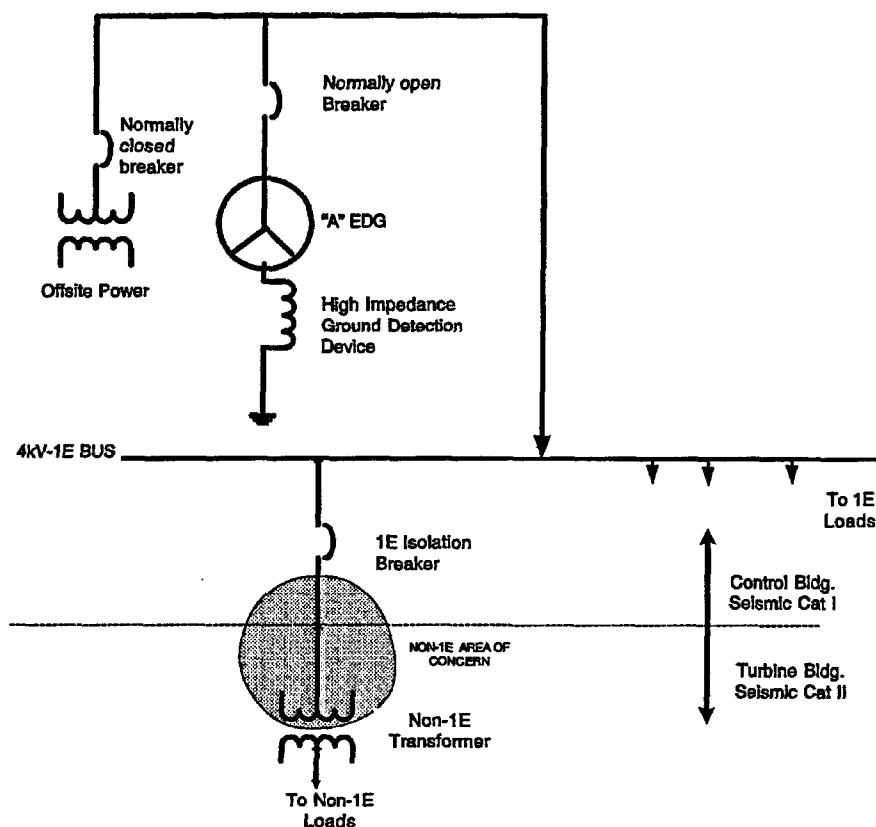
"A" EDG Circuitry

San Onofre Units 2 and 3 each have two emergency diesel generators (EDGs) [EK] to provide emergency AC power if preferred (offsite) AC power is unavailable. The "A" train EDGs provide standby power directly to safety related (1E) and one non-safety related (non-1E) 4 kV transformer; whereas, the "B" train EDGs supply standby power directly only to 1E-4kV loads. Consistent with NRC Regulatory Guide (RG) 1.75, "Physical Independence of Electric Systems," the "A" train EDGs are protected by a 1E isolation breaker [BKR] and a non-1E transformer [XFMR]. The 1E breaker isolates the non-1E loads from the EDG if there is a phase-to-phase fault in the non-1E circuitry. The non-1E transformer isolates the non-1E loads from the EDG if there is a ground fault on the secondary side of the transformer. See the attached drawing.

In January 2005, SCE recognized that a ground fault on the non-1E 4 kV circuit on the primary side of the non-1E transformer would not trip the 1E isolation breaker to isolate the non-1E circuit from the emergency diesel generator (EDG). Therefore, if there was a loss of offsite power with no SIAS and a coincidental or resulting ground in the non-1E circuitry on the primary side of the transformer, the "A" train EDGs could be tripped by the ground detection device before the 1E isolation breaker could isolate the EDG from the faulted non-1E circuit.

If a seismic event had occurred followed by a loss of offsite power and a ground fault on the primary side of the non-1E transformer, it is possible the "A" train EDG could have been tripped. If this had occurred during an EDG "B" train outage, both EDG trains would have been unavailable to perform their required safety function. At times in the past, a "B" train EDG has been taken out of service for planned work as allowed by the Technical Specifications. Based on the guidance provided in NRC NUREG-1022, on July 20, 2006 (discovery date), SCE concluded this past condition is reportable in accordance with 10CFR50.73(a)(2)(v)(A) and (B), as an event or condition that could have prevented fulfillment of a safety function required to maintain the reactor in a safe shutdown condition and to remove residual heat.

In 1983, SCE modified the original design to attach a non-1E circuit to a 1E bus. At that time the 1E isolation breaker was installed consistent with RG 1.75 requirements. However, it was not realized that the ground fault protective trip on the EDG was faster than the 1E isolation breaker. Due to the passage of time, it is not clear why this design did not preclude this condition.

In 2005, the EDG stator ground protection scheme was modified to immediately isolate the non-1E circuit when a line-to-ground fault is detected and to add a 5-second delay to the EDG ground fault protective trip. If the fault is cleared within 5 seconds of isolation of the non-1E circuit, the stator ground relay will reset and the EDG will not trip. If the fault has not cleared after 5 seconds, the EDG will trip. This change provides sufficient time for the existing non-1E circuit to separate from the 1E bus without affecting the EDG.
