Subject: 2006 Annual Site Inspection and Monitoring Report for UMTRCA Title I Disposal Sites

# 2006 Annual Site Inspection and Monitoring Report for Uranium Mill Tailings Radiation Control Act Title I Disposal Sites

Work Performed by S.M. Stoller Corporation under DOE Contract No. DE-AC01-02GJ79491  
for the U.S. Department of Energy Office of Legacy Management, Grand Junction, Colorado

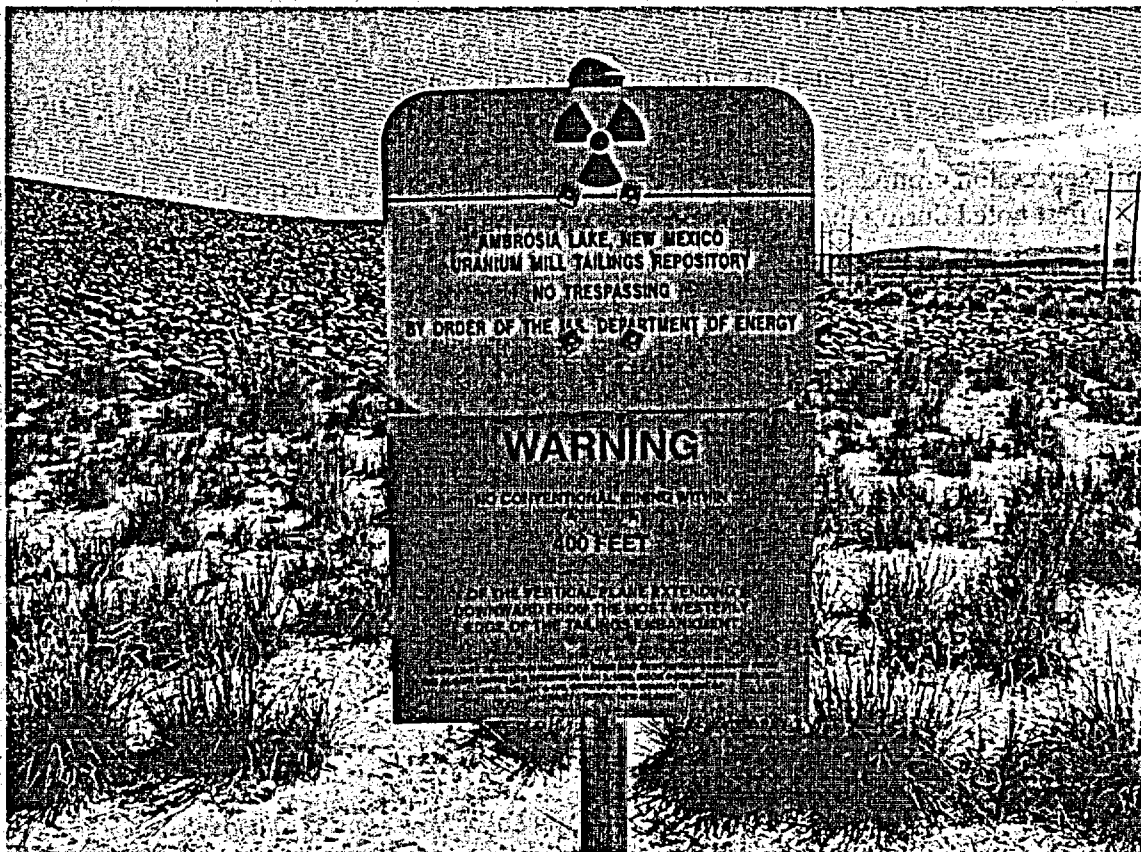
The entrance sign and all perimeter signs were in good condition. Posts for perimeter signs P1 through P15 include mining restriction area warning signs (PL-1).

AMB 8/2006. PL-1. Perimeter sign P2 with the restrictive easement warning sign below.

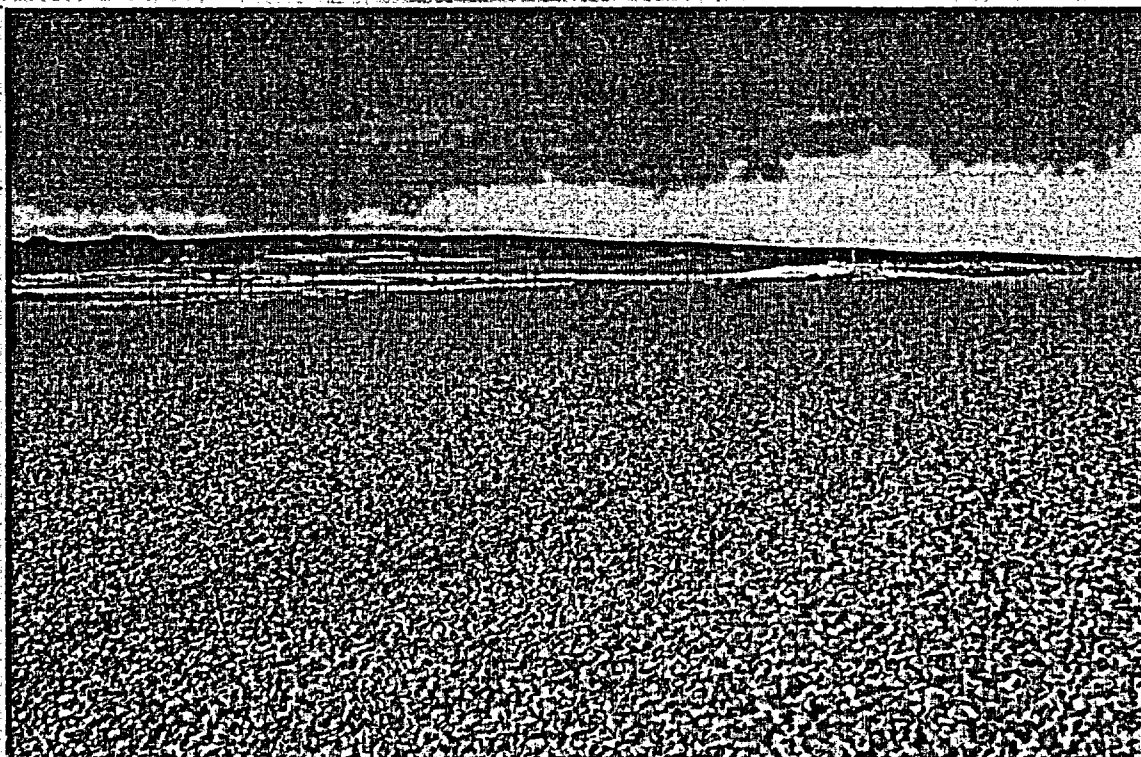
**Top of Disposal Cell**—The disposal cell was completed in 1994. The basalt riprap-covered top of the disposal cell is in excellent condition (PL-2). There was no evidence of cracking, settling, slumping, or erosion. Repairs were made in August 2005 to a shallow depression in the cell cover around settlement plate SP-4; the repaired area was in good condition (PL-3).

AMB 8/2006. PL-2. View of the disposal cell top from settlement plate SP-3.

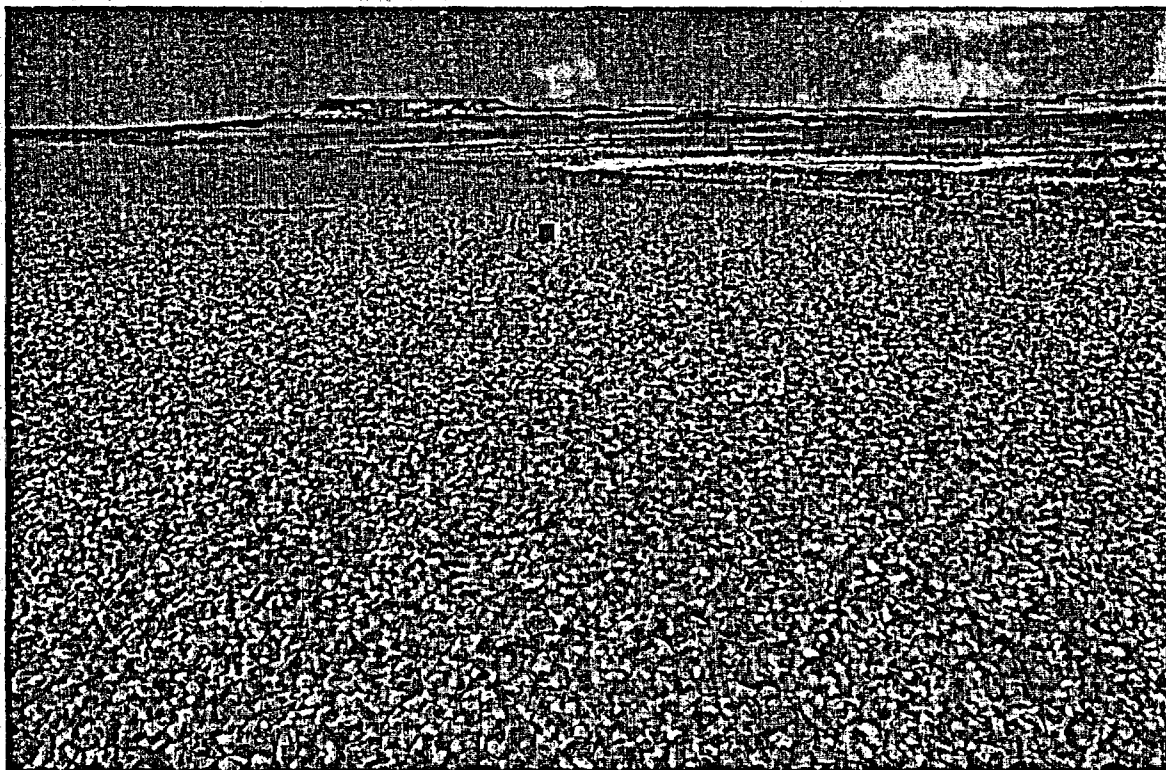
1D A shallow depression around settlement plate SP-4, near the northeast corner of the disposal cell cover, was first noted during the 1997 inspection and continued to grow in depth and area in subsequent years. The depression was repaired in August 2005. Surveys of the eight settlement plates in September 2005 and September 2006 indicate that the cover is stable and no new settling has occurred at SP-4. One more post-repair survey is planned for 2007. After that survey, settlement plate surveys will be conducted only if visual inspections indicate significant settlement on the disposal cell top.

*AMB 8/2006. PL-3 Repaired settlement area surrounding settlement plate SP-4.*

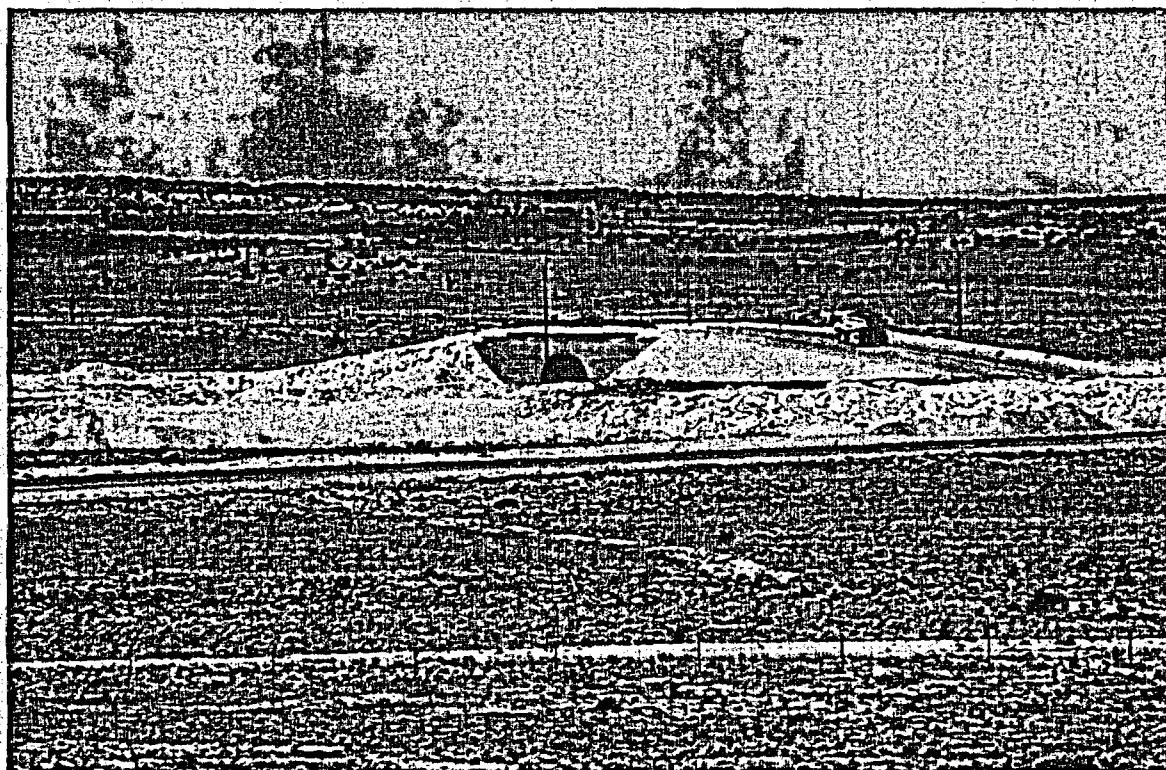
*AMB 8/2006. PL-4 Loaded haul truck crossing recently constructed Rio Algom haul road bridge over Highway 509.*

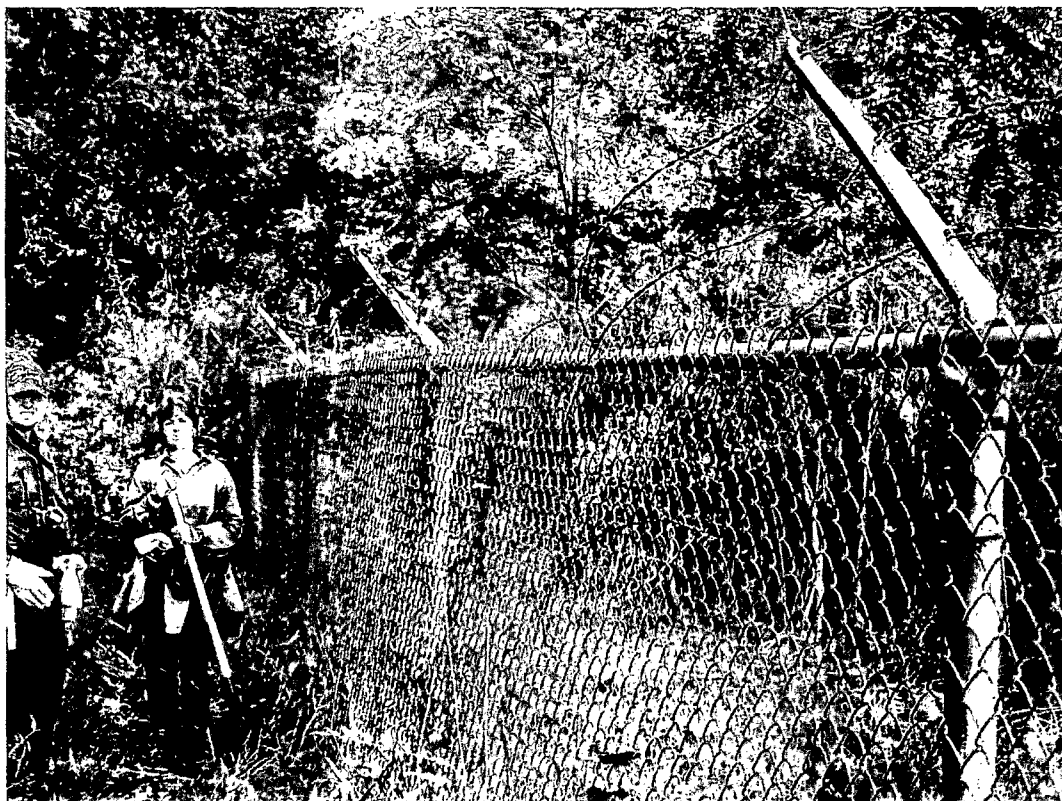
Overall, the security fence was in good condition at the time of the inspection. Several strands of barbed wire were found broken along the south fence line and need repair (PL-1). DOE replaced the fabric on the south panel of the security fence after a maintenance contractor found it damaged.

*BUR 9/2006. PL-1. Broken strands of barbed wire on south fence line.*

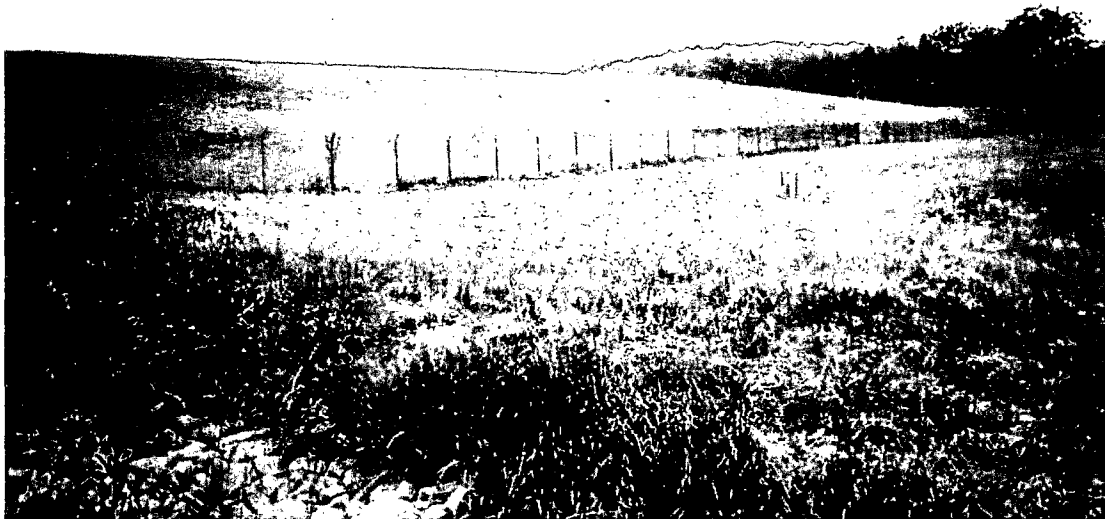
*CAN 9/2006. PL-1. Turf condition on northeast site slope.*

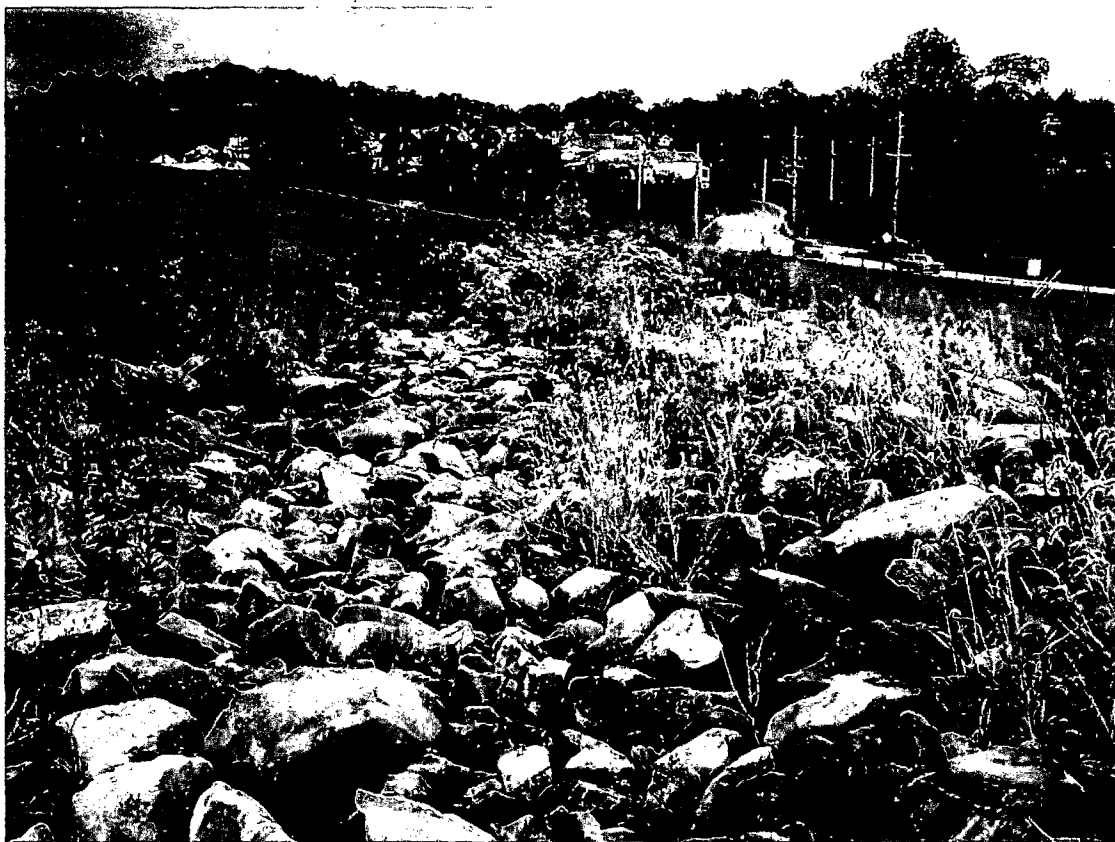
*CAN 9/2006. PL-2. Vegetation in diversion channel.*

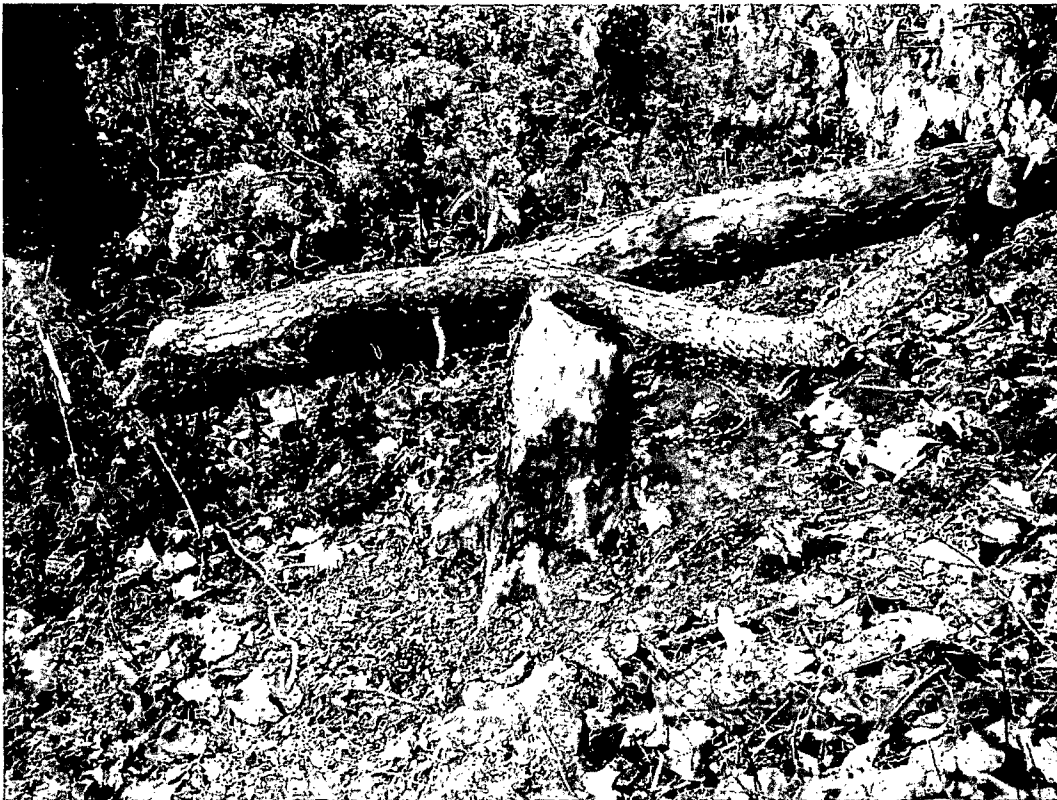
*CAN 9/2006. PL-3. Beaver damage along Chartiers Creek.*

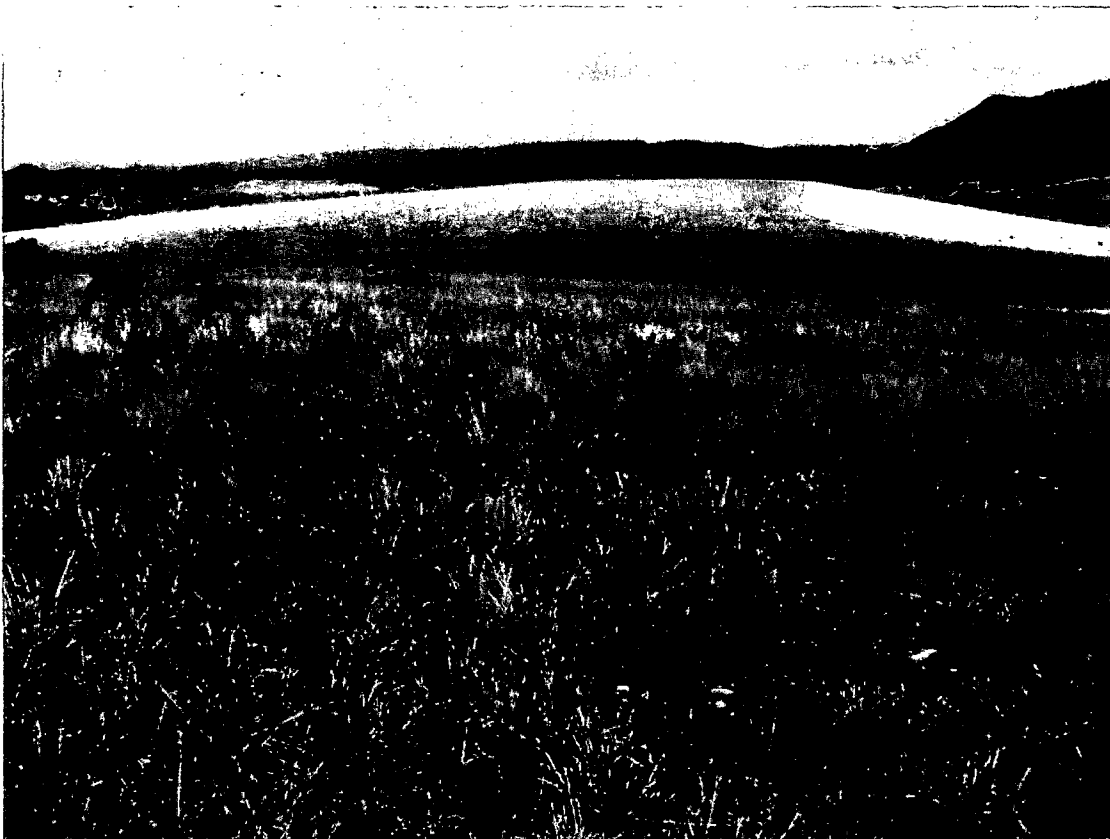
*DUR 6/2006. PL-1. Disposal cell top.*

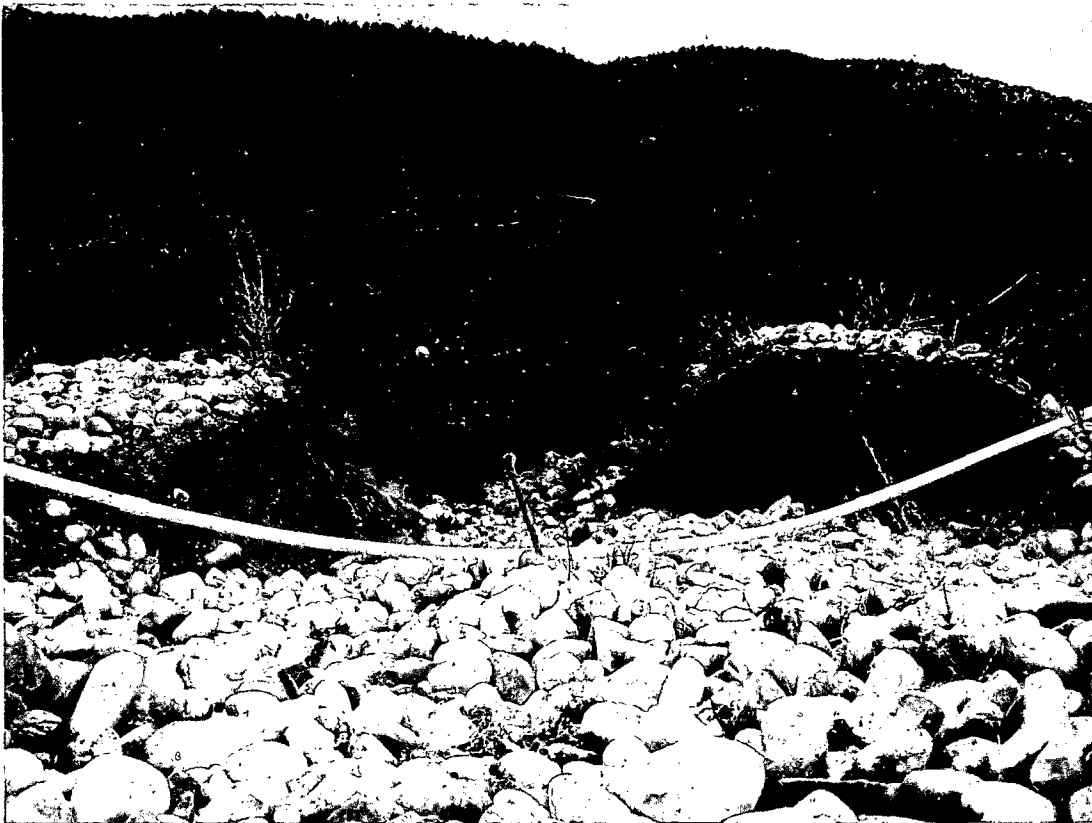
*DUR 6/2006. PL-3. Northeast Outflow; no new erosion.*

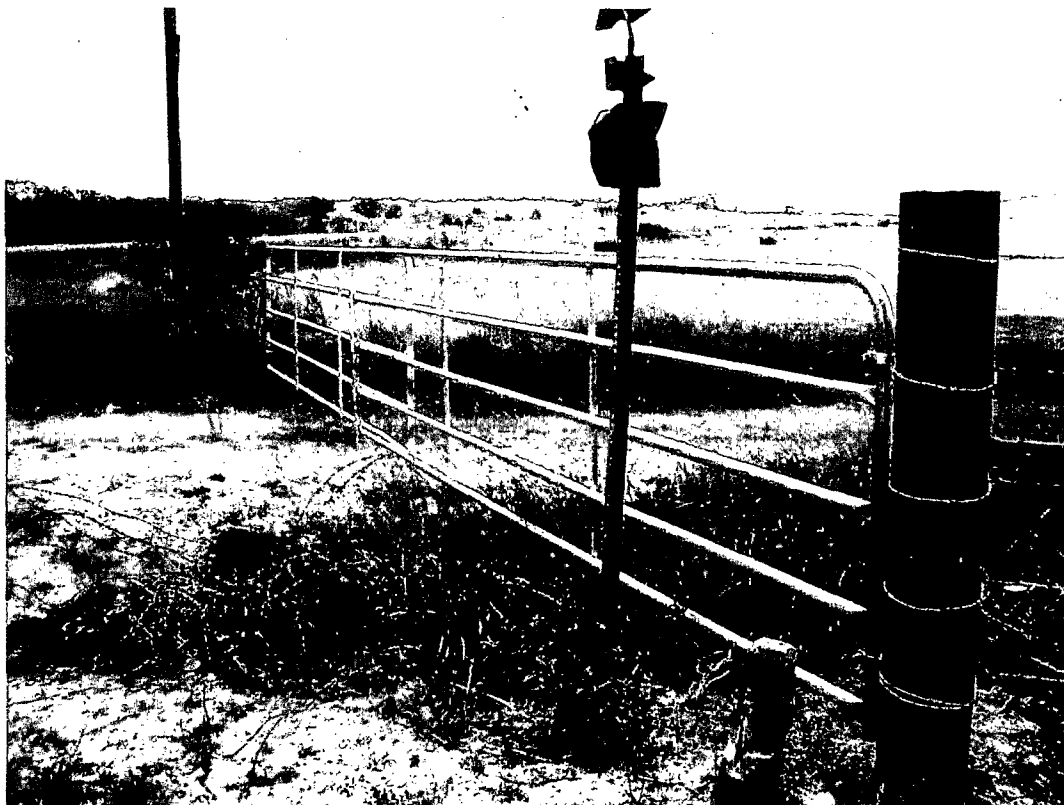
*FCT 1/2006. PL-1. New vehicle gate, north corner of the site.*

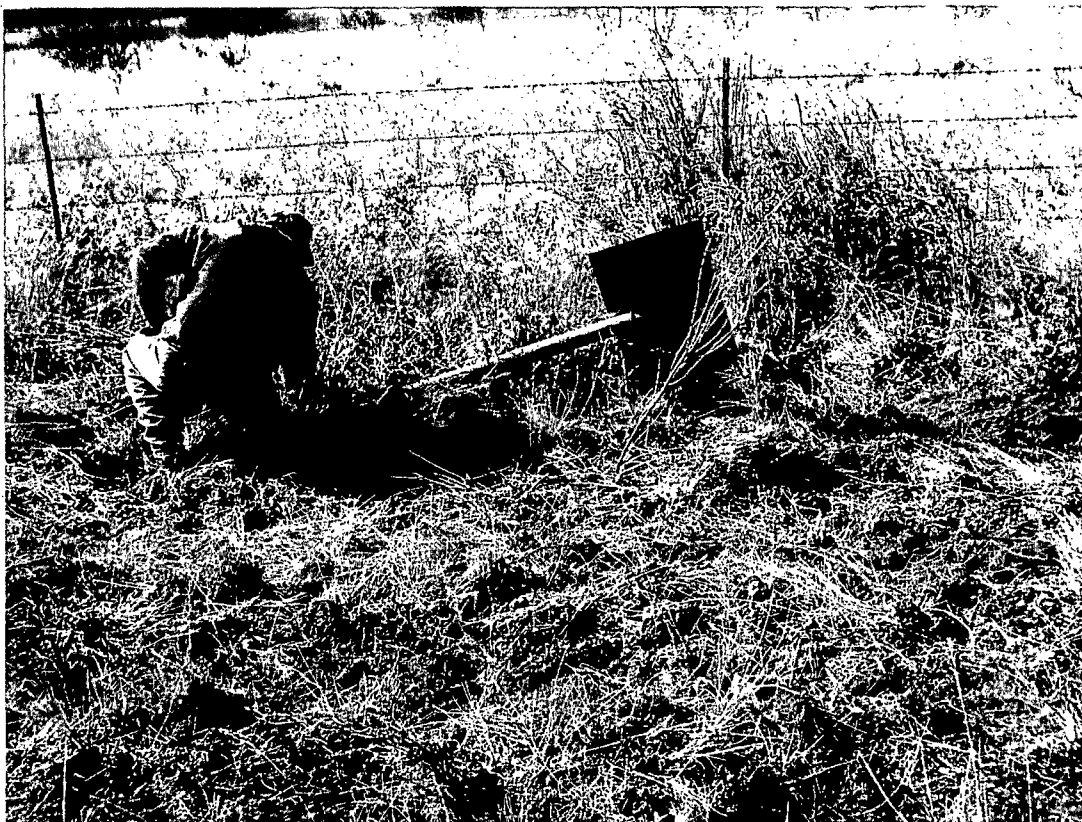
*FCT 1/2006. PL-3. Perimeter sign P20; damaged.*

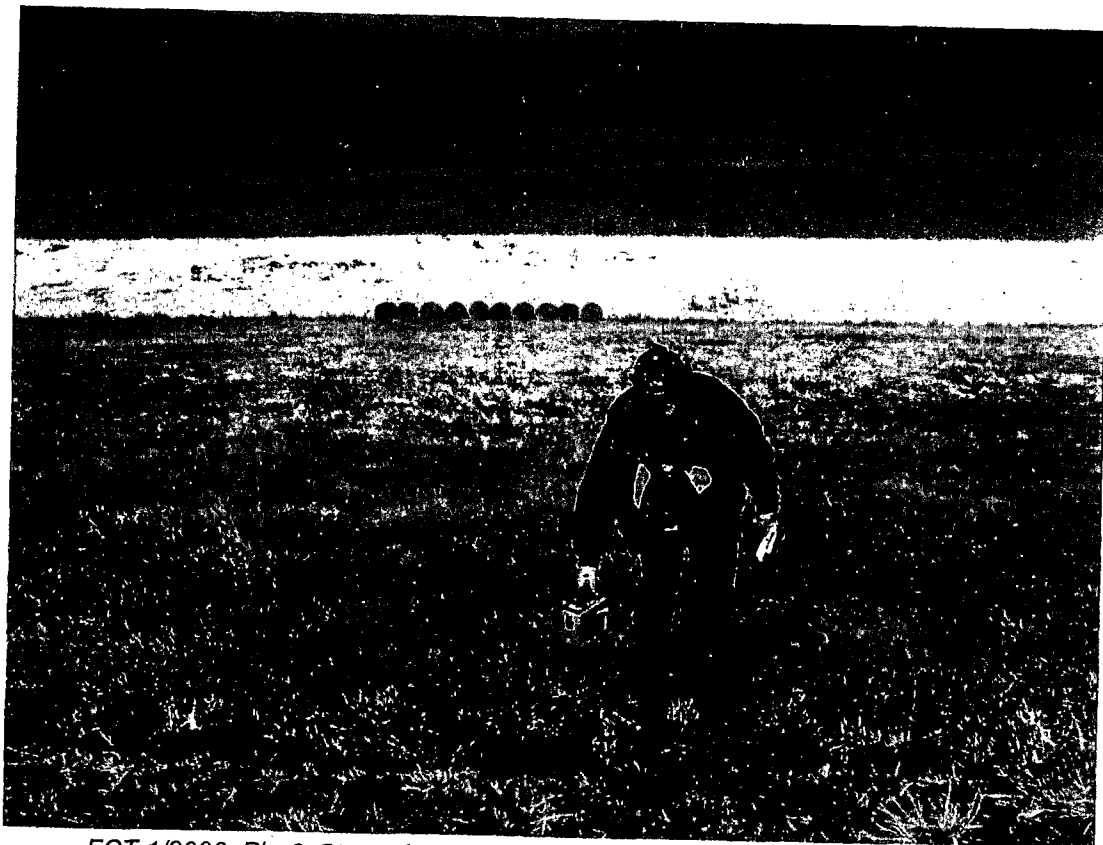
*FCT 1/2006. PL-6. State of Texas inspector collecting gamma exposure rates.*

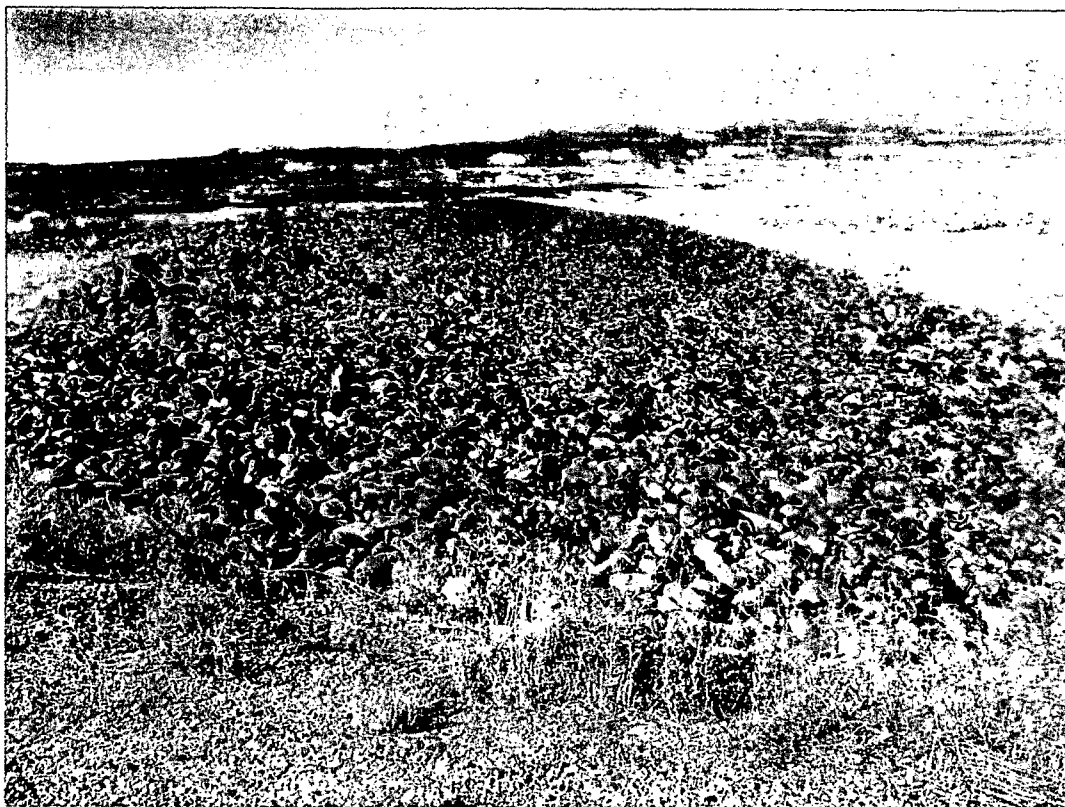
*GRJ 3/2006. PL-1. North side slope of the disposal cell.*

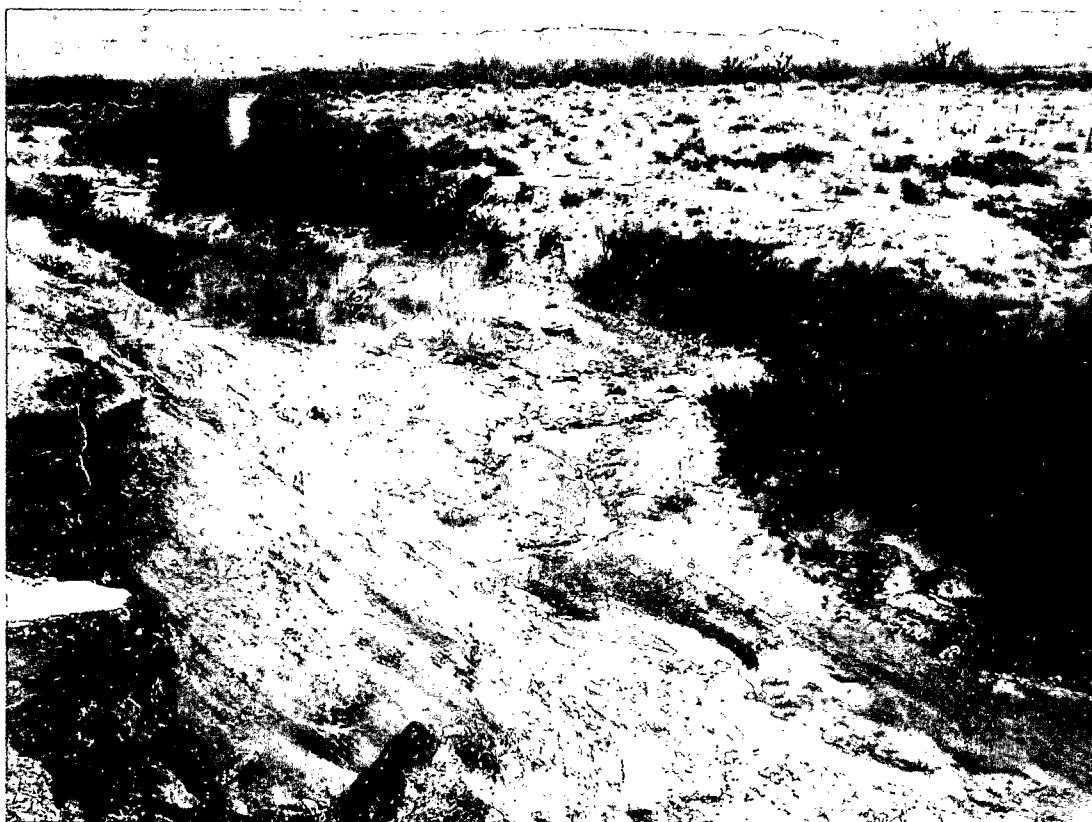
GRN 3/2006. PL-3. Pools in scour holes below Cedar Mountain Formation outcrops in Browns Wash  
(view downstream toward the Green River).

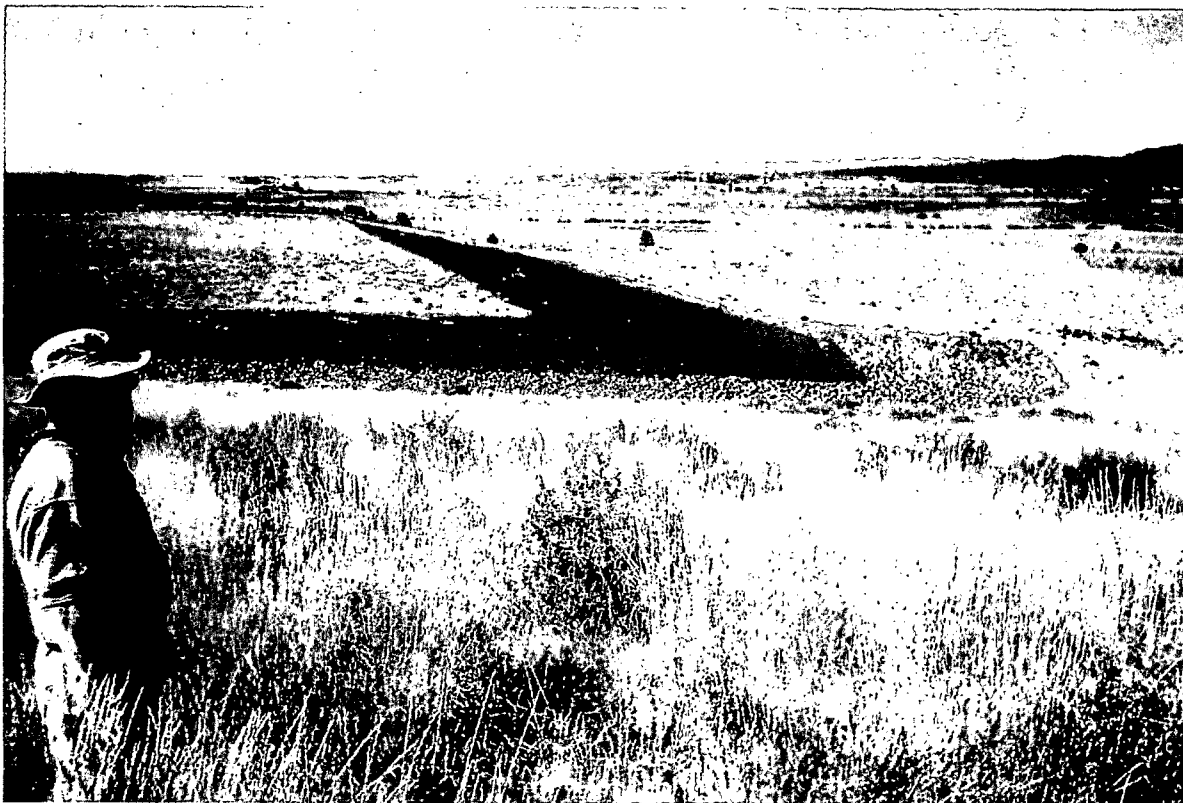
LKV 7/2006. PL-1. Disposal cell (background – upper left) showing vegetative cover on the cell top.

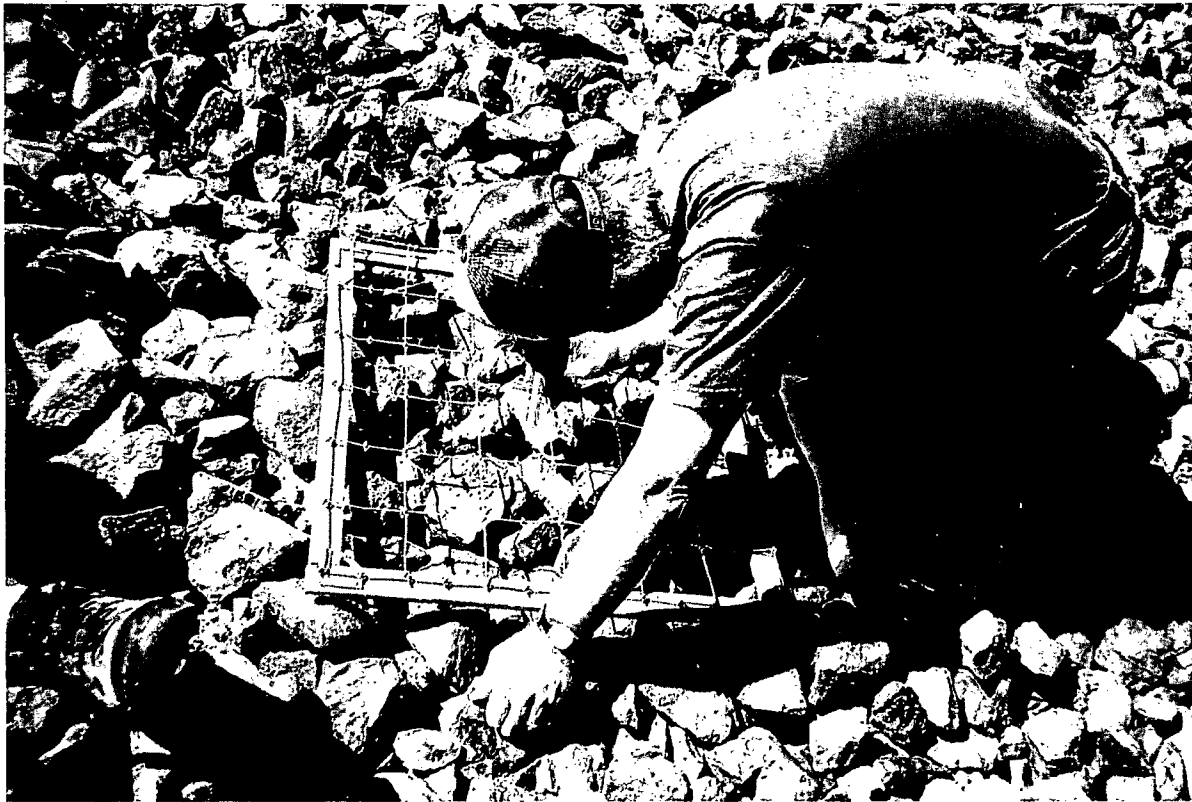
*LKV 7/2006. PL-3. Measuring riprap size on the side slope of the disposal cell.*

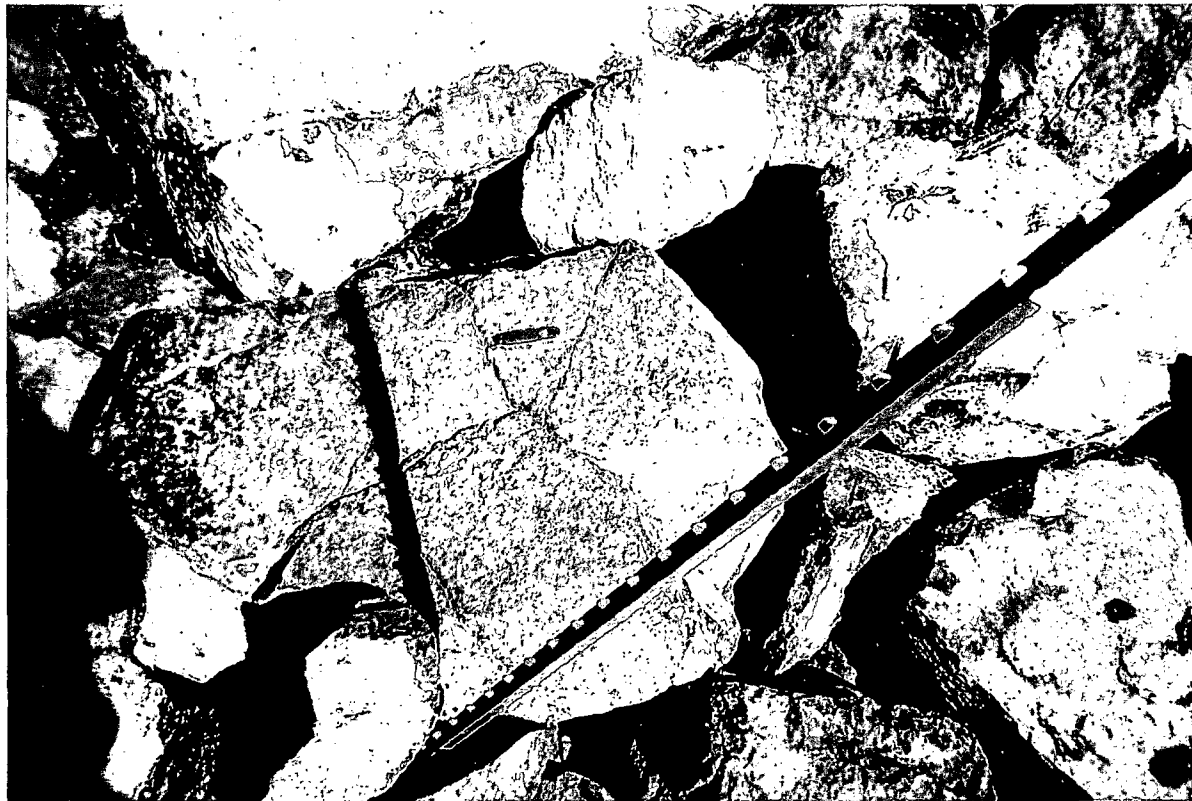
*LKV 7/2006. PL-4. Riprap monitoring location 9 at the energy dissipation area.*

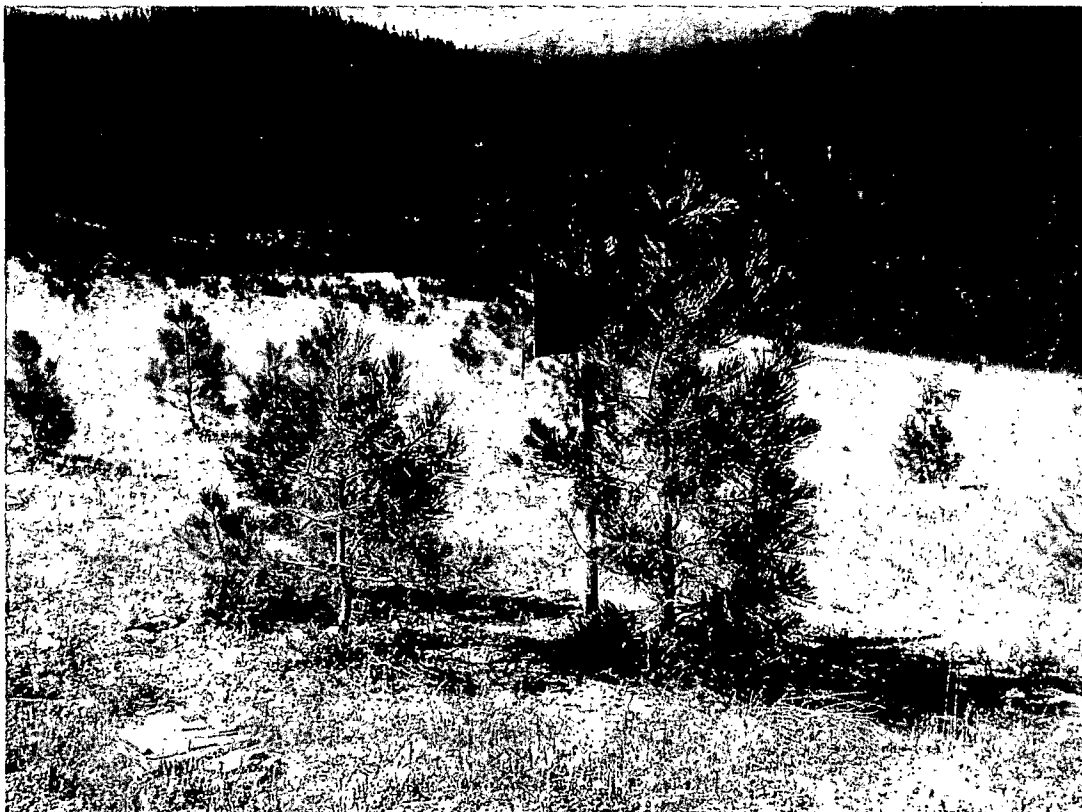
*LOW 7/2006. PL-1. Ponderosa pine trees obscuring view of perimeter sign P6.*

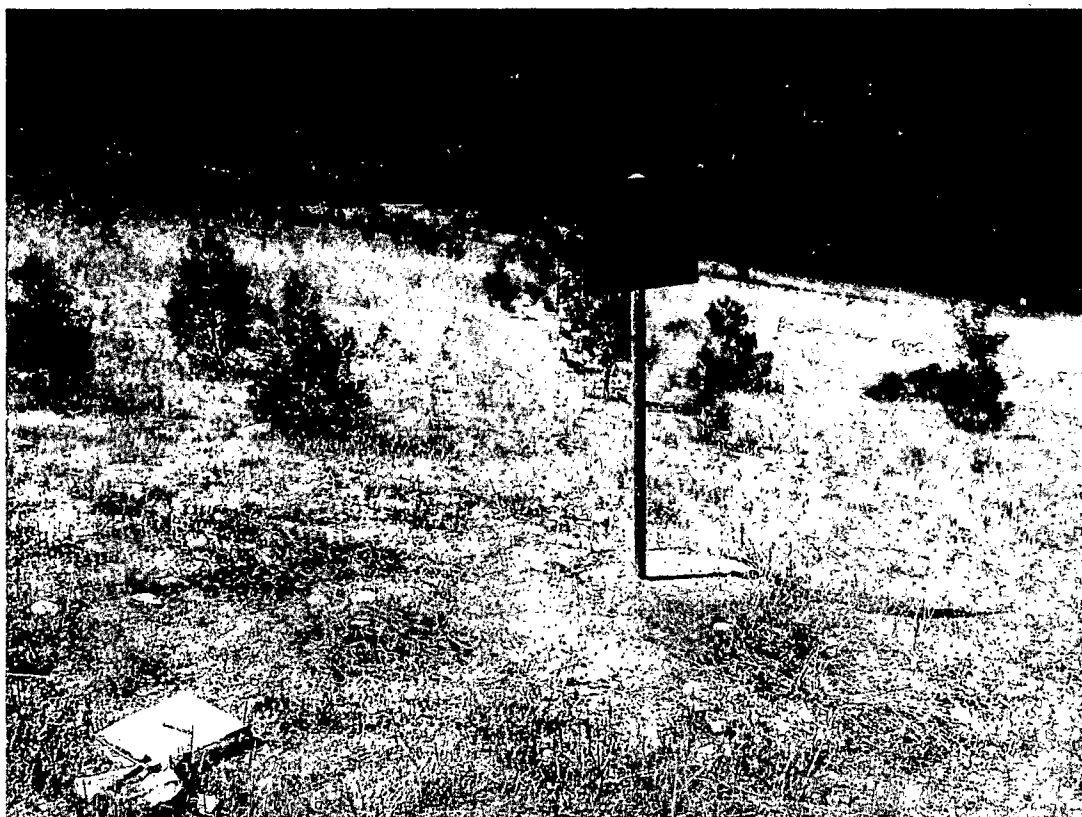
*LOW 7/2006. PL-2. View of perimeter sign P6 after removal of the pine trees.*

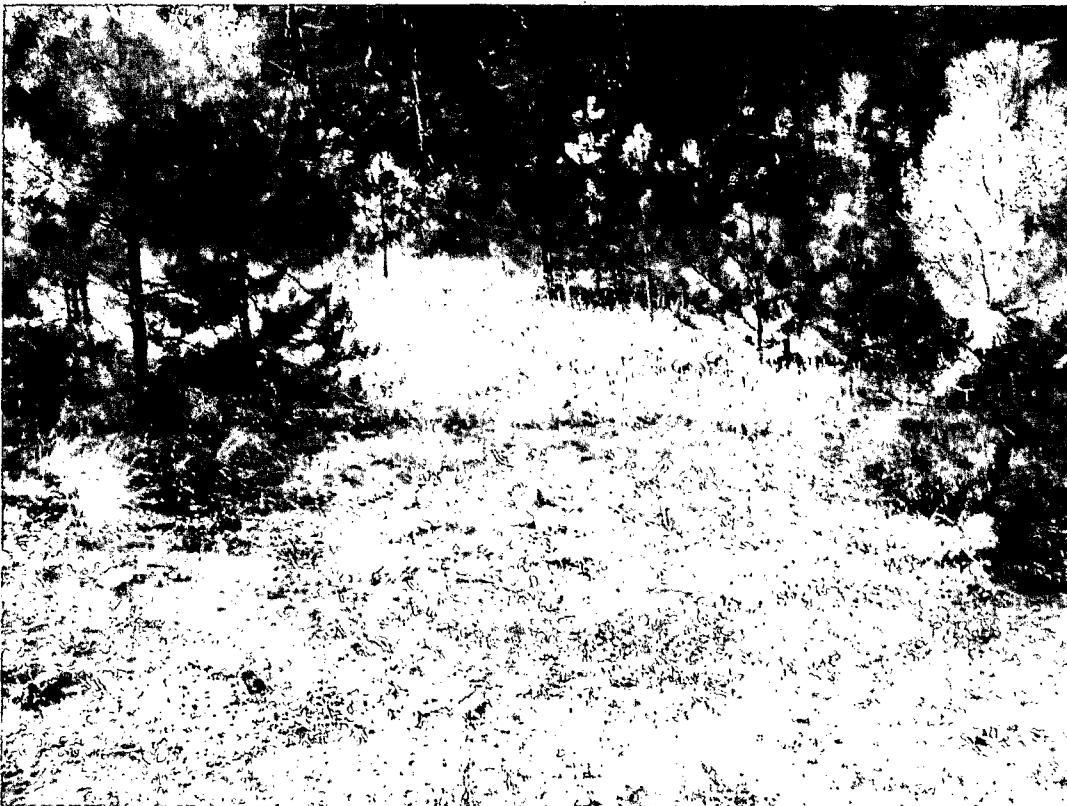
*LOW 7/2006. PL-4. Reclaimed location of decommissioned monitor well MW-0580.*

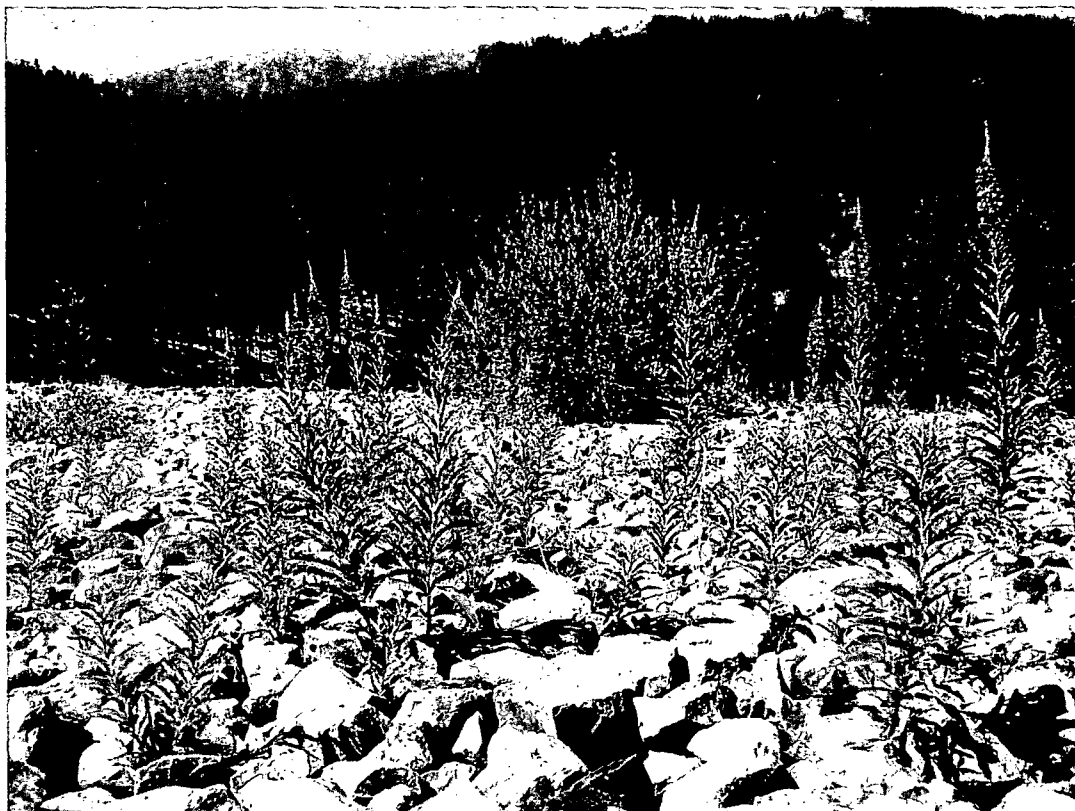
*LOW 7/2006. PL-5. Fireweed, redosier dogwood, and ponderosa pine on the cell top.*

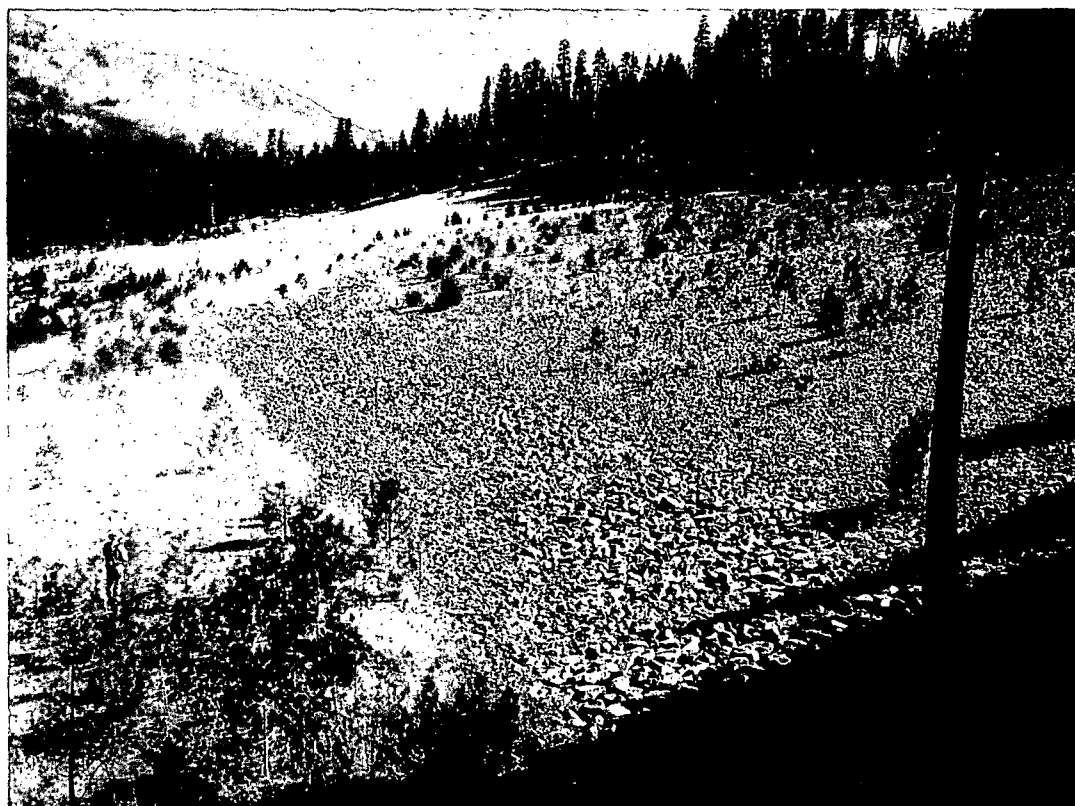
*LOW 7/2006. PL-6. Plant encroachment on the west portion of the cell top and apron.*

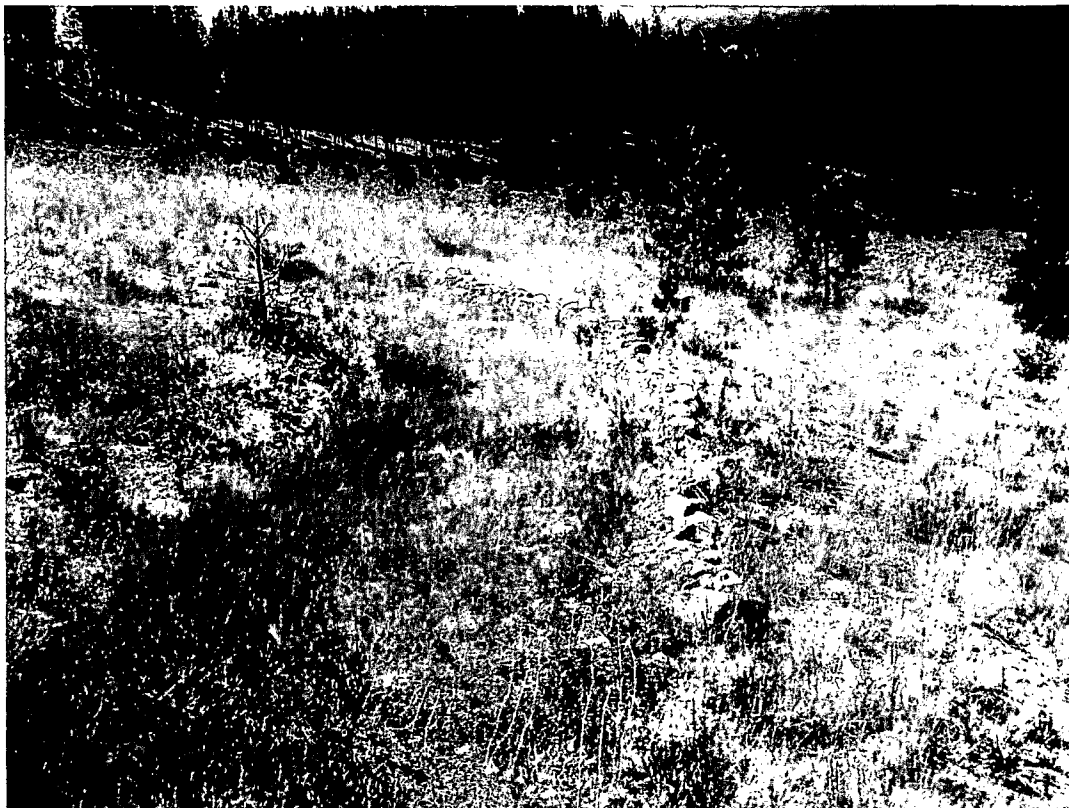
*LOW 7/2006. PL-7. Repaired area on south end of Interceptor Bench 1.*

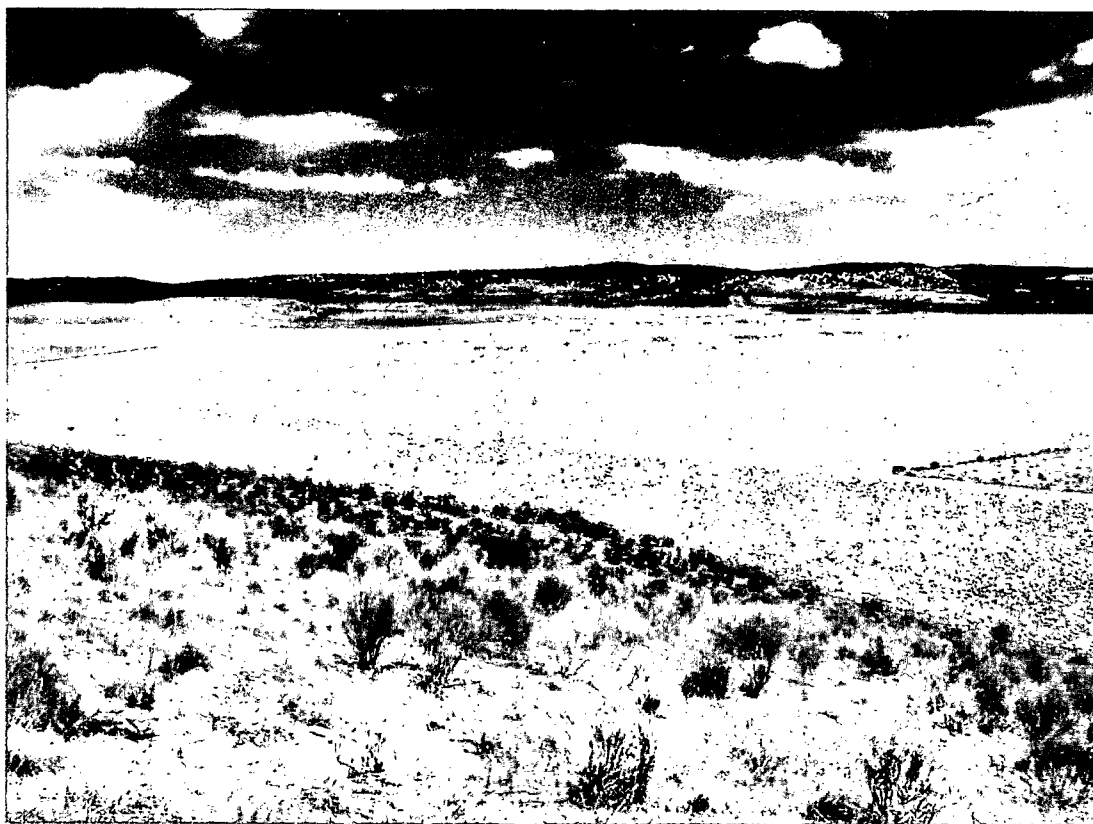
*MAY 8/2006. PL-3. North view of the disposal cell.*
