Subject: 2006 Annual Site Inspection and Monitoring Report for UMTRCA Title I Disposal Sites

# 2006 Annual Site Inspection and Monitoring Report for Uranium Mill Tailings Radiation Control Act Title I Disposal Sites

Work Performed by S.M. Stoller Corporation under DOE Contract No. DE-AC01-02GJ79491  
for the U.S. Department of Energy Office of Legacy Management, Grand Junction, Colorado

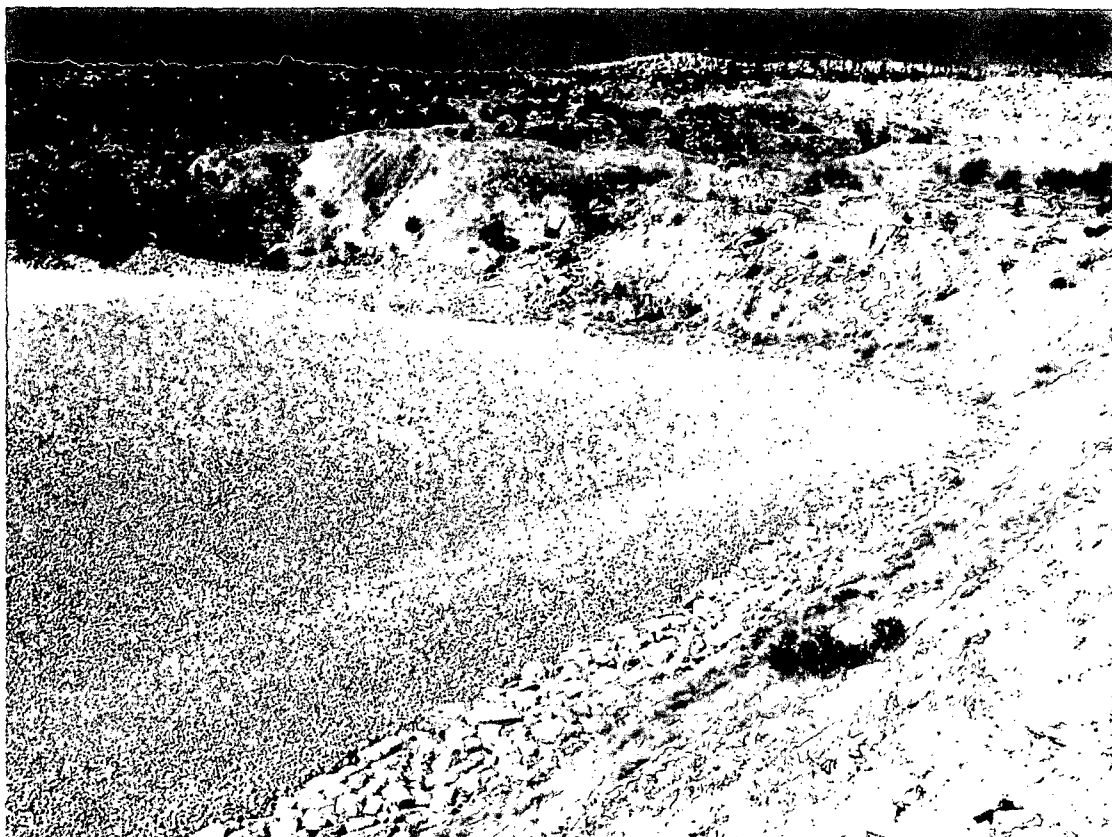
*NAD 4/2006. PL-3. The northwest corner of the disposal cell showing the east toe drain.*

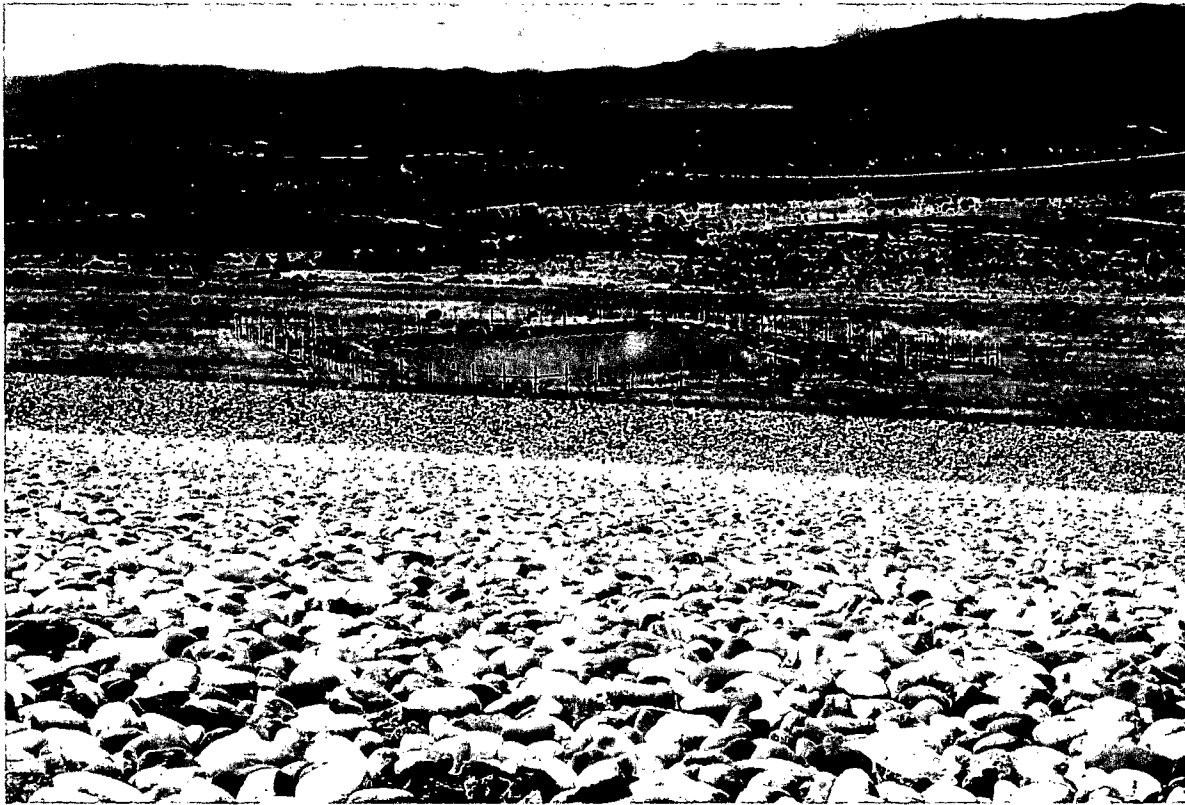
*RFL 8/2006. PL-3. Evaporation pond directly south of the disposal cell.*

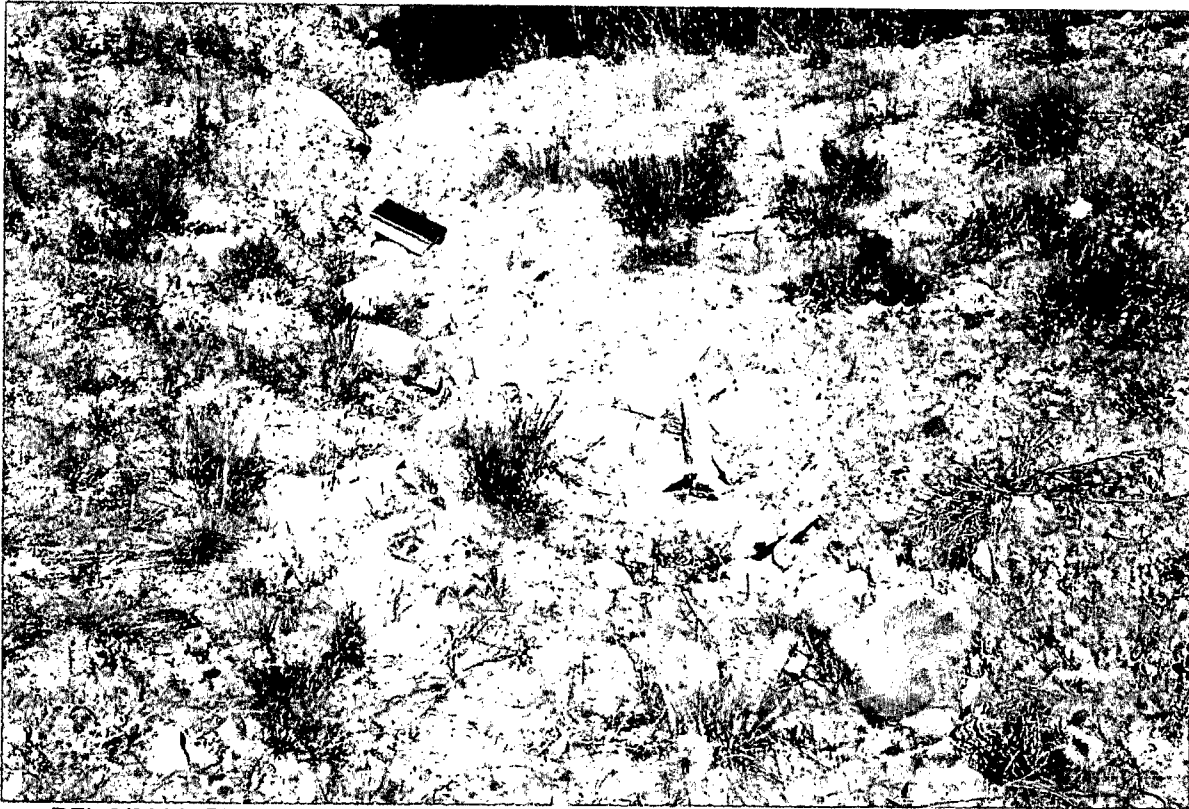
*RFL 8/2006. PL-5. Erosion control in interceptor trench completed fall 2005, no new erosion.*

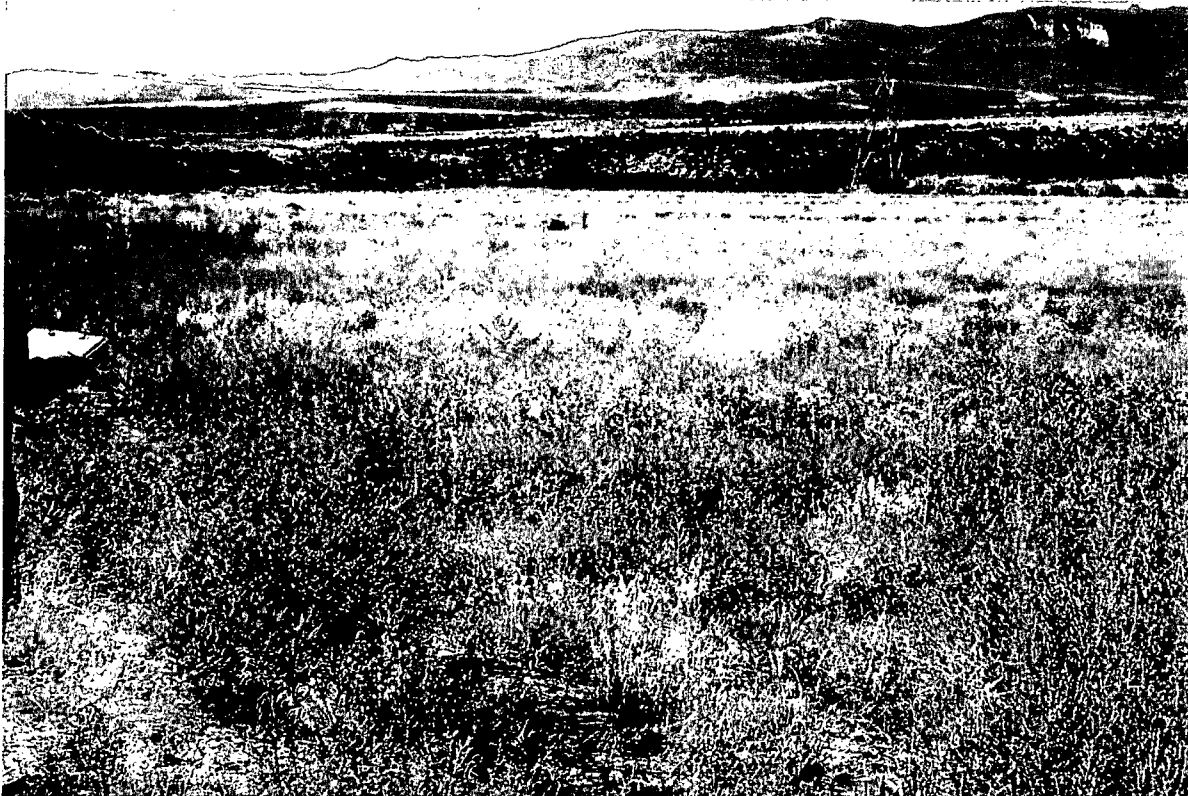
*RFL 8/2006. PL-6. BLM Right of Way Reservation area south of disposal cell; plowed and reseeded in 2005.*

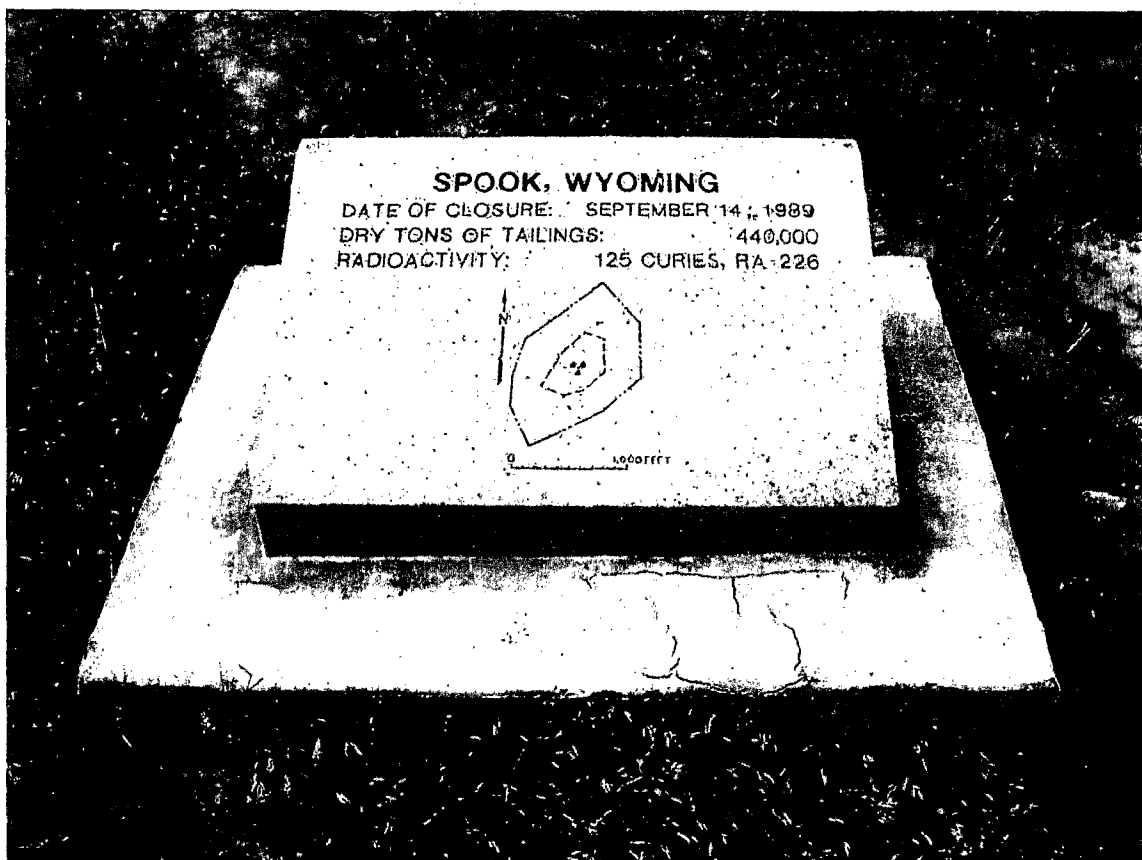
SPK 6/2006. PL-1. Site marker SMK-1, showing cracking of patched concrete.

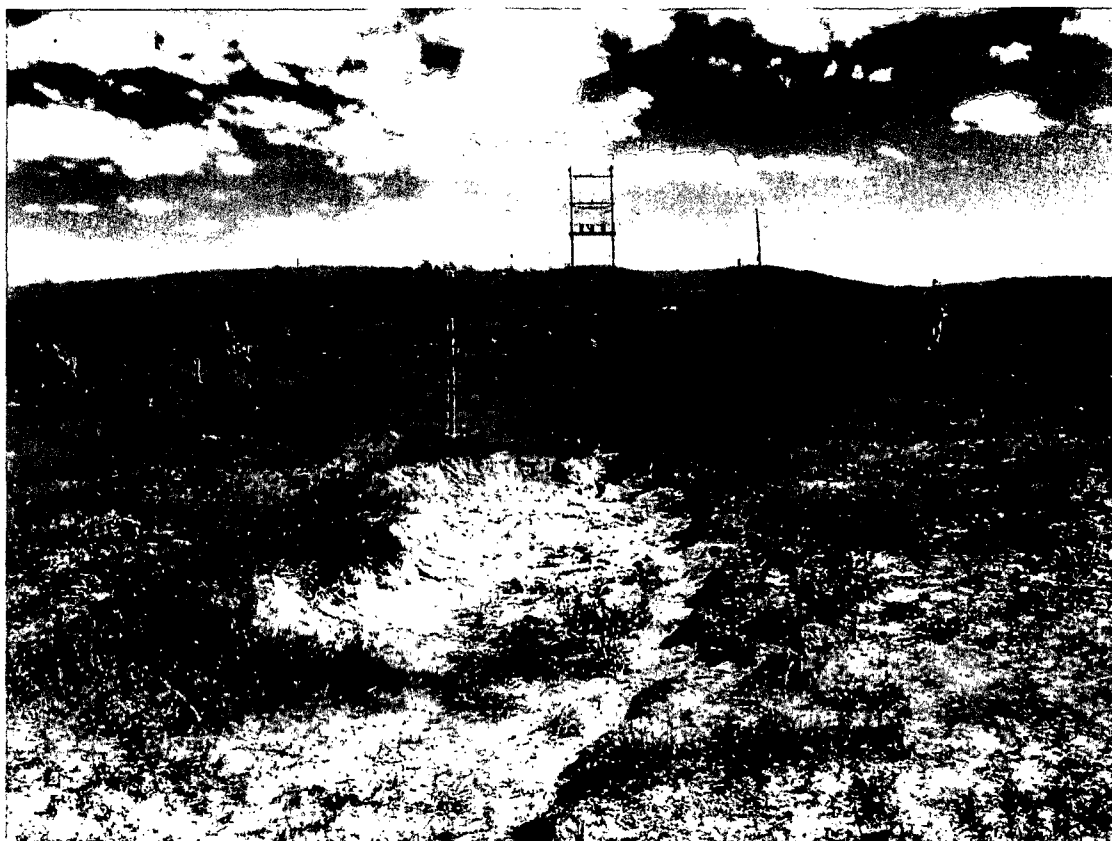
*SPK 6/2006. PL-4. Erosion near perimeter sign P4.*

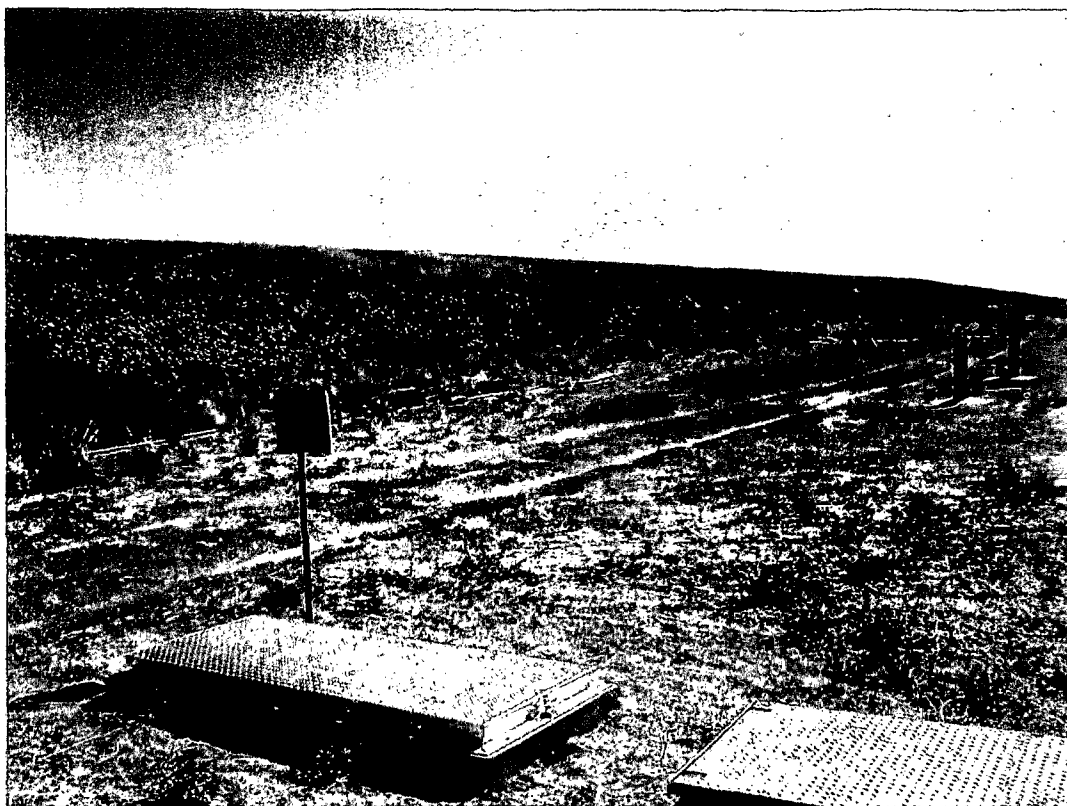
*TUB 4/2006. PL-3. Vegetation encroachment on the south side slope of the disposal cell (reference photograph).*
