Operating Experience Feedback Report – Solenoid-Operated Valve Problems

Commercial Power Reactors

U.S. Nuclear Regulatory Commission

Office for Analysis and Evaluation of Operational Data

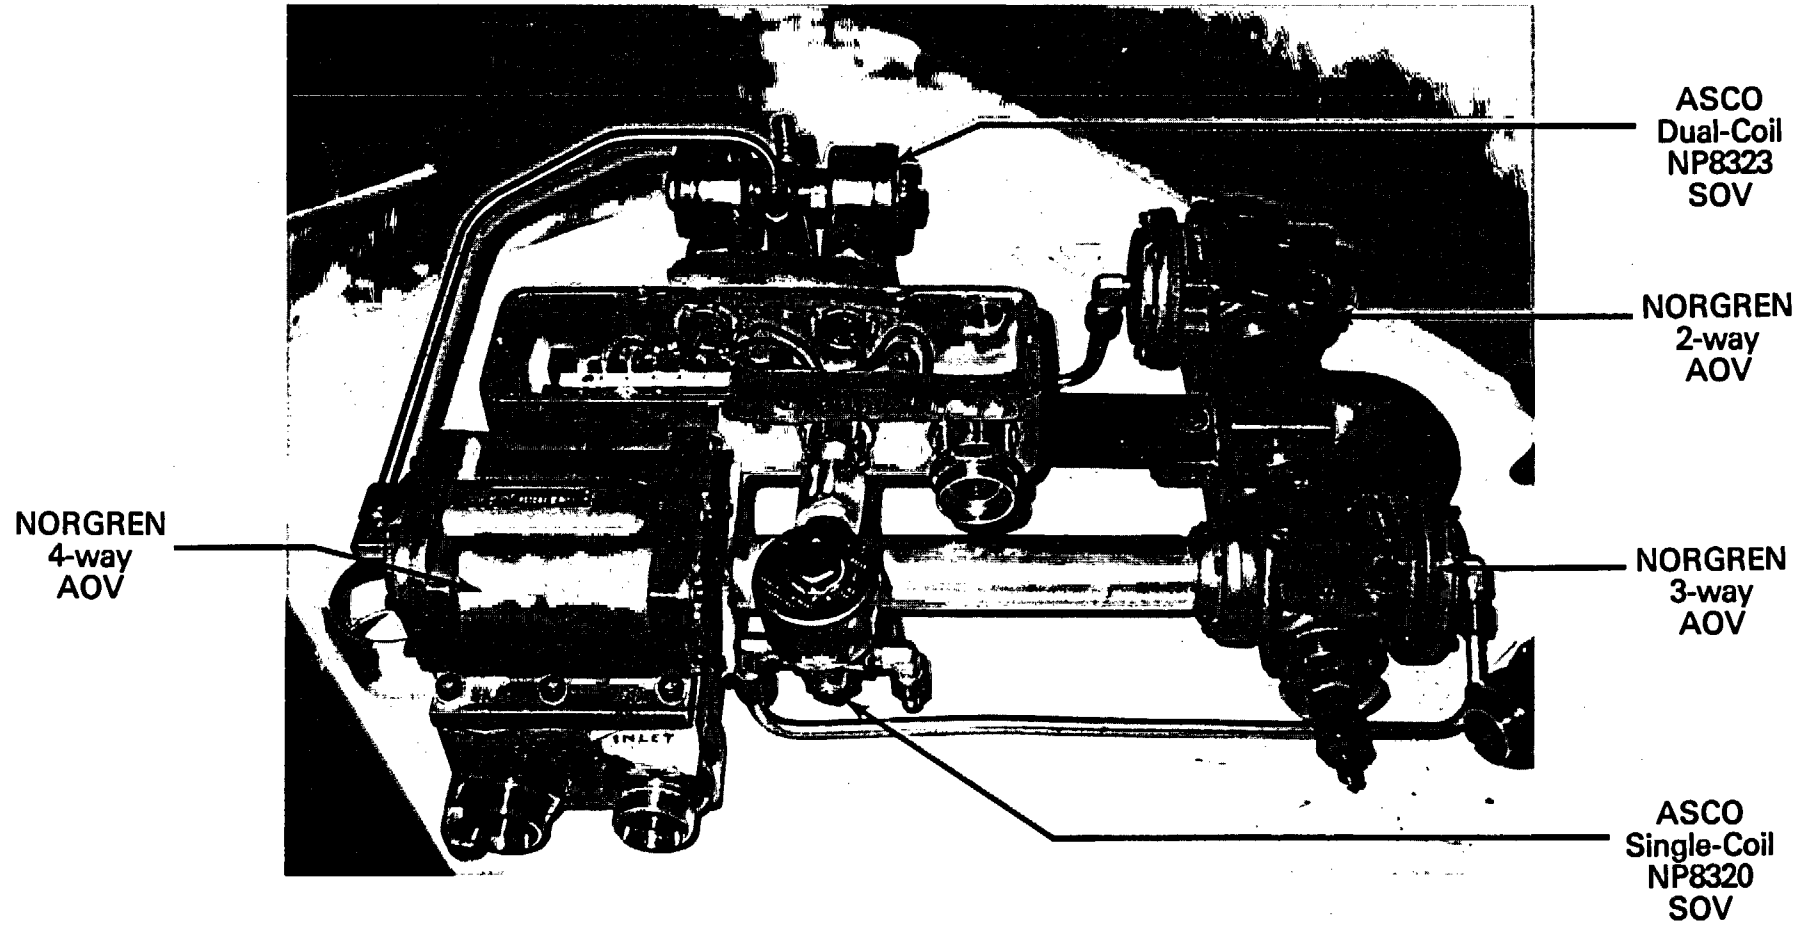
Figure 5 MSIV air pack from Perry Nuclear Power Plant, November 1987

On October 29, 1987, while performing MSIV stroke time testing, three of the plant's eight MSIVs failed to

Since the valves all stroked satisfactorily subsequent to their initial failures, the licensee believed that the failures were due to the presence of impurities in the air pack SOVs controlling the MSIVs and that the impurities were apparently discharged during subsequent MSIV operation. As a result, the three MSIVs that had failed to meet their stroke closure time requirements were declared operable.

In response to NRC concerns, the licensee performed additional MSIV stroke testing. As a result, on November 3, 1987, the inboard and outboard MSIVs in one of the steam lines that had the earlier failures again failed to close within the required 5 seconds (outboard MSIV closed in 2 minutes and 49 seconds and the inboard MSIV closed in 18 seconds). Additional MSIV stroke tests were performed, and both MSIVs again closed within allowable times of the Technical Specifications.

Because of continued NRC concerns about MSIV reliability, the licensee shut down the plant and established a plan to determine the root cause of the MSIV failures (Refs. 7, 8, 9). Intense investigative efforts were conducted by the utility to determine the root cause of the MSIV failures. The failures of the MSIVs on October 29 and November 3, 1987, were attributed to the failure of the ASCO dual-coil Model NP8323 SOVs to shift position upon de-energization. The SOVs failed to shift position because of degradation of their ethylene propylene diene monomer (EPDM) seats and discs. The degradation was caused by high temperatures that had existed in the vicinity of the SOVs as a result of several steam leaks.

Originally, hydrocarbon impurities were suspected as having contributed to the degradation of the EPDM seats and discs. Samples of instrument air taken locally at the MSIVs were analyzed for particulates and hydrocarbon contamination. The analyses indicated that the air supply was free of particulates and condensable hydrocarbons. Further microscopic and spectral analyses performed at an independent laboratory (Ricerca) conclusively eliminated the possibility of impurities from hydrocarbon intrusion as a root cause of these failures (Ref. 10). How-

ever, as part of its corrective action to prevent future failures, the licensee took steps to improve the maintenance of the instrument air system. In addition, the licensee undertook an aggressive program to review the effects of all known steam leaks that could affect other safety-related equipment.

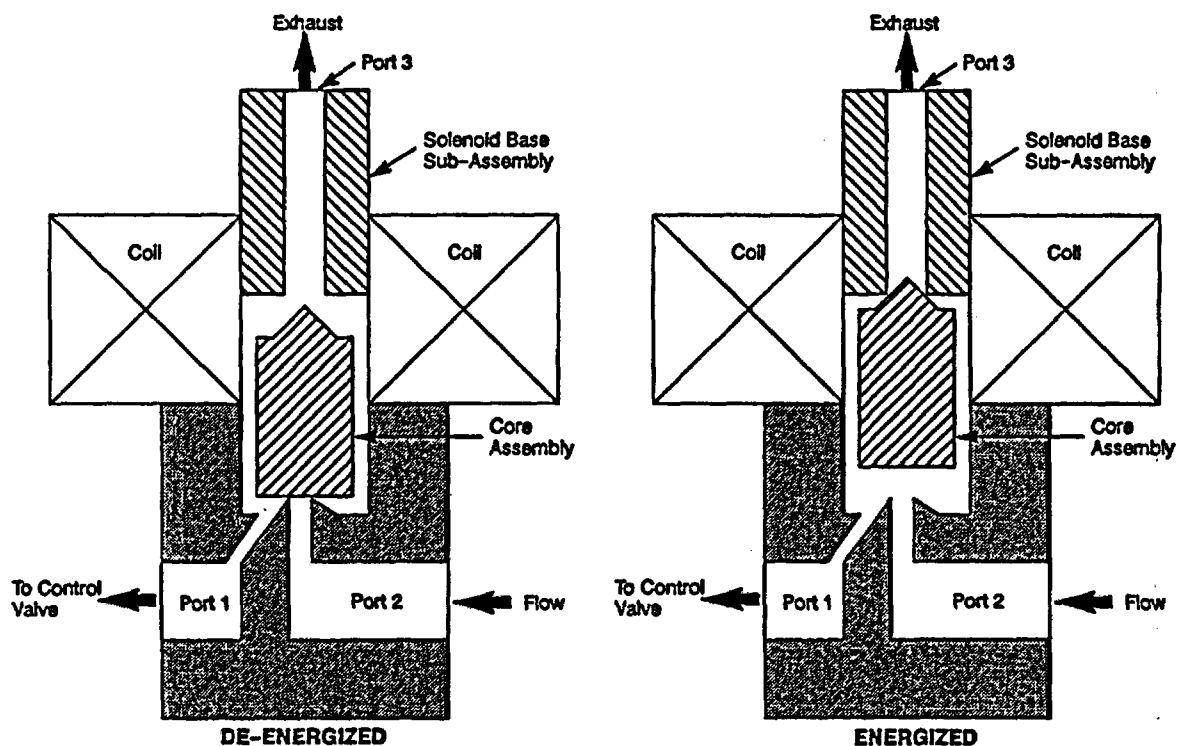
Figure 6 Schematic of a solenoid-operated valve illustrating effect of operating pressure differentials

In May 1988, the NRC issued Information Notice 88-24 (Ref. 24), which informed licensees of two SOV failures that were experienced at Kewaunee (Ref. 25) and of the potential for additional failures at Kewaunee and Calvert Cliffs 1 and 2 (Refs. 26-28). Subsequently, several licensees informed the NRC of similar discoveries at their plants, where the potential for overpressurizing SOVs existed, which could prevent the SOVs from performing their safety-related functions. At some plants, the task of verifying the potential for overpressurizing SOVs has been complicated by the fact that documentation is not readily available. For example, Millstone 1 and 2 (Ref. 29) and Crystal River 3 (Ref. 30), have reported that documentation to identify SOVs in containment is not readily available and that containment walkdowns are necessary for their identification.

It is not clear that all licensees have taken appropriate corrective action on the issue of SOV overpressurization as presented in Information Notice 88-24. This concern is predicated on the Crystal River 3 event (Ref. 30) and a followup discussion in which the licensee stated that its review of the potential for SOV overpressurization assumed the proper operation of in-line pressure regulators, it did not address the consequences of pressure regulator failures.* One of the events described in Information Notice 88-24 involved the discovery at Calvert Cliffs that several safety systems were vulnerable to single failures of pressure regulators in the air supply system.
