SEABROOK UPDATED FSAR

APPENDIX 2L

GEOLOGIC INVESTIGATION OF SOILS AND THE BEDROCK SURFACE AT
UNIT 2 CONTAINMENT SITE. **SEABROOK** STATION

October 24, 1974

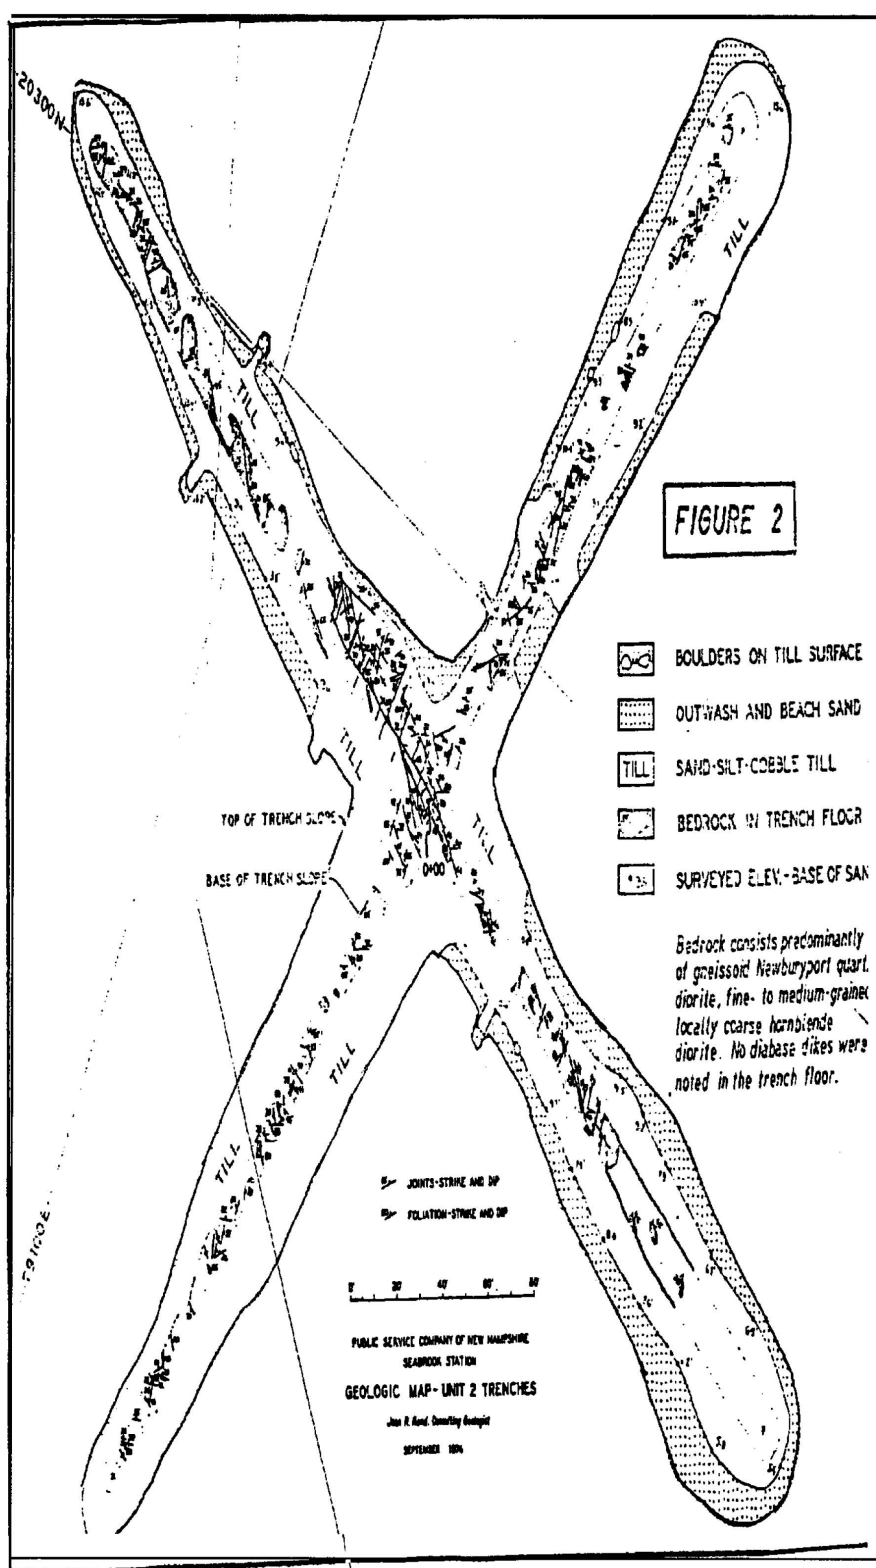
Figure 2 Geologic Map - Unit 2 Trenches

When examined in conjunction with joint mapping of the bedrock surface (Figure 2), Borings E2-15, E2-16, E2-17 and E2-18 do not indicate the presence of a through-going fault structure in the area of Unit 2. These borings do appear, however, to suggest that the most prominent or continuous high-angle chlorite-coated joint system in the containment area trends approximately east-west (True) through the central part of the containment, and dips 70-80° to the north.

Figure 2 shows by half-tone shading the areas of bedrock mapped by J. R. Rand in the several trenches. Although the trenches were excavated to bedrock, throughout, the bedrock in the low elevation areas was too obscured by water and mud to permit the observation of joints or other pertinent structural features. Although much of the bedrock surface is rough and irregular due to glacial plucking or breaking by the backhoe, wide areas of the bedrock are locally smooth and show glacial striations.

As shown on Figure 2, jointing in the bedrock is closely spaced throughout the Unit 2 containment area, occurring at intervals which rarely exceed 5' and commonly occurring at less than 3' intervals.

At the centerline of Unit 2, the most continuous joint trend is N80-90E with steep dips to the north. This set is seen commonly to have chlorite-coated surfaces. The N65-70W joints appear to converge and terminate against the N80-90E set, while the N05-20W joints are characteristic & very short and discontinuous. Slickenside striations which occur on many of the joints exhibit widely divergent directions of movement.

From about Station 1+15 to 1+50 in the East trench, the bedrock is subject to closely-spaced jointing, and the upper 1-3' of the bedrock was sufficiently fractured to permit excavation by t'ne backhoe. Joints in this area are chlorite-coated and smooth, and show some polishing on conchoidal surfaces. Thin gray clay fillings occur locally in discontinuous patches between some joints. Slickensides show no preferred orientation, and no strike direction could be determined for this zone.

Subsequent to backhoe excavation of the trenches, the contact horizon between the till and overlying outwash sand was exposed and cleaned by hand throughout the length of its exposure in the West, North and East trenches. The contact was inspected and photographed by J. R. Rand throughout its exposed length in these trenches, and its elevation determined by transit leveling along both walls of each of these trenches. The extent of the outwash sand deposits in the trench walls and the elevations of the till/outwash contact from place to place are shown on Figure 2.

No features were observed along this till/outwash contact in any of the trenches to suggest either static or dynamic deformation subsequent to deposition of the sand on the beveled till surface. Throughout the zone of close and slippery bedrock jointing between Stations 1+15 and 1+50 in the East trench, the overlying till/outwash contact horizon is sub-planar and continuous.

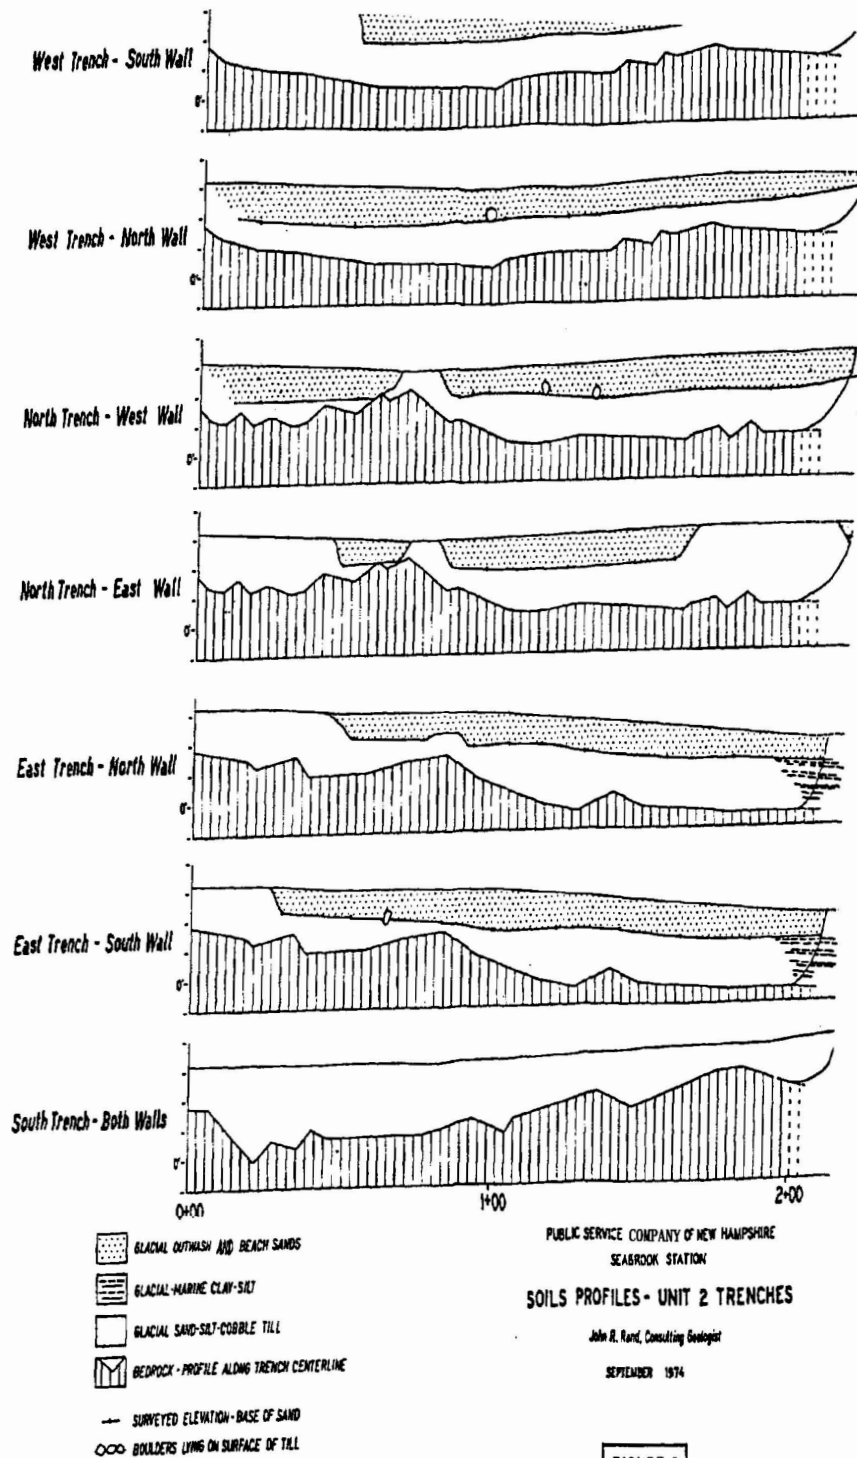
Figure 3 Soils Profiles - Unit 2 Trenches

Ground surface elevations in the area of the trenches range from about +10' to +20'. The elevation of the bedrock surface in the floor of the trenches ranges from about -3' at Station 1+80 in the East trench, to +14' at Station 1+85 in the South trench. Profiles of the bedrock surface along the centerlines of the trenches, as surveyed by Public Service Company of New Hampshire personnel, are shown on Figures 1 and 3.

As shown on trench profiles on Figure 3, brown sand-silt-cobble till directly overlies the bedrock surface throughout the area exposed by the four trenches. Till rises to ground surface throughout the length of the South trench, and rises locally to ground surface in the North trench and in the area of the Unit 2 centerline. Where the till does not rise to ground surface in the trenches, the upper surface of the till is a gently undulating, sub-planar erosion surface on which was deposited a layer of medium-fine outwash sand. At the east end of the East trench, a sequence of interbedded, evenly-layered marine clays and sands lies between the till and the overlying outwash sand iayer. At scattered intervals in the West, North and East trenches, isolated boulders ranging to 3' in diameter lie enclosed in outwash sand and rest on the upper surface of the till.
